Hayden Gulch LO inspection

Miranda and Mike,
Here is the Hayden Gulch LO, C-1992-081, inspection report for June 2024.
Brock

Permit Number: C-1992-081 Mine Name: Hayden Gulch Loadout Operator: Hayden Gulch Terminal, LLC Operator Address: Ms Miranda Kawcak 29515 Routt County Road 27 Oak Creek, CO 80467	County: Routt Operation Type: Loadout Permit Status: Active Ownership: Private
	Operator Representative Present: Michael Howard
Operator Representative Signature: (Field Issuance Only)

Inspection Start Date: June 11, 2024 Inspection Start Time: 14:30 Inspection End Date: June 12, 2024 Inspection End Time: 09:30	Inspection Type: Coal Complete Inspection Inspection Reason: Normal I&E Program Weather: Clear
Joint Inspection Agency: None	Joint Inspection Contacts:
Post Inspection Agency: None	Post Inspection Contacts:
Inspector(s): Brock Bowles	Inspector's Signature:

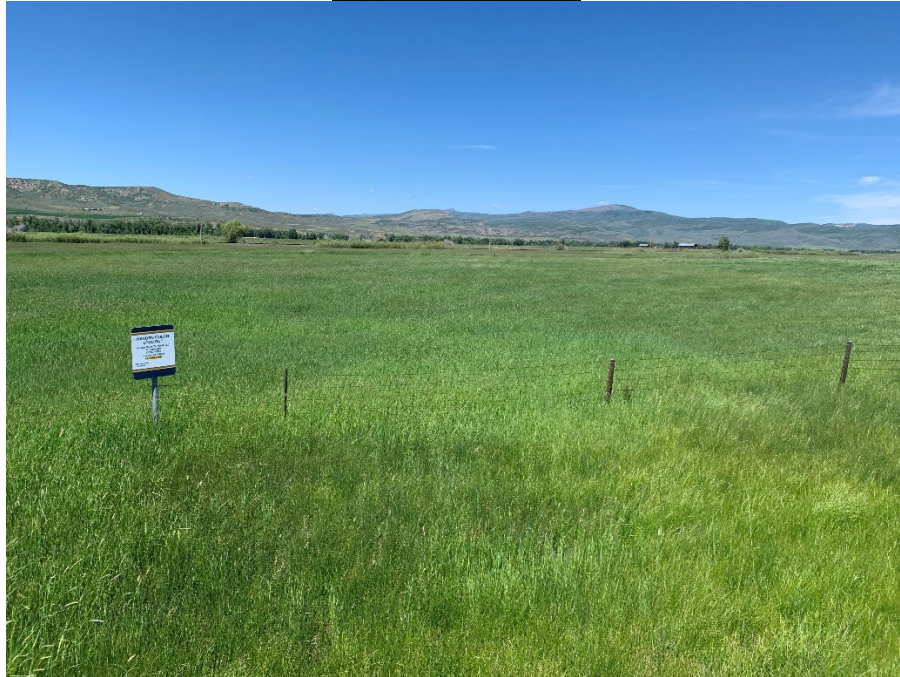
The vegetation on the reclaimed area north of Hwy 40 looked very good. It looked similar in color, growth, and height to the other surrounding areas (photo 1).

Two mine identification signs were noted. One on Hawthorne Street and one on the north side of Hwy 40 (photo 1).

Photo 1 – Area north of Hwy 40

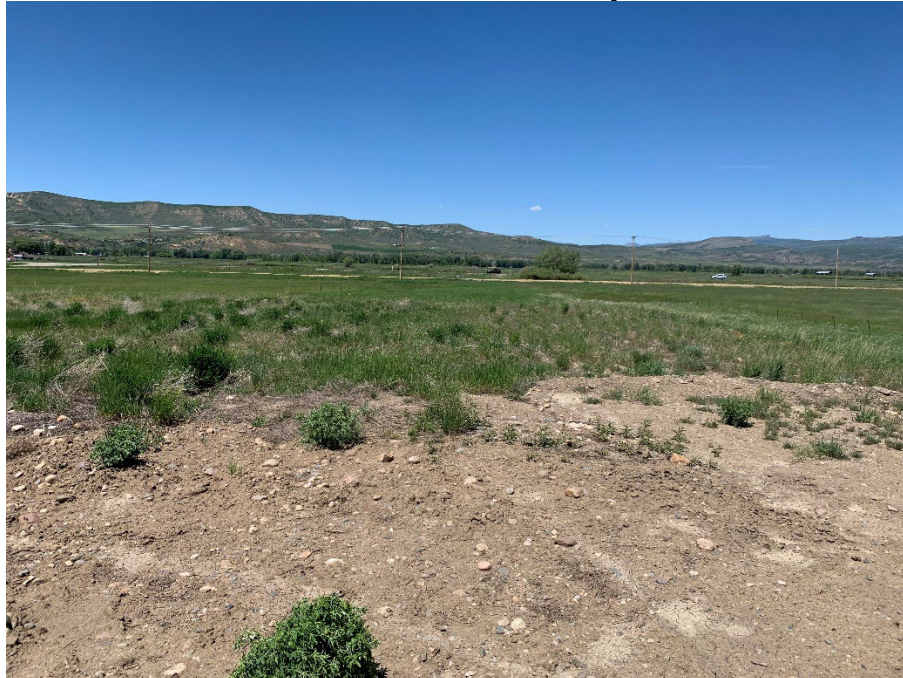
The vegetation in the area between the trailhead parking lot and Hwy 40 looked good (photo 2). It was a little patchy in spots but overall getting established nicely. The construction of the sewer line near the power poles appears to be complete.

Photo 2 – Area between parking lot and Hwy 40
