TRAPPER MINING INC.
CRAIG, COLORADO

HORSE GULCH FILL
QUARTERLY FILL CERTIFICATION

Horse Gulch Fill Quarterly Inspection Report

Second Quarter 2024

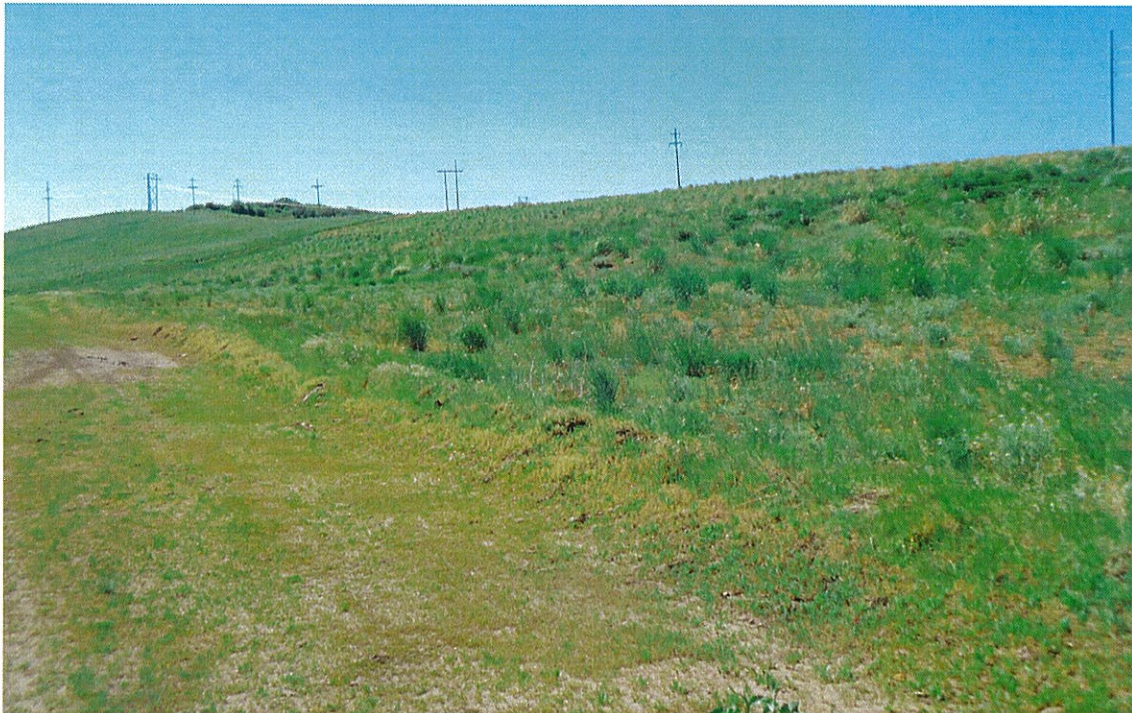
No appearances of instability, structural weakness, or other hazardous conditions were observed. Both the southeast side of the fill and the northeast side of the fill were inspected this quarter (Photographs 1 and 2). The area where cracks were detected on the top south portion of the dump during the first quarter of 2013 inspection was checked. There was no additional cracking found.

Photograph 1: North-east Side Looking South (6/17/2024)

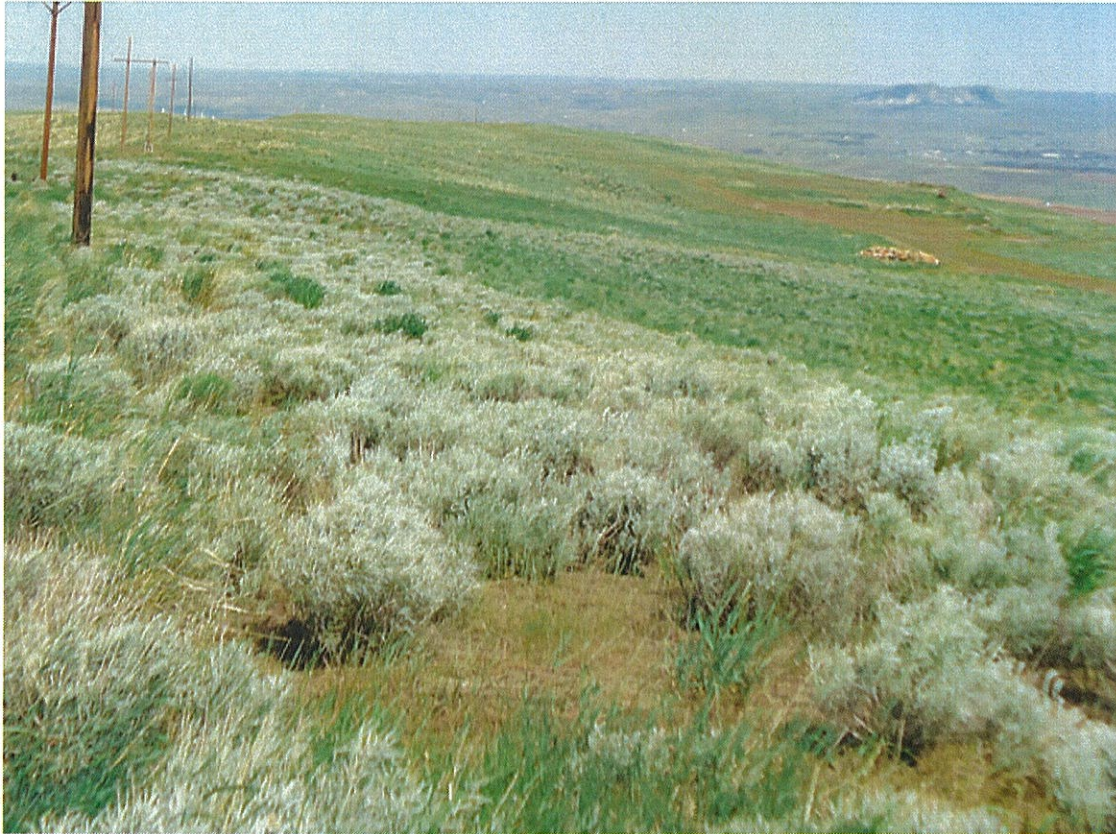
Photograph 2: South Side Looking North (6/17/2024)

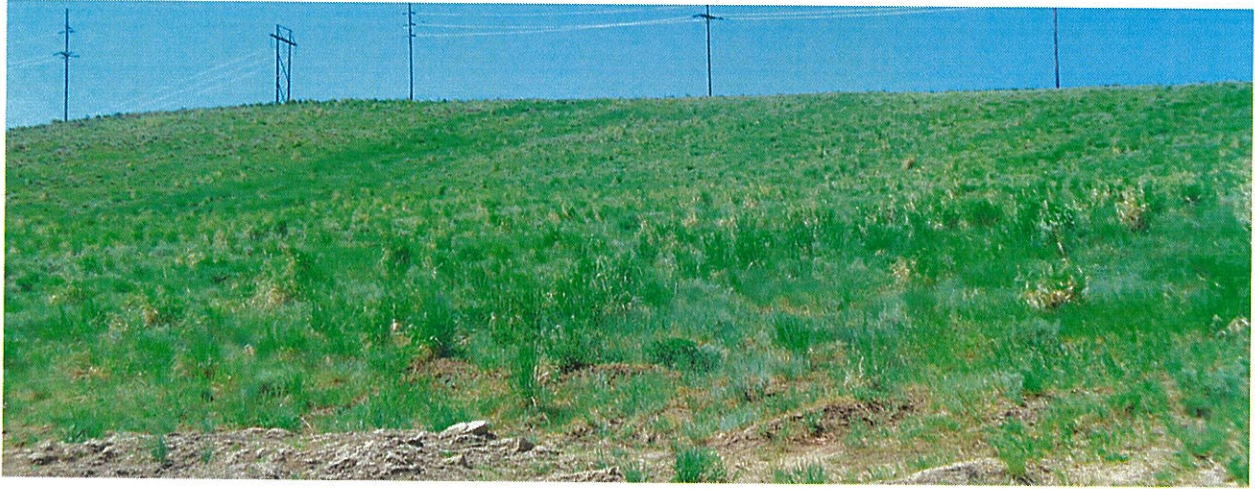
Photograph 3 depicts the east facing slope of the fill.

Photograph 3: East Side of the Fill Looking South-west (6/17/2024)
