Division of Reclamation,  
Mining and Safety

### PERMIT INFORMATION

<b>Permit Number:</b> C-1982-056 <b>Mine Name:</b> Foidel Creek Mine <b>Operator:</b> Twentymile Coal, LLC <b>Operator Address:</b> Ms. Miranda Kawcak 29515 Routt County Road No. 27 Oak Creek, CO 80467	<b>County:</b> Routt <b>Operation Type:</b> Underground <b>Permit Status:</b> Active <b>Ownership:</b> Private
	<b>Operator Representative Present:</b>  Michael Howard
<b>Operator Representative Signature: (Field Issuance Only)</b>

<b>Inspection Start Date:</b> June 11, 2024 <b>Inspection Start Time:</b> 08:00 <b>Inspection End Date:</b> June 12, 2024 <b>Inspection End Time:</b> 09:30		<b>Inspection Type:</b> Coal Complete Inspection <b>Inspection Reason:</b> Normal I&E Program <b>Weather:</b> Clear	
<b>Joint Inspection Agency:</b>  None		<b>Joint Inspection Contacts:</b>  	
<b>Post Inspection Agency:</b>  None		<b>Post Inspection Contacts:</b>  	
<b>Inspector(s):</b>  Brock Bowles	<b>Inspector's Signature:</b>

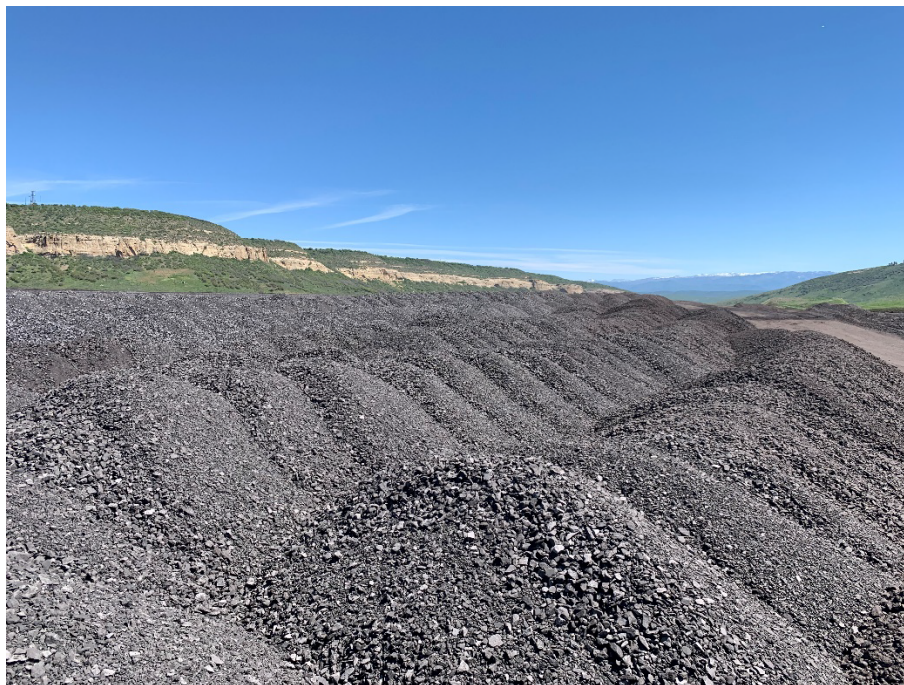
The wash plant was not running and therefore no waste was being hauled to the coal refuse pile. A large area of end-dumped material was on the wasted pile and had not been graded (photo 1). The area of end-dumped material was 10-15 acres in size. No machinery capable of grading the waste rock was on the stockpile.

Photo 1 – Waste material end-dumped on coal refuse pile.

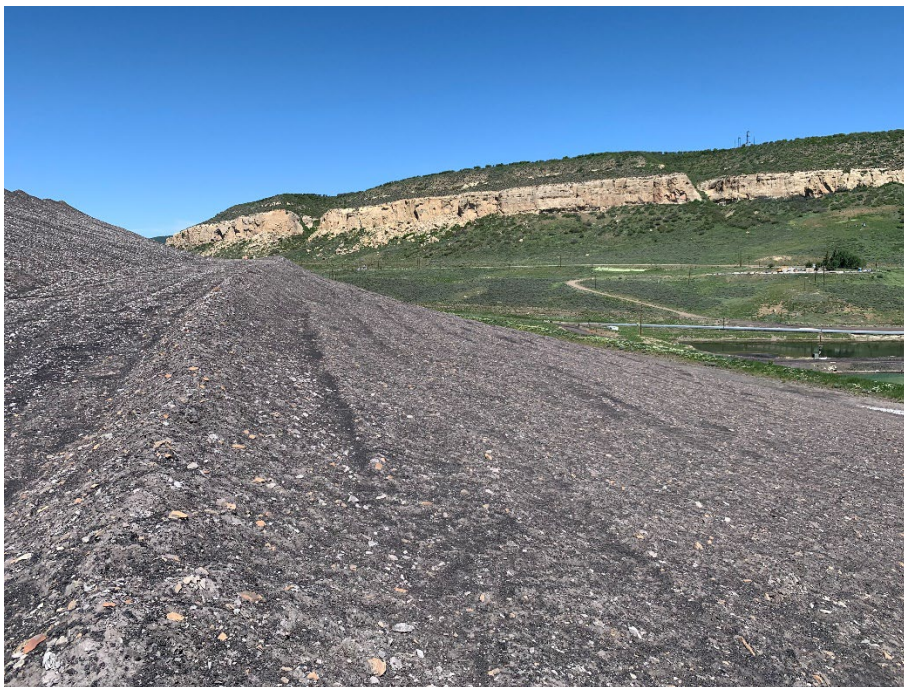
The face of the waste pile was inspected. The bench below the bench currently being built is planned to be final graded during sometime in the next couple of months (photo 2). Survey stakes were in place marking the final configuration. No erosion gullies were seen on the face of the pile.

Photo - Face of Coal refuse pile

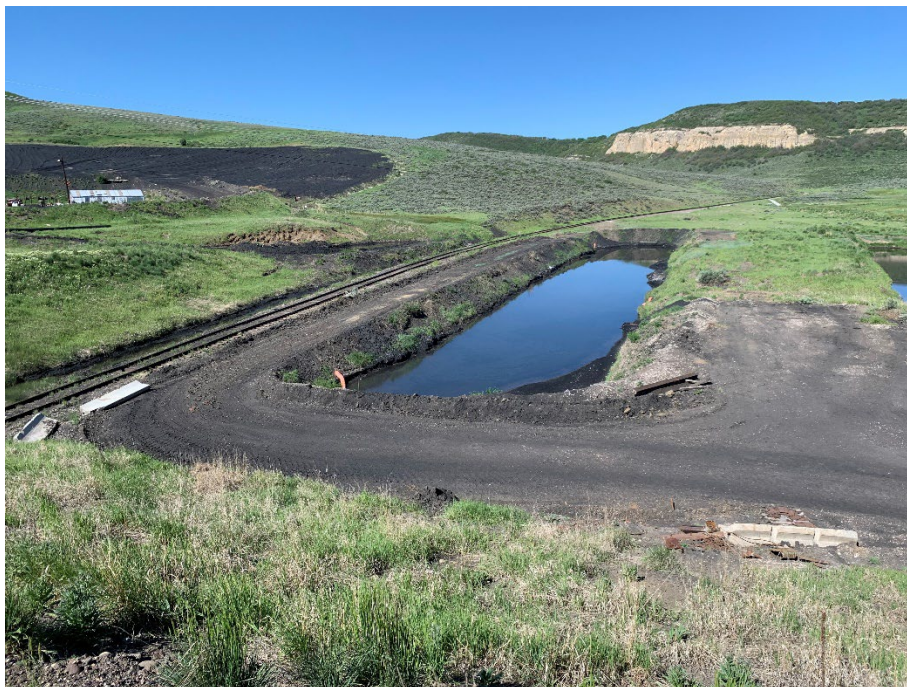
Pond B had recently been cleaned and contained water (photo 3).

Photo 3 – Pond B, southern cell

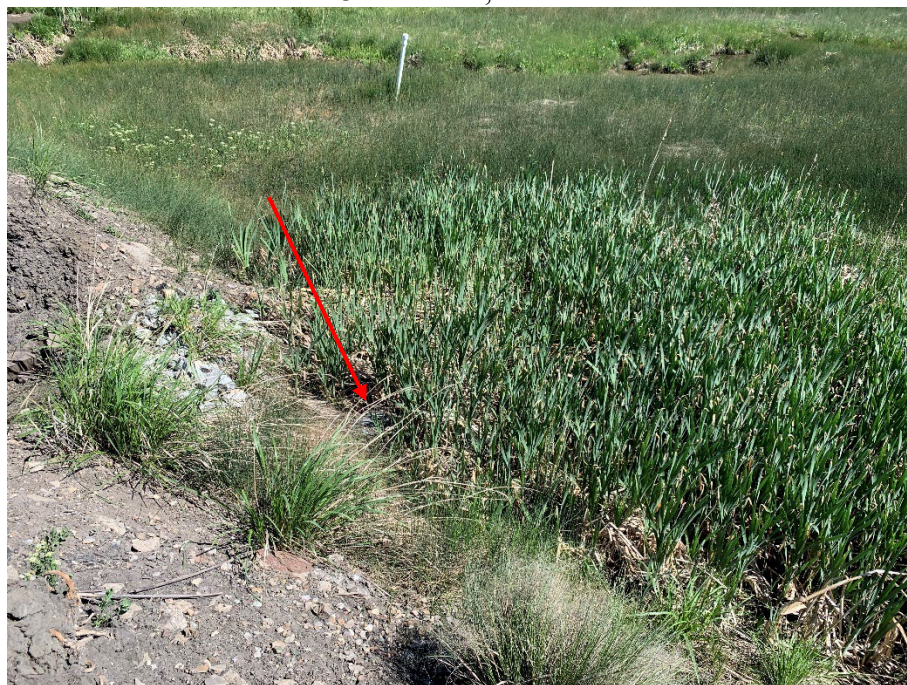
The sumps along the batch weigh loadout road were clean and free of obstructions. The culvert outlet under the batch weigh loadout road needs to have the cattails cleared (photo 4). The cattails are effectively clogging the culvert.

Photo 4 – culvert outlet from pond c under batch weigh loadout road

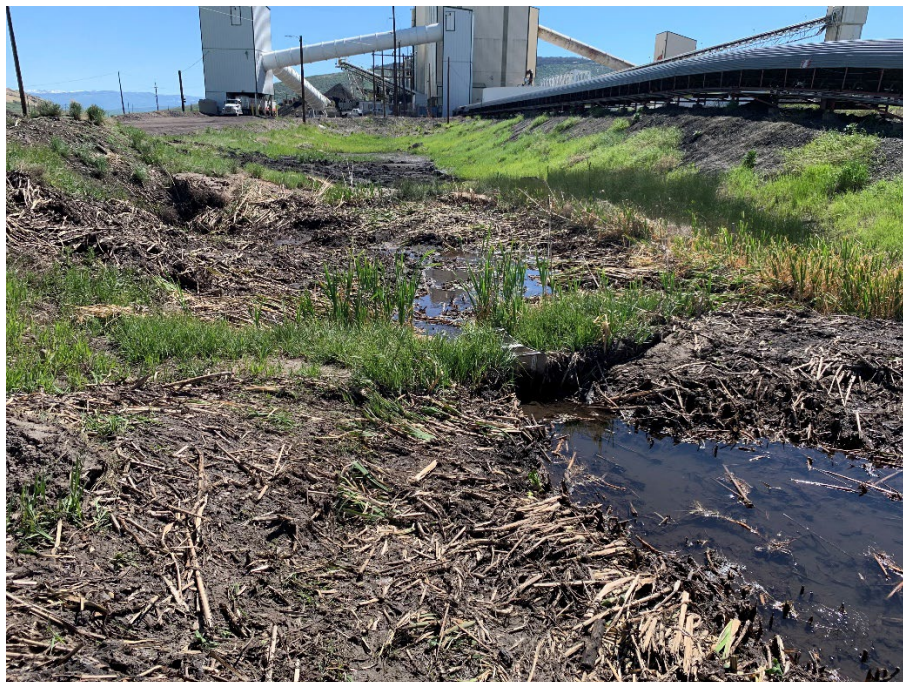
Pond D contained water and was discharging. The embankment appeared stable and was well vegetated. The primary and emergency spillways were clear of obstructions. The cattails at the discharge of Pond D had recently been cleaned (photo 5). The Pit Pond contained water and the pumps were running, supplying water to the mine workings.

Photo 5 – Pond D discharge point cleared of cattails.

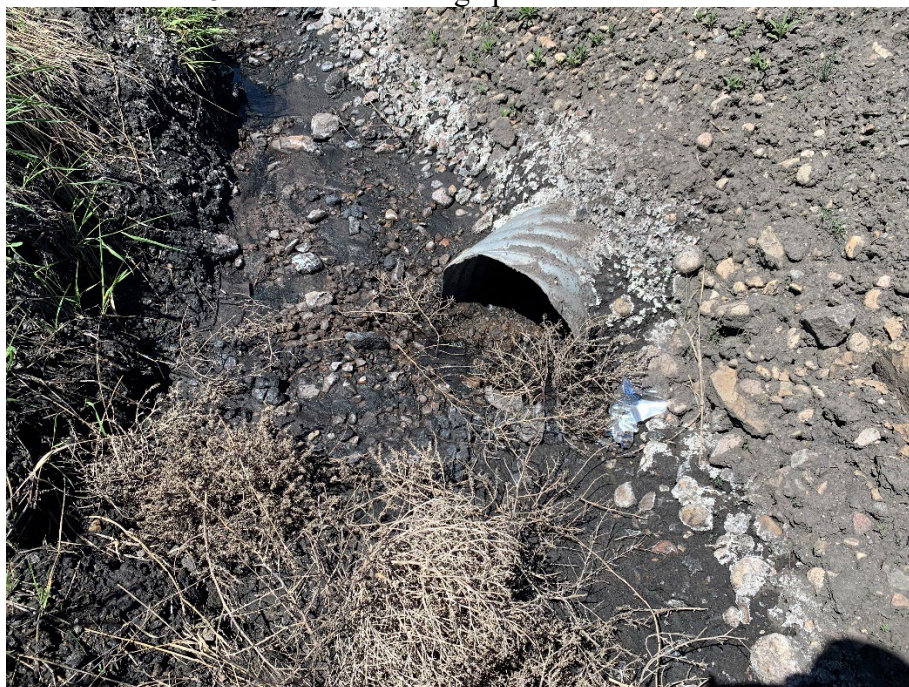
Both cells in Pond E contained water and were not discharging. The embankment was well vegetated and appeared to be stable. The south cell was recently cleaned, and water was not flowing between the cells. The culvert E2E that goes under the road just south of Pond E is partially full of debris and needs to be cleaned (photo 6). The cattails surrounding the discharge culvert need to be cleared because they are obstructing the water flow (photo 7). The emergency spillway was clear of obstructions.

Photo 6 – Culvert under road leading to Pond E

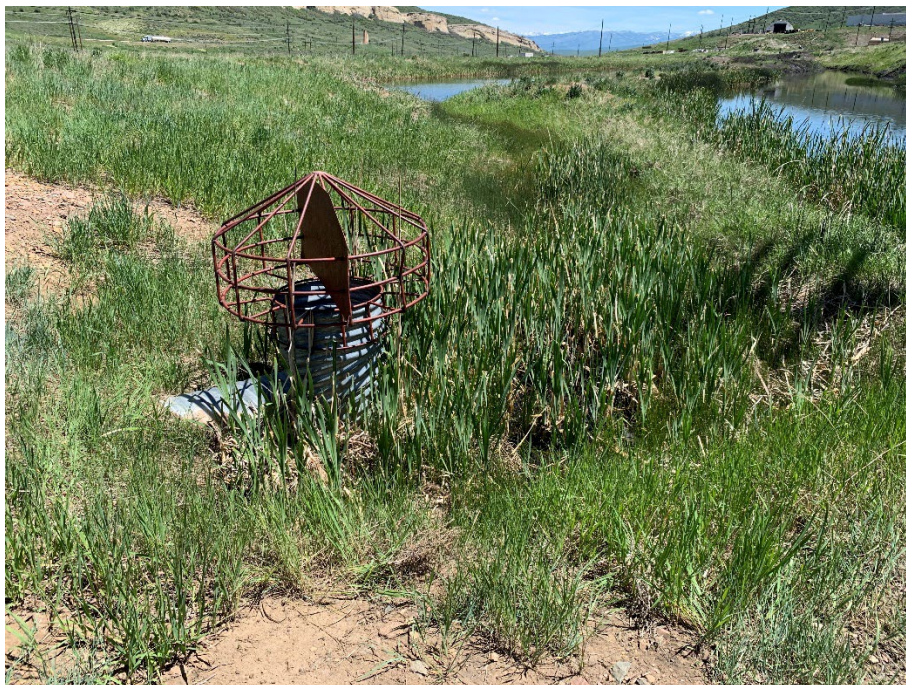
Photo 7 – Pond E discharge point needs to have cattails cleared.

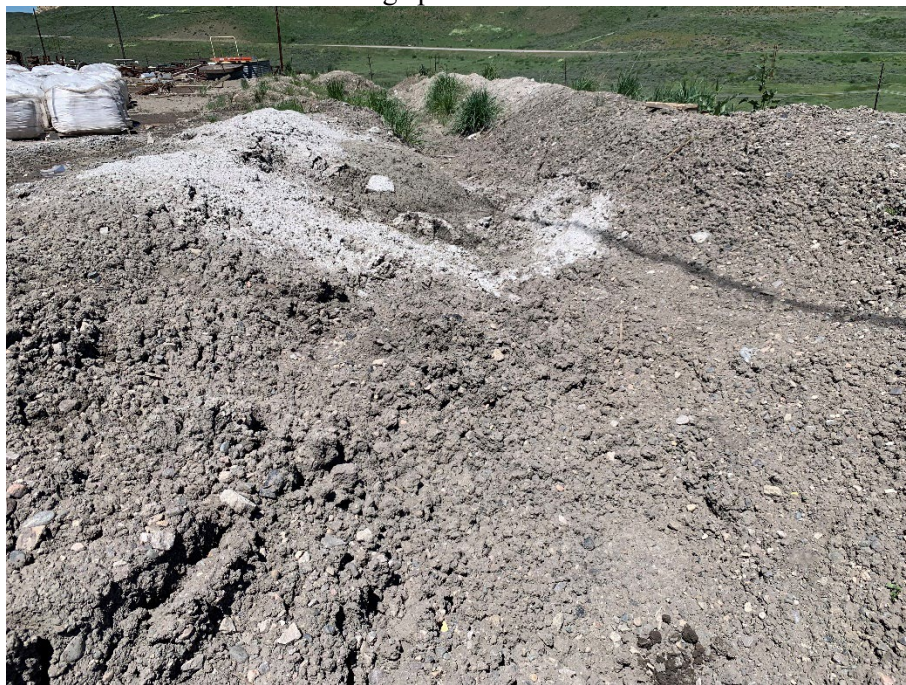
The E-1 ditch behind the maintenance shop was noted in the April 10, 2024 inspection report as being blocked by a pile of ice and debris. The large pile has melted and is no longer blocking the ditch but some debris remains in the ditch that needs to be removed to ensure proper operation (photo 8). Approximately 100 west of that pile there is another pile that is partially obstructing the E-1 ditch (photo 9). This pile also needs to be removed from the ditch to ensure the ditch can operate as designed.

Photo 8 – Ditch needs additional maintenance after snow pile melted.

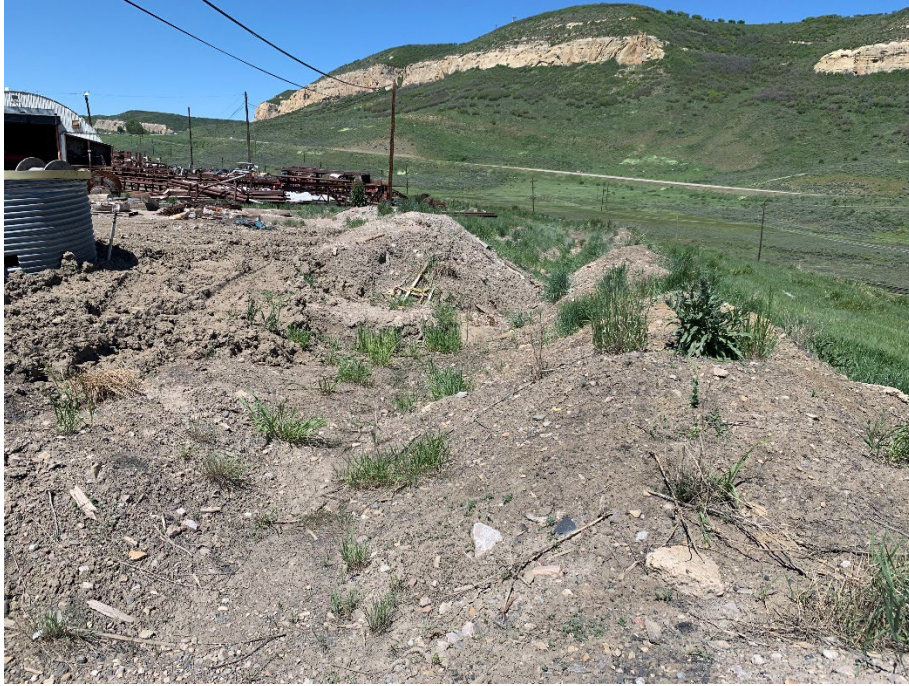
Photo 9 – A second pile behind maintenance shop needs to be removed from Ditch E-1

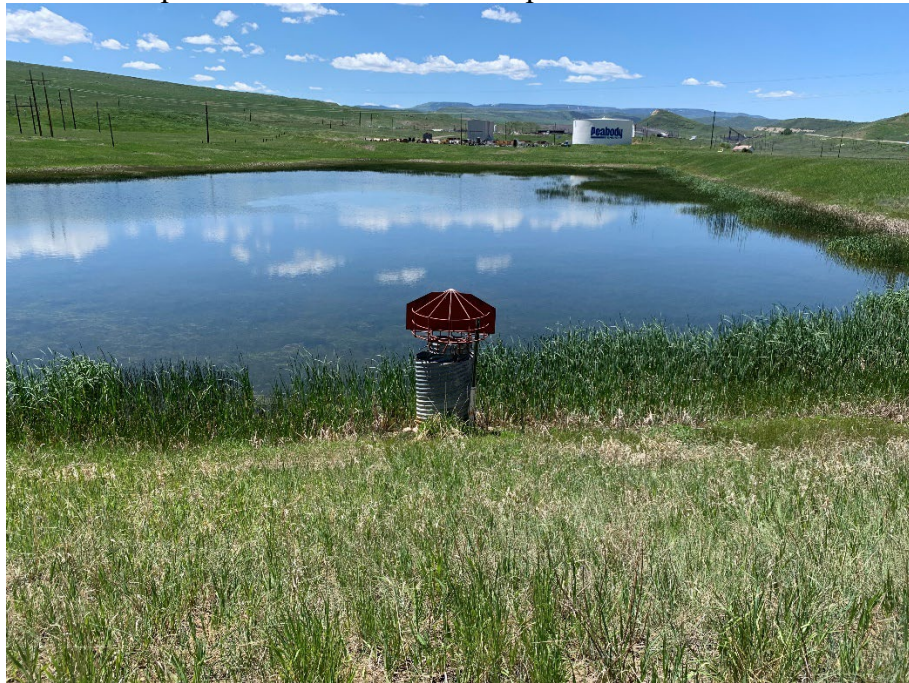
Pond G contained water but was not discharging (photo 10). The primary and emergency spillways were clear of obstructions. The embankment was well vegetated and appeared to be stable.

Photo 10 – Pond G primary spillway structure

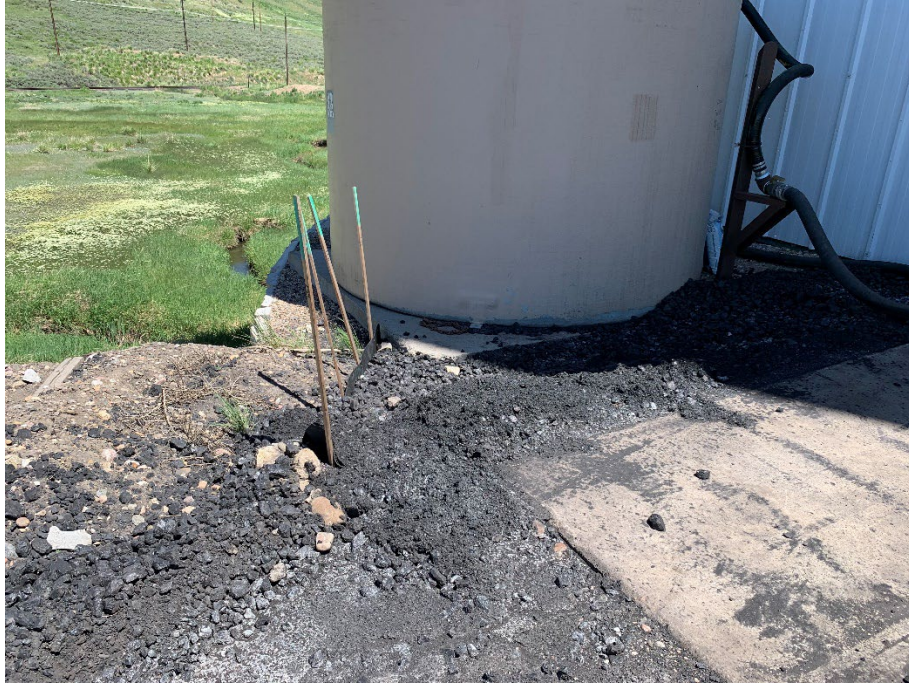
The area north of the stoker coal loadout was clear of coal fines. The area to the west of the loadout building needs to be addressed (photo 11). There is a small pile of coal that needs to be cleaned up. The silt fence is loaded with coal and is not able to function properly. The sump along the road about 100 feet west of the stoker coal load out was in working order.

Photo 11 – Drainage area by Stoker Coal Loadout that needs to be maintained.

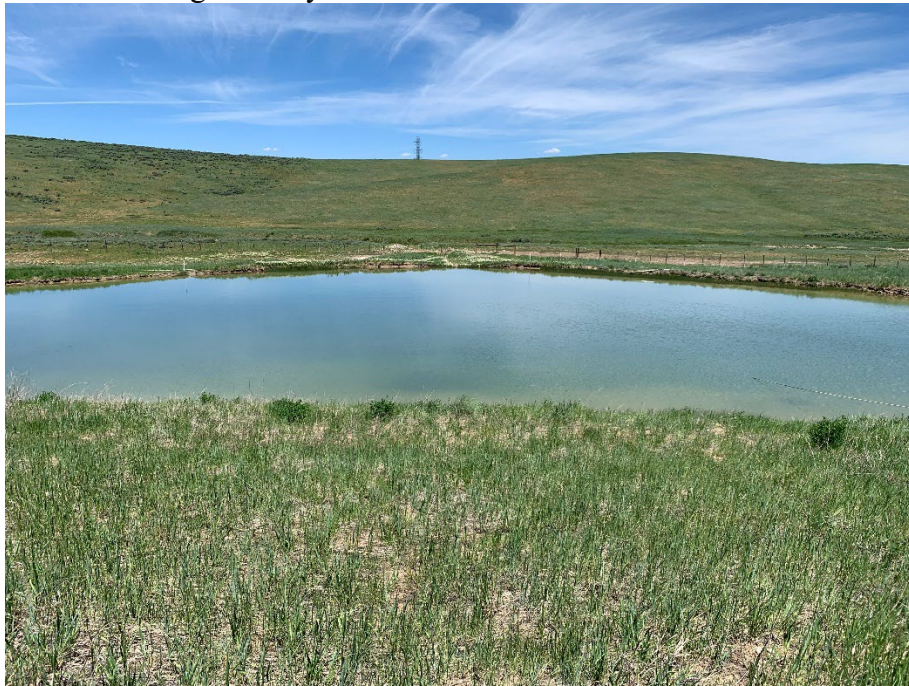
The 6 MN Ventilation Shaft pond contained water but was not discharging (photo 12).

Photo 12 - 6 MN Ventilation Shaft Pond.

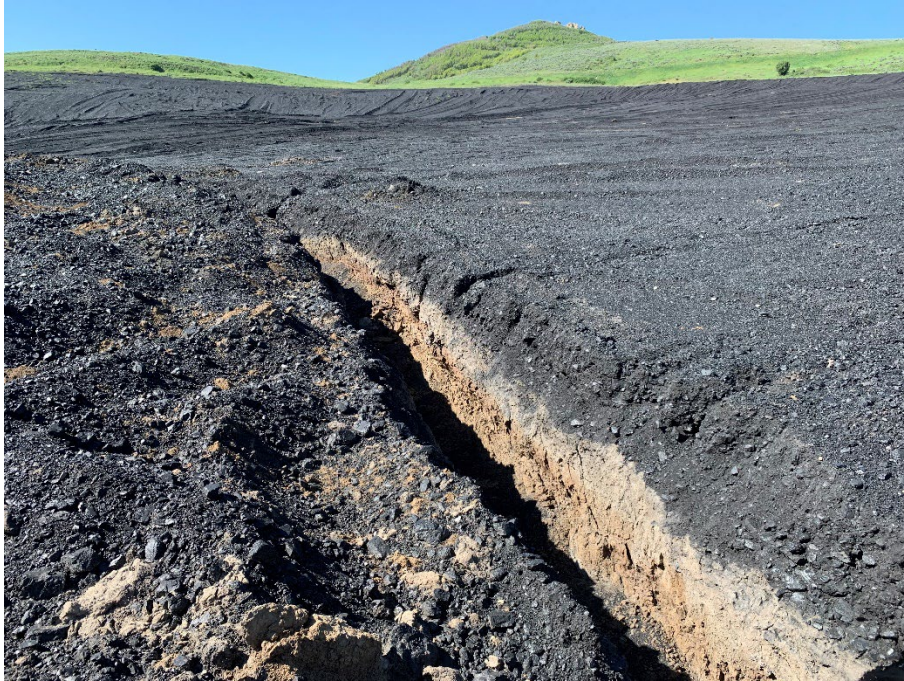
The BOB pile on the west end of the mine facility is used to store clean coal. The pile was empty of coal and the French drain at the bottom of the pile was being repaired (photo 13). The trench was dug and is ready for a new pipe to be installed. The pipe will direct any water that accumulates in the pile to Pond B.

Photo 13 – French Drain trench under the BOB pile
