**MINERALS PROGRAM INSPECTION REPORT**  
**PHONE: (303) 866-3567**

<b>MINE NAME:</b> Iron Mountain Road Gravel Pit	<b>MINE/PROSPECTING ID#:</b> M-1994-092	<b>MINERAL:</b> Gravel	<b>COUNTY:</b> Fremont
<b>INSPECTION TYPE:</b> Monitoring	<b>WEATHER:</b> Clear	<b>INSP. DATE:</b> May 23, 2024	<b>INSP. TIME:</b> 08:50
<b>OPERATOR:</b> Rocky Mountain Excavating, LLC	<b>OPERATOR REPRESENTATIVE:</b> Shawnee Koch, Bennie Koch, Bennie Koch Jr.	<b>TYPE OF OPERATION:</b> 110c - Construction Limited Impact	
<b>REASON FOR INSPECTION:</b> Normal I&E Program	<b>BOND CALCULATION TYPE:</b> Complete Bond	<b>BOND AMOUNT:</b> \$18,220.00	
<b>DATE OF COMPLAINT:</b> NA	<b>POST INSP. CONTACTS:</b> None	<b>JOINT INSP. AGENCY:</b> None	
<b>INSPECTOR(S):</b> Jocelyn Carter	<b>INSPECTOR'S SIGNATURE:</b>

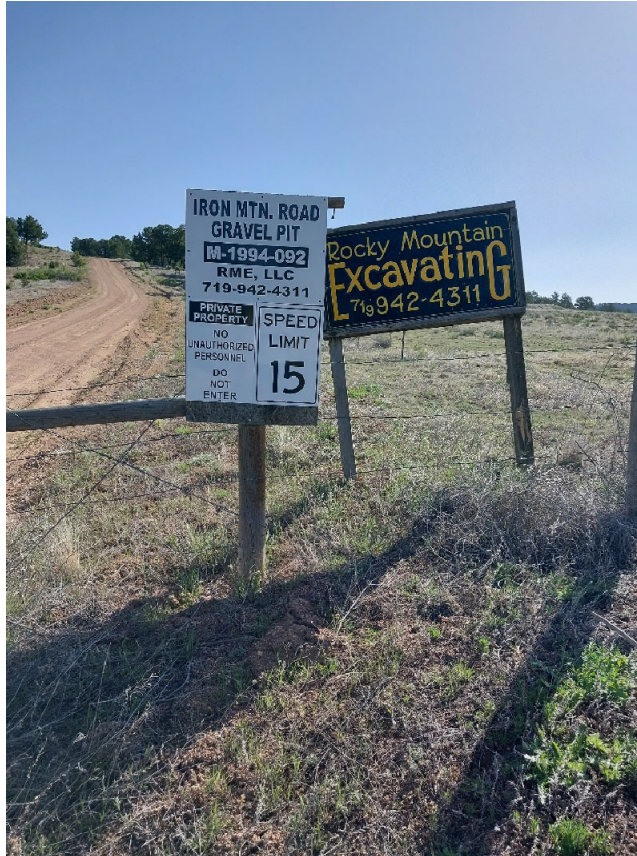
There was a sign in accordance with Rule 3.1.12 (see Photo #1). The permit boundary is fenced, the fence appeared to be in good condition with no issues.

Photo #1: Posted mine sign per Rule 3.1.12(1).

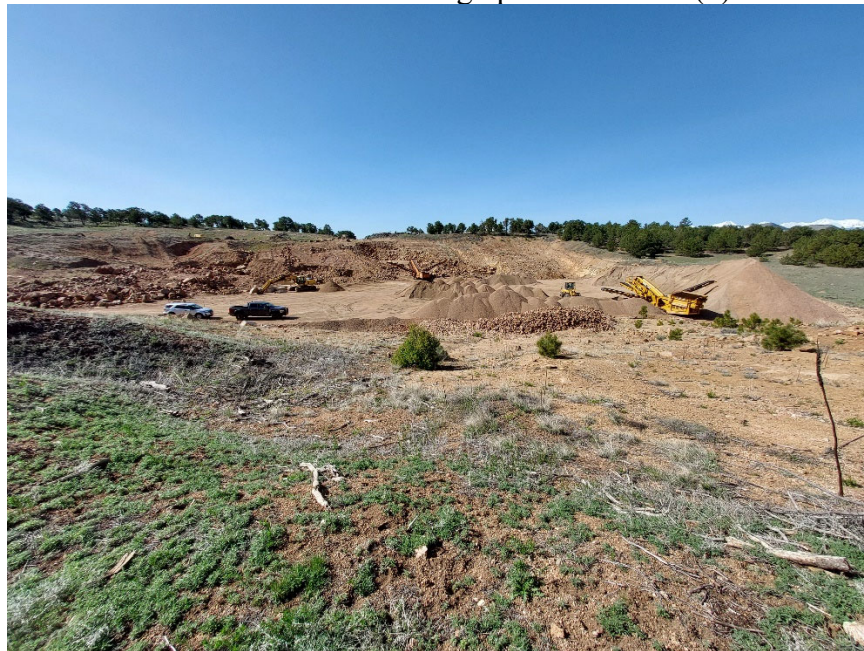
Photo #2: View of mine site from north portion of permit area, looking south.

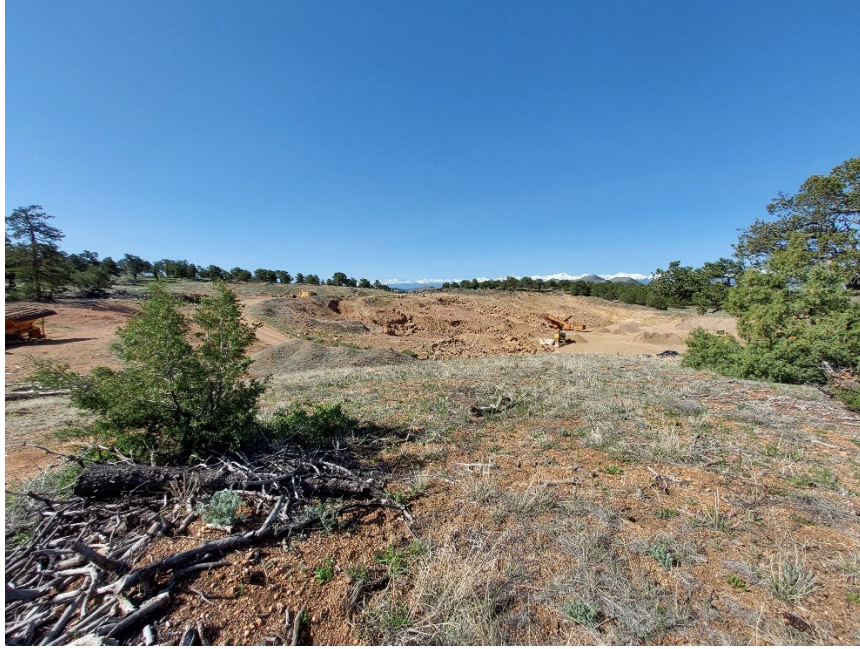
Photo #3: View of mine site from northeast portion of permit area, looking southwest.

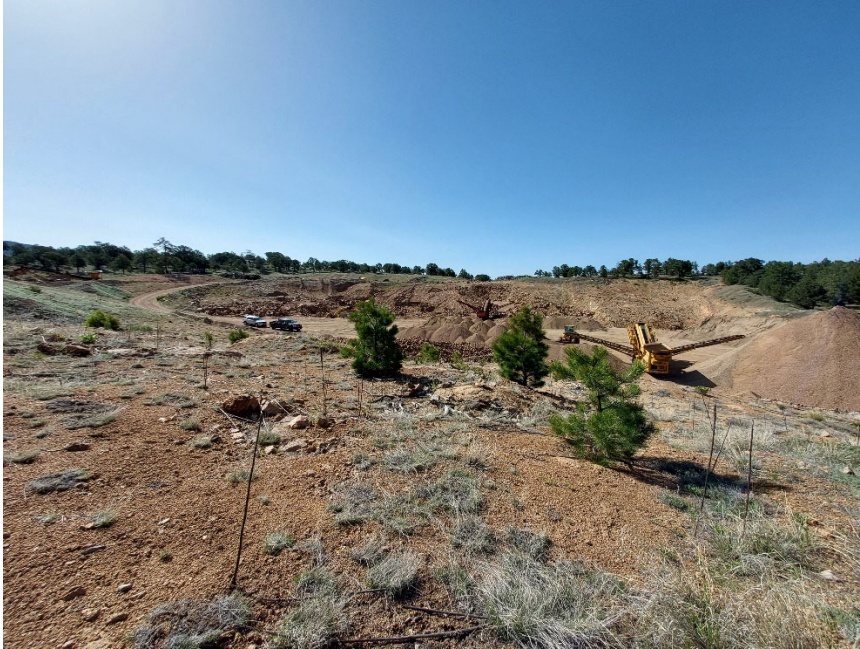
Photo #4: View of mine site from northwest portion of permit area, looking southeast. Large screener and crusher and associated processing stockpiles are seen on the right side of the photo.

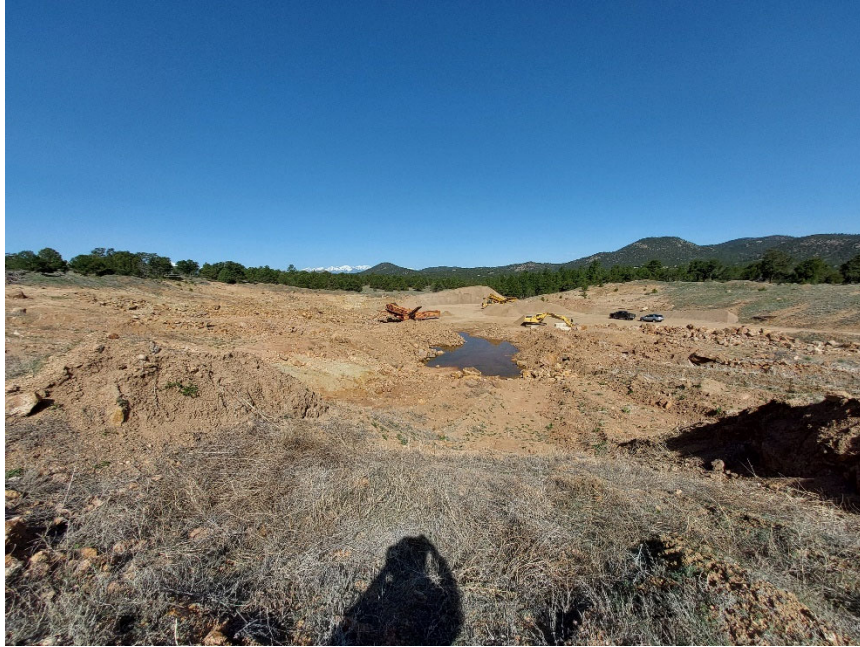
According to the last inspection, conducted by Tim Cazier on July 24, 2019, there was exposed groundwater on the west end of the pit. The exposed groundwater has been backfilled and there was no exposed groundwater observed during the inspection. There was some water observed on the pit floor in the center of the operation (see Photo #5). The observed water is attributed to a recent spring snow and rain events. There are no apparent issues with the hydrologic balance in the area.

Photo #5: View of pit from the southeast portion of the permit area, looking to the northwest. The standing water from recent storm events can be seen in the center of the photo.

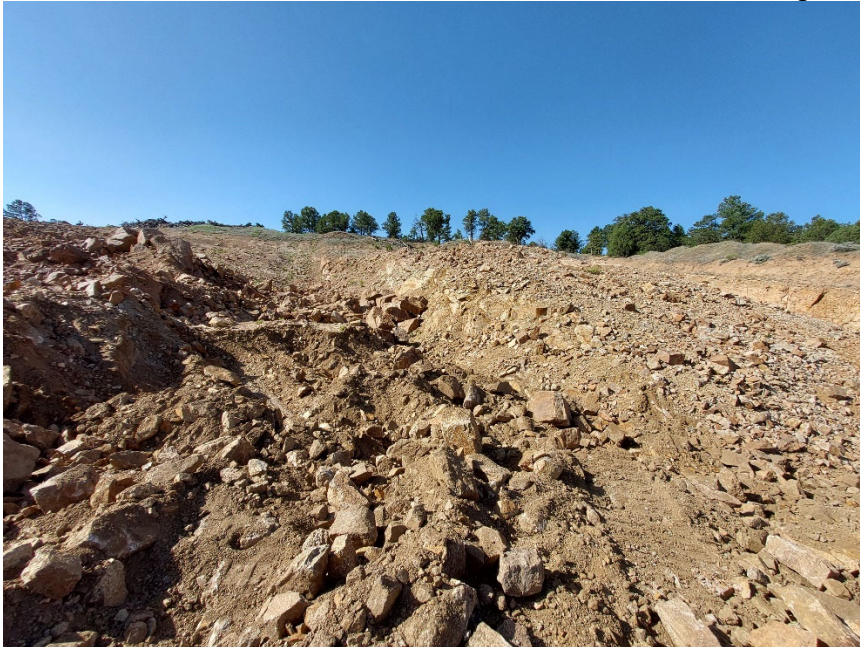
The west portion of the pit has been backfilled to address exposed groundwater. The backfilling has prevented the continuance of groundwater exposure, but grading would still need to be done and is included in the attached REC (see Photo #6).

Photo #6: View of the backfilled area where groundwater had been exposed; from the west portion of the pit floor looking to the west southwest.

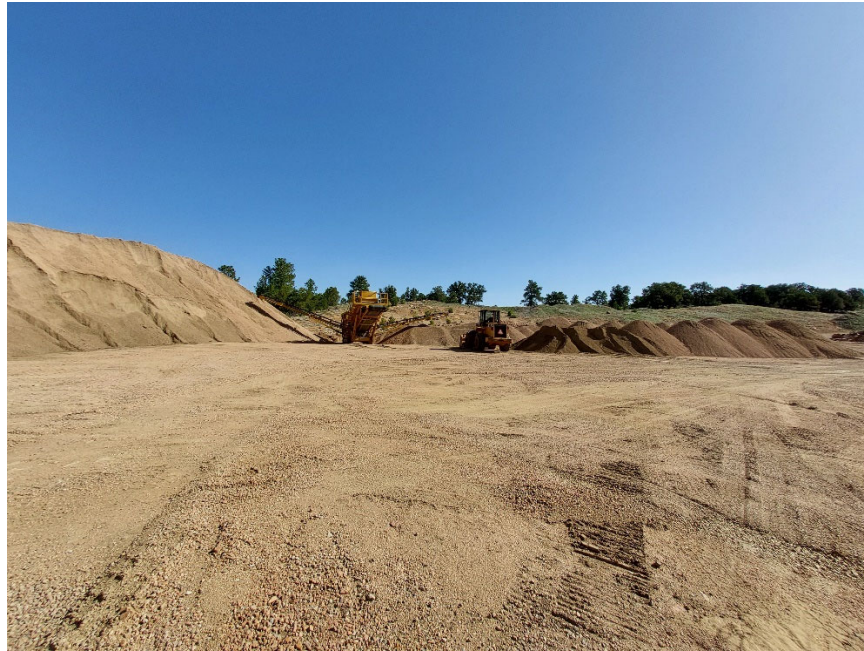
Photo #7: View of the recent processing activity, looking to the north.

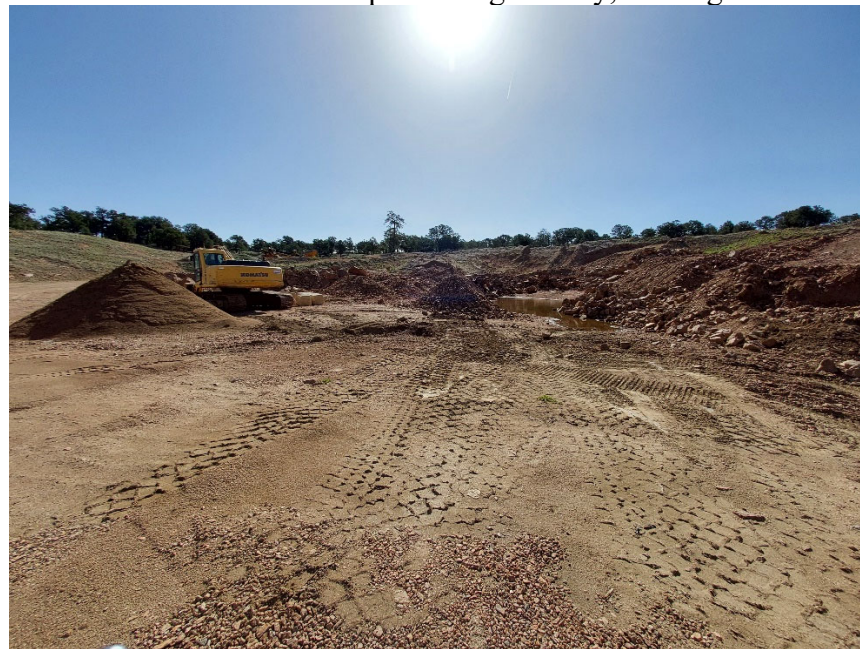
There was no mining activity occurring during the inspection, the equipment on site included four screeners and crushers, a generator, a hydraulic excavator, a wheel loader, and a flatbed trailer. There was a large stockpile of processed material and a series of smaller stockpiles of processed material observed near the largest screener and crusher (see Photo #4). There were multiple stockpiles of larger material observed around the perimeter of the pit floor. There were also a few concrete blocks observed near where the hydraulic excavator was parked (see Photo #8).

Photo #8: View of the recently excavated area, the standing water can be seen along with the concrete blocks next to the hydraulic excavator.

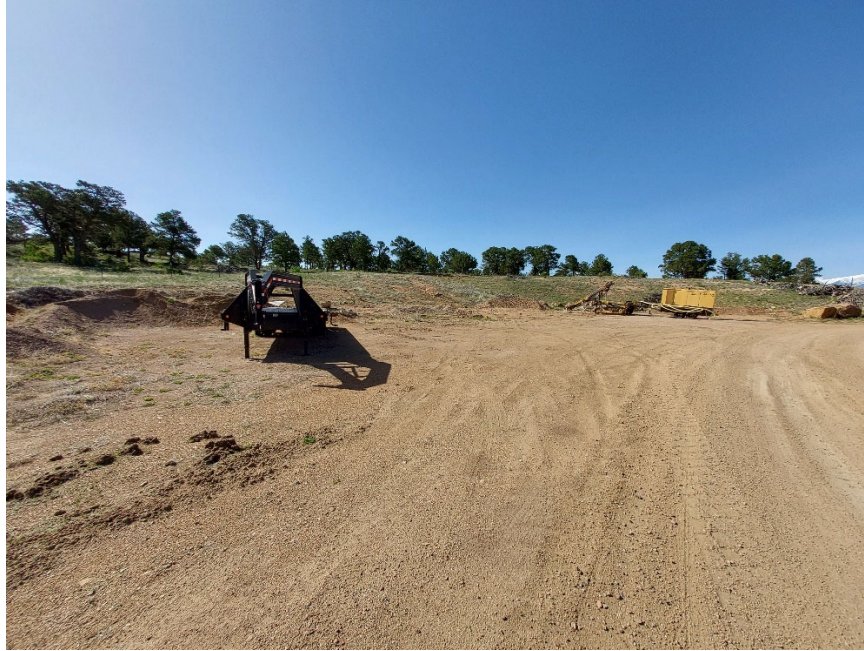
Photo #9: View of the upper portion of the road, looking to the south at an equipment parking area, the flatbed trailer, one of the screeners, and the generator can be seen.

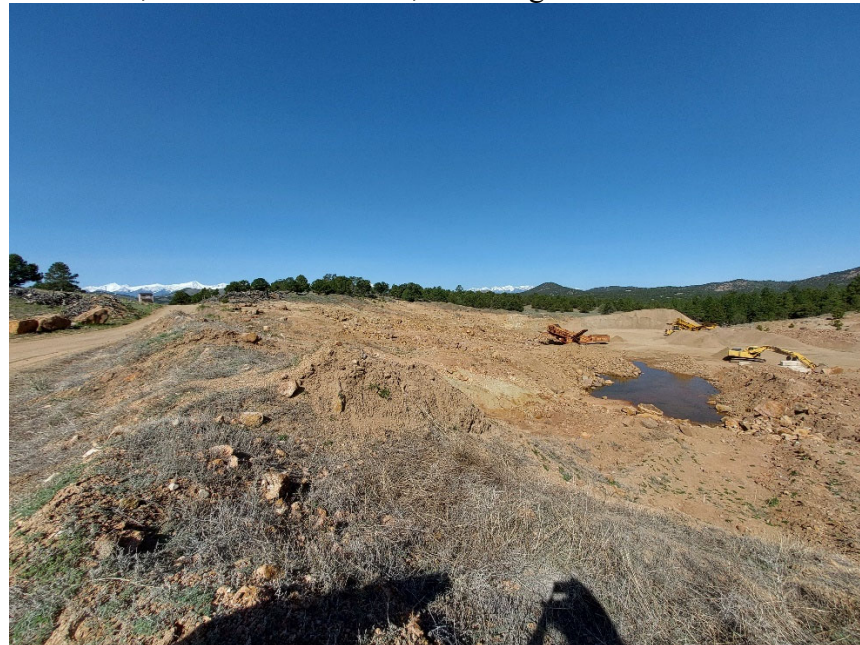
There are no permanent processing facilities on site, but there is a small structure on the east side of the road at the entrance of the mine site. The small shed/shack is about 4' x 4' x 9' and is in good condition (see Photo #10). All processing equipment are mobile units, there were four screeners/crushers observed on site. Two of the four were located on the pit floor and were extended with recent processed stockpiles at the end of the conveyor belts. The other two screeners appeared to have been moved away from the operation and not in use.

Photo #10: View of the pit area to the right and the upper portion of the road can be seen on the left of the photo. The small shack/shed can be seen to the left of the road.
