MINERALS PROGRAM INSPECTION REPORT
PHONE: (303) 866-3567

MINE NAME: Cross Gold Mine	MINE/PROSPECTING ID#: M-1977-410	MINERAL: Gold and Silver, ect	COUNTY: Boulder
INSPECTION TYPE: Monitoring	WEATHER: Clear	INSP. DATE: June 19, 2024	INSP. TIME: 09:30
OPERATOR: Grand Island Resources LLC	OPERATOR REPRESENTATIVE: Je'an-Paul Brewer	TYPE OF OPERATION: 110(2) - Hard Rock Limited Impact	
REASON FOR INSPECTION: Priority	BOND CALCULATION TYPE: None	BOND AMOUNT: \$546,751.00	
DATE OF COMPLAINT: NA	POST INSP. CONTACTS: None	JOINT INSP. AGENCY: None	
INSPECTOR(S): Patrick Lennberg	INSPECTOR'S SIGNATURE:

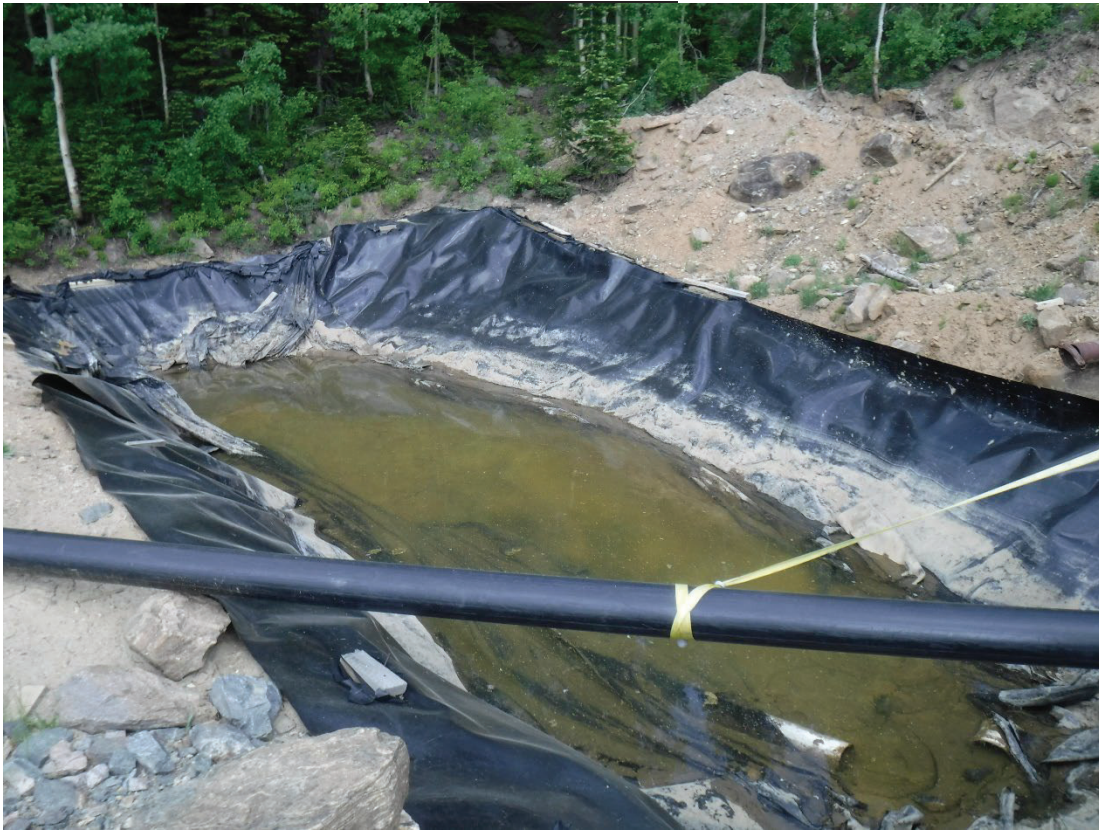
Photo 1: Pond 3a

As noted in the March inspection report, the Operator is diverting the Idaho Tunnel effluent into a pipeline that bypasses the series 3 Ponds and discharges to Pond 1. The Operator then has the ability to direct water from Pond 1 to Joliet Raise for storage prior to being treated and released. The 3 series Ponds, 3a, 3b and 3c, were observed during this inspection. The ponds contained some sediment and some water. It was recommended the Operator collect sediment samples for TCLP, or similar analysis, to determine proper disposal of the residual sediment. During the inspection the Division discussed with the Operator what steps were needed to abandon the ponds. The Division stated the Ponds could be abandoned through a Technical Revision that provided the details on disposal of the sediment and the remaining geomembrane. Once the revision was approved the Operator could proceed. Ultimately the Operator would like to use the current pond locations for equipment laydown and to allow better access to the tunnel.

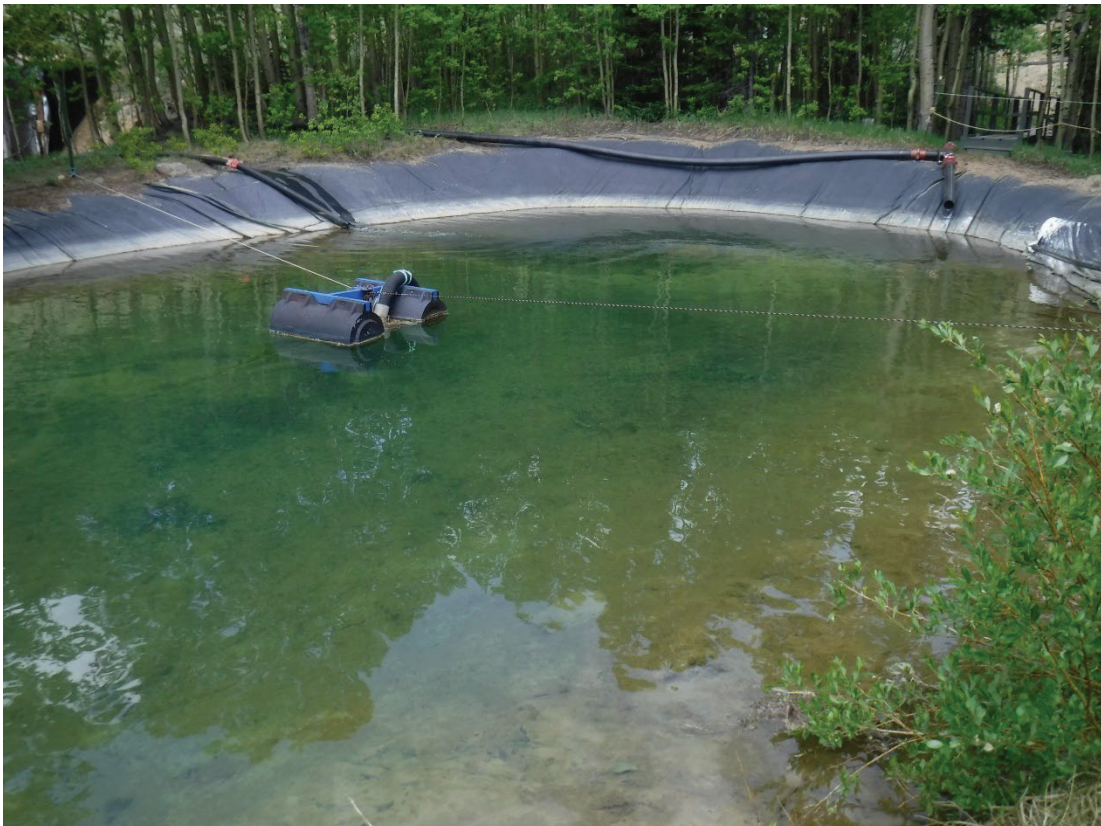
Photo 6: Pond 1

The other ponds, Pond 1 and Pond 2, were observed during the inspection. Pond 1 was clear and was operating as intended. Pond 2 was holding some water. The water in this pond is a combination of back-flush water from the water treatment plant, meteoric water, and runoff water.
