MINERALS PROGRAM INSPECTION REPORT

| MINE NAME: Peters Pit | MINE/PROSPECTING ID#: M-1991-078 | MINERAL: Gravel | COUNTY: Crowley |
| INSPECTION TYPE: Monitoring | WEATHER: Clear | INSP. DATE: June 12, 2024 | INSP. TIME: 08:04 |

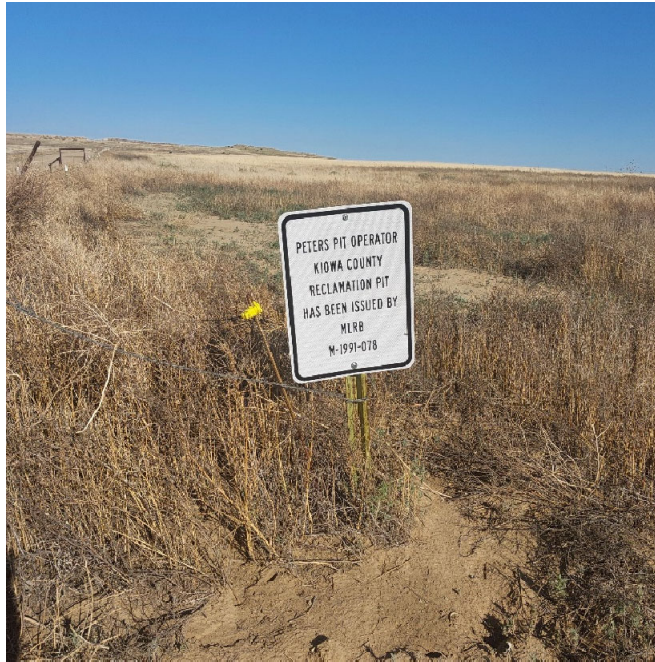
There is a sign posted in accordance with Rule 3.1.12(1) (see Photo #1). There is a problem cited at the

Photo #1: Posted mine sign per Rule 3.1.12(1).

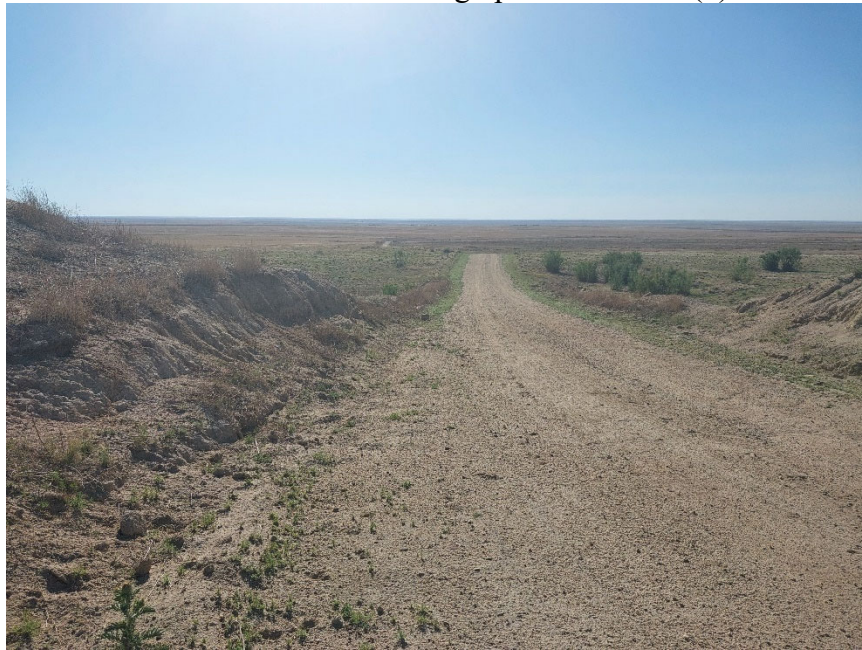
Photo #2: View of road, looking east at the area that has been backfilled, graded, and topsoiled.

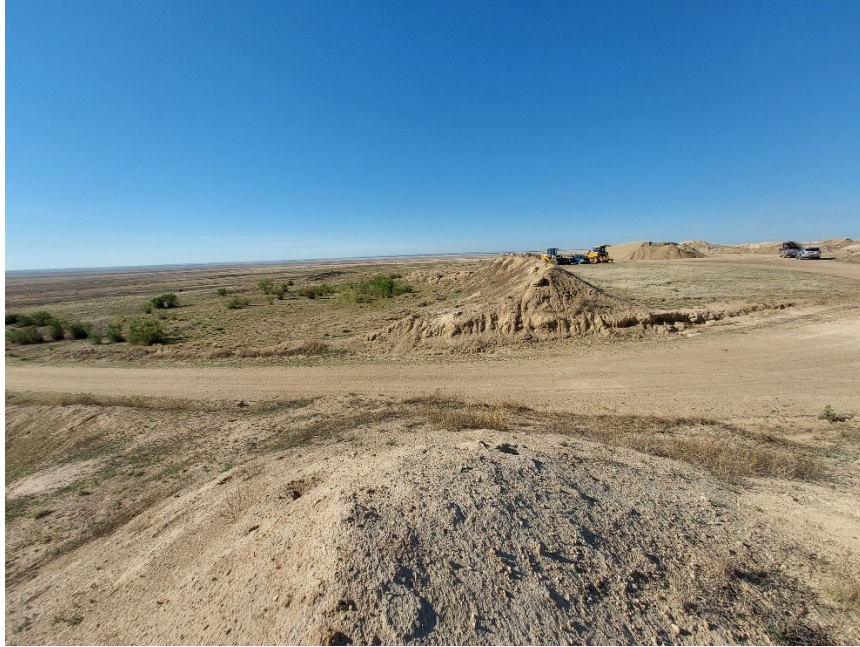
Photo #3: Looking to the south, on the left is the area that has been backfilled, graded, and topsoiled. On the right side of the photo is the recent active mining area. The wheel loader and bulldozer can be seen between the overburden berm and the product stockpile.

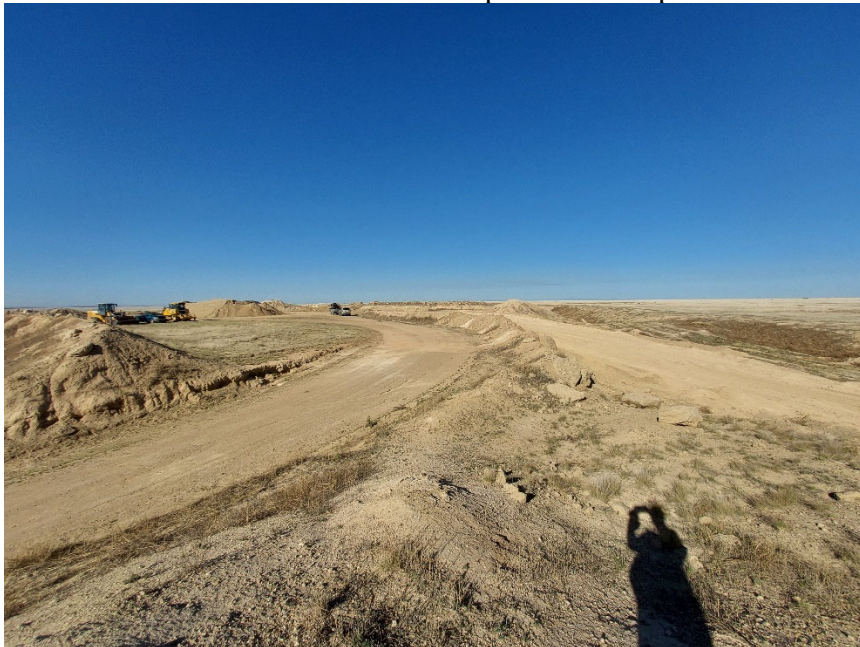
Photo #4: Looking to the west southwest at the recent active mining area.

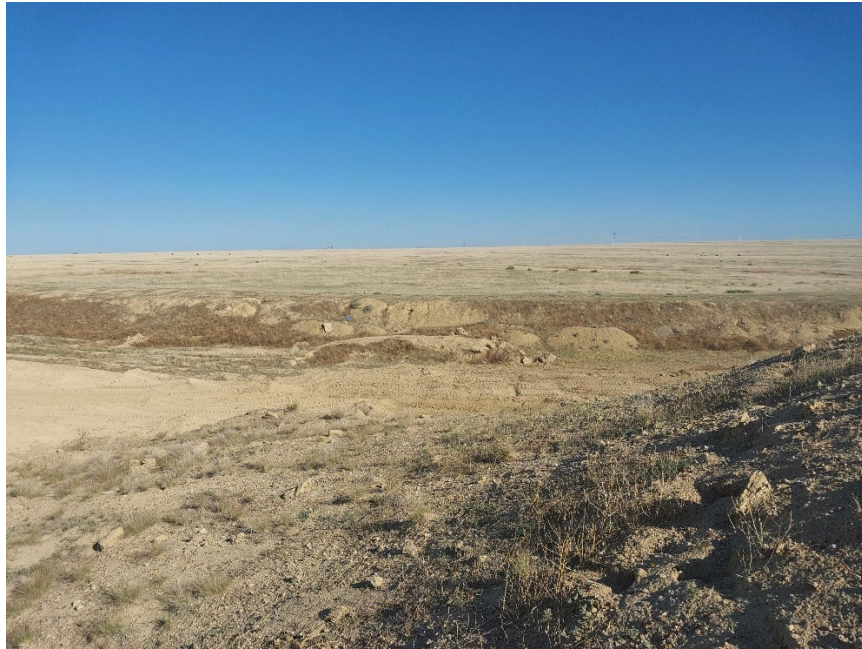
Photo #5: Looking to the north at the most recent active mining area.

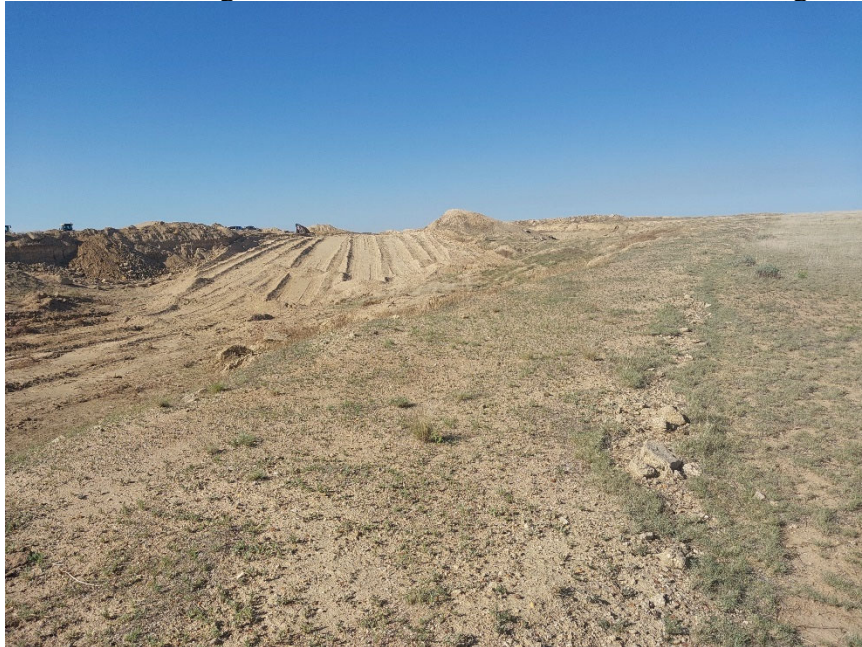
Photo #6: Looking to the south from the northwest region of the permit boundary; the most recently disturbed land can be seen.

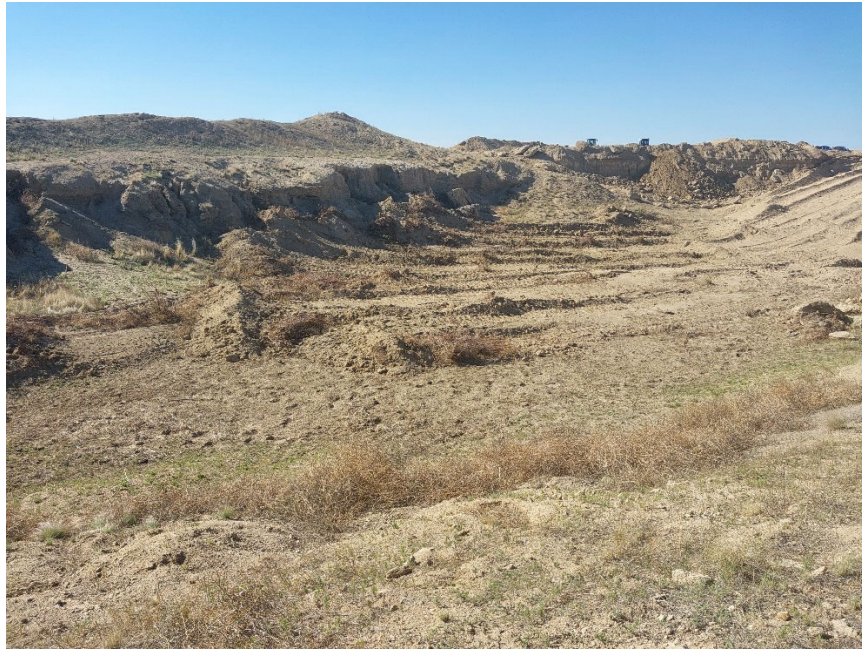
Photo #7: Looking east southeast at the most recent disturbances.

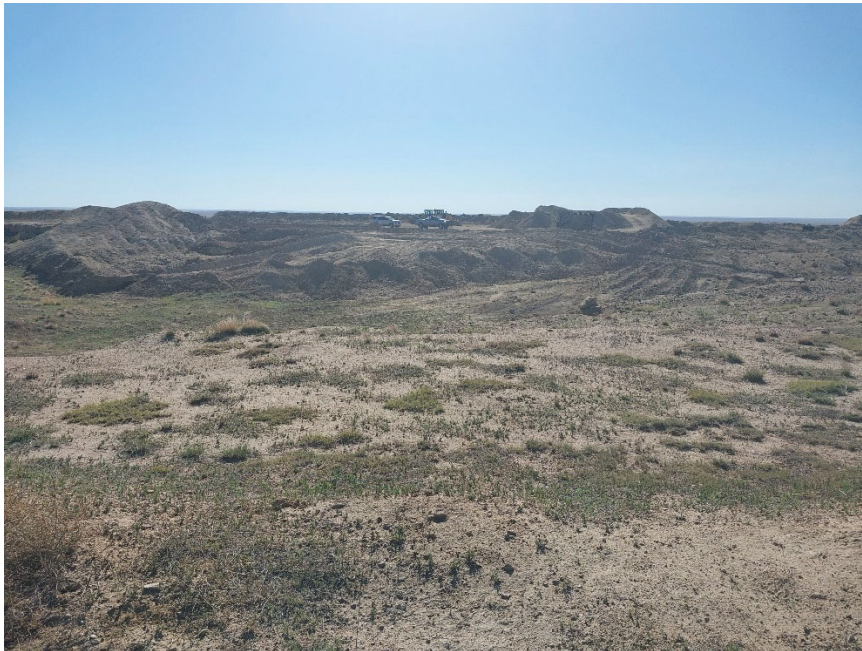
Photo #8: Looking east southeast at the most recent active mining area from Point #2 on Map #2.

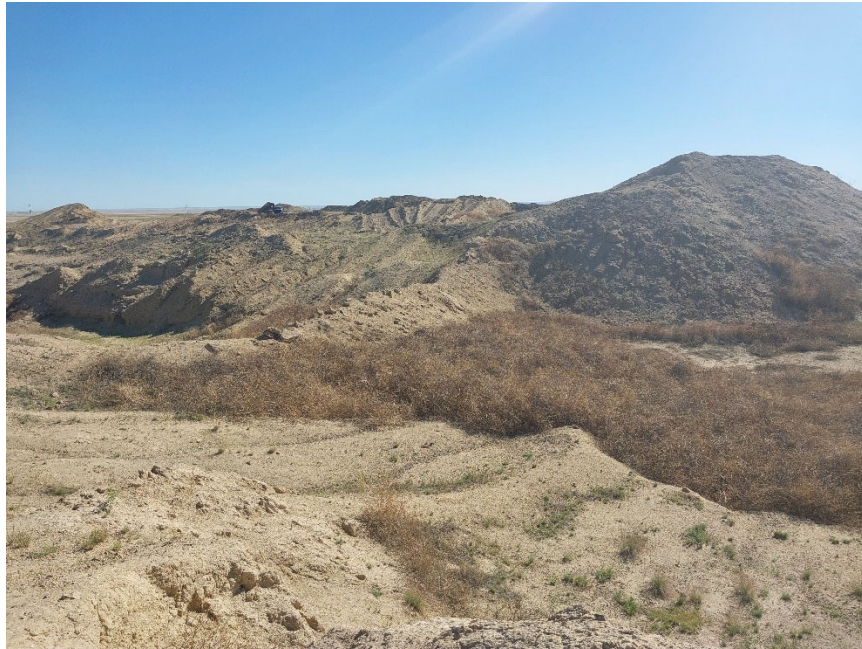
Photo #9: Looking east at the southern portion of active mining area.

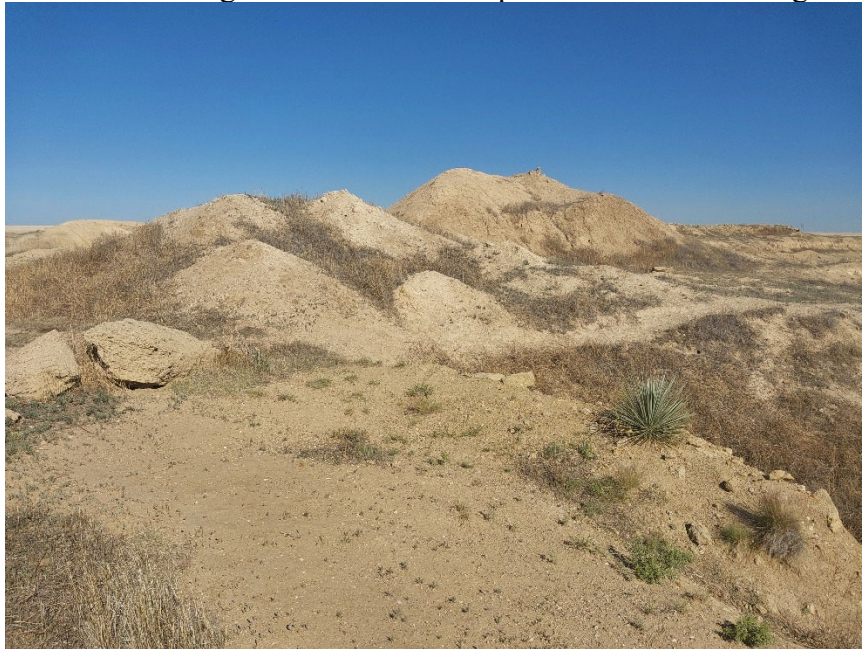
Photo #10: Looking north at the southern portion of the active mining area from the southern portion of the permit area.

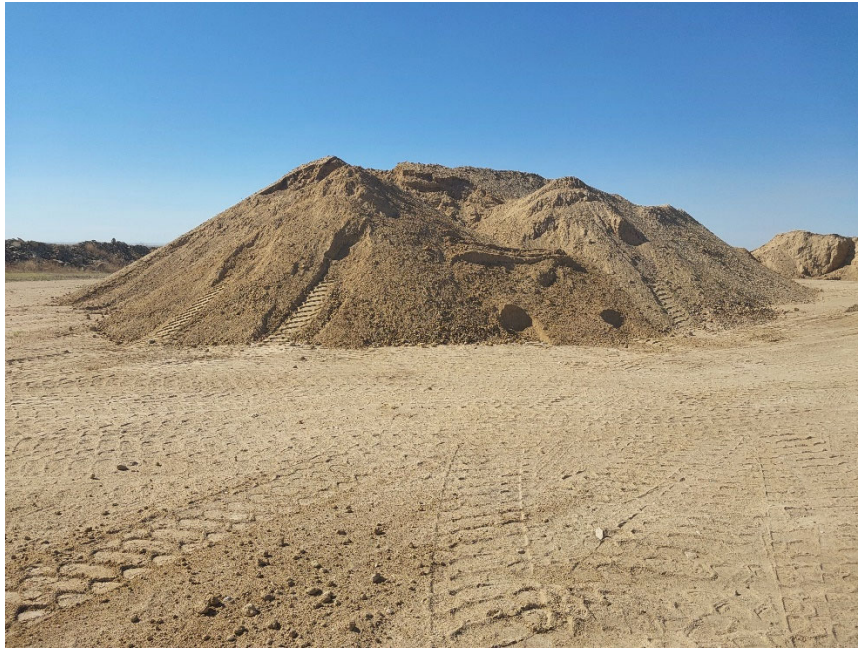
Photo #11: Looking south at the material stockpile that is outlined in green on Map #2.

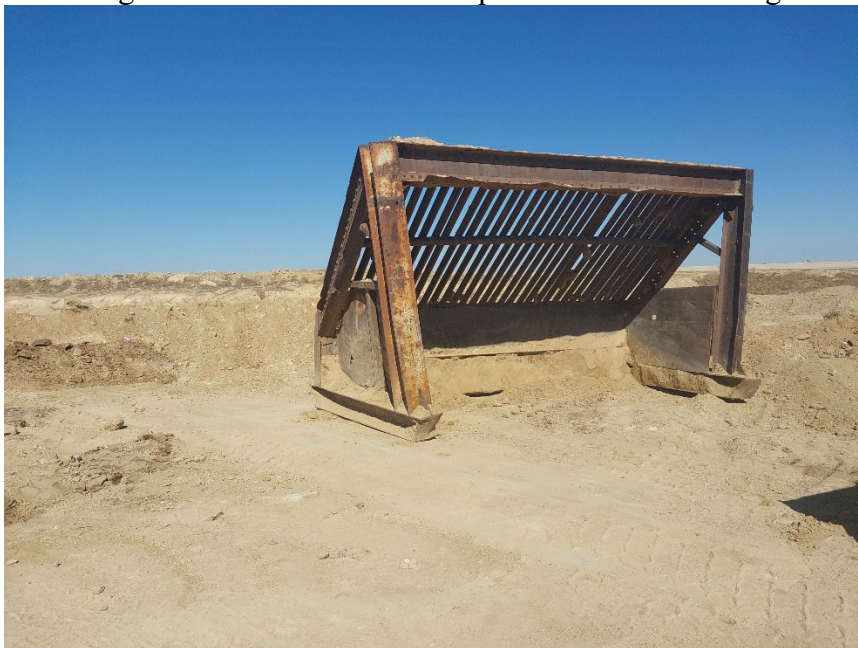
Photo #12: The screener located to the west of the stockpile.

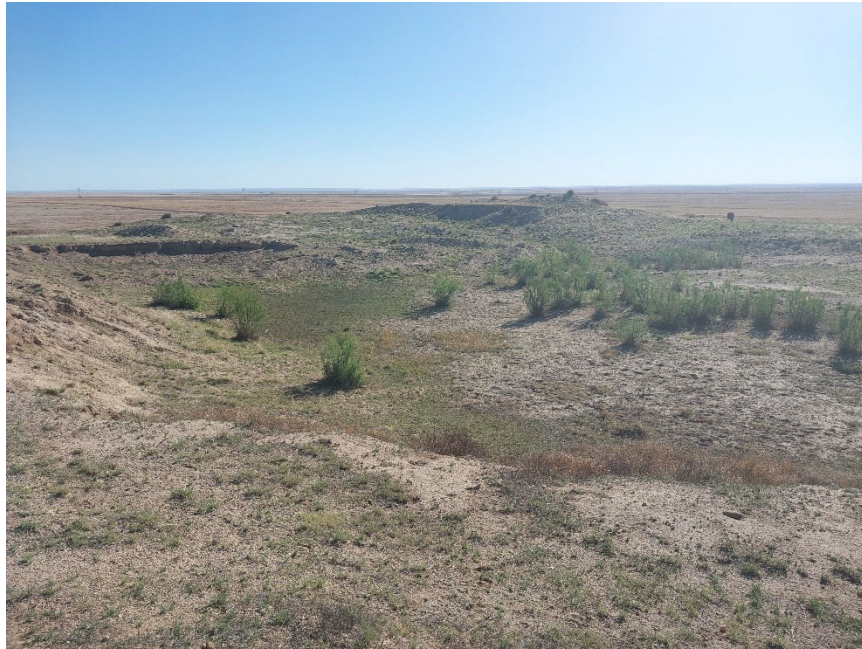
PROBLEM/POSSIBLE VIOLATION: Problem: Tamarisk (salt cedar) trees are present within or have volunteered into the permit area and are becoming established. This is a problem for failure to employ weed control methods for a state listed noxious weed species within the permitted area, and to reduce the spread of weeds to nearby areas as required by Section 3.1.10 (6) of the rule.

Photo #13: Looking to the east northeast at the backfilled, graded, and topsoiled area from Point #1 on Map #2.
Salt Cedar can be seen in this area.

CORRECTIVE ACTIONS: The operator shall either implement the existing weed control plan, or develop a weed control and management plan in accordance with Section 3.1.10 (6) of the Rule. This plan should be developed in consultation with the county extension agency, or weed control district office and should include specific control measures to be applied, a schedule for when control measures will be applied and a post-treatment monitoring plan. This weed control plan shall be submitted to the Division as a Technical Revision to the approved plan with the appropriate Technical Revision fee of \$216.00 by the corrective action date.

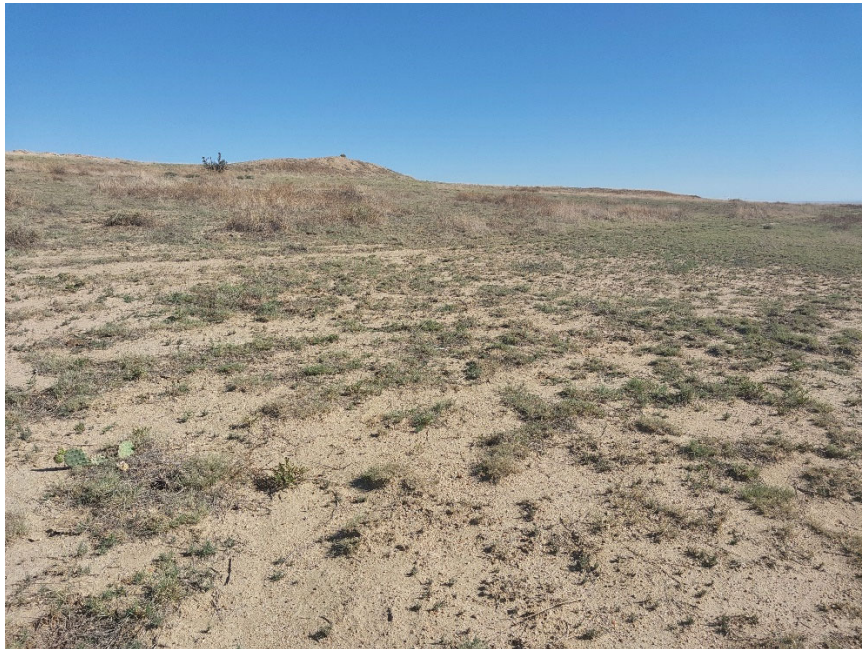
Photo #14: Looking to the northwest at the area that has been backfilled, graded, and topsoiled from the
southeastern portion of the permit area.

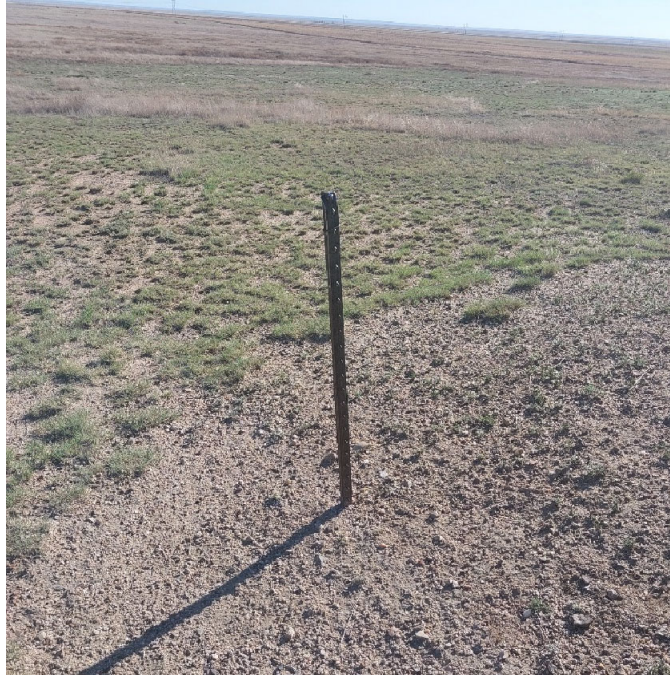
Photo #15: Permit boundary marker viewed at the northwest corner of the permit area.

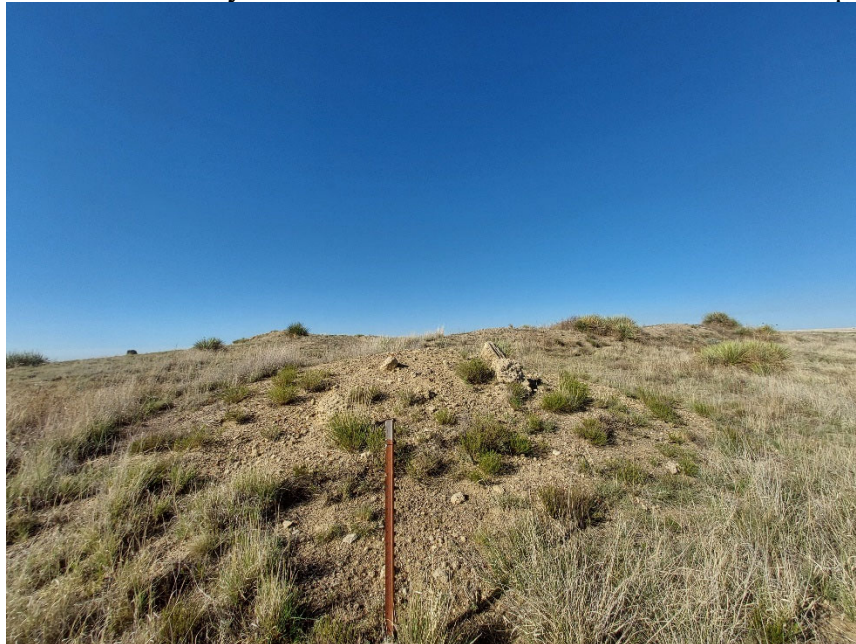
Photo #16: Permit boundary marker viewed at the northeast corner of the permit area.

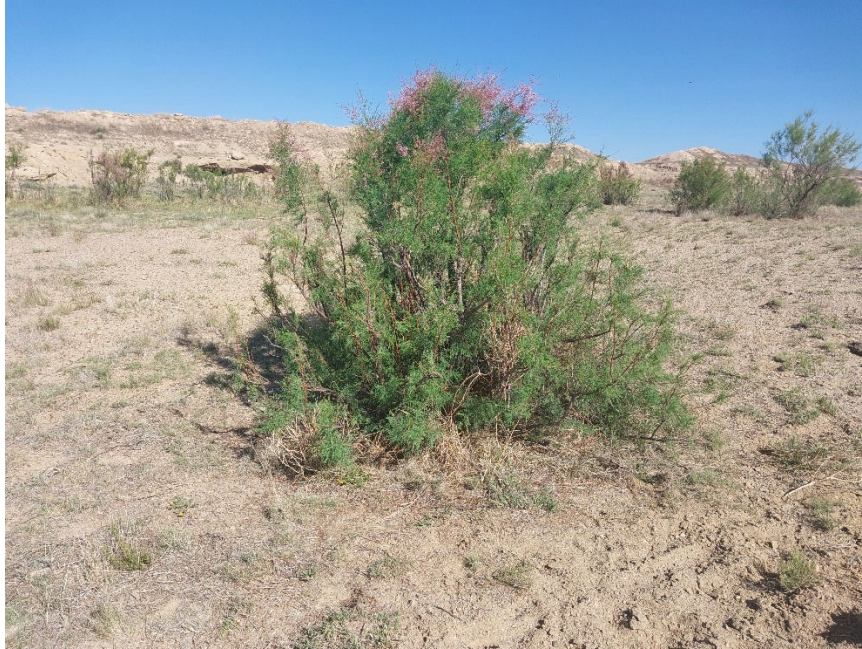
Photo #17: Salt Cedar located at Point #3 on Map #2.

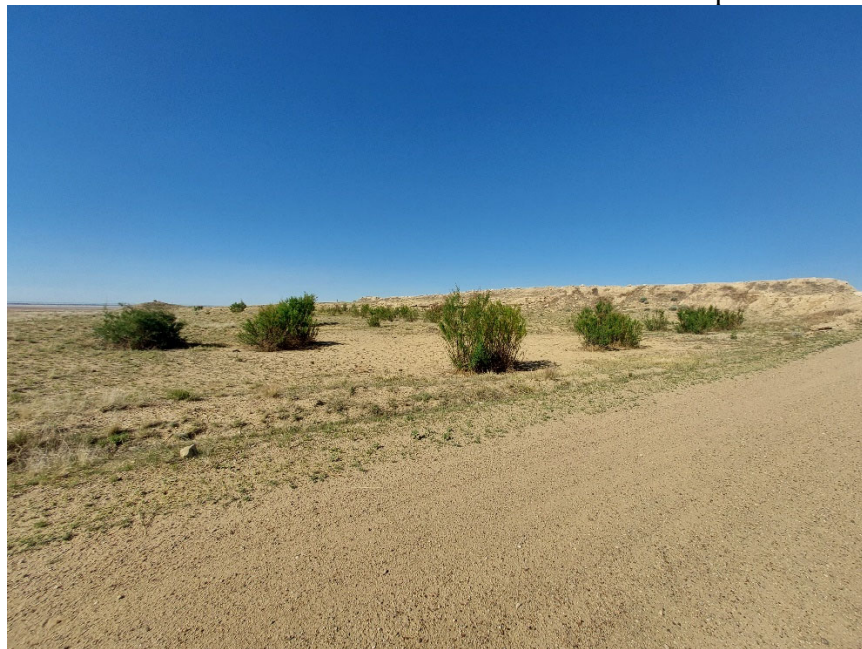
Photo #18: Salt Cedar plants growing on the south side of the road.

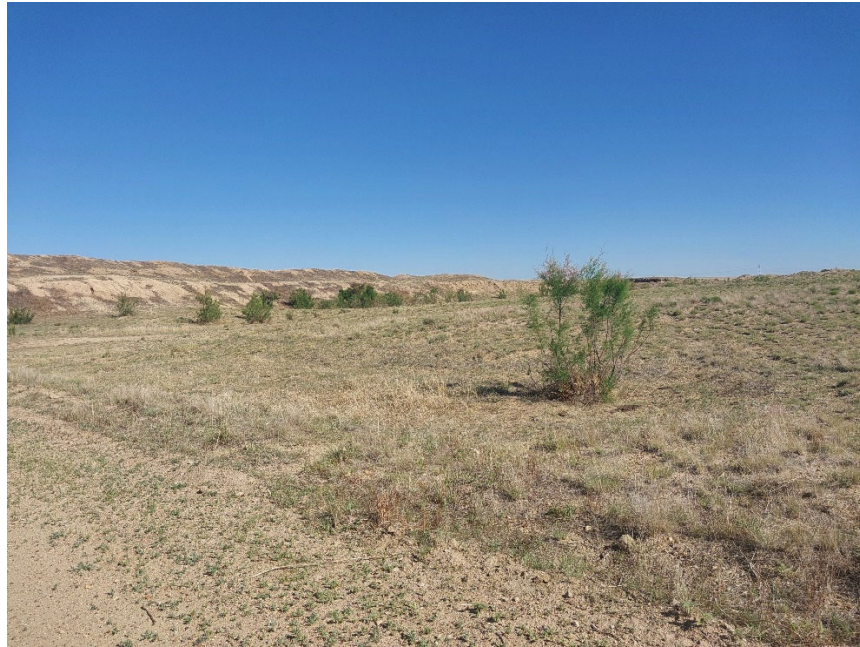
Photo #19: Salt Cedar plants growing to the north of the road.

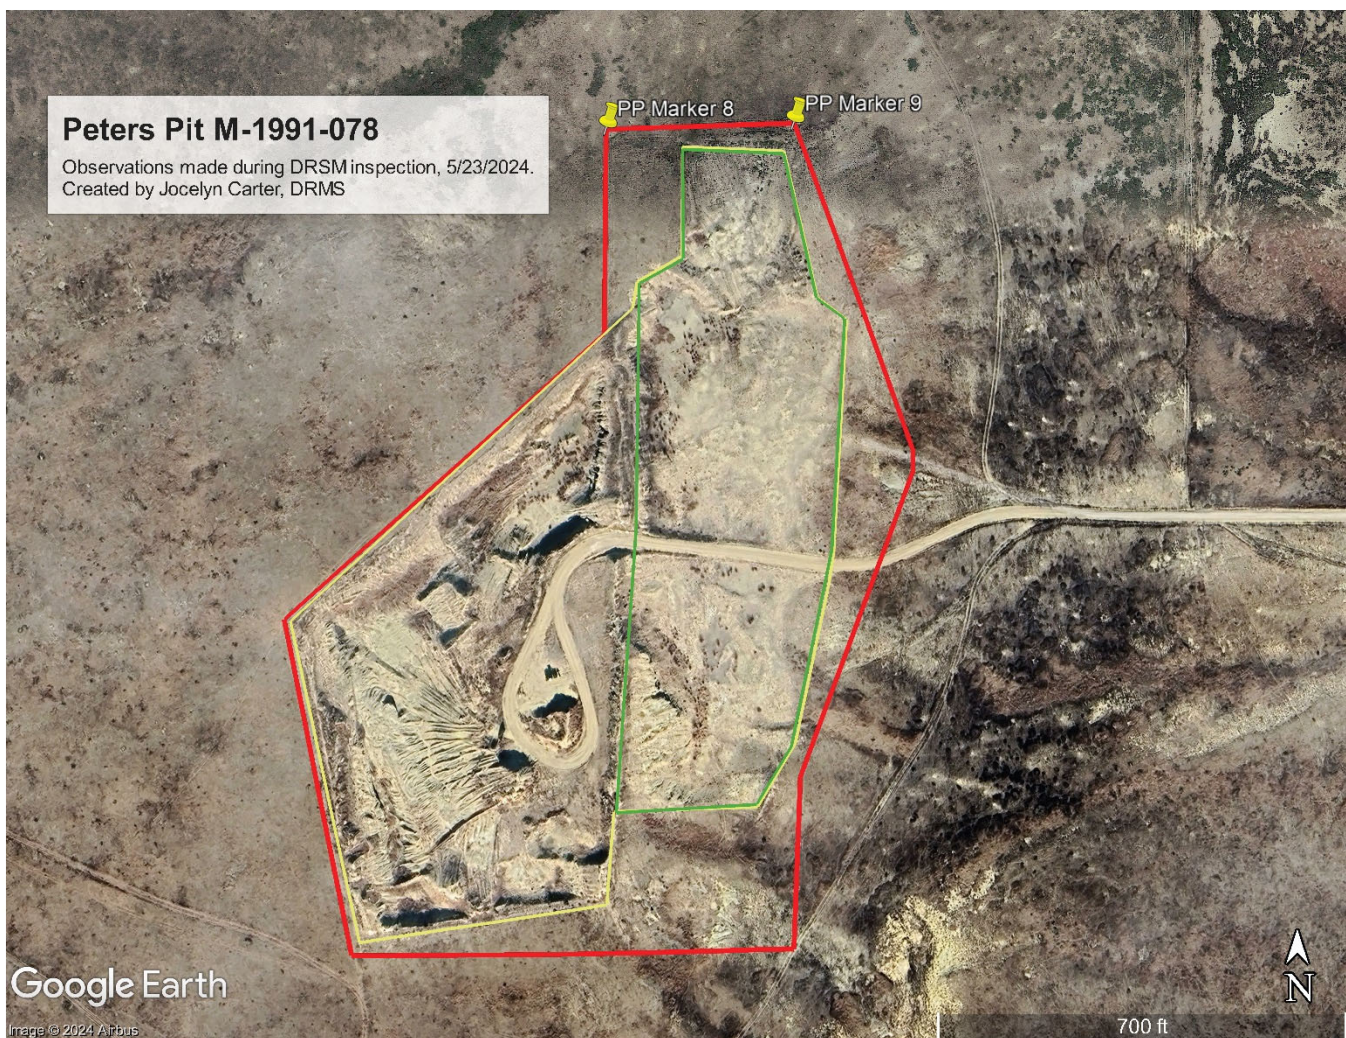
PROBLEM/POSSIBLE VIOLATION: Problem: The affected area boundary markers are missing. This is a problem for failure to maintain boundary markers around the affected area as required by Section 3.1.12(2) of the rule. Of the 9 boundary markers, the 2 marking the north boundary were observed to be in place, the remaining markers were missing, see Map #1 for reference.

Map #1: Red polygon represents the permit boundary (21.49), yellow polygon represents the affected area

(approximately 16.4 acres), and the green polygon represents the approximate backfilled, graded, and topsoiled area (approximately 7.25 acres). The yellow pins, PP Marker 8 and PP Marker 9, represent the two permit boundary markers that were observed at the time of the inspection. Map created with Google Earth Pro; satellite imagery is from November 17, 2023.

CORRECTIVE ACTIONS: The operator shall conduct a survey and replace the boundary markers in the correct location(s). The operator shall provide proof to the Division that this has been done by the corrective action date.

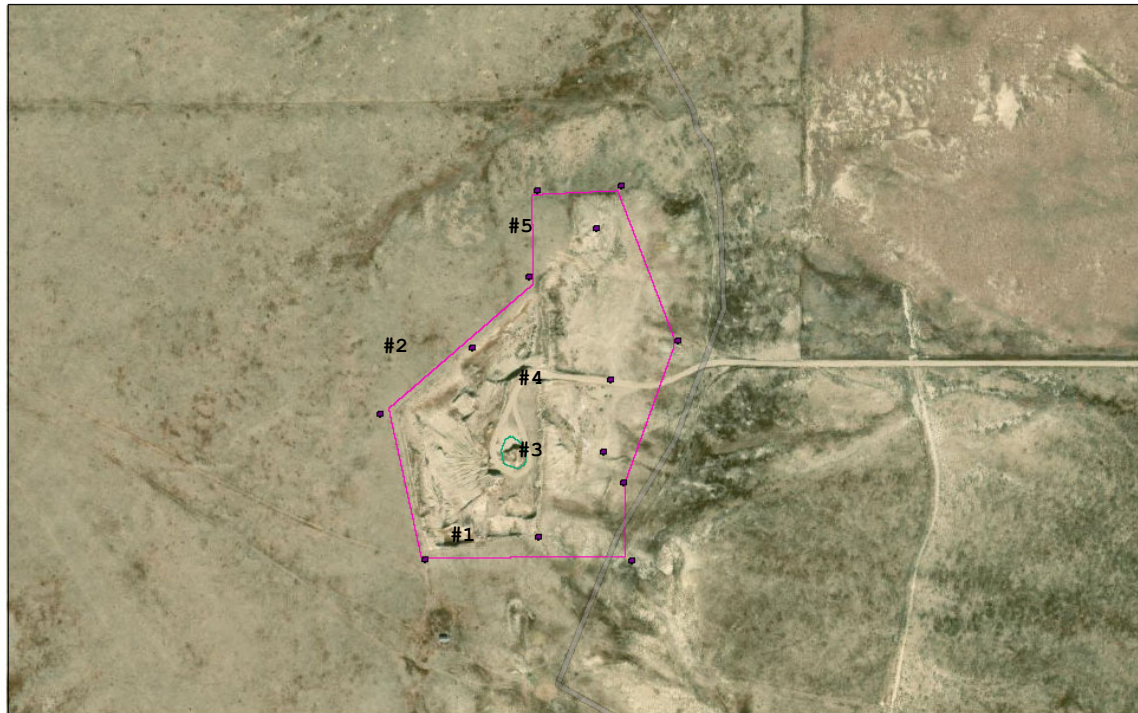
Map #2: Purple polygon represents the permit boundary. The purple points represent where notes were taken. The points along the boundary make note of whether a marker was observed or not, Map #1 shows where the two boundary markers were observed. Point #1 is where a marker was observed, according to Shane Lessenden the marker is to mark the extent of the current mining activities to the west. Point #2 is north of the most recent mining activity. Point #3 and #4 is where salt cedar was observed. Point #5 is a portion of where backfilling, grading, and topsoiling has been completed. The green polygon is the main product stockpile, perimeter is about 336 feet, height was about 15 feet, and at an angle of repose. Map was created with FieldMaps and ArcGIS; the date of the satellite image is not available.
