**PERMIT INFORMATION**

<b>Permit Number:</b> C-1981-014 <b>Mine Name:</b> Southfield Mine <b>Operator:</b> Energy Fuels Coal, Inc. <b>Operator Address:</b> Mr John Adams P.O. Box 773457 Steamboat Springs, CO 80477	<b>County:</b> Fremont <b>Operation Type:</b> Underground <b>Permit Status:</b> Revoked <b>Ownership:</b> Private
	<b>Operator Representative Present:</b>  None
<b>Operator Representative Signature: (Field Issuance Only)</b>

**INSPECTION INFORMATION**

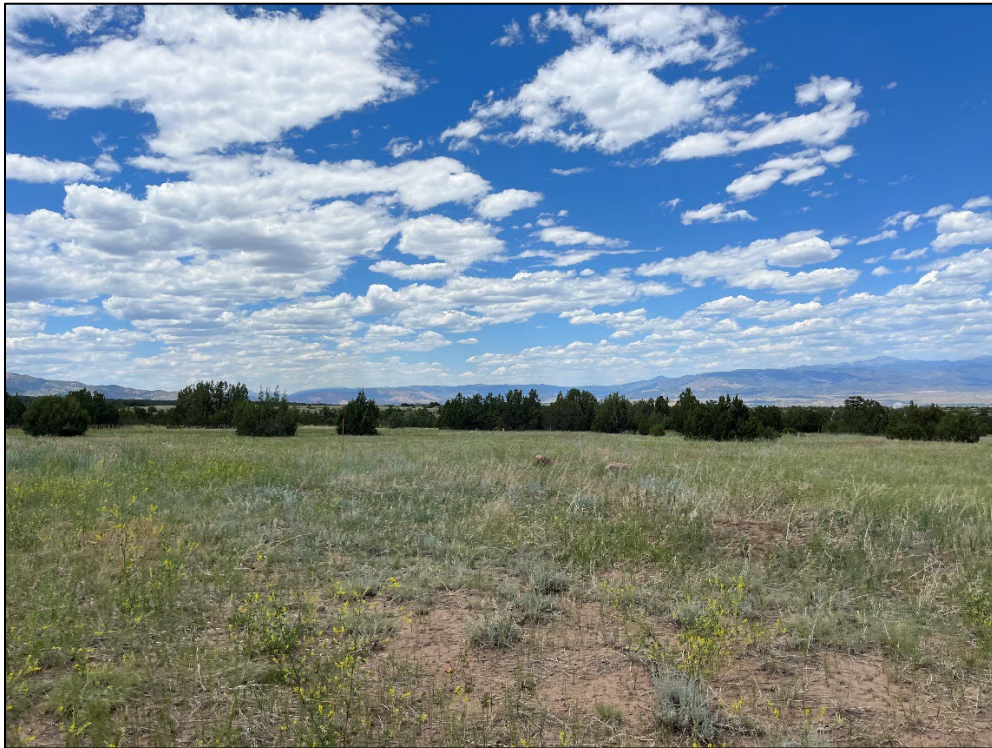
The reclaimed road spur and access road to the NW-MW well were also inspected. The road spur is well vegetated and blends into the adjacent undisturbed lands. The access road for the NW-MW well also appears to be well vegetated with species similar to the surrounding vegetation. The NW-MW well pad is stable with increased growth of various grasses, shrubs, and cacti (Photo 1). No issues were observed.

*Photo 1: View north of the road spur reclamation area and NW-MW access road.*

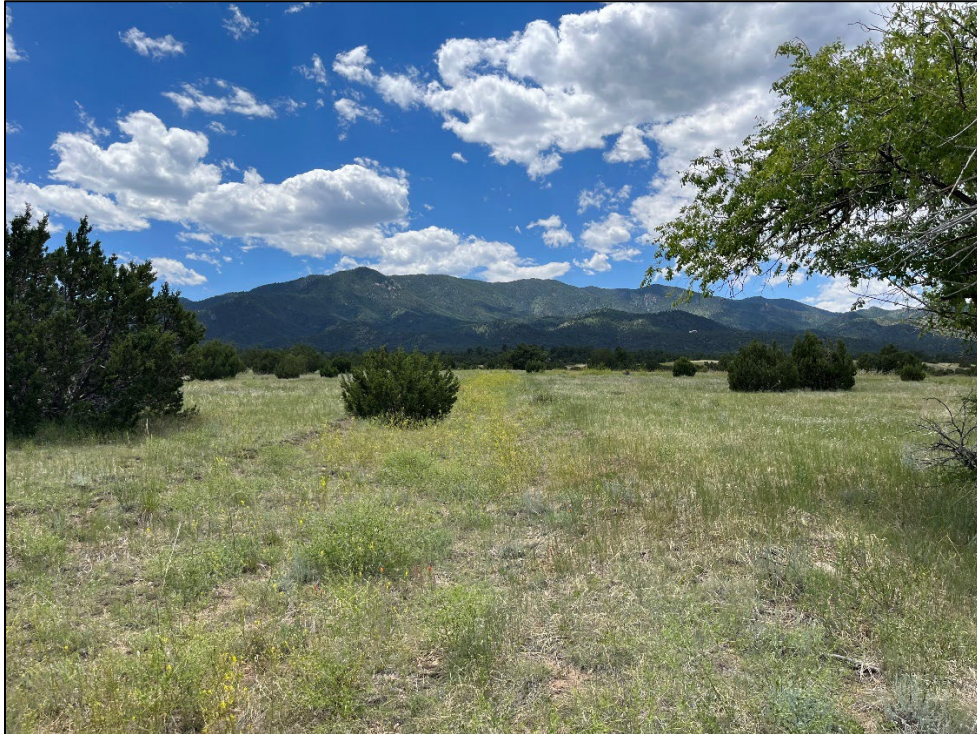
The two-track road off County Road 51 was inspected. This portion of the disturbance was not formally reclaimed, but surrounding vegetation continues to establish itself along the road. Cactus, shrubs and grasses have naturally encroached from the surrounding undisturbed area. No signs of recent use were observed on the road (Photo 2). No issues were observed.

*Photo 2: View of the two-track road off CR51.*

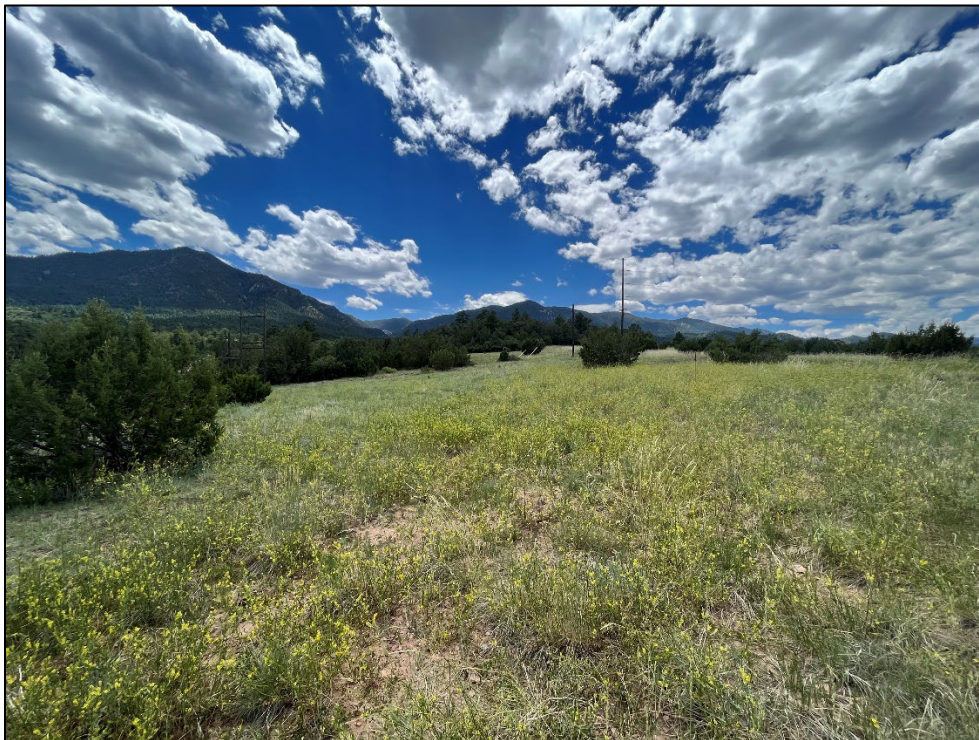
vegetation and continues to be harder to distinguish from adjacent undisturbed lands (Photo 3). No issues were observed.

*Photo 3: Reclaimed substation pad area, minimal bare earth, mostly covered with vegetation.*

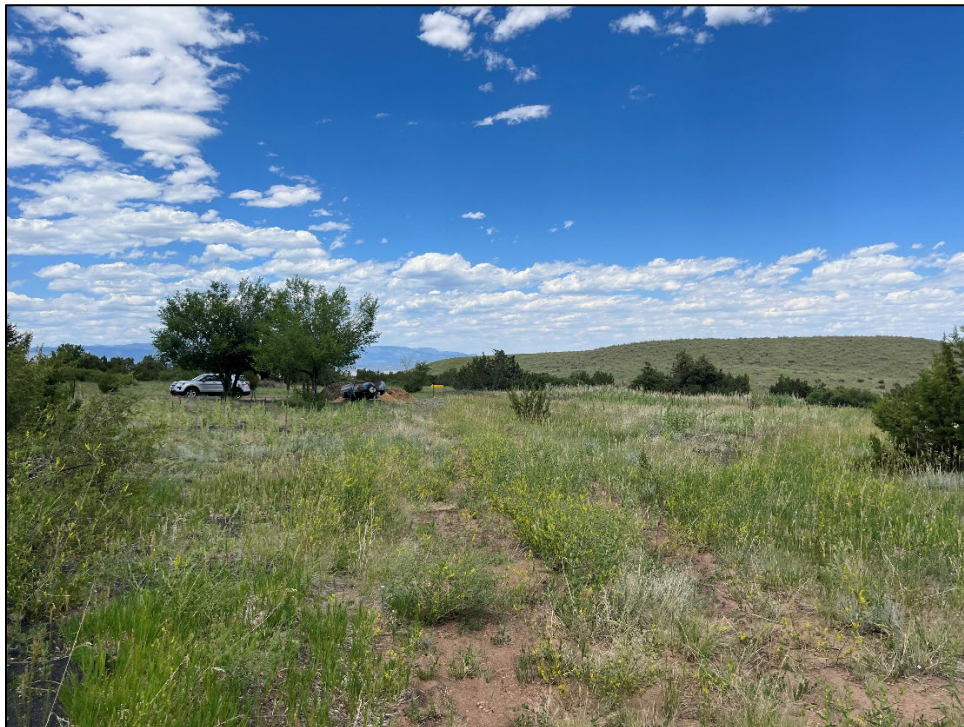
Adjacent vegetation continues to encroach on the reclaimed substation access road, however over is still patchy in some areas. Post-reclamation usage has hindered total regrowth and reclamation along this two-track path (Photo 4). The reclaimed substation pad is well established with vegetation. The area blends to the surrounding

*Photo 4: View of the reclaimed two-track road.*
