**MINERALS PROGRAM INSPECTION REPORT**  
**PHONE: (303) 866-3567**

<b>MINE NAME:</b> Henderson Mine	<b>MINE/PROSPECTING ID#:</b> M-1977-342	<b>MINERAL:</b> Molybdenum	<b>COUNTY:</b> Clear Creek, Grand
<b>INSPECTION TYPE:</b> Monitoring	<b>WEATHER:</b> Clear	<b>INSP. DATE:</b> June 25, 2024	<b>INSP. TIME:</b> 08:25
<b>OPERATOR:</b> Climax Molybdenum Company	<b>OPERATOR REPRESENTATIVE:</b> Geoff Niggeler and Ben Alcox	<b>TYPE OF OPERATION:</b> 112d-3 - Designated Mining Operation	
<b>REASON FOR INSPECTION:</b> Normal I&E Program	<b>BOND CALCULATION TYPE:</b> None	<b>BOND AMOUNT:</b> \$167,995,252.00	
<b>DATE OF COMPLAINT:</b> NA	<b>POST INSP. CONTACTS:</b> None	<b>JOINT INSP. AGENCY:</b> None	
<b>INSPECTOR(S):</b> Amber M. Gibson Nikie Gagnon	<b>INSPECTOR'S SIGNATURE:</b>

The focus of this inspection was the stormwater structures on the mine side of Henderson, and treatment facilities of the URAD water treatment plant.

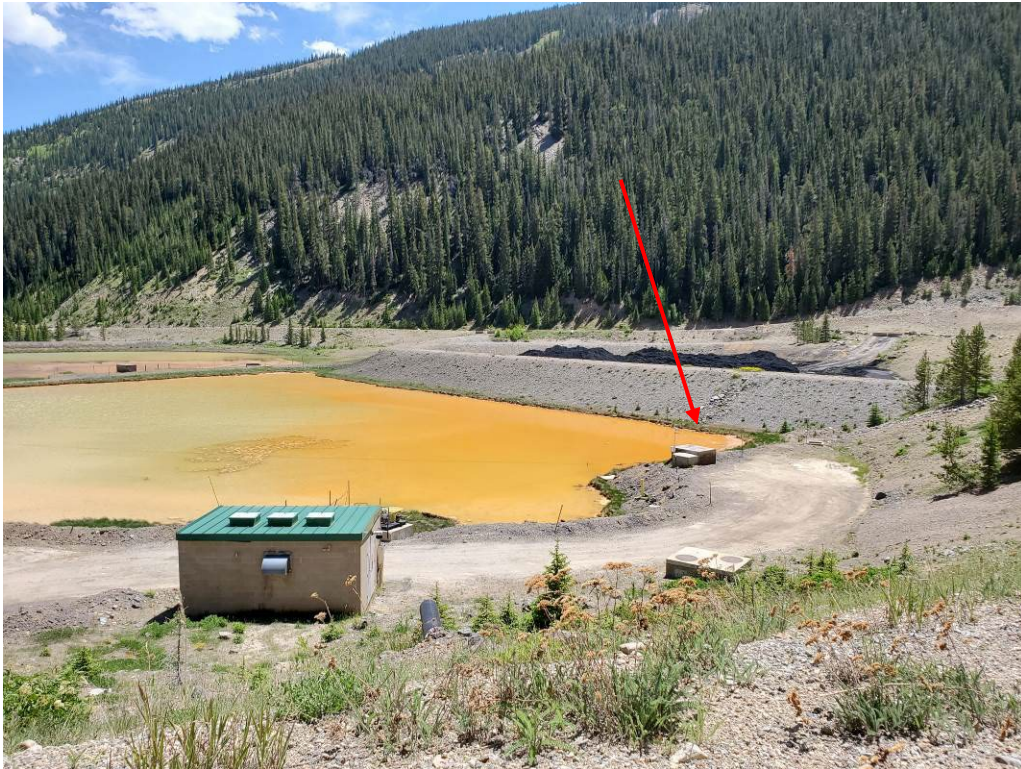
The Division observed the exterior and interior facilities at the URAD water treatment plant. At the time of the inspection, sludge was being pumped into Sludge Pond 2, and was drying in Sludge Pond 1. The ponds appeared to be functioning as intended and no structural deficiencies were observed at the time of the inspection (Photo 1).

**Photo 1:** Looking east at external ponds at the URAD water treatment plant. The arrow points to Sludge Pond 1 where sludge was drying at the time of the inspection.

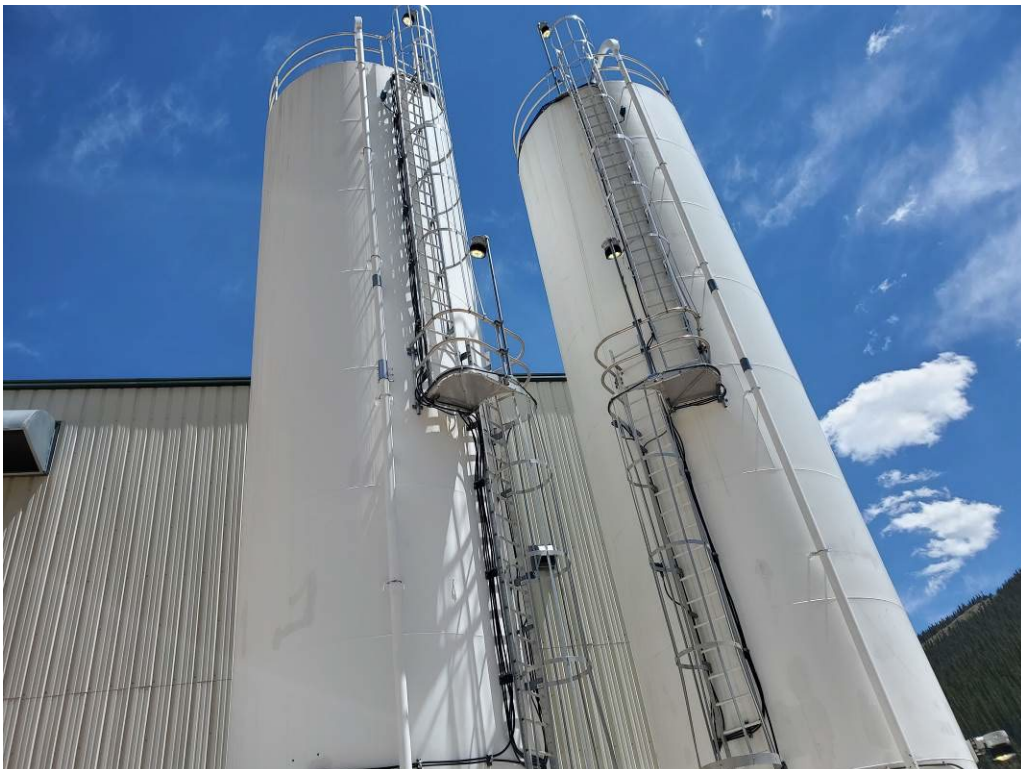
The internal water, agitation, and settling tanks were operating at the time of the inspection. No issues were observed. The storage tanks for Lime, Flocculant, and Sulfuric Acid were also observed (Photos 2-4). All of the storage tanks had secondary containment measures in place, and no structural deficiencies were observed during the inspection. Some lime that had spilled when the tank was being deposited into by the tank truck was observed along the south side of the road to the plant. The lime was contained by an earthen berm that had a drainage path leading into the containment pond area, and thus was contained on-site.

**Photo 2:** Lime silos located on the south side of the URAD water treatment plant.

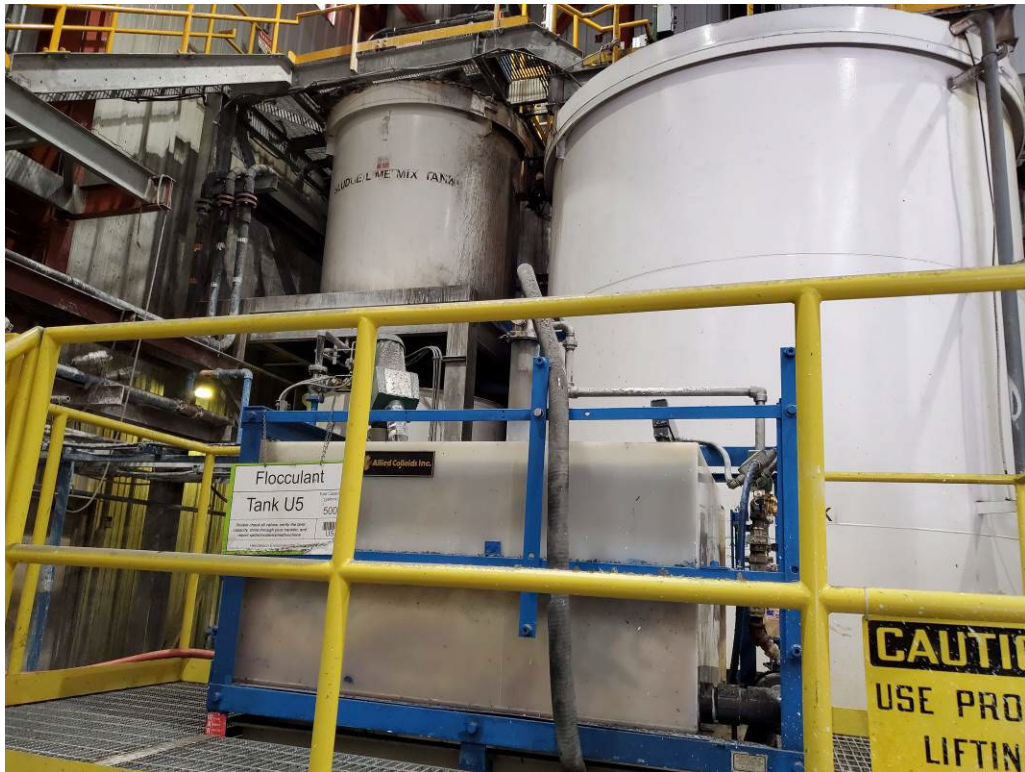
**Photo 3:** Floculant storage tank located within the URAD water treatment plant.

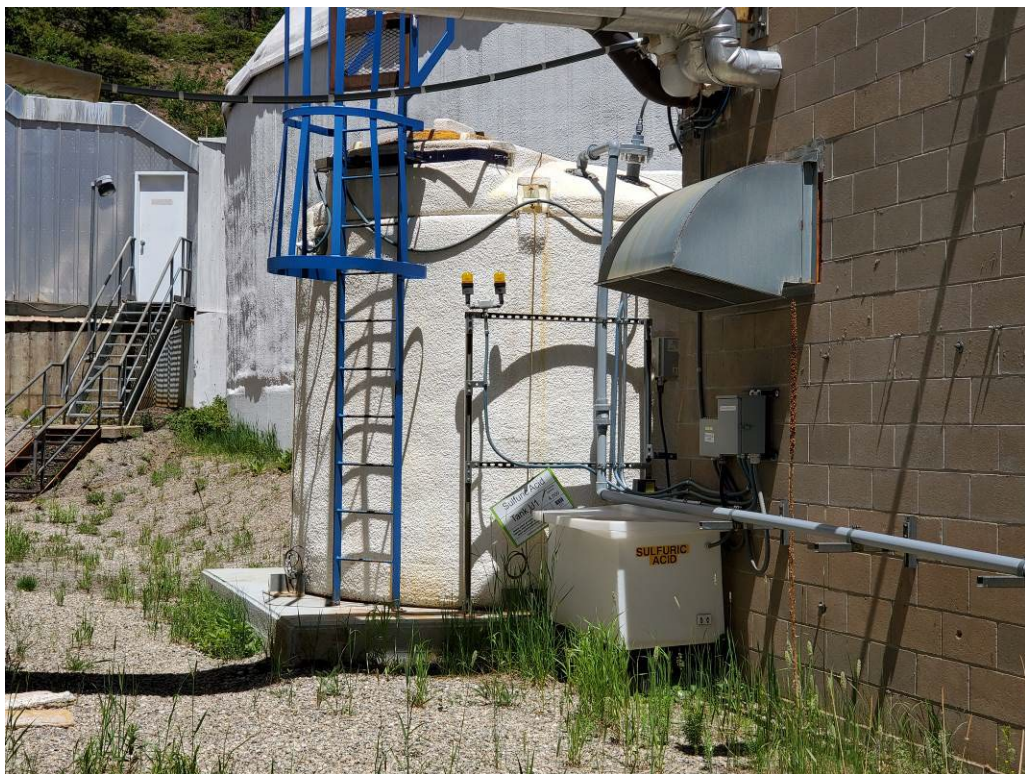
**Photo 4:** Insulated Sulfuric Acid tank located outside of the URAD water treatment plant.

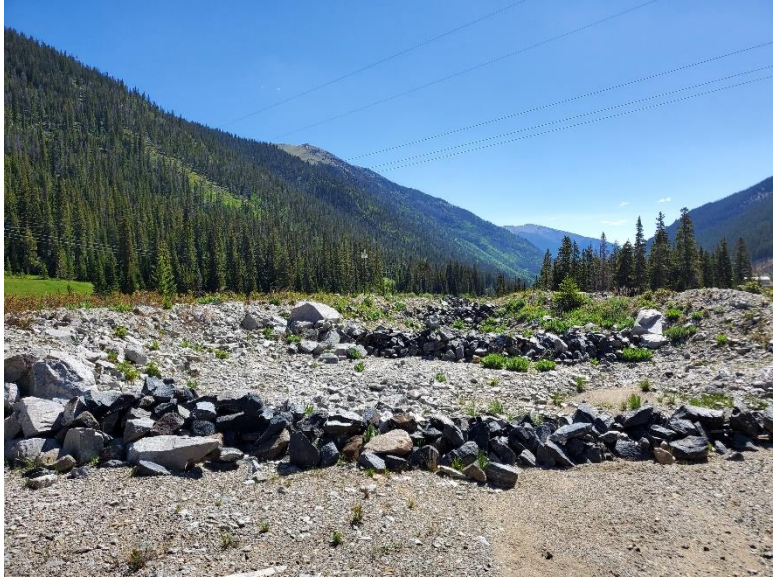
Outfall #	Comments/Observations from the June 25, 2024 Inspection
OF-1	<p>Consists of a few rock check-dams, located in the northeast corner of the West Lay-Down Area.</p> <p>Observations:</p> <ul style="list-style-type: none"> <li>• Appears to be functioning as intended.</li> <li>• The rip-rap appears to be in good condition.</li> <li>• The check dams were dry at the time of the inspection.</li> <li>• No excess sediment accumulation was observed.</li> </ul>

<p style="text-align: right;"><b>Photo 5:</b> Looking east at OF-1.</p>
OF-2	<p>Consists of a rock check-dam, located northwest of the Warehouse Lay-Down yard.</p> <p>Observations:</p> <ul style="list-style-type: none"> <li>• Appears to be functioning as intended.</li> <li>• The rip-rap appears to be in good condition.</li> <li>• The check dams were dry at the time of the inspection.</li> <li>• No excess sediment accumulation was observed.</li> </ul>

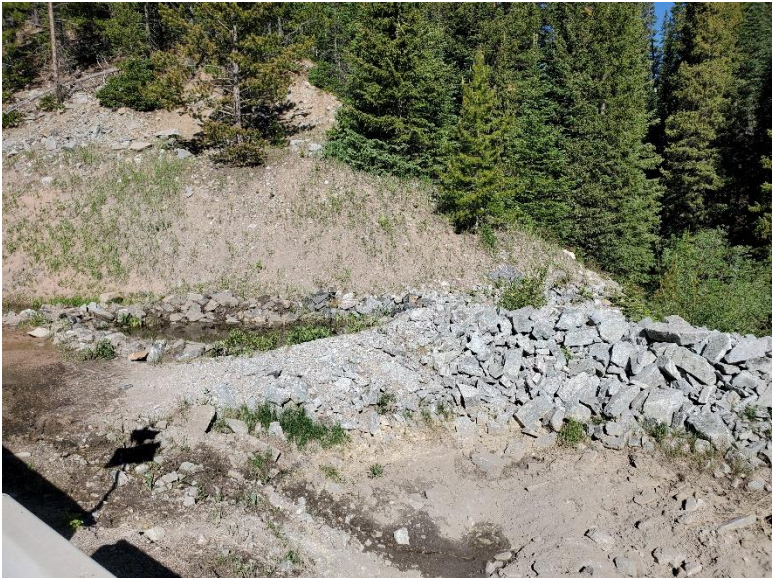
<p style="text-align: right;"><b>Photo 6:</b> Looking at the drainage basin to the south side of OF-2.</p>

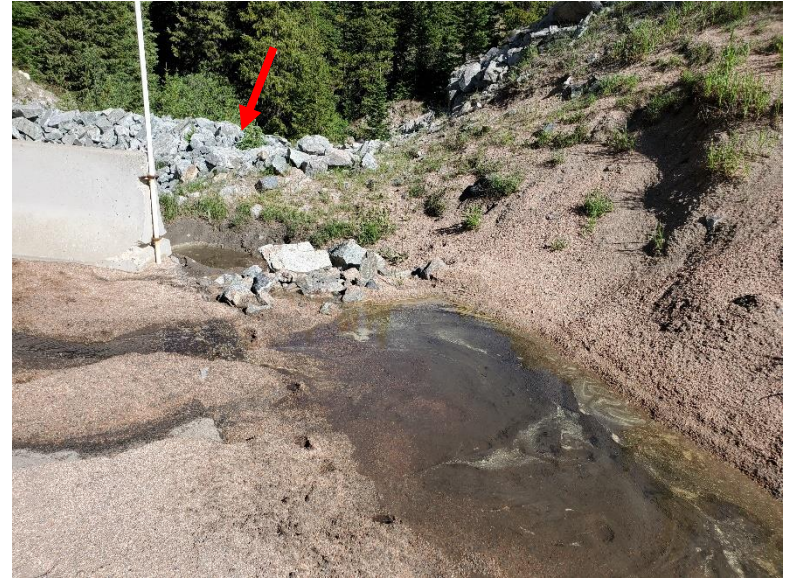
**Photo 7:** Looking at the drainage into OF-2 from the north side.  
Arrow points to the location of OF-2.

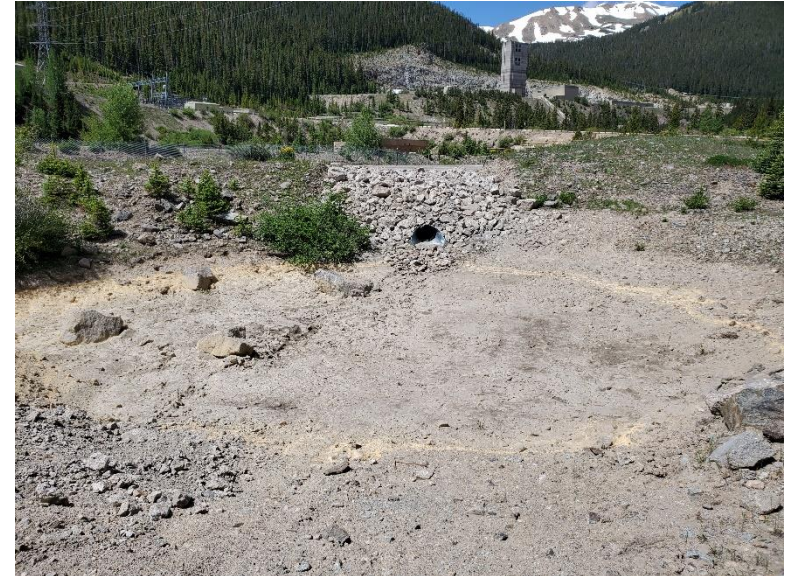
- Appears to be functioning as intended.
- The rip-rap appears to be in good condition.
- The check dams were dry at the time of the inspection.
- No excess sediment accumulation was observed.

**Photo 8:** Looking south at the basin preceding OF-3. OF-3 sign and location not pictured. OF-3 located within the western side of the West Fork Clear Creek, along the north side of the current disturbance boundary.

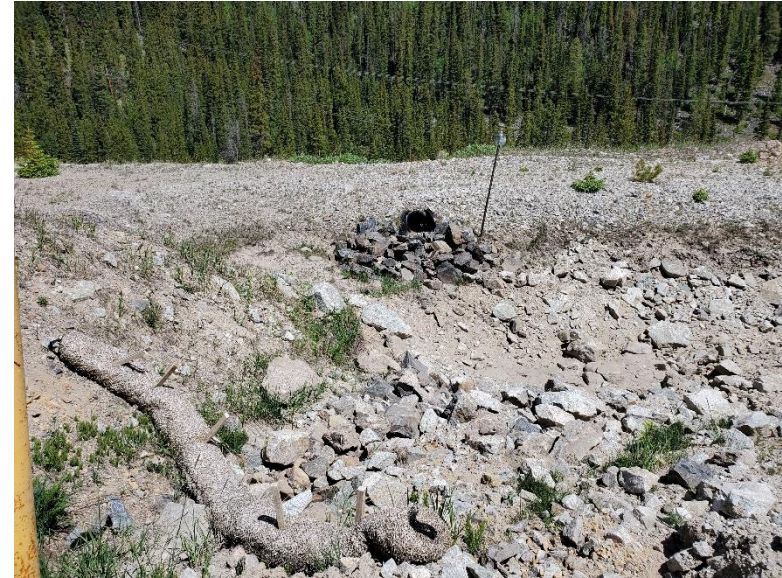
**Photo 9:** Looking north at OF-5.

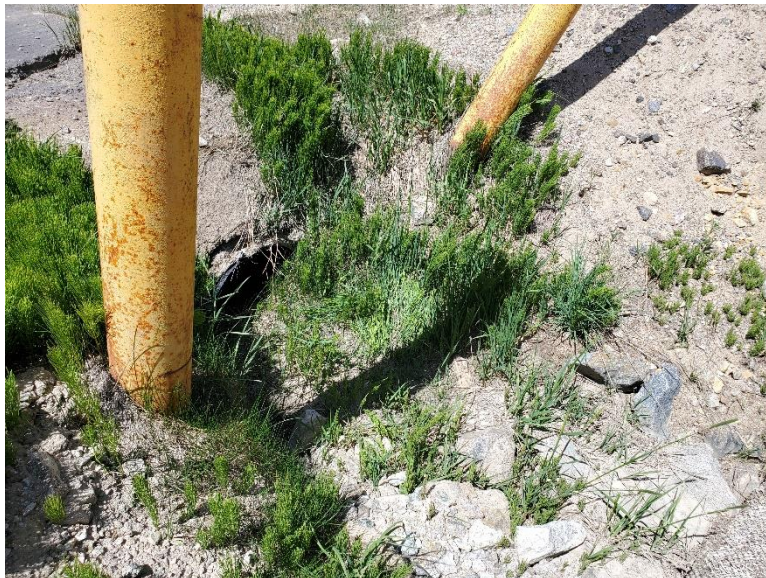
- Appears to be functioning as intended.
- The rip-rap appears to be in good condition.
- The check dams were dry at the time of the inspection.
- Excess sediment was observed in the culvert on the south side of OF-5 at both the culvert's inlet and outlet (Photos 10 and 11). The Operator stated that this will be addressed during their upcoming internal storm water maintenance inspection.

**Photo 10:** Outlet of the culvert south of OF-5.

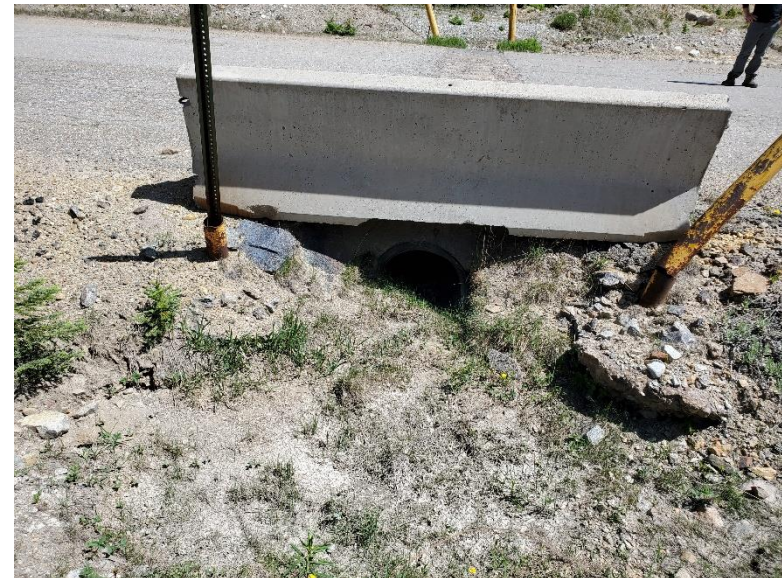
**Photo 11:** Inlet of the culvert south of OF-5.

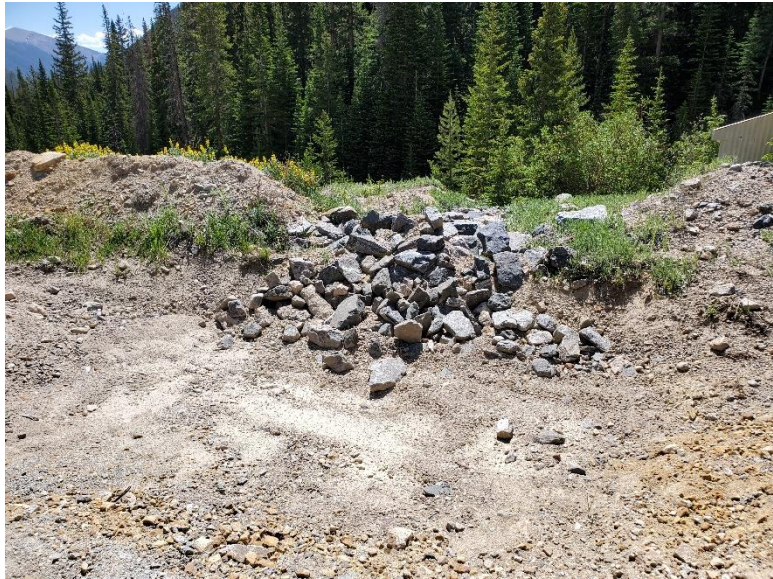
<p><b>Photo 12:</b> Looking east at OF-6.</p>
<p>OF-7</p>	<p>Consists of a rock check-dam, located northwest of the Warehouse Lay-Down yard.</p> <p>Observations:</p> <ul style="list-style-type: none"><li>• Appears to be functioning as intended.</li><li>• Banks surrounding the check-dam appear to be stable.</li><li>• Located in an area where snow plows have pushed sediment into the check dam. Due to this, the rip-rap is coated in sediment, but still has plenty of capacity. The Operator stated that during their upcoming internal BMP maintenance, they will clean the sediment out of the check-dam, likely replace the rip rap, and re-stabilize the area.</li><li>• The OF-7 sign is bent. The Operator stated it will soon be replaced.</li></ul>

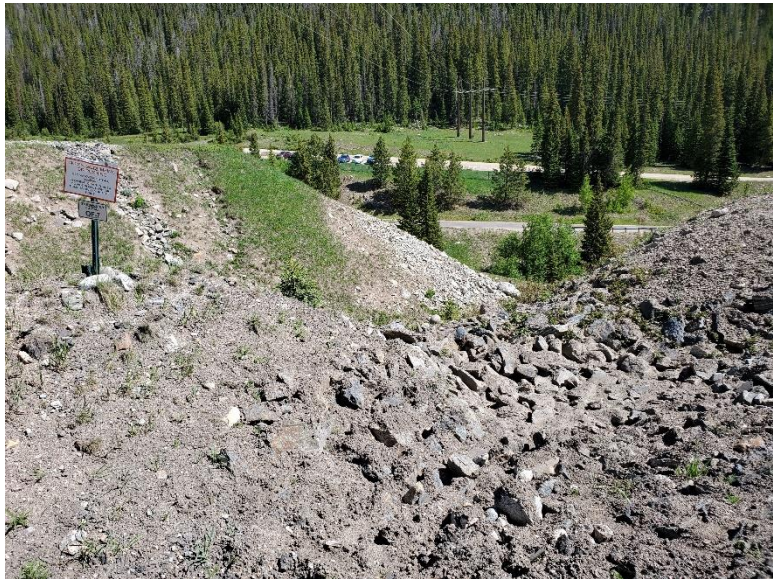
<p><b>Photo 13:</b> Looking northwest at OF-7.</p>

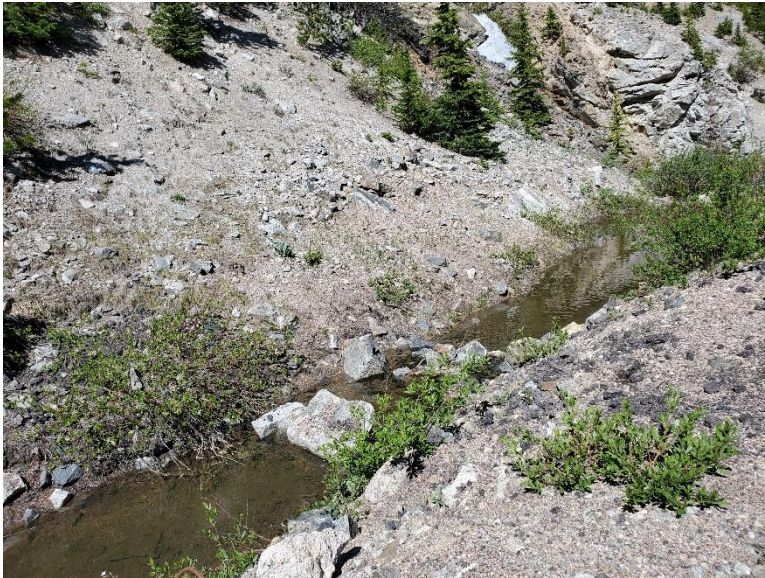
- Holding water at the time of the inspection.
- Appears to be functioning as intended.
- Banks surrounding the check-dams appear to be stable.
- No excess sediment accumulation was observed.

**Photo 14:** Looking northwest along the check dams leading to OF-8a.

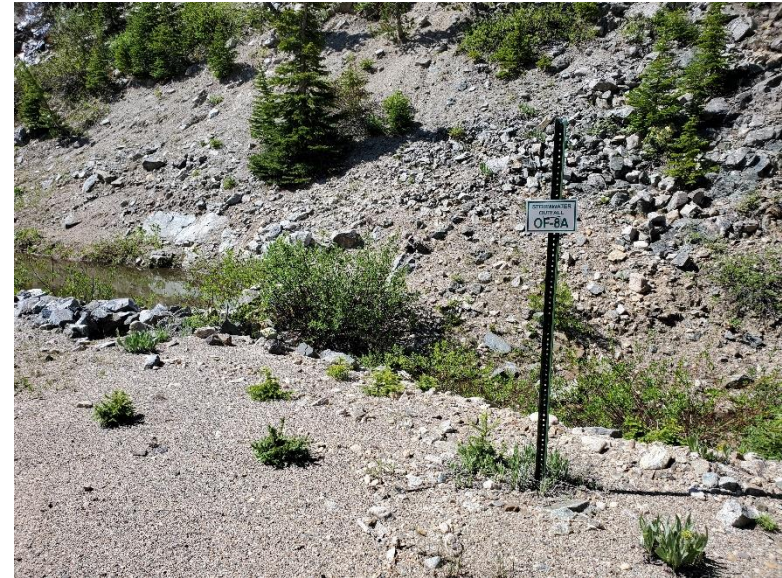
**Photo 15:** Looking southeast at OF-8a.

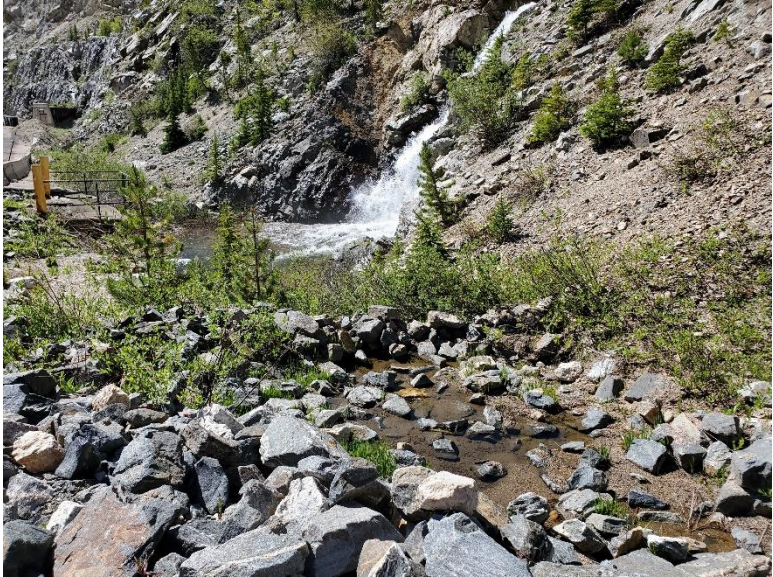
<p><b>Photo 16:</b> Looking southwest at OF-8b.</p>
<p>OF-8c</p>	<p>Consists of a series of rock check-dams, downgradient of the southeast corner of the West Lay-Down Yard. Outlets into Butler Gulch.</p> <p>Observations:</p> <ul style="list-style-type: none"><li>• The check dams were dry at the time of the inspection.</li><li>• Appears to be functioning as intended.</li><li>• Banks surrounding the check-dams appear to be stable.</li><li>• Straw wattles and rip-rapped dams appear to be in great condition.</li><li>• No excess sediment accumulation was observed.</li></ul>

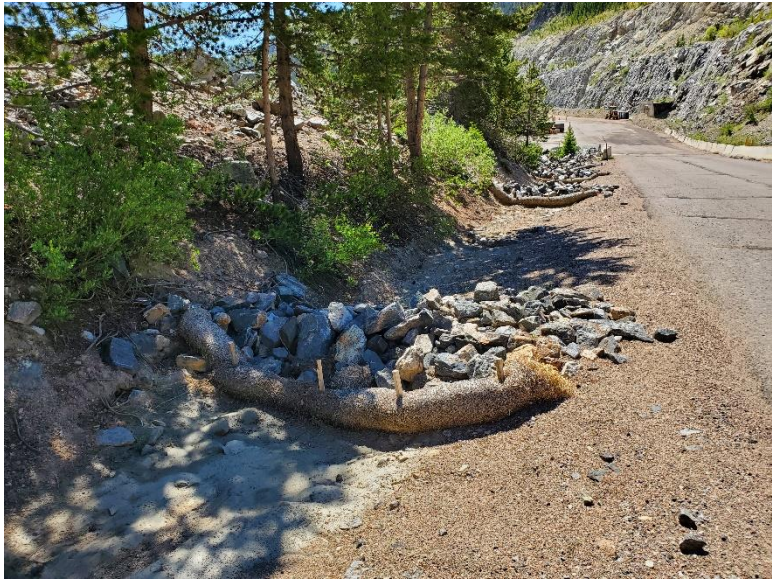
<p><b>Photo 17:</b> Looking southwest at the series of check dams leading to OF-8c.</p>

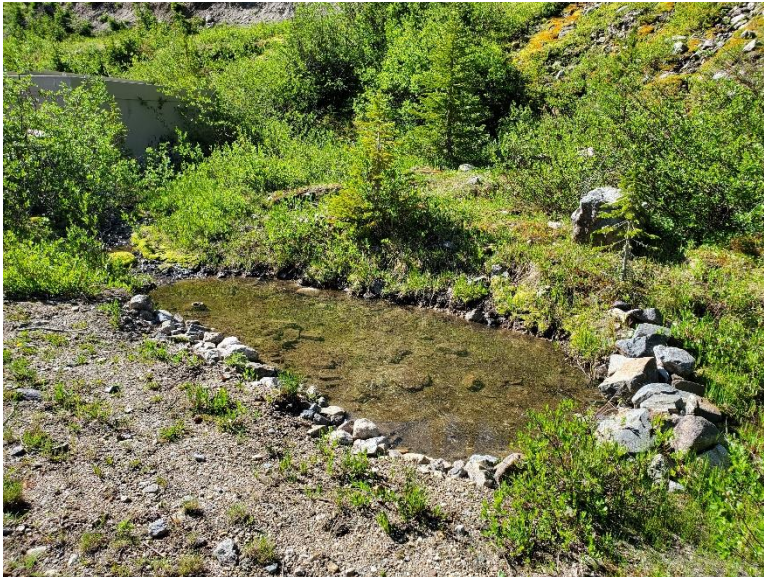
- Drainage basin holding water at the time of the inspection.
- Appears to be functioning as intended.
- The rip-rap appears to be in good condition.
- No excess sediment accumulation was observed.

**Photo 18:** Rip-rapped drainage basin located upslope and south of OF-9.

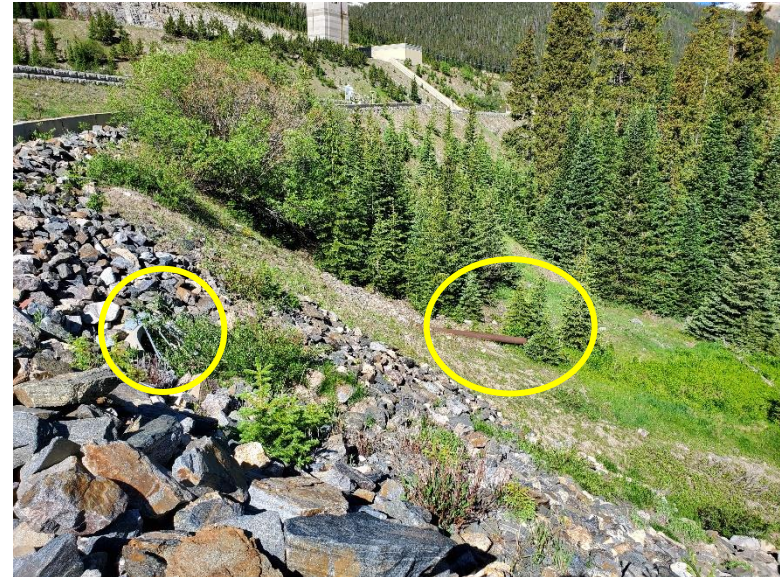
**Photo 19:** Circled are two drainage pipes (one box culvert one metal pipe), discharging onto the rip-rapped slope leading to OF-9.

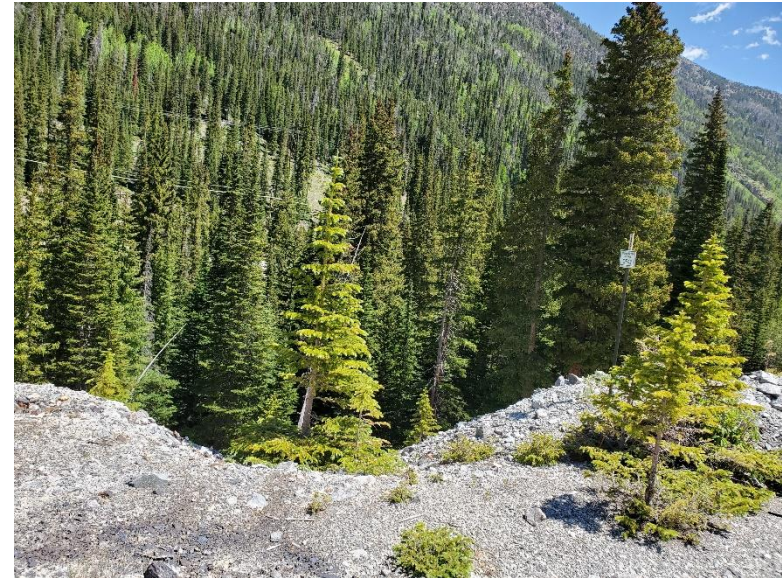
- Appears to be functioning as intended.
- The rip-rap appears to be in good condition.
- The check dams were dry at the time of the inspection.
- No excess sediment accumulation was observed.

**Photo 20:** Looking north at OF-12.

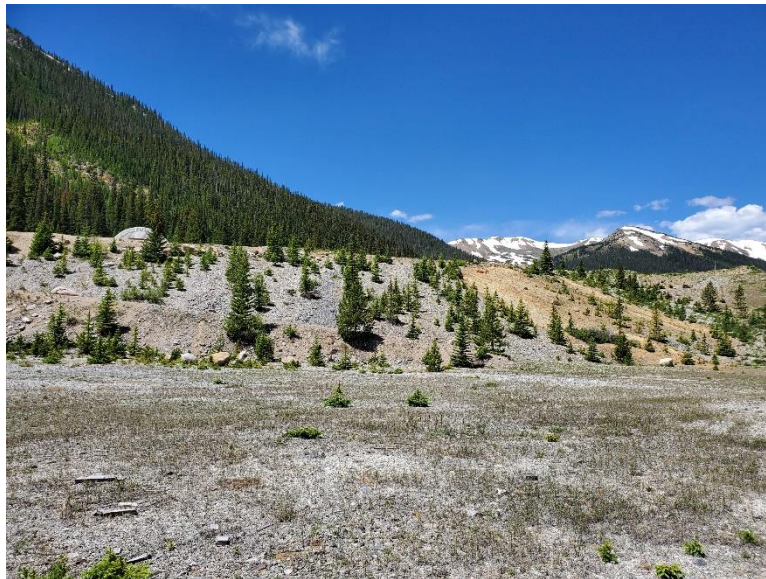
**Photo 21:** Looking south, upslope of OF-12 at the reclaimed waste tailings pile. In the foreground is a flat area that has earthen berms around the perimeter, leading to OF-12.

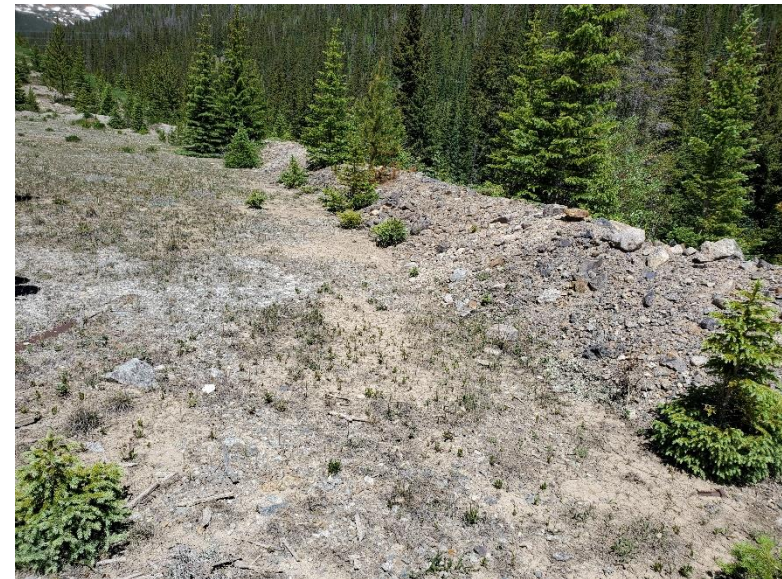
**Photo 22:** Looking west along one of the perimeter berms. Photo shows evidence of standing water (mudcracks) retained by the berms and leading to OF-12.

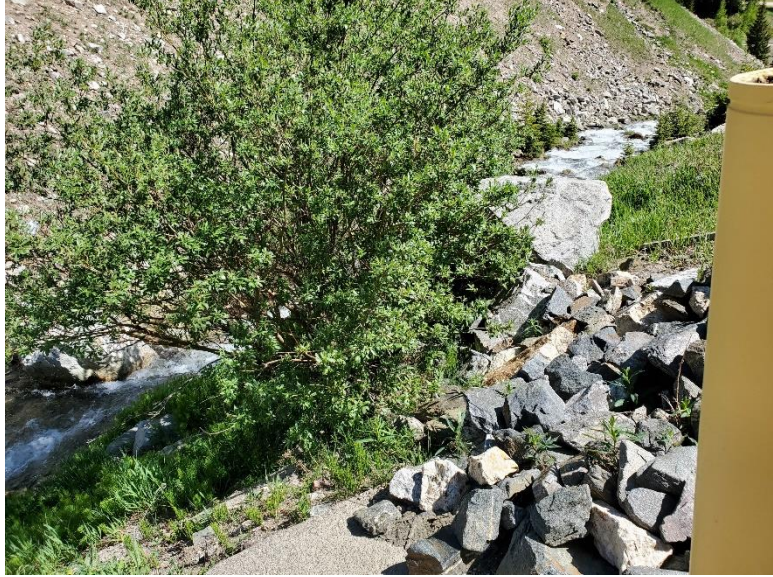
A photograph looking downslope from OF-14. A yellow vertical pipe is visible on the right. The slope is covered with rip-rap stones and green vegetation. A small stream or runoff channel is visible on the left side of the slope.</div> <p><b>Photo 24:</b> Looking downslope from OF-14 at Butler Gulch.</p>

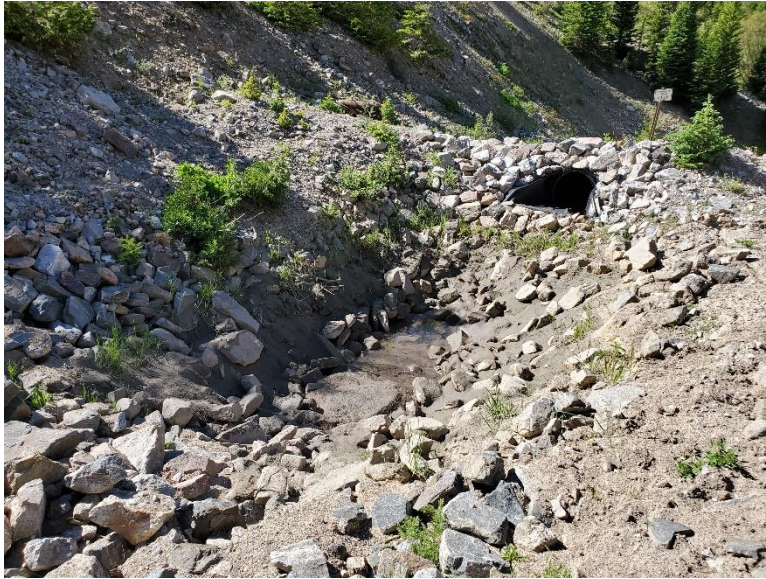
OF-15	<p>Consists of a rip-rapped drainage basin leading to a culvert. OF-15 is located north of the West Fork Clear Creek, and down slope of the Mine entrance road.</p> <p>Observations:</p> <ul style="list-style-type: none"><li>• Appears to be functioning as intended.</li><li>• The rip-rap appears to be in decent condition. The Operator stated that this basin and the rip-rapped banks may receive maintenance during the upcoming internal storm water maintenance inspection.</li><li>• The basin was mostly dry at the time of the inspection.</li><li>• Some sediment was contained within the basin but no excess sediment accumulation was observed.</li><li>• The Operator stated that they may build up the western portion of the road west of the outfall to encourage more positive drainage into the outfall and way from the bermed portion of the road located north of the creek.</li></ul>

**Photo 25:** Looking south at the rip-rapped drainage basin at OF-15.

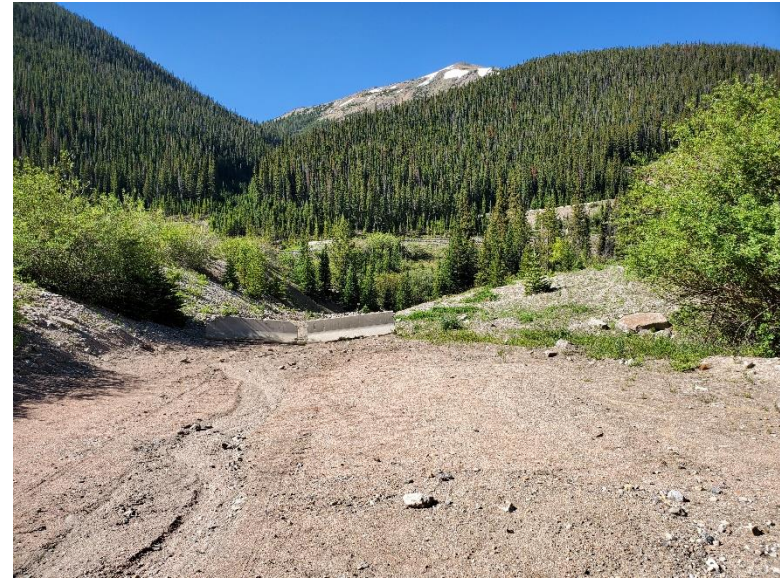
**Photo 26:** Looking upslope of OF-15 at the road leading to the drainage basin in Photo 25.

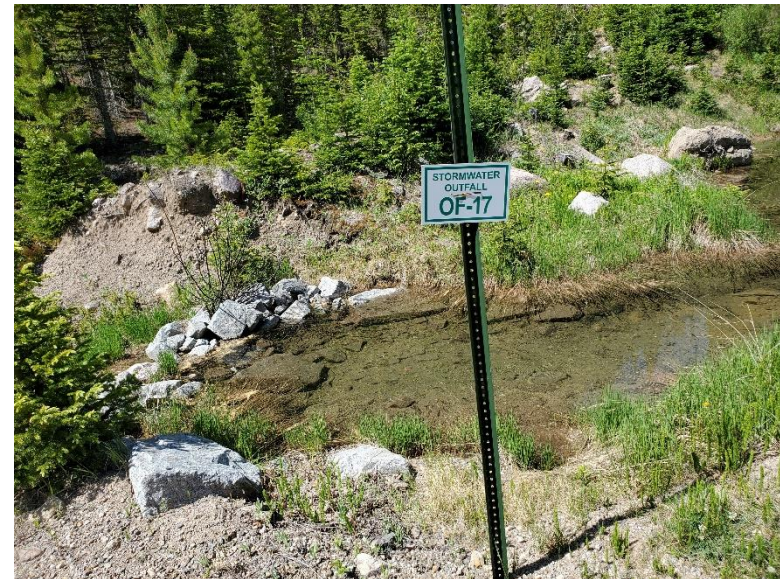
- Appears to be functioning as intended.
- The rip-rap and surrounding banks appear to be in good condition.
- The check dams contained water at the time inspection, and water was flowing down the No Name Gulch.
- No excess sediment accumulation was observed.

**Photo 27:** Looking southwest at check dams along No Name Gulch, south of OF-17.

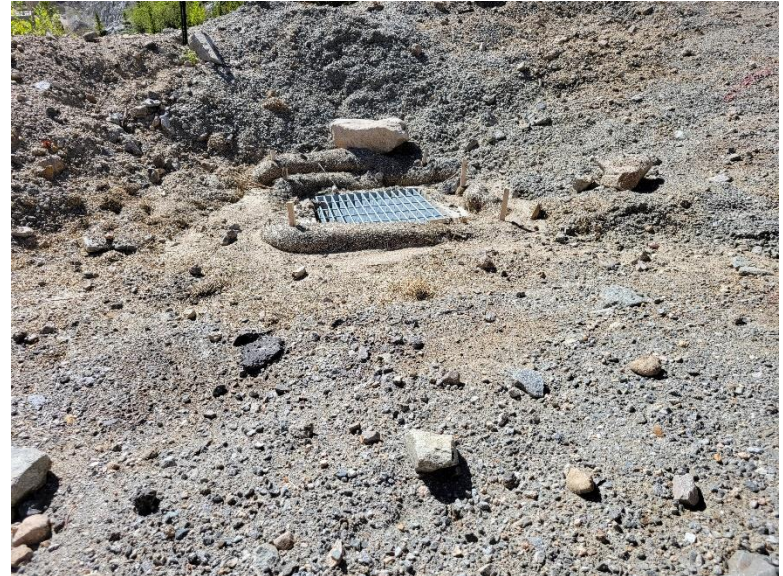
- Appears to be functioning as intended.
- The wattles are in decent condition but will likely be replaced during the Operator's internal storm water maintenance inspection.
- The t-post for the sign was bent and the sign was missing – likely resulting from piled snow from snow plows in the winter. The Operator stated that this will also be addressed during the internal storm water maintenance inspection.
- The area around the box culvert and the drainage path to the culvert were free from obstructions.
- Some sediment has accumulated around the wattles but no excess sediment accumulation was observed.

**Photo 28:** Looking northeast at the OF-18 box culvert.

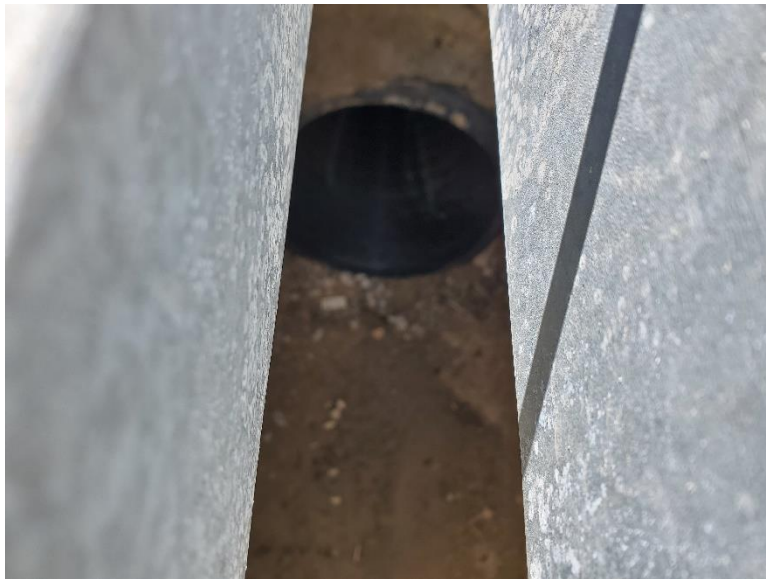
**Photo 29:** Looking into the grate of the box culvert. The culvert is free of obstructions.

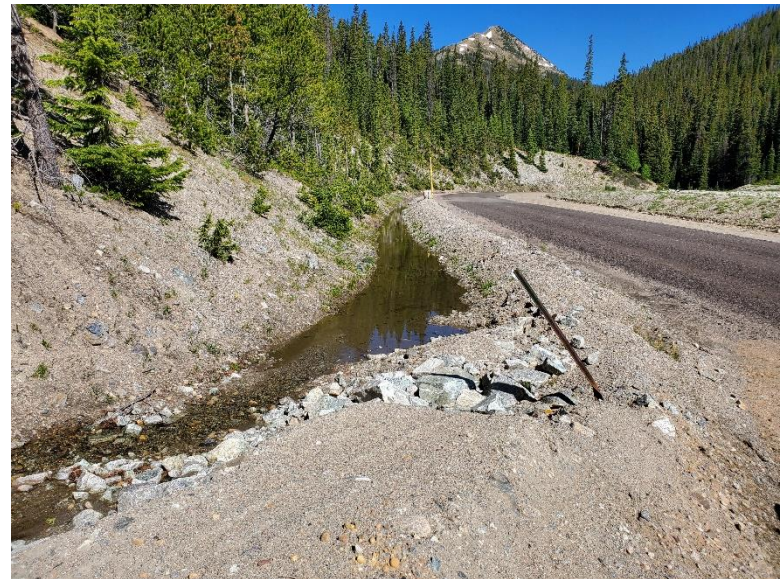
**Photo 30:** Looking northwest along the drainage path south and west of the Potable Water Storage area.

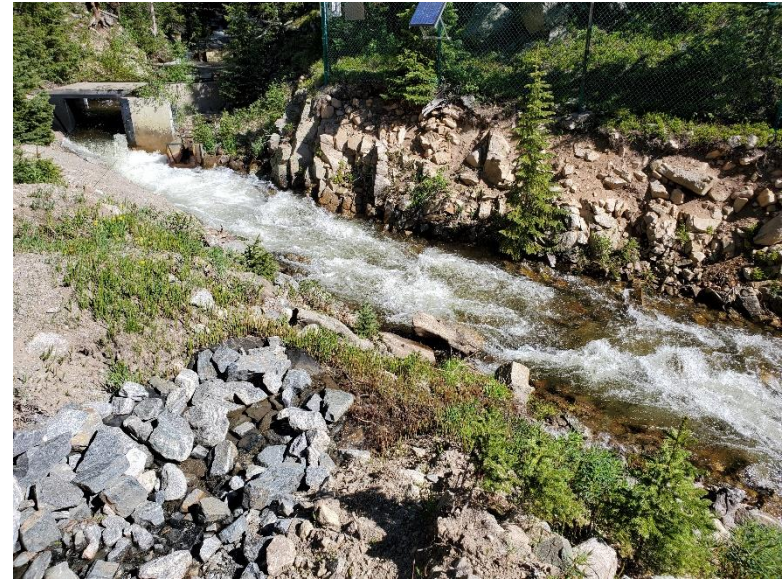
- Appears to be functioning as intended.
- The rip-rap appears to be in good condition.
- The ditch leading to the outfall and the rip-rapped channel contained flowing water at the time of the inspection.
- No excess sediment accumulation was observed.

**Photo 31:** Looking north at where the outfall enters West Fork Clear Creek.

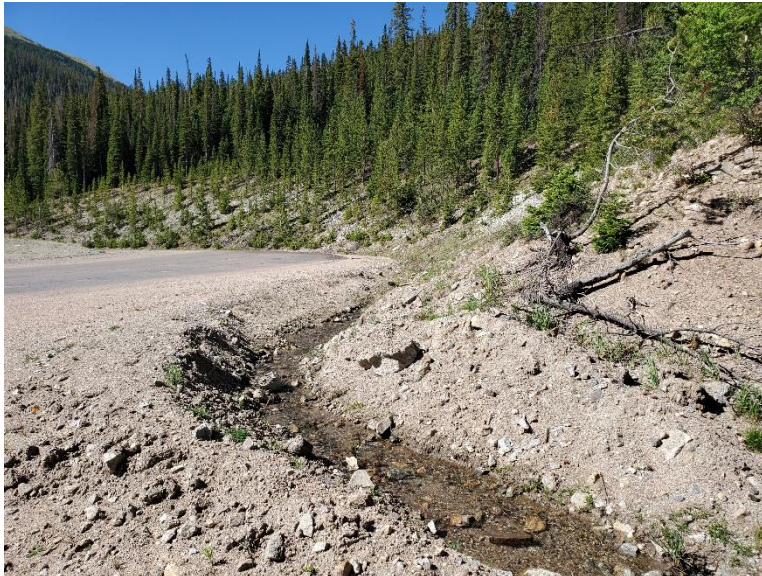
**Photo 32:** Looking south and uphill of OF-19 at the drainage leading to the outfall.

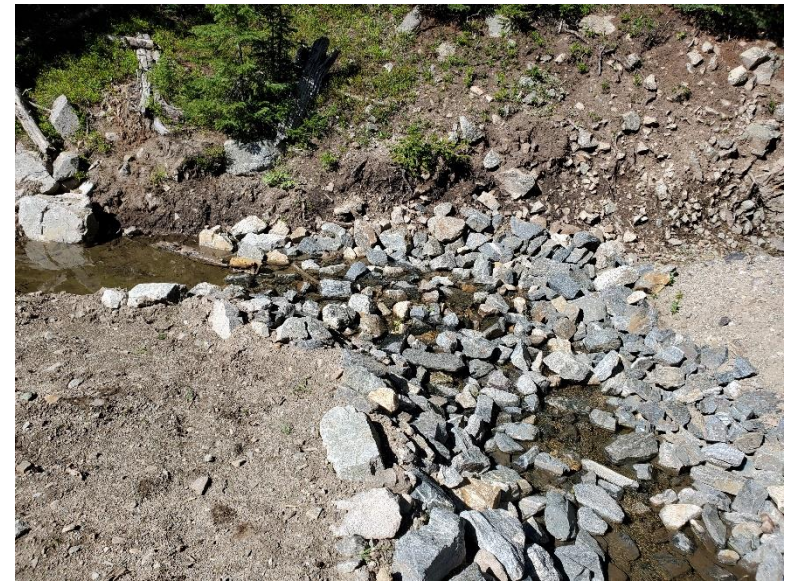
**Photo 33:** Looking at where the drainage in Photo 32 meets with the armored channel leading to OF-19.
