**MINERALS PROGRAM INSPECTION REPORT**  
**PHONE: (303) 866-3567**

<b>MINE NAME:</b> Henderson Mine Exploration Drilling – Puzzler Target	<b>MINE/PROSPECTING ID#:</b> P-2022-006	<b>MINERAL:</b> Molybdenum	<b>COUNTY:</b> Clear Creek
<b>INSPECTION TYPE:</b> Monitoring	<b>WEATHER:</b> Clear	<b>INSP. DATE:</b> June 25, 2024	<b>INSP. TIME:</b> 13:30
<b>OPERATOR:</b> Climax Molybdenum Company	<b>OPERATOR REPRESENTATIVE:</b> Geoff Niggeler and Ben Alcox	<b>TYPE OF OPERATION:</b> MP - Mineral Prospecting	
<b>REASON FOR INSPECTION:</b> Normal I&E Program	<b>BOND CALCULATION TYPE:</b> None	<b>BOND AMOUNT:</b> \$17,000.00	
<b>DATE OF COMPLAINT:</b> NA	<b>POST INSP. CONTACTS:</b> None	<b>JOINT INSP. AGENCY:</b> None	
<b>INSPECTOR(S):</b> Amber M. Gibson Nikie Gagnon	<b>INSPECTOR'S SIGNATURE:</b>

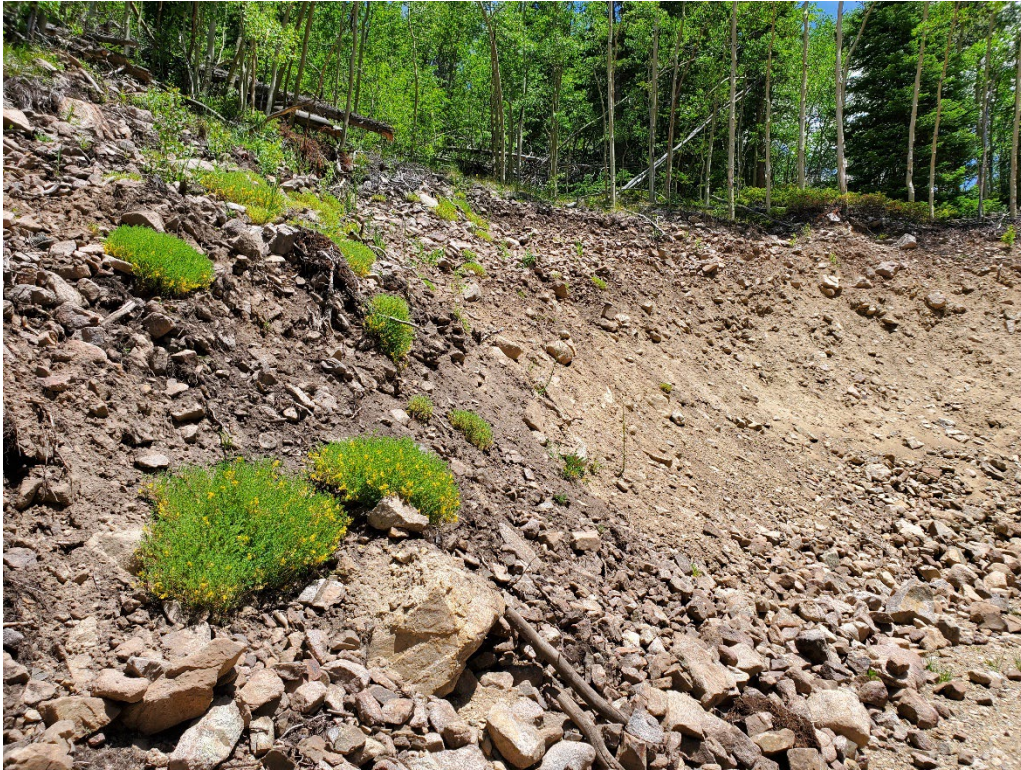
No drilling was taking place and no equipment was observed on site. The Operator stated that they have finished all exploration activity at the site. The site is currently anticipated to be reclaimed by 2025. The approved plan accounts for the current highwalls west of where the drilling pad had been (Photo 1-2) and the access road will be graded and filled to blend with the adjacent terrain and natural drainage patterns will be re-established upon reclamation. Topsoil and salvaged woody debris (Photo 3) will be replaced on top of the slopes and the affected areas will be seeded with the approved seed mixture.

**Photo 1:** Looking west at some volunteer vegetation growing on the remaining affected slope.

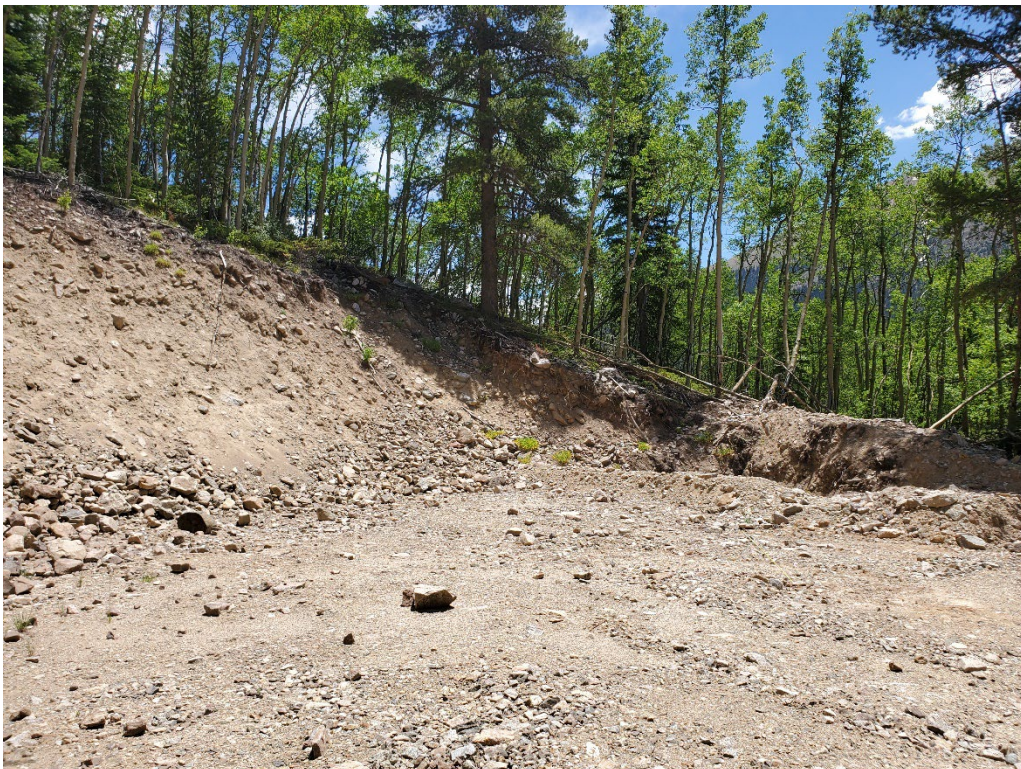
**Photo 2:** Looking at the north-east corner of the affected area.

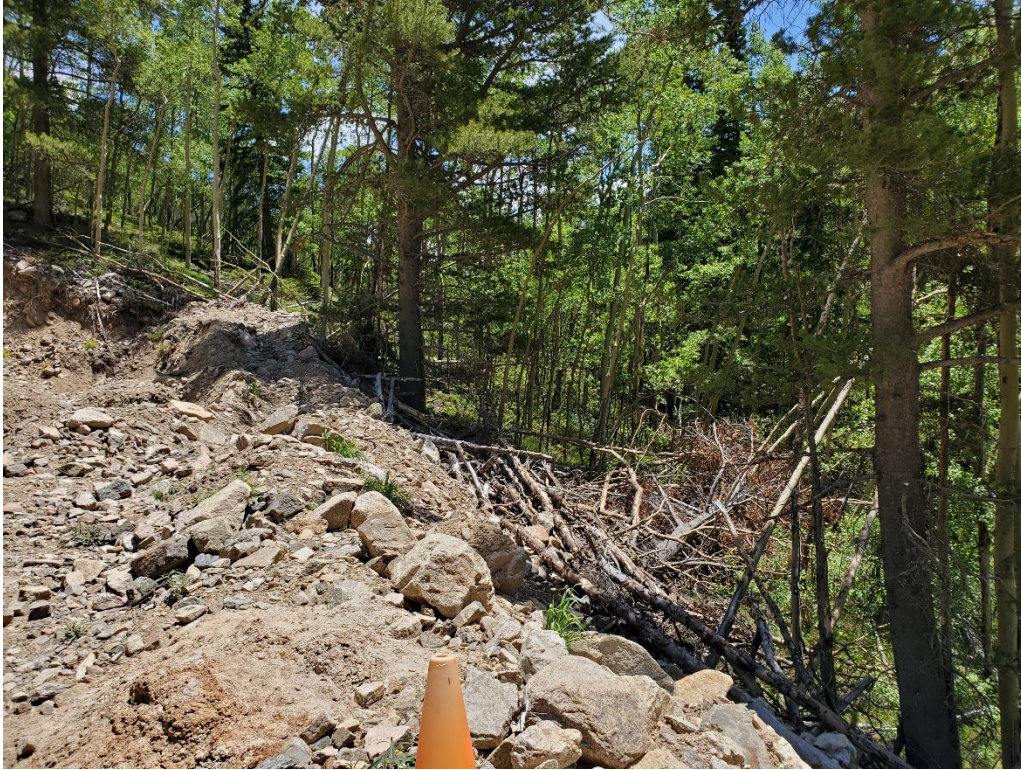
**Photo 3:** Looking downslope, east where the drill pad had been, at the salvaged woody debris and topsoil.

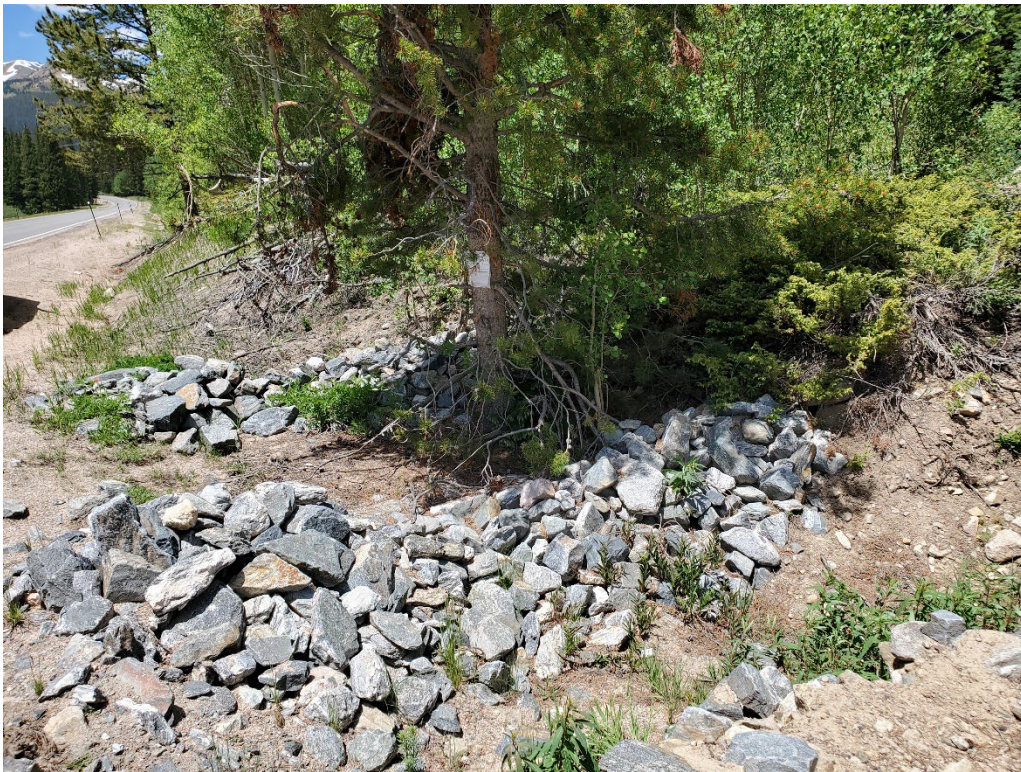
Five possible Pollutant Sources (PS) are listed for the site in the Storm Water Management Plan (SWMP). These PS's include PS#1 sediment, PS#2 drilling muds, PS#3 fuel, oil, and lubricants (equipment), PS#4 sanitary facilities, and PS#6 general refuse and food scraps. Because the last date of activity on the site was in October 2022, PS sources 2-5 are not needed to be actively monitored at this time. Best management practices (BMPs) were observed throughout the site. Sediment berms, a few rock check dams, and some straw wattles were observed alongside the access road and near where the drill pad would have been. These appear to be in good condition and appear to effectively control and limit sediment run-off from the affected area (Photos 4-8).

**Photo 4:** Looking west at a series of rock check dams along the entrance to the access road.

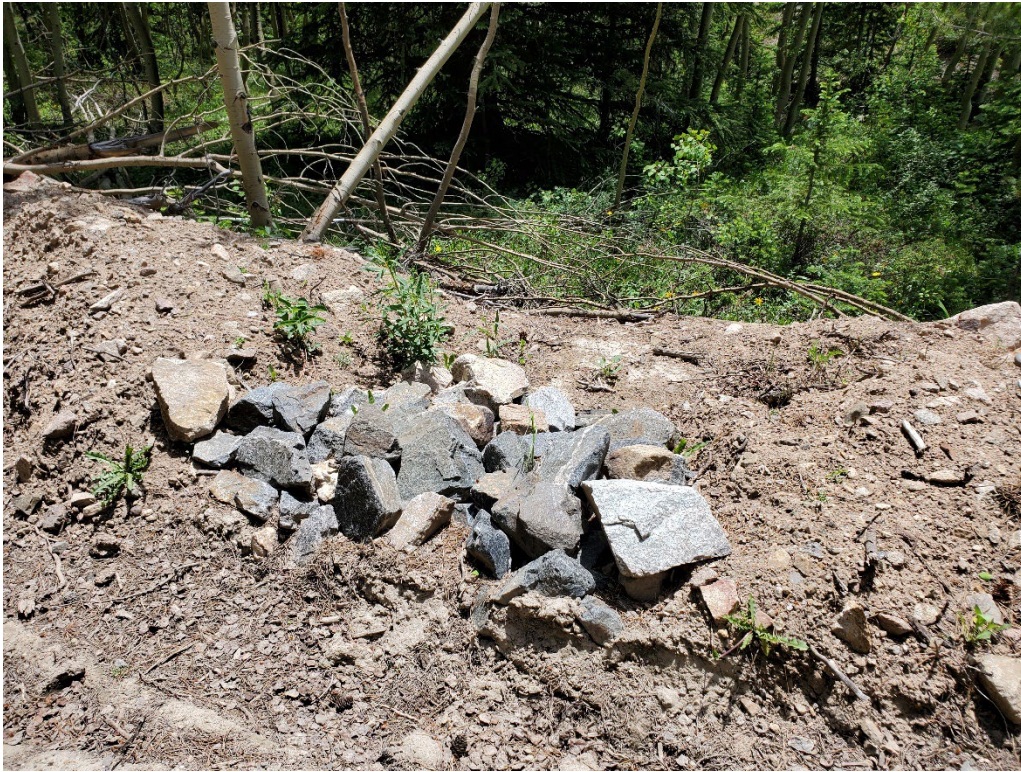
**Photo 5:** Looking north-east at a check dam along the access road.

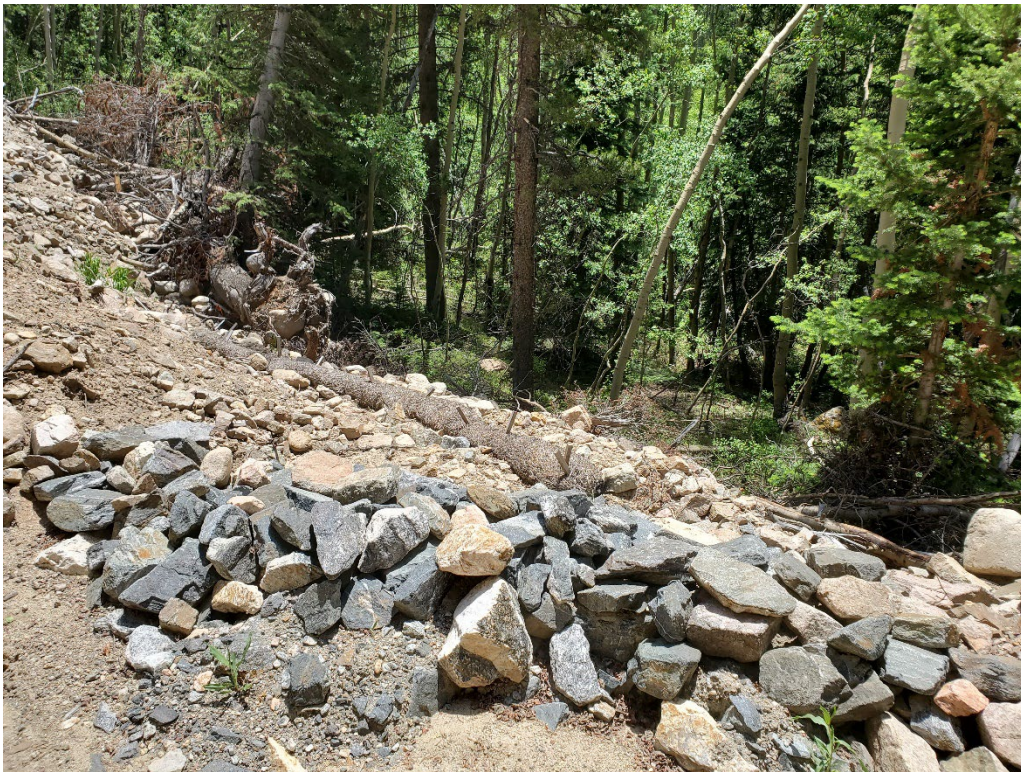
**Photo 6:** Looking north-east at a check dam along the access road.

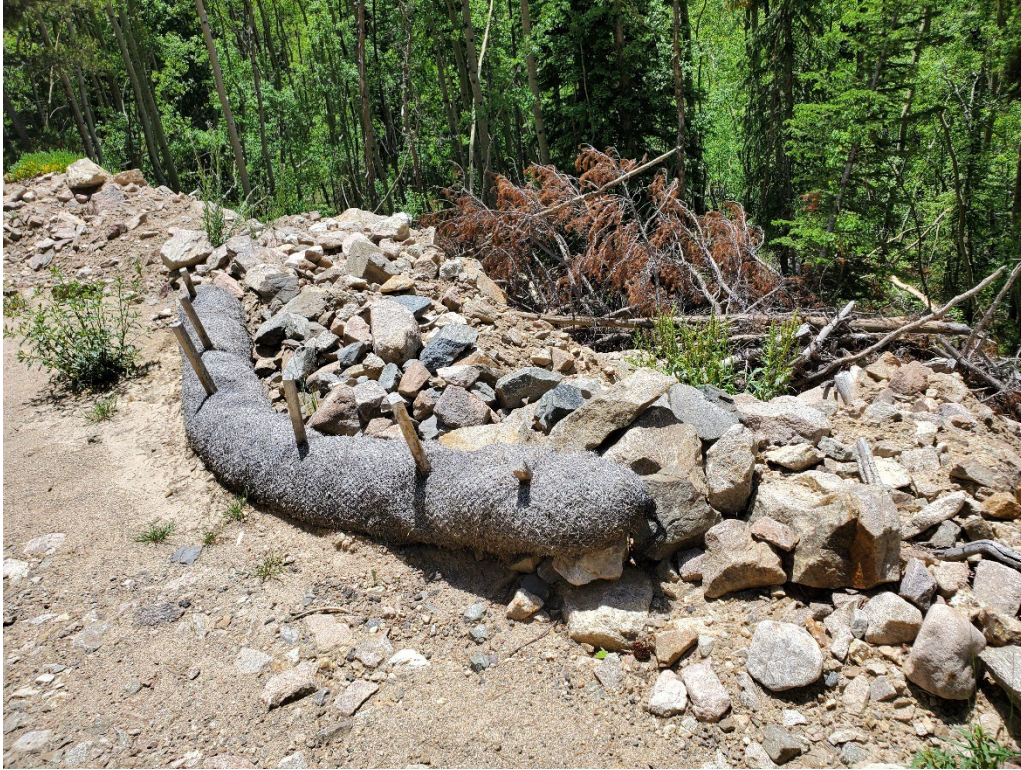
**Photo 7:** Looking north-east at a check dam and straw wattle along the access road.

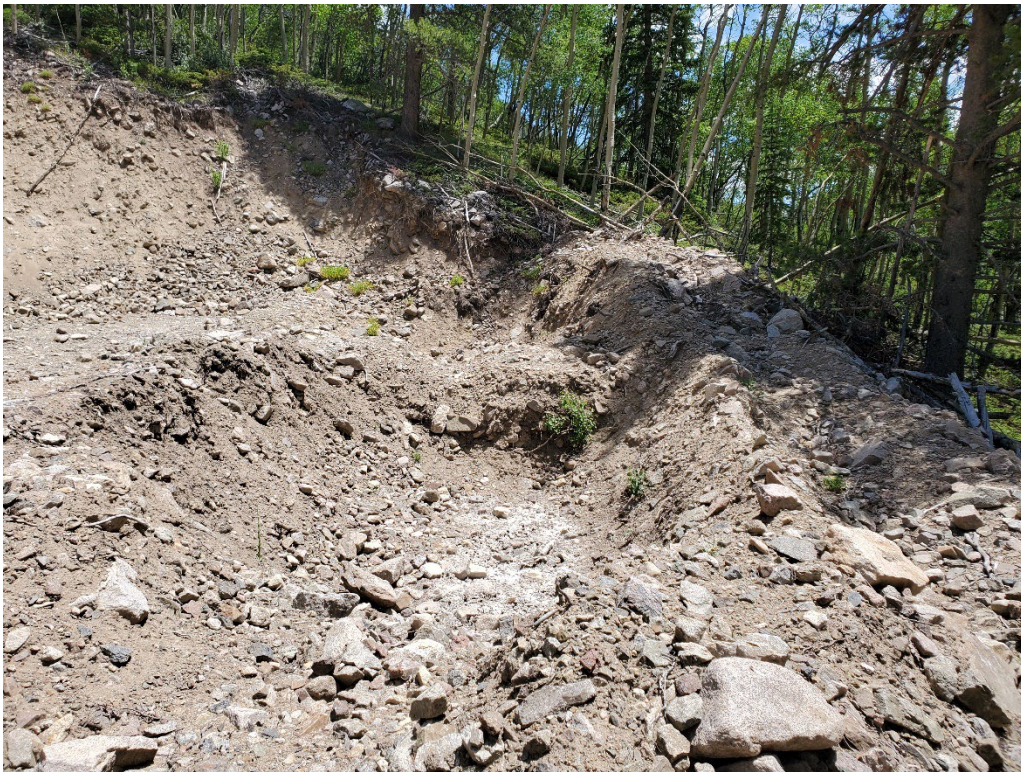
**Photo 8:** Looking north towards the north corner of the affected area. Pictured is the remaining containment sump that had been used a preventative maintenance for PS#2 - Drilling Muds.
