File: May 2024 Monitoring Summary

Date: June 30, 2024

Reference: May 2024 Geotechnical Monitoring Summary Pikeview Quarry

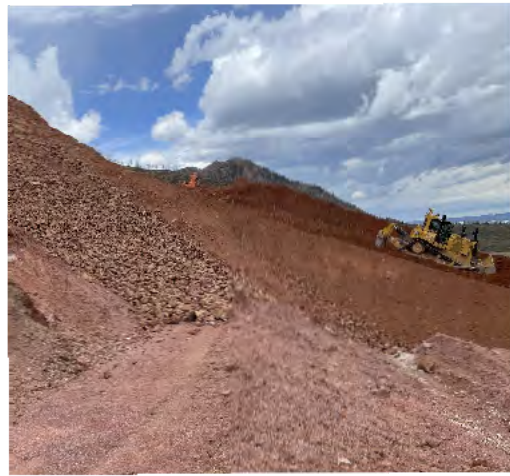
6. FILL PUSHED DOWN FROM ABOVE ROAD.

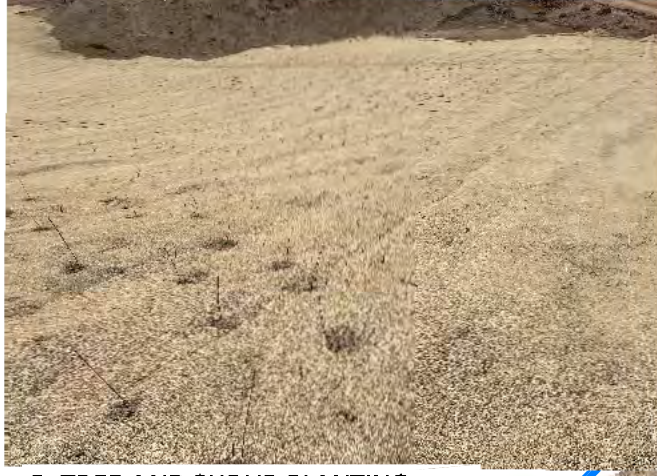
5. TREE AND SHRUB PLANTING.

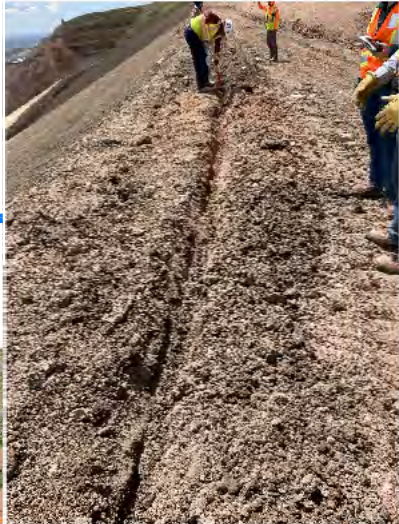
4. ANCHOR TRENCHING FOR MATTING.

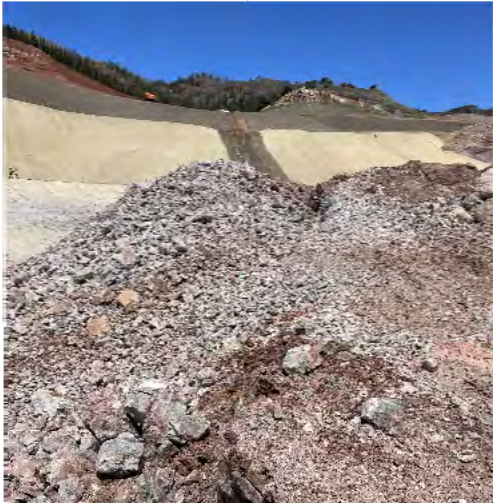
3. LOWER CHANNEL BLASTING AREA

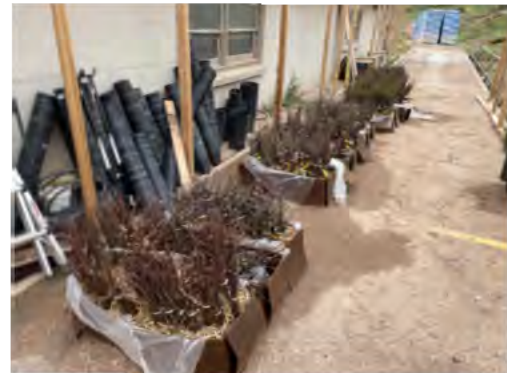
7. CONTAINER STOCK READY FOR PLANTING.

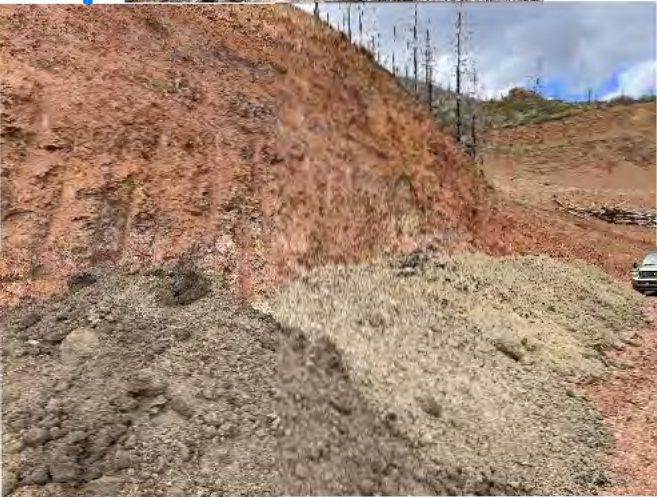
2. SOUTH PEAK BENCH WITH FILL PLACED.

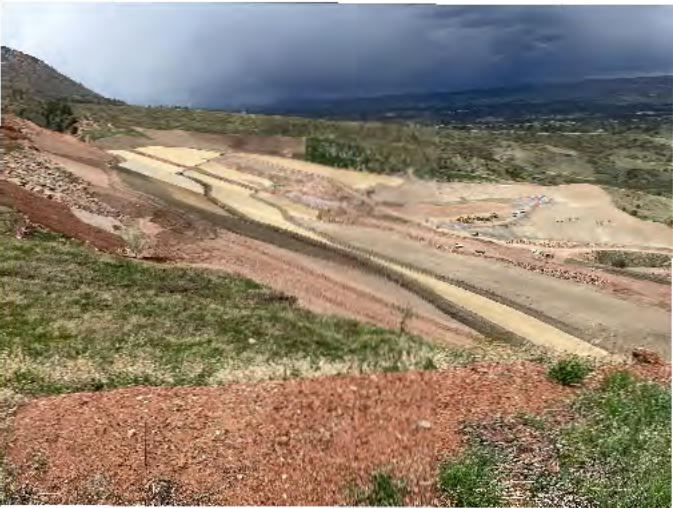
1. VIEW NORTHEAST OF RECLAIMED SLOPES.

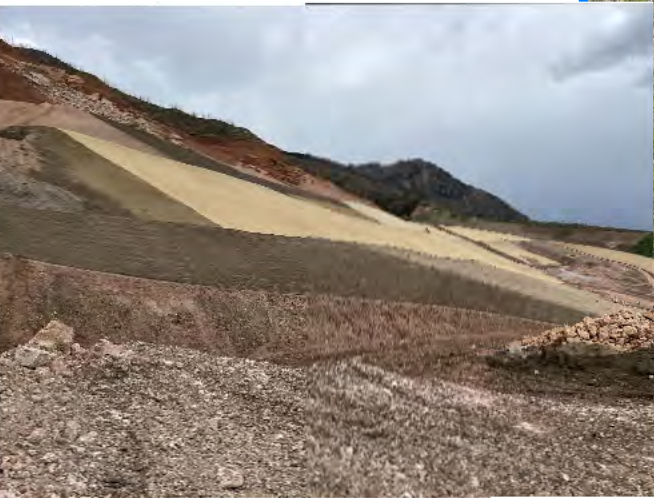
8. VIEW NORTHWEST OF RECLAIMED SLOPES.

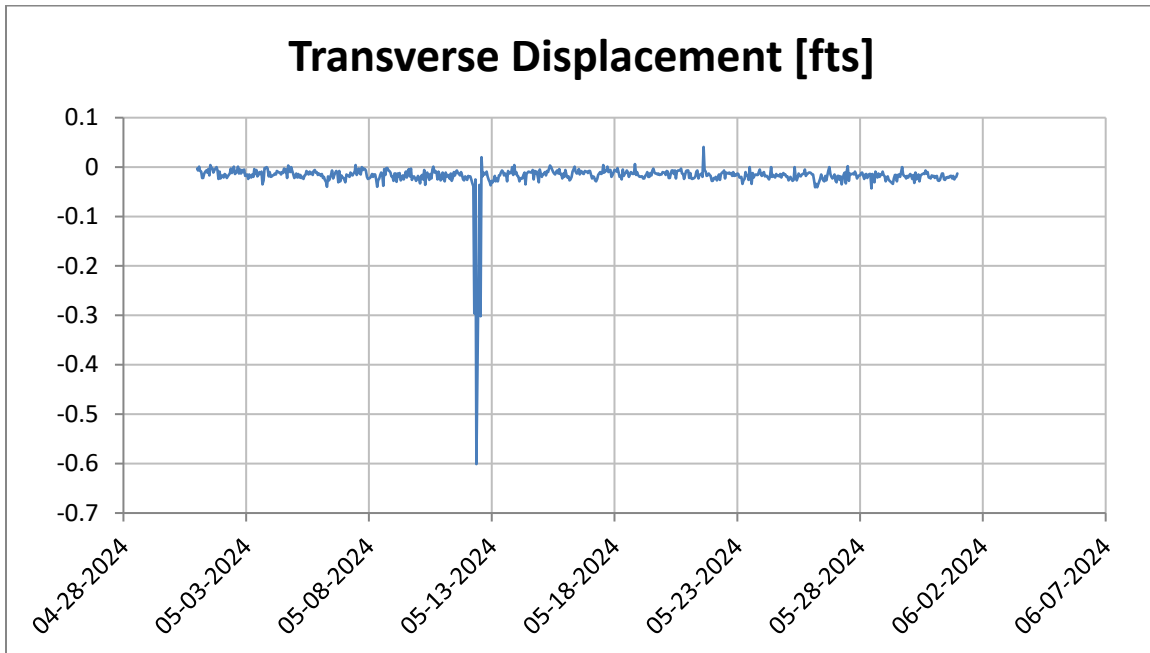
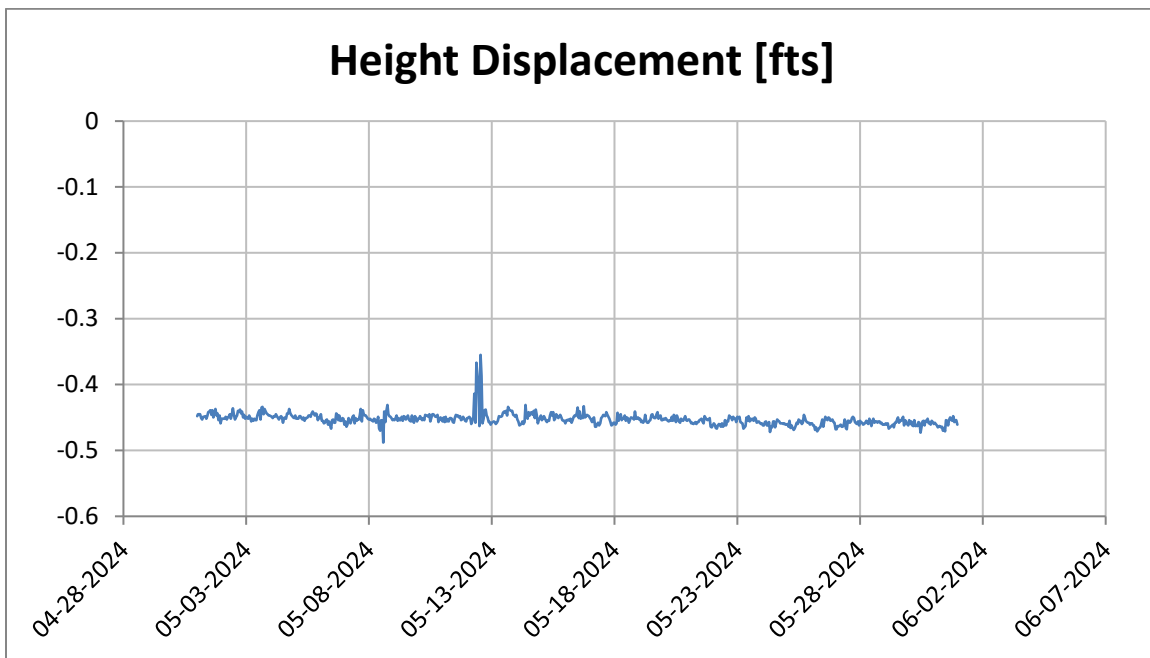
Prism BR1

1. Survey accuracy is ± 0.016 feet.
2. Alert threshold is ± 0.35 feet.
3. Transverse displacement is in the horizontal direction. Positive direction means closer to the robotic total station.
4. Height displacement is in the vertical direction. Positive direction means higher in elevation.
5. Prism previously recorded slope creep movements.

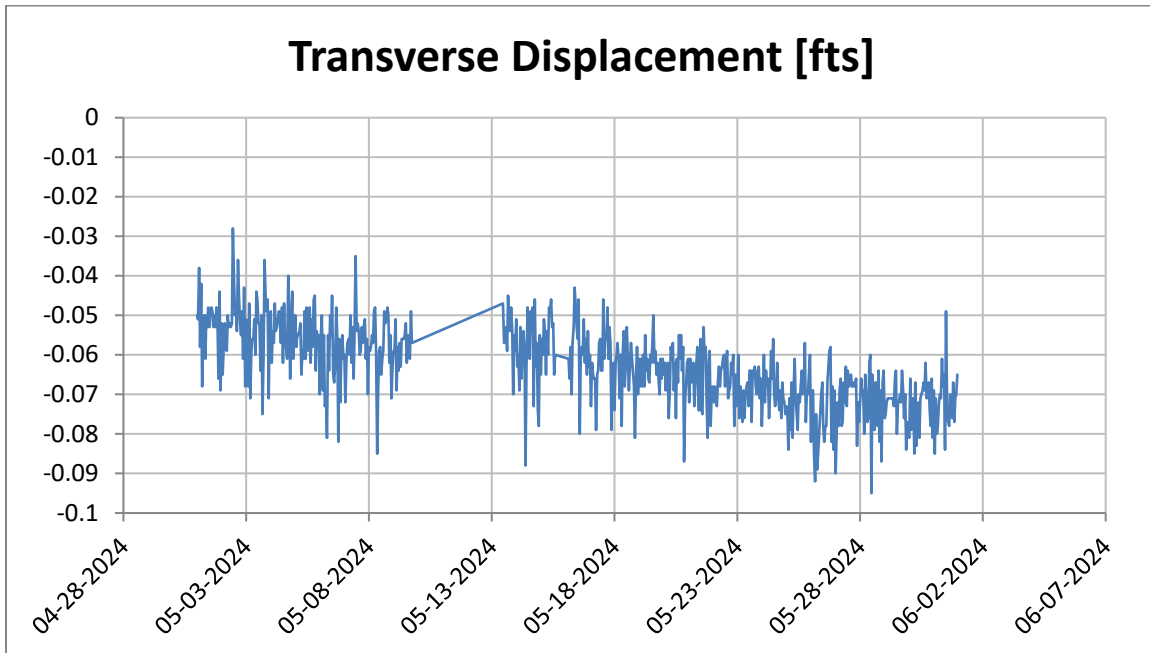
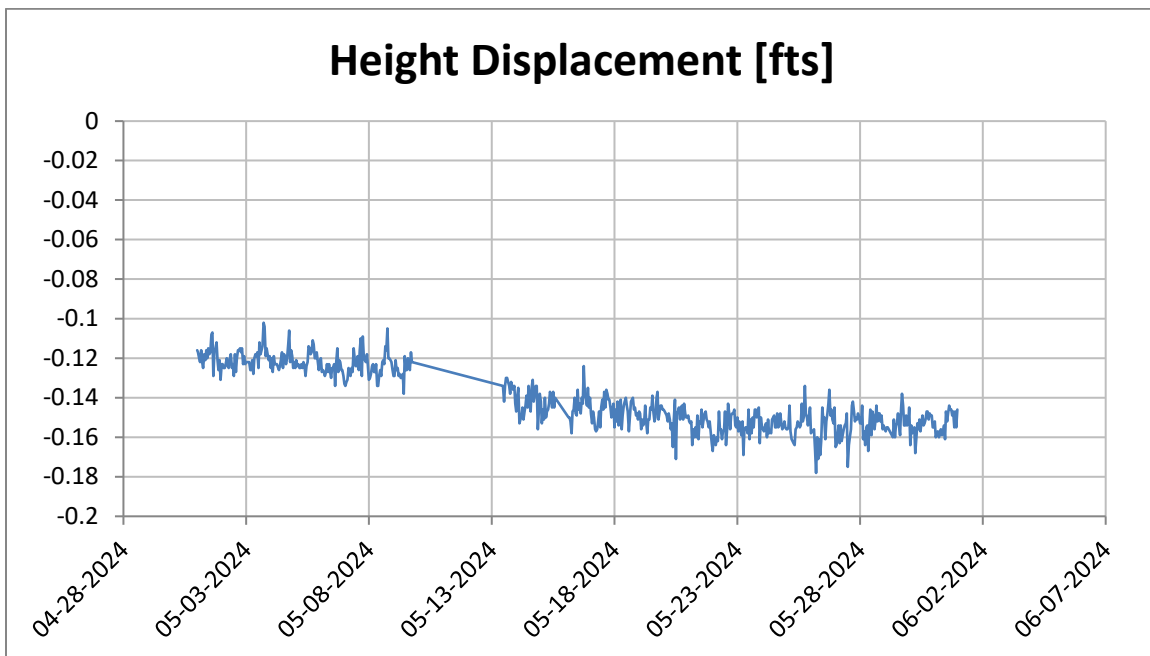
Prism BR3

| Date(s) | Alert | Cause/Actions taken | Resolved |
|---|---|---|---|
| 9-May to 13-May | BR3 not found | Prism turned by rock raveling during grading operations higher on the slope. Spotter used or no work during alerts. | 13-May |
| 15-May to 16-May | BR3 not found | Prism turned by grading operations higher on the slope. Spotter used or no work during alerts. | 16-May |

| Prism ID | Cumulative Transverse Displacement (ft) | Cumulative Height Displacement (ft) | Monthly Delta (ft) | Cumulative Delta (ft) | Notes / Recommendations |
|---|---|---|---|---|---|
| BR3 | -0.065 | -0.146 | 0.0452 | 0.1796 | Prism impacted by grading operations. |

1. Survey accuracy is +/-0.016 feet.
2. Alert threshold is +/-0.35 feet.
3. Transverse displacement is in the horizontal direction. Positive direction means closer to the robotic total station.
4. Height displacement is in the vertical direction. Positive direction means higher in elevation.
5. Prism previously recorded slope creep movements.
6. Prism turned by rock raveling during grading operations on May 9 to 13.

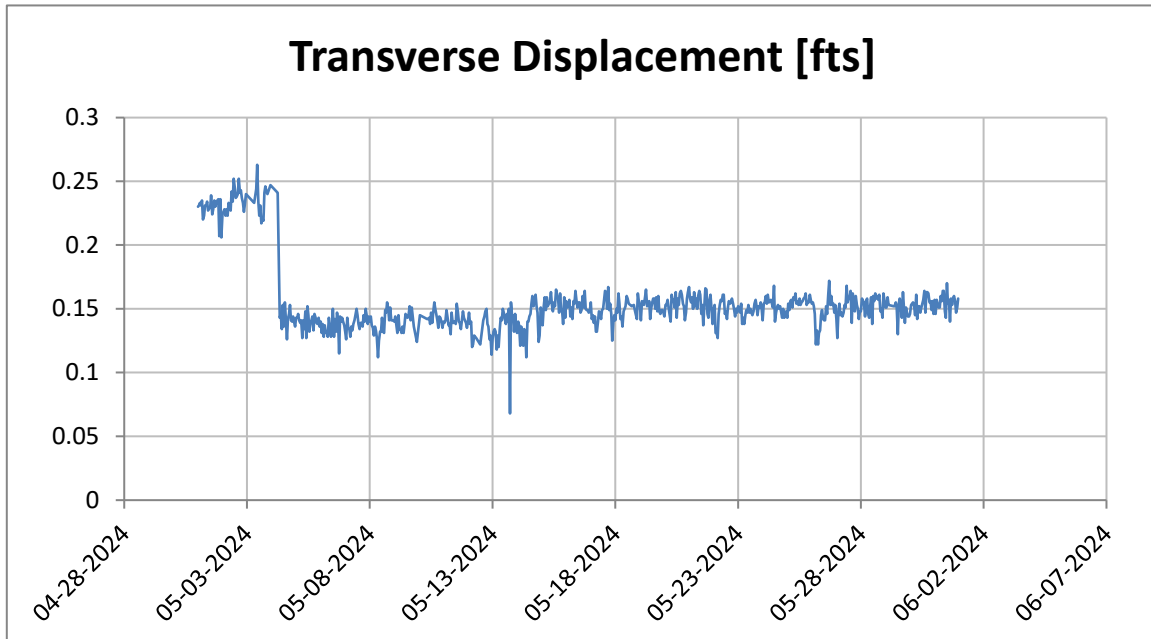
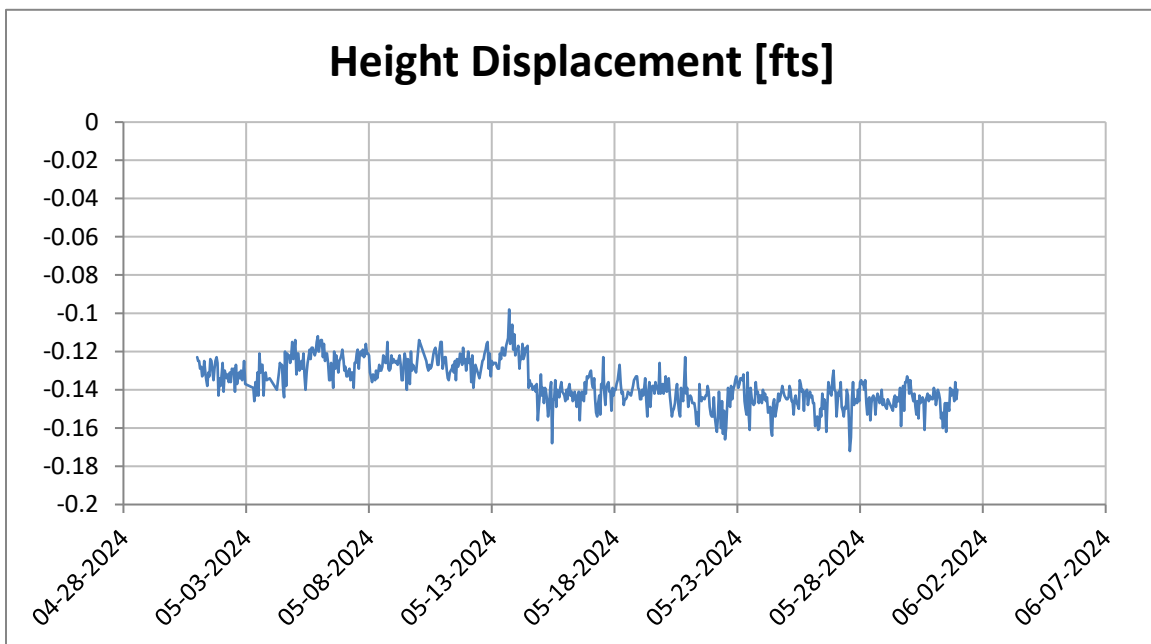
Prism B7300-4

| Date(s) | Alert | Cause/Actions taken | Resolved |
|---|---|---|---|
| 3-May to 4-May | B7300-4 not found | Prism impacted by topsoil placement. No work during alerts. | 4-May |

| Prism ID | Cumulative Transverse Displacement (ft) | Cumulative Height Displacement (ft) | Monthly Delta (ft) | Cumulative Delta (ft) | Notes / Recommendations |
|---|---|---|---|---|---|
| B7300-4 | 0.538 | -0.323 | 0.0259 | 0.7331 | Prism impacted by topsoil operations. |

1. Survey accuracy is ± 0.016 feet.
2. Alert threshold is ± 0.35 feet.
3. Transverse displacement is in the horizontal direction. Positive direction means closer to the robotic total station.
4. Height displacement is in the vertical direction. Positive direction means higher in elevation.
5. Prism impacted by topsoil placement on May 4.

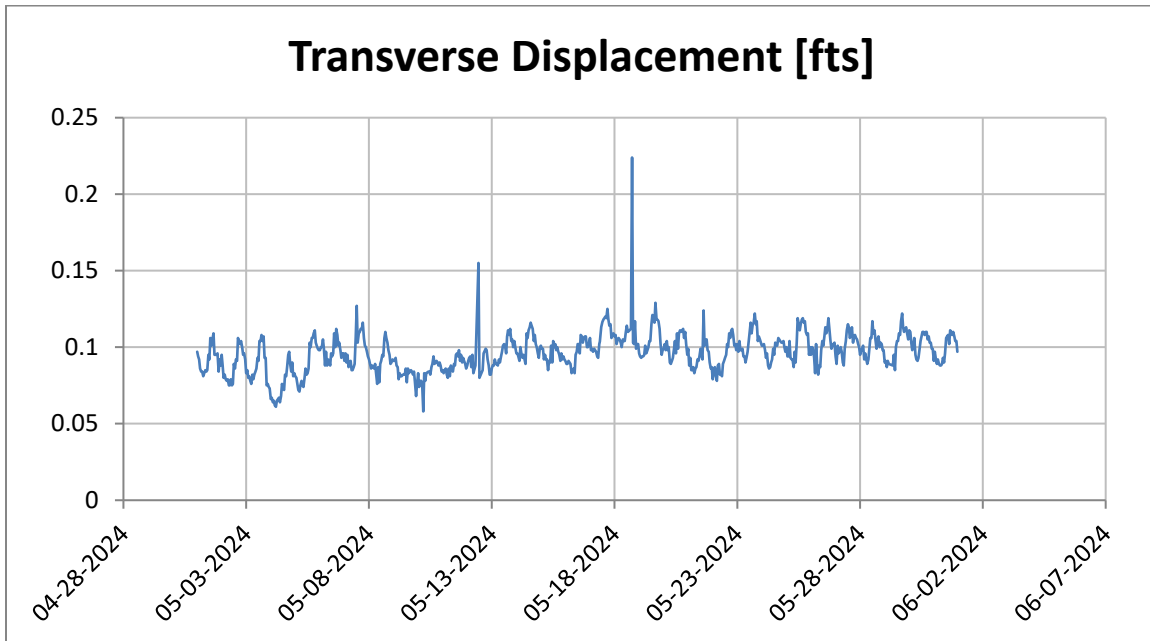
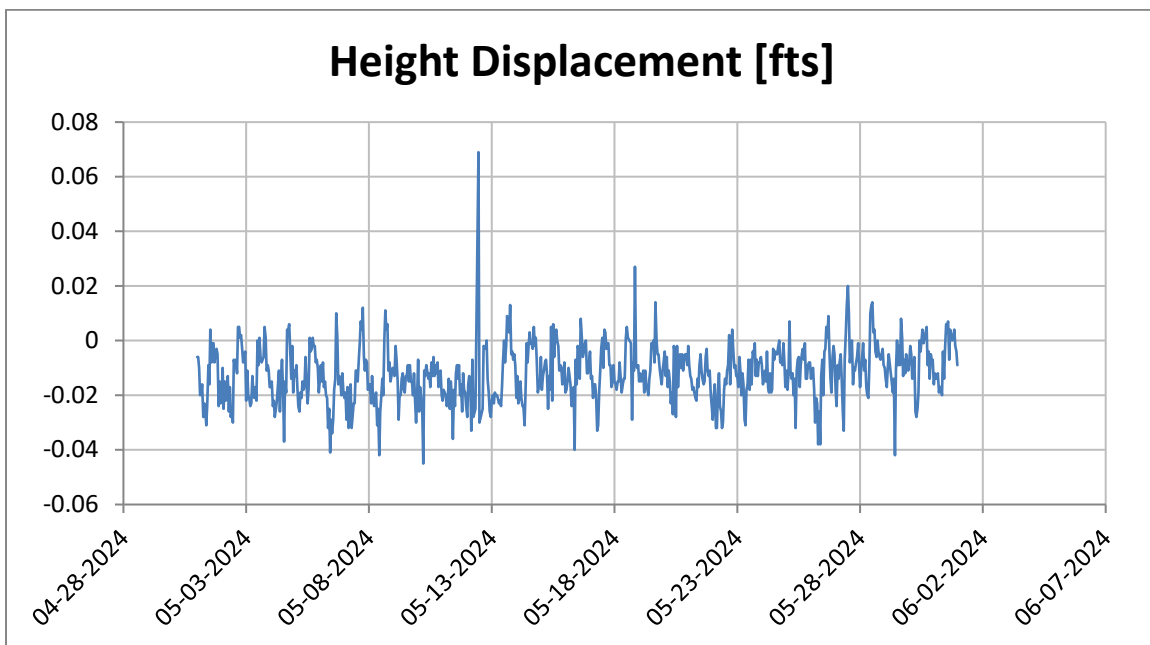
Prism P33

| Date(s) | Alert | Cause/Actions taken | Resolved |
|---|---|---|---|
| 18-May | P33 regression limit | Rain and fog at time of alerts. Readings in positive and negative directions. | 18-May |

1. Survey accuracy is ± 0.016 feet.
2. Alert threshold is ± 0.35 feet.
3. Transverse displacement is in the horizontal direction. Positive direction means closer to the robotic total station.
4. Height displacement is in the vertical direction. Positive direction means higher in elevation.
5. Regression limit received on May 18.

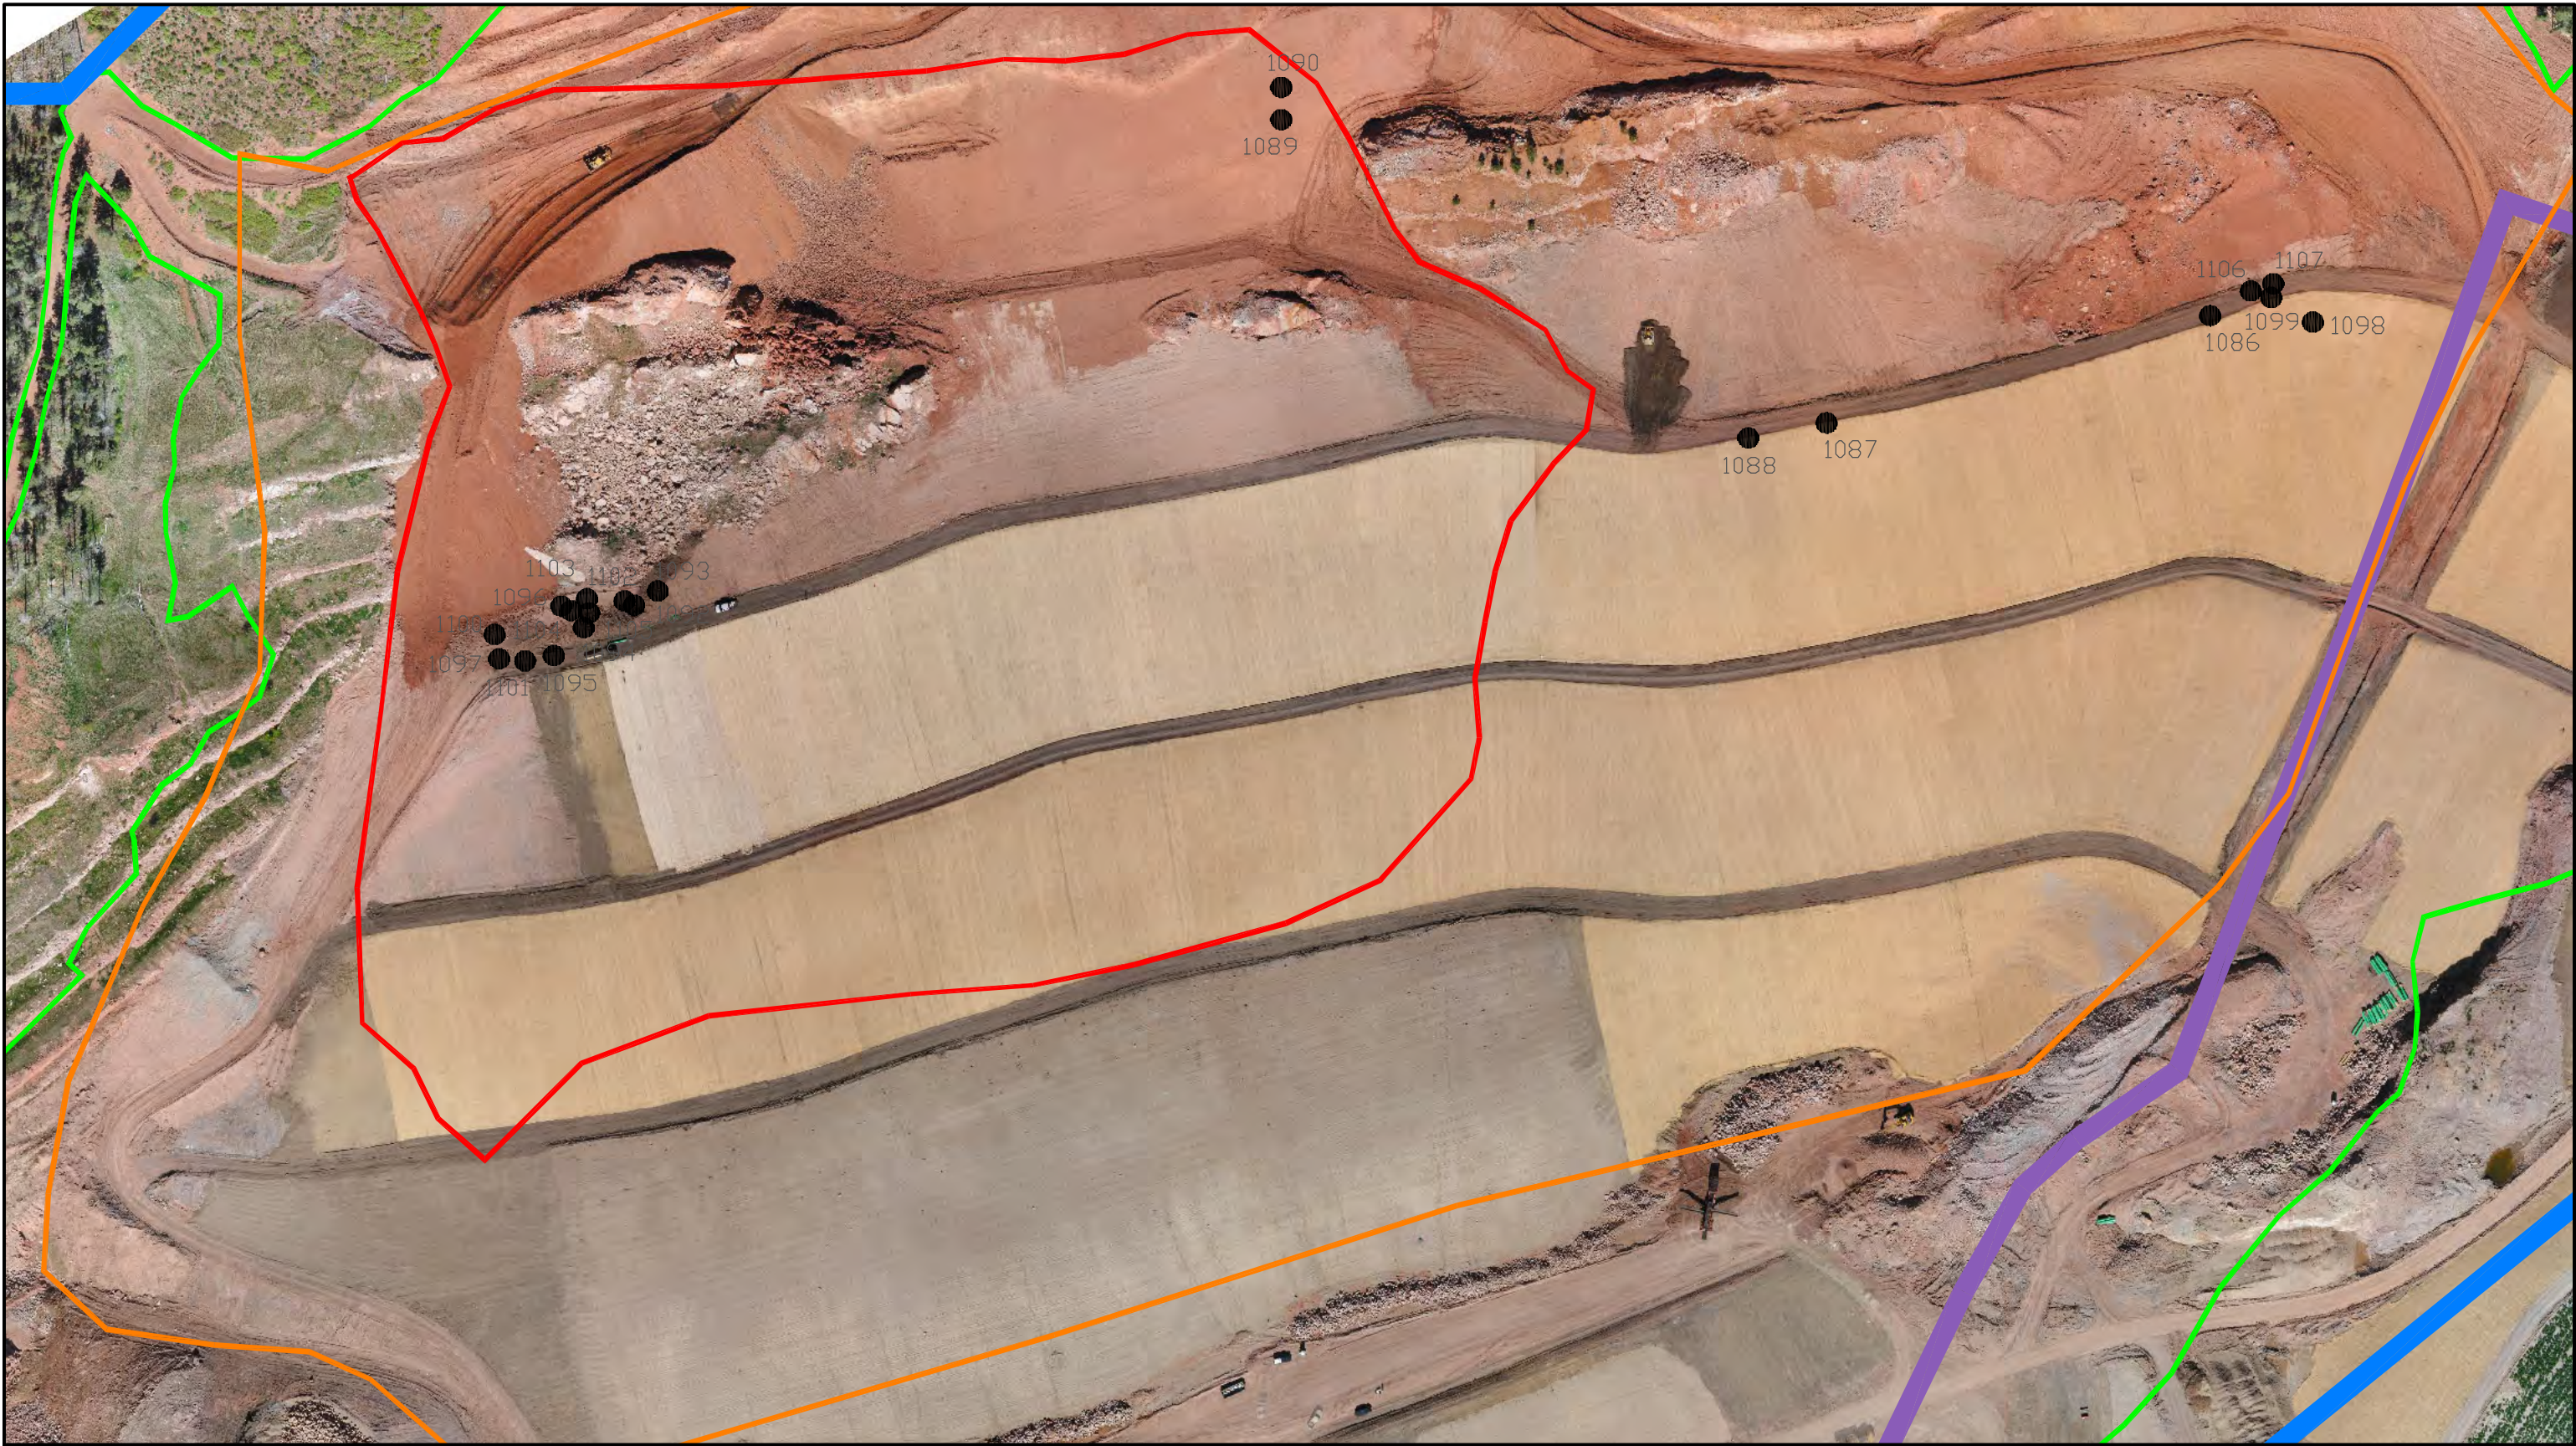
- Cracking was previously observed on the graded slopes near the upper extents of the fill slope. These tension cracks were inspected in May and observed to be similar in nature from previous inspections. Based on the aerial imagery, the upper crack had extended approximately 30 feet to the south, and this is still within the area of cracking when the upper and lower cracks are considered. Compaction tests in the area of the cracks resulted in densities that exceeded the fill specifications.

1. THERE WAS NO TEST 1091.
2. TESTS 1089 AND 1090 ARE BELOW AND ABOVE THE CRACKING AREA.
3. LOCATIONS FOR TESTS 1089, 1090, 1100, AND 1101 ARE APPROXIMATE.
