MINERALS PROGRAM INSPECTION REPORT
PHONE: (303) 866-3567

MINE NAME: Pikeview Quarry	MINE/PROSPECTING ID#: M-1977-211	MINERAL: Limestone (general), granite gneiss and do	COUNTY: El Paso
INSPECTION TYPE: Monitoring	WEATHER: Clear	INSP. DATE: June 25, 2024	INSP. TIME: 10:00
OPERATOR: Riverbend Industries Inc.	OPERATOR REPRESENTATIVE: Jerry Schnabel	TYPE OF OPERATION: 112c - Construction Regular Operation	
REASON FOR INSPECTION: Normal I&E Program	BOND CALCULATION TYPE: None	BOND AMOUNT: \$13,389,784.00	
DATE OF COMPLAINT: NA	POST INSP. CONTACTS: None	JOINT INSP. AGENCY: None	
INSPECTOR(S): Hunter Ridley Zach Trujillo	INSPECTOR'S SIGNATURE:

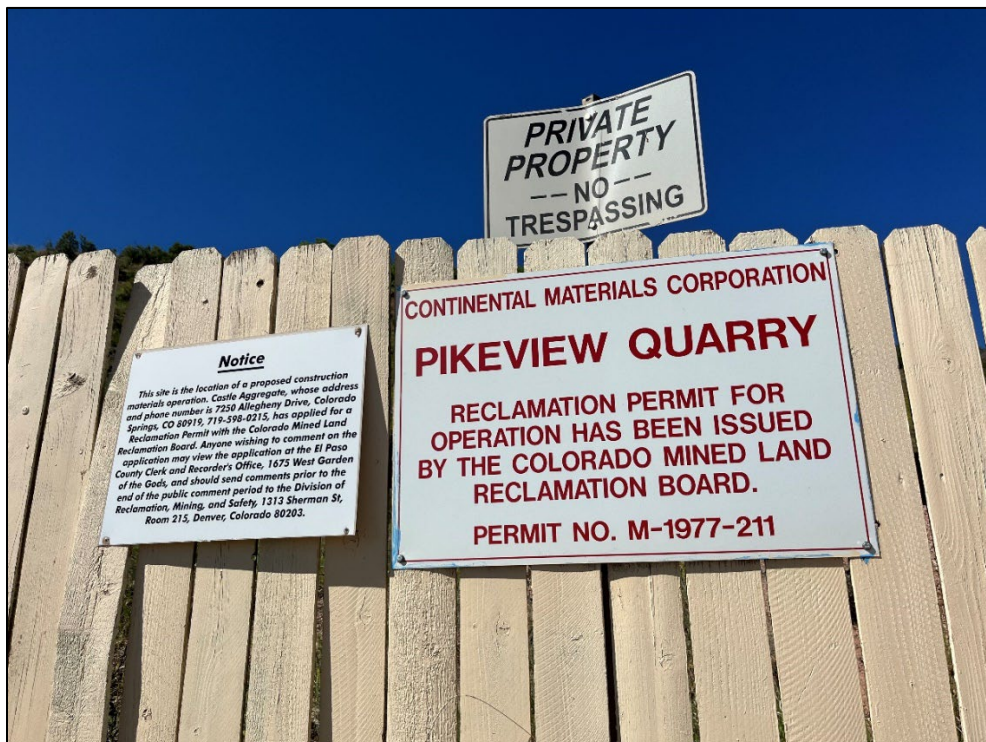
The mine sign, which included all required information, was located at the site's access road (Photo 1).

Photo 1: Mine sign identification is located on the gate at the site access road entrance.

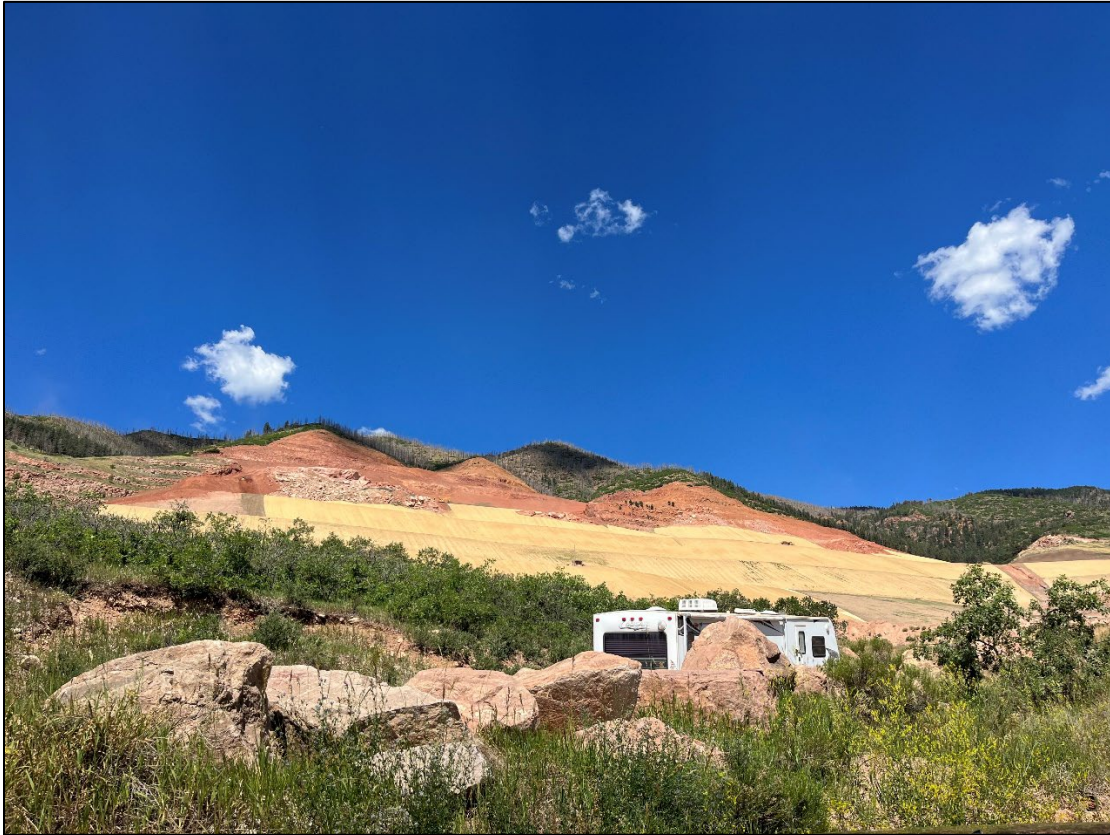
Earthwork is nearly complete at the site. Slopes at final grade are being topsoiled, seeded, and matted and revegetation efforts are being closely monitored by staff on site (Photo 2).

Photo 2: View west of the partially matted butte and three peaks.

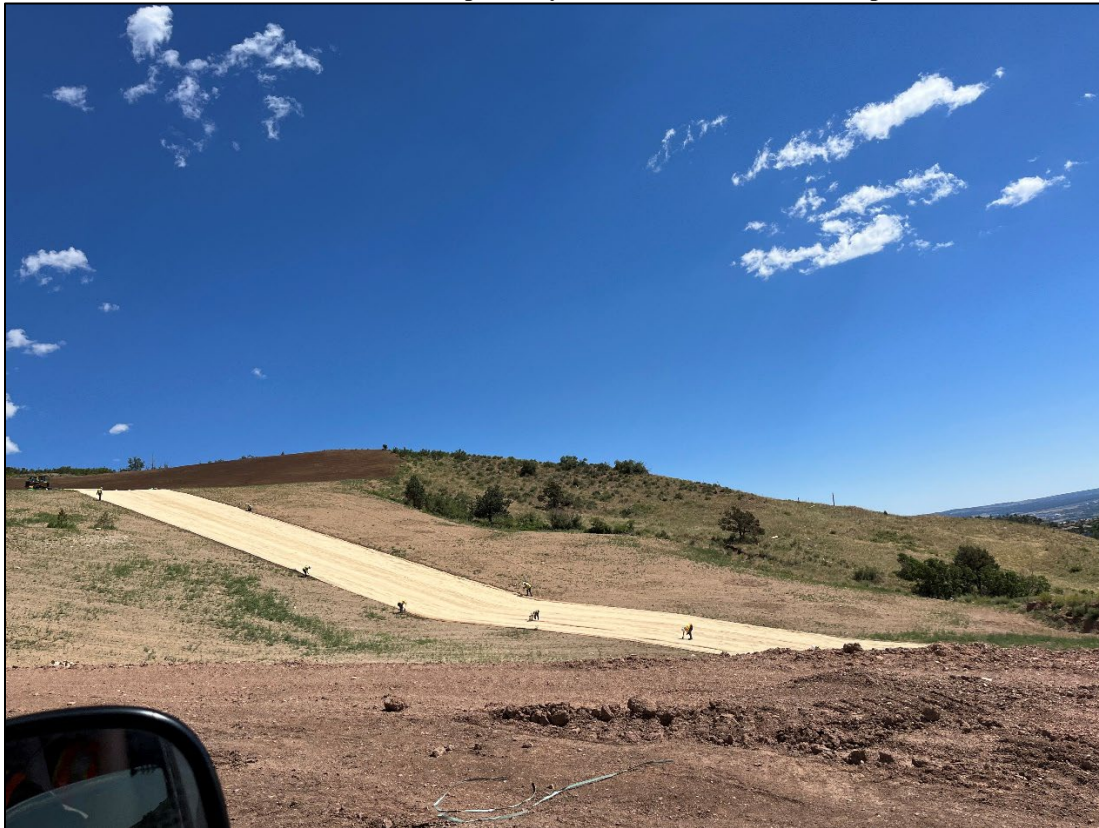
Extra coconut matting blankets were being installed at the time of inspection to address erosional features occurring above the shop area (Photo 3). Matting procedures onsite are usually reserved for 2H:1V or greater slopes.

Photo 3: Erosion control matting was being placed on a northeastern slope where erosion rills were present.

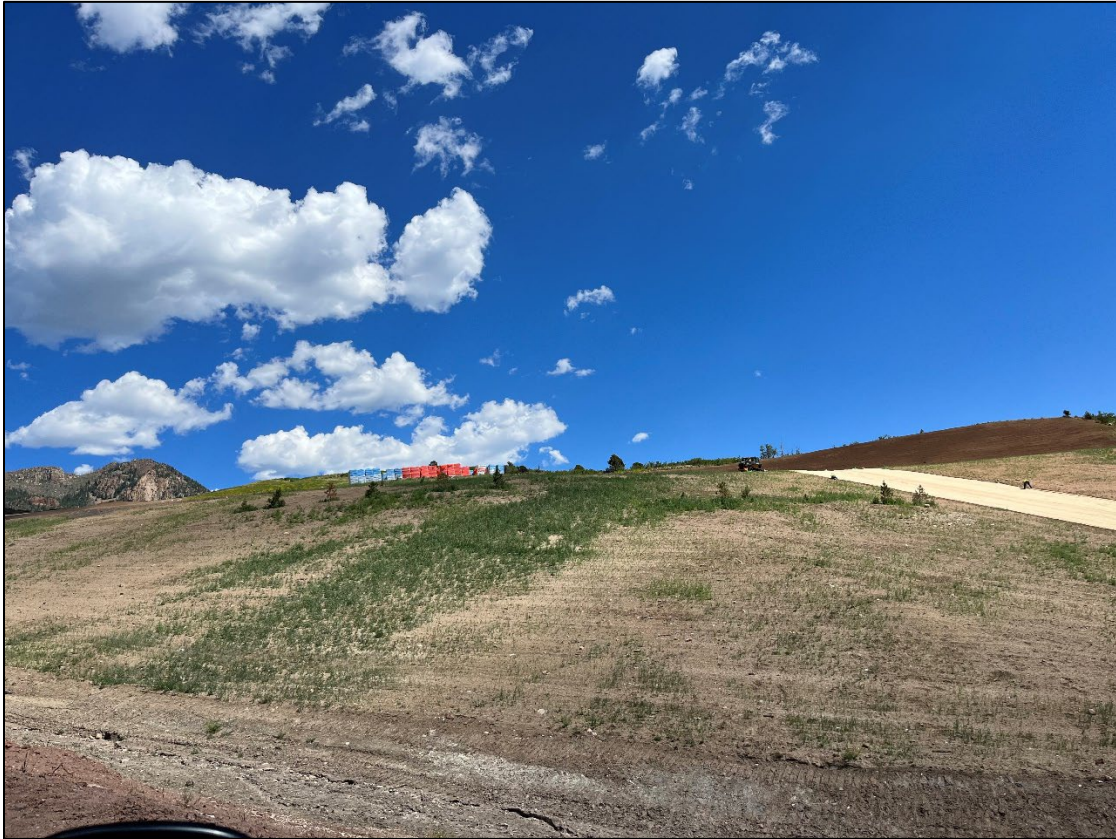
Recent vegetation growth was mostly observed in the northern portion of the site, on City property (Photos 3,4, and 7). Growth in this area appeared to be supporting multiple species of grasses and transplanted shrubs were noted to be greening and getting taller. The 10 acres test plot planted ~ 2 years ago also shows some signs of successful revegetation. However, most of this is limited to 1-2 species, mainly alfalfa and sweet clover (Photo 6). This slope will need to show a more diverse species composition in final reclamation. Mr. Schnabel indicated that he was aware of this requirement and noted that additional seeding may have to occur to improve the growth of grass species in this area.

Photo 4: View of a reseeded slope on city property. Test plot areas for tree growth are located at the top of this slope.

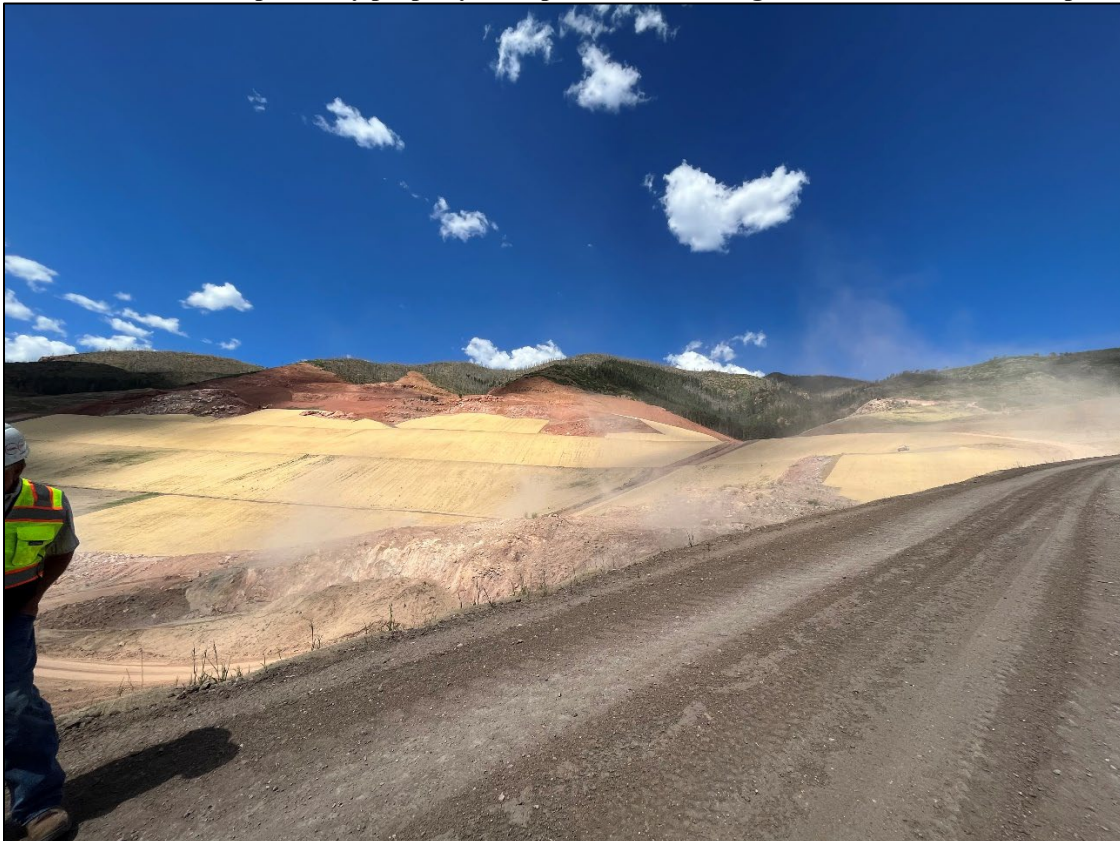
Hydrologic Balance: Preliminary cuts for the final configuration of the surface water drainage channels continue to be constructed onsite (Photo 5). Channels above and directly below the Kiewit Cliffs area have been partially laid out, but not yet formally cut. In final reclamation, each drainage terrace will have prisms permanently installed. TR 24 addressed design changes needed for the upper drainage channels at the site. As final reclamation progresses, rip rap which will be used to construct and stabilize these channels. This rip rap is already stored on site and has been largely sourced from onsite areas like the Dragon's Back area and three peaks areas.

Photo 5: View west of the 'Dragon's back' area, matted slopes, and the beginning cuts for the main drainage channel.

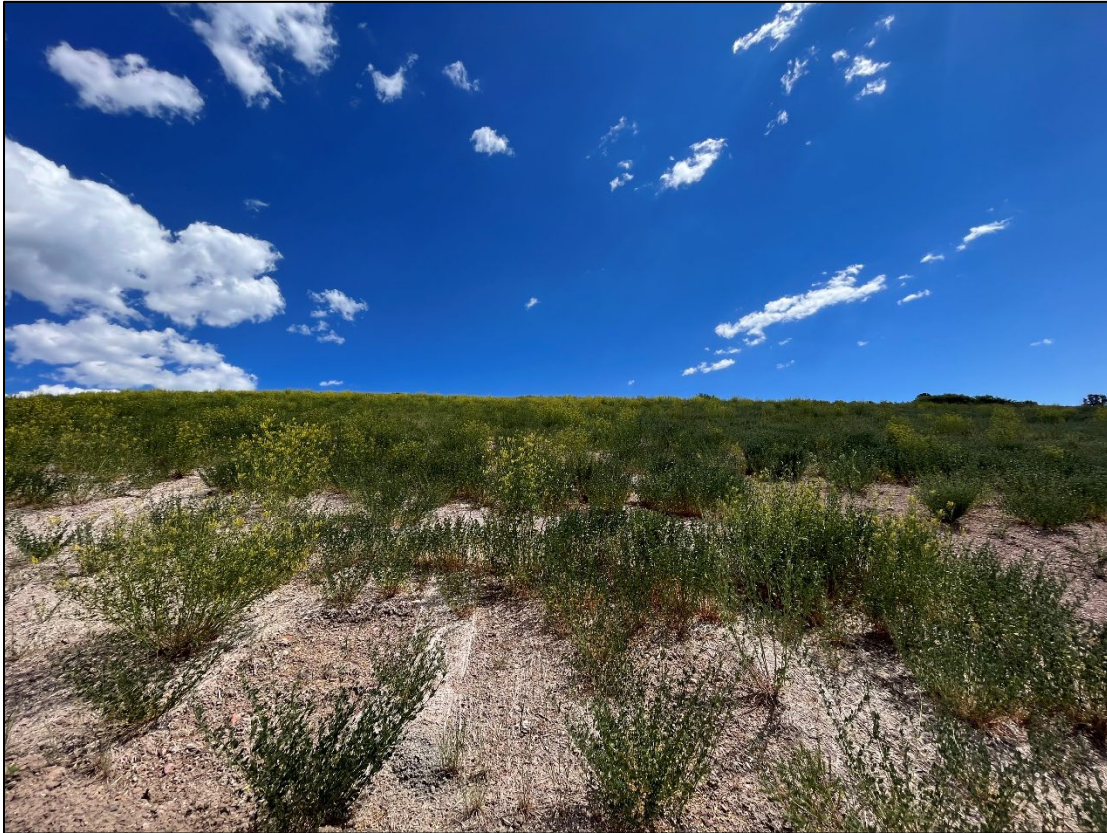
Photo 6: The 'test plot' area on city property. Sweet clover and other shrubs are growing in abundance but lacks sufficient grass cover.

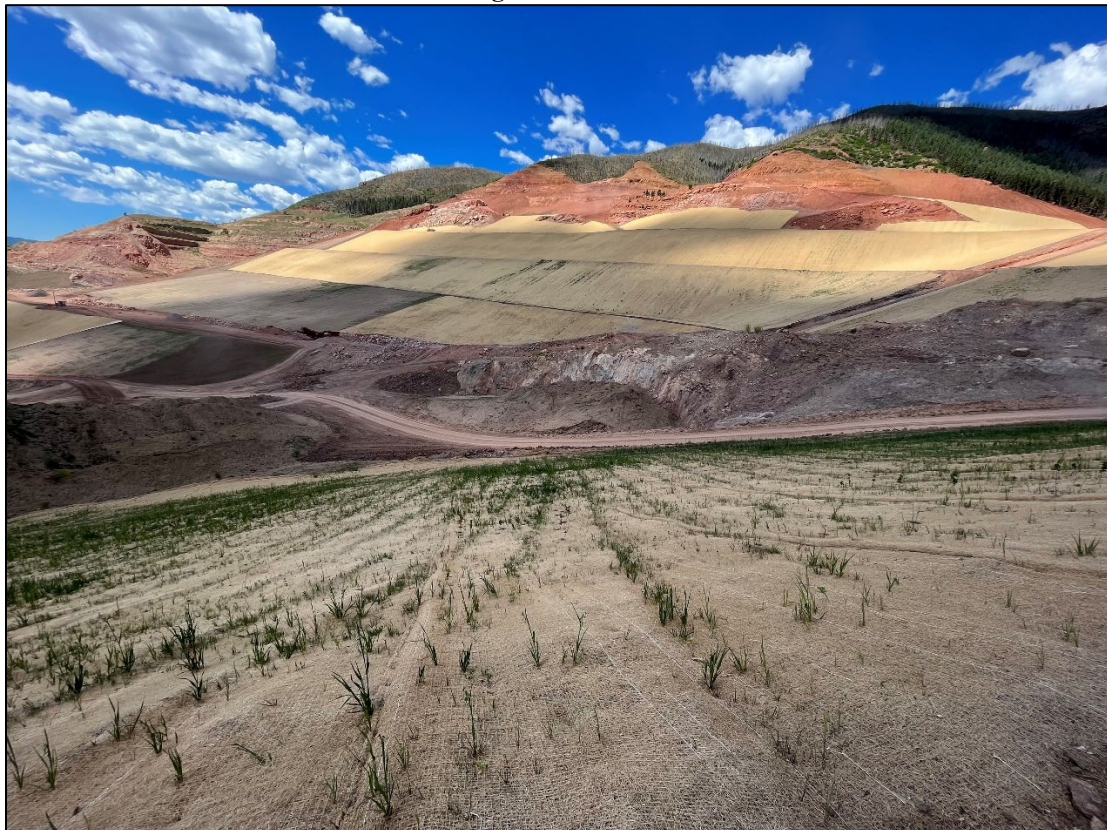
Revegetation & Topsoil: The first, second, third, and fourth benches of the buttress have been topsoiled, seeded, and matted. These tasks are nearly complete on the fifth bench. Shrubs and trees continue to be planted across the north borrow area and first few buttress slopes (Photos 5 and 7). Shrubs are planted in clusters throughout the slopes and vary in cluster design to encourage more natural growing conditions. Should any large areas of shrub or tree vegetation fail, the site's team will attempt to replace these plants with species that are doing well in other areas of the site. Sufficient topsoil is onsite to complete the rest of reclamation and adhere to the 6-inch depth of topsoil reclamation requirement.

Photo 7: Recent growth in the City's portion of the permit, matting and planted occurred in the past month.

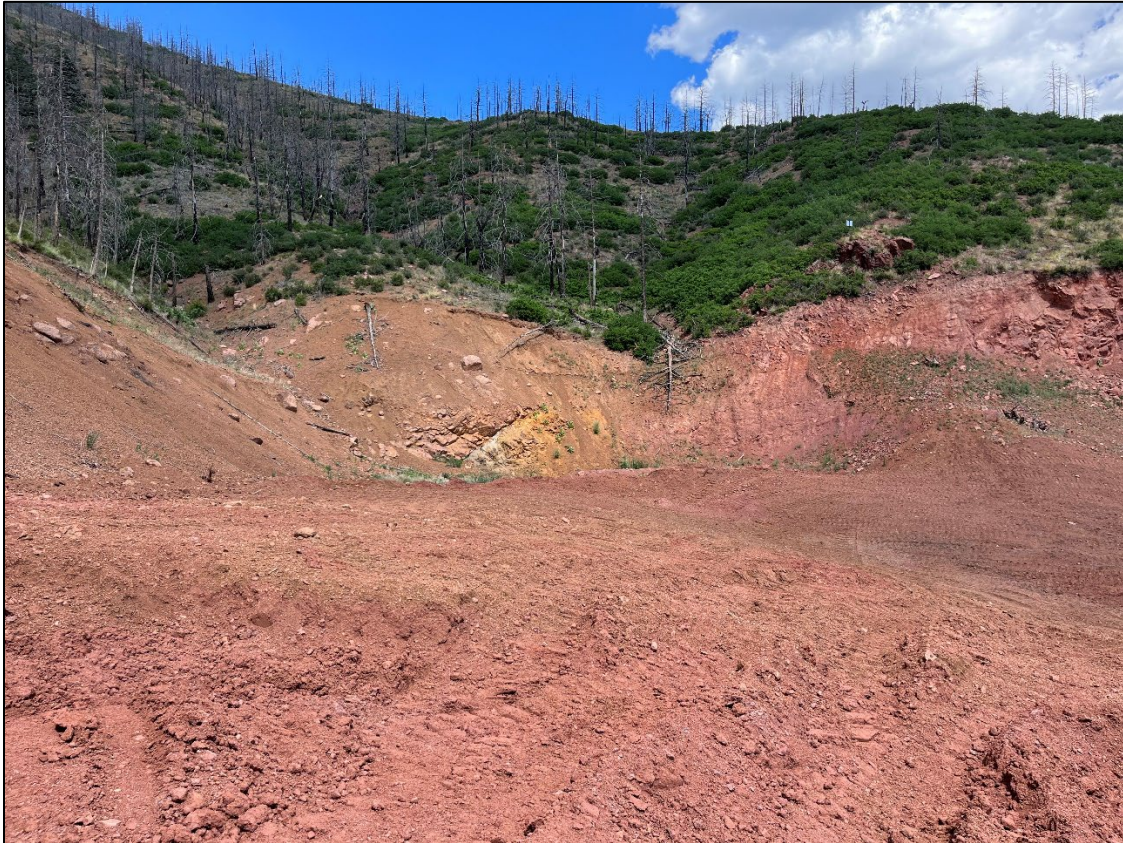
A small impoundment feature is present adjacent to the middle peak area (Photo 8). This impoundment feature is fed via a seep from further up the mountainside. Water depth was estimated at slightly above 2-3 feet. A few small clumps of cattails were growing in the water. Mr. Schnabel indicated his preference to keep this impoundment as a wildlife support feature in final reclamation. This impoundment is on Forest Service property. If the feature is to remain in final reclamation, the Division will need written approval from the Forest Service that they also wish the feature to be permanent. Additionally, the Division will need to see the appropriate water rights and or permit documentation that addresses the permanent impoundment of this water. Documentation of the appropriate permits would also be required if the impoundment feature was relocated onsite. Should the Pikeview team decide not to keep this impoundment area as a permanent feature or should the Forest Service not allow for permanent impoundment, the most recent re-design of upper drainage channel has the potential to drain this impounded seep water fully or partially and mitigate the need for additional permits or water rights. Mr. Kos and Mr. Schnabel indicated that they would keep in contact with the Division as these decisions are made in the coming weeks.

Photo 8: View west of the small impoundment area.

- Monitoring of the tension crack and eventual installation of prisms in this area
- Future reduction of monthly inspection and report requirements to begin after the July inspection
- Action will need to be taken to address the small impoundment of water near the western peaks

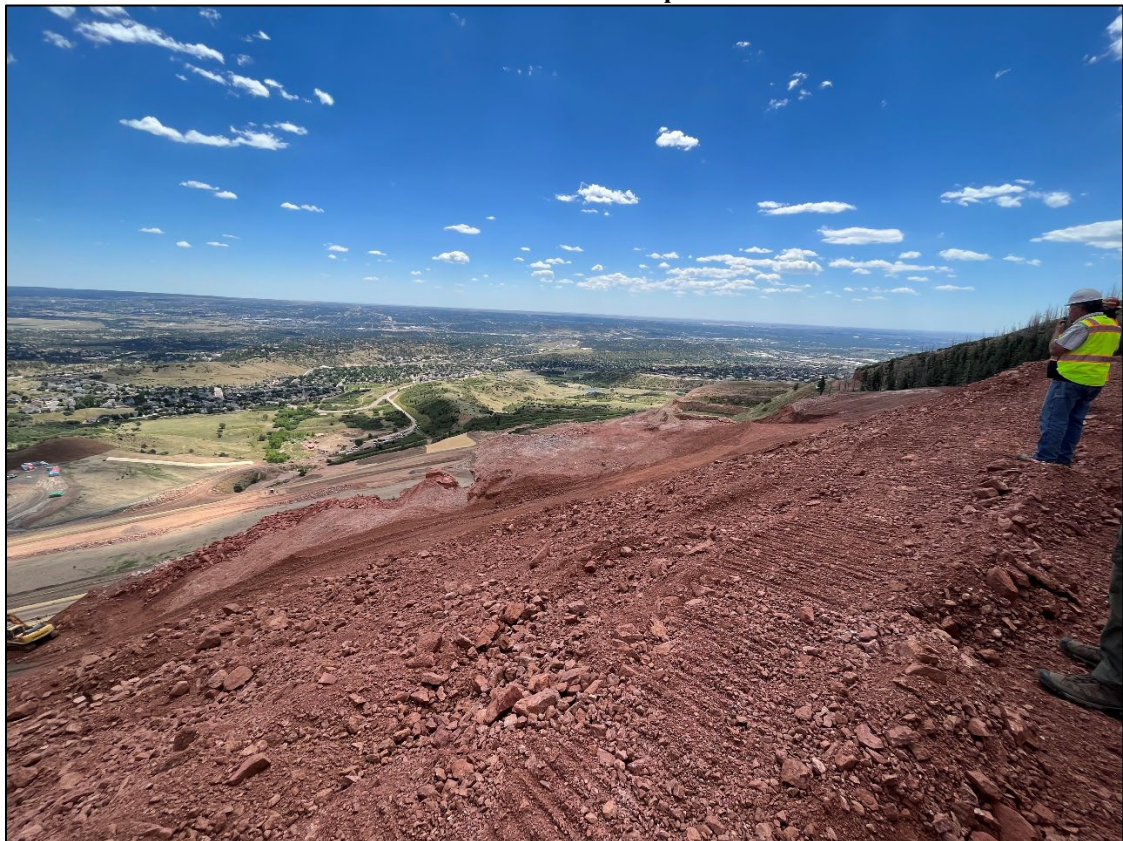
Prisms BR1 and BR3 were recently removed from the BFR area to allow for final rock reduction, backfilling of the area to its planned 2H:1V slope, and the tying in of this area to the southern edge of the bench (Photo 9). These two prisms will be replaced and rock bolted down once earthwork in this area is complete.

Photo 9: View of the BFR, the southern extent is begin filled in to grade, rocky material has been left below the BFR to serve as wildlife habitat.

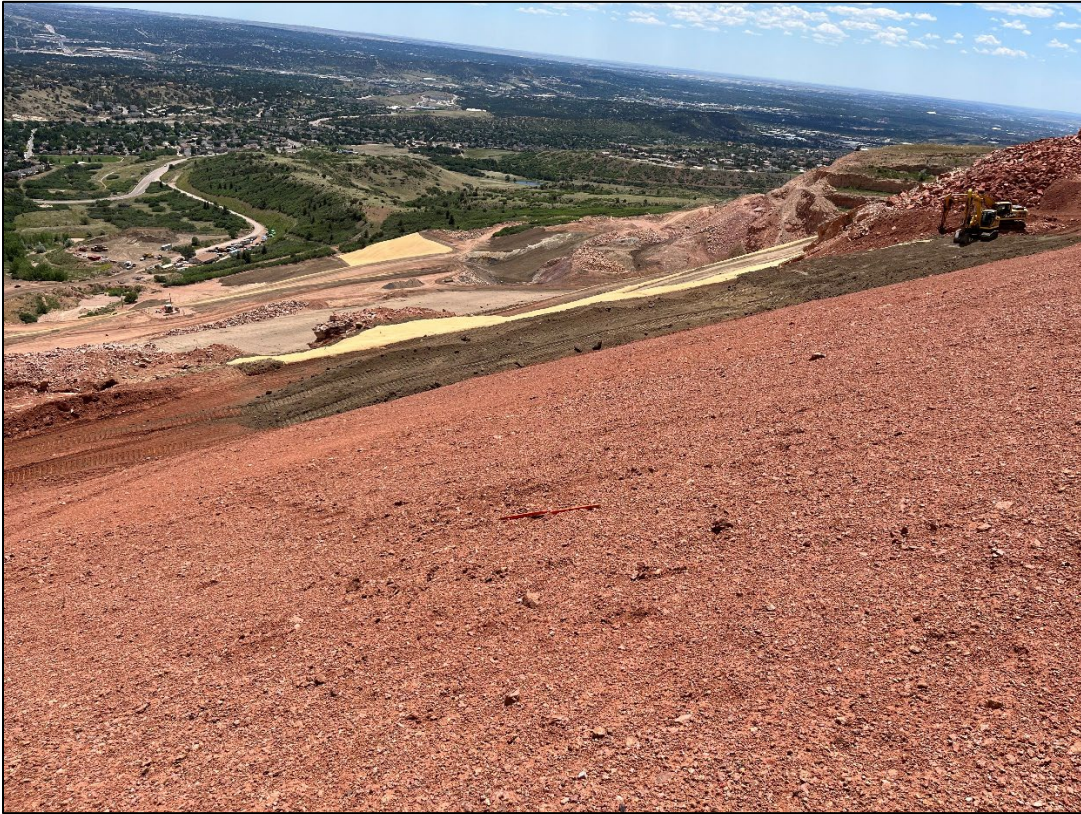
The site's April geotechnical report noted that two tension cracks had formed on the upper slope fill. The report described these features as ~100ft x 2in cracks which were noted at two of the site's visual inspections in April. The report cited the cause of these cracks as expected settlement from the buttress below. This crack area is inspected weekly by the Stantec team. Stantec's geotechnical report for May stated that the crack had extended ~ 30 feet to the south in the last month, but that this was still within the same area the original cracks are being monitored. Compaction tests are still completed for this area. The Division revisited this area to observe the cracks during this inspection. Mr. Kos explained that while this area was awaiting topsoiling and seeding, a makeshift extensometer was fashioned with two, staked down pieces of wood. These wooden stakes were positioned with their points touching (Photo 10). Therefore, any movement of the cracks could be noted by way of inspecting whether these wooden stakes were or were not still touching. At the time of inspection, the stakes had moved a minimal amount. After topsoiling and seeding, the wooden stakes will be removed, and two additional prisms will be installed above and below the area of the cracks to monitor movement. Overall, the cracks remain superficial in depth and length and have begun to fill in naturally with small amounts of erosion. All cracks are located above the historic landslide area. No mounding or bulging of material was noted in the area immediately below the cracks or further down on the next bench. Should the movement of these prisms continue to be minimal in over time, the Division has no major concern for slope stability.

Photo 10: View of the tension crack slope, topsoiling has begun on the southern portion of this slope.
