MINERALS PROGRAM INSPECTION REPORT
PHONE: (303) 866-3567

MINE NAME: Nahcolite Project	MINE/PROSPECTING ID#: M-1983-194	MINERAL: Carbonates	COUNTY: Rio Blanco
INSPECTION TYPE: Monitoring	WEATHER: Clear	INSP. DATE: June 27, 2024	INSP. TIME: 09:00
OPERATOR: Natural Soda LLC	OPERATOR REPRESENTATIVE: Jamie Reck	TYPE OF OPERATION: 112d-3 - Designated Mining Operation	
REASON FOR INSPECTION: Normal I&E Program	BOND CALCULATION TYPE: None	BOND AMOUNT: \$4,466,425.00	
DATE OF COMPLAINT: NA	POST INSP. CONTACTS: DRMS	JOINT INSP. AGENCY: U.S.BLM	
INSPECTOR(S): Amy Yeldell	INSPECTOR'S SIGNATURE:

This is the second quarter inspection for 2024. The focus of this inspection was reclamation success of recently reclaimed areas. Recently drilled wells were also observed. No acreage reduction or other release request has been submitted to date. There are no open revision for this permit. No changes to production level or staffing have occurred or are anticipated in the near future. Division staff first checked in at the main office.

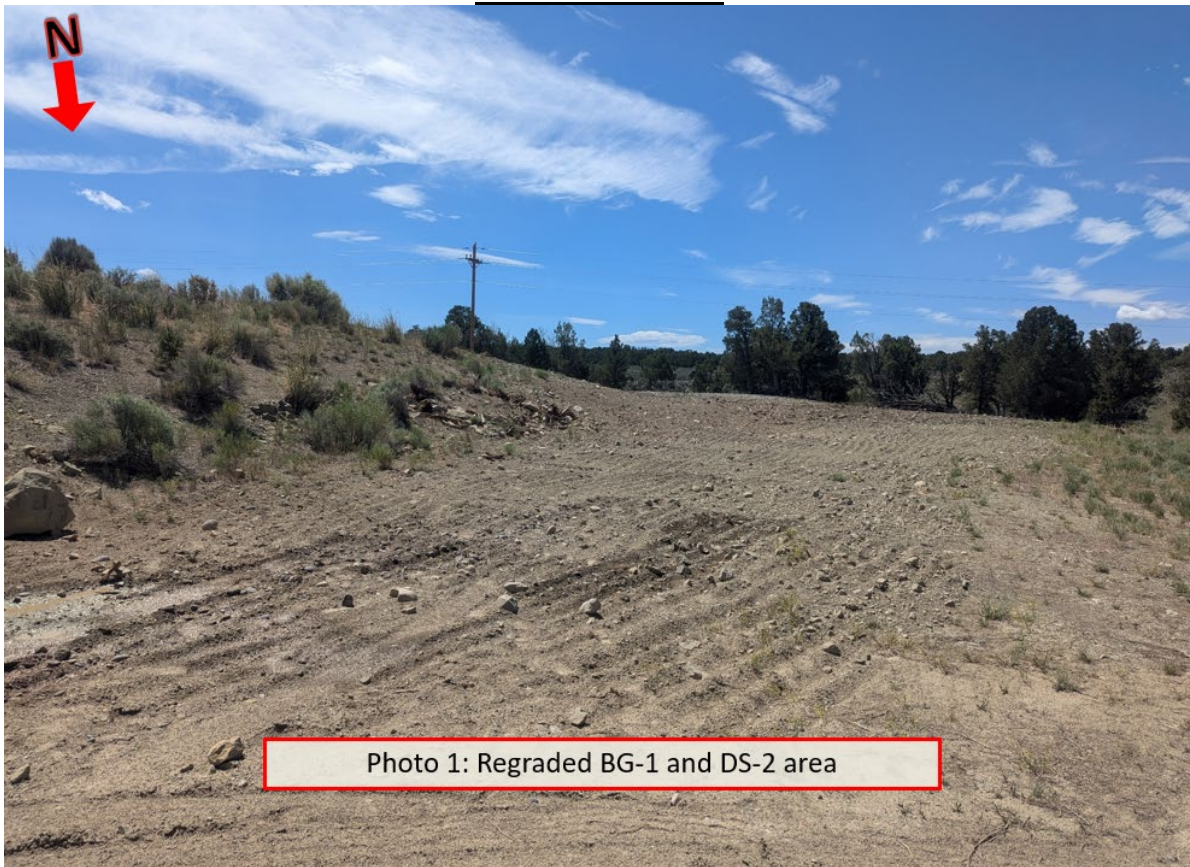
Some minor blending and grading occurred in May near BG-1 and DS-2 (Photo One). Topography naturally blends with the surrounding reclaimed areas of Pad 8. All slopes have been graded to a 3H: 1V or less and are easily traversable by livestock and wildlife.

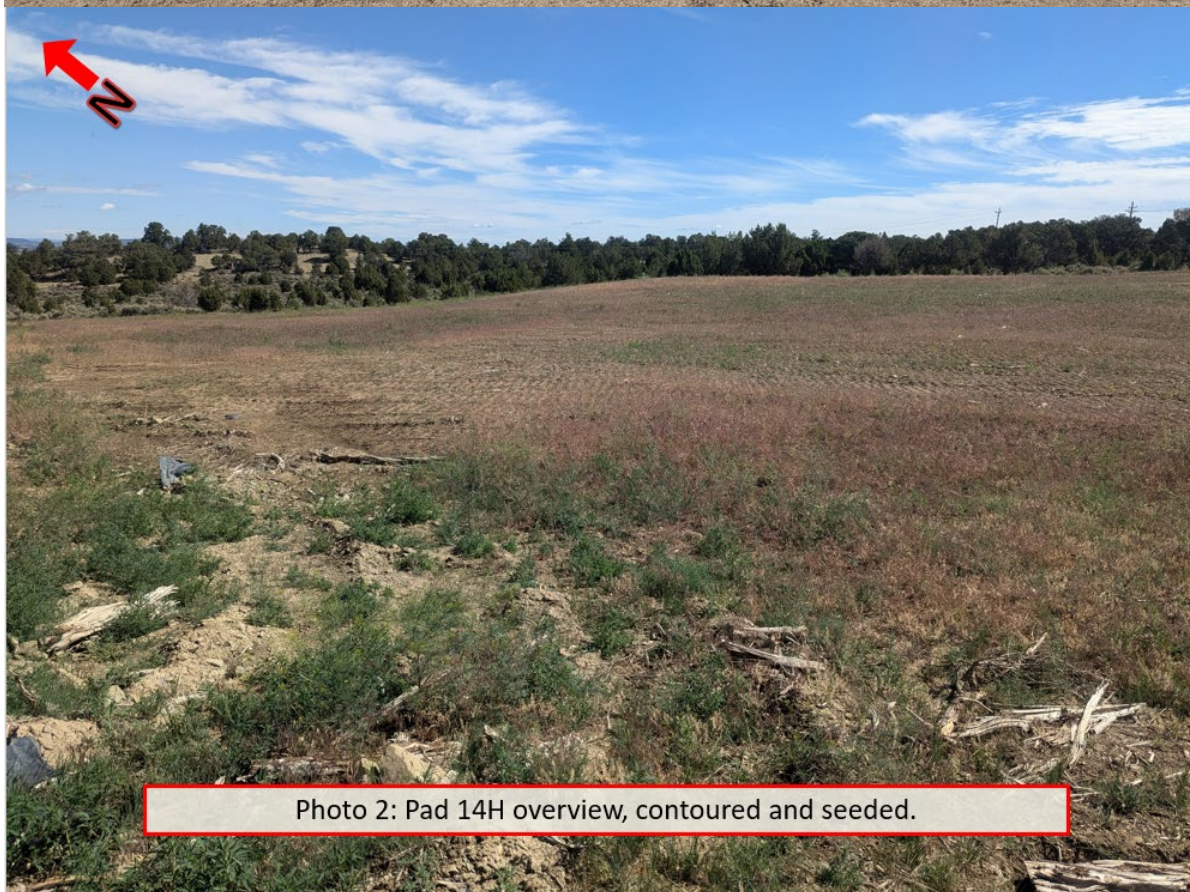
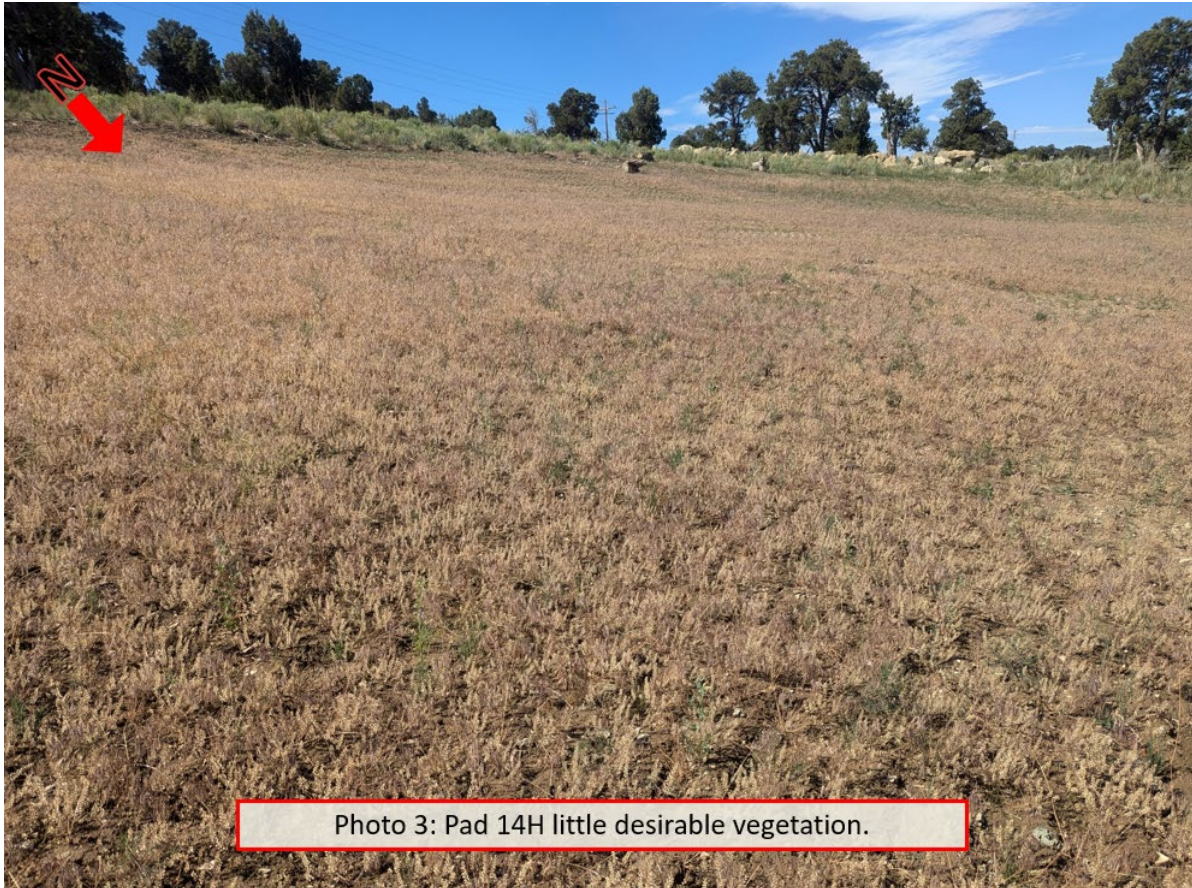
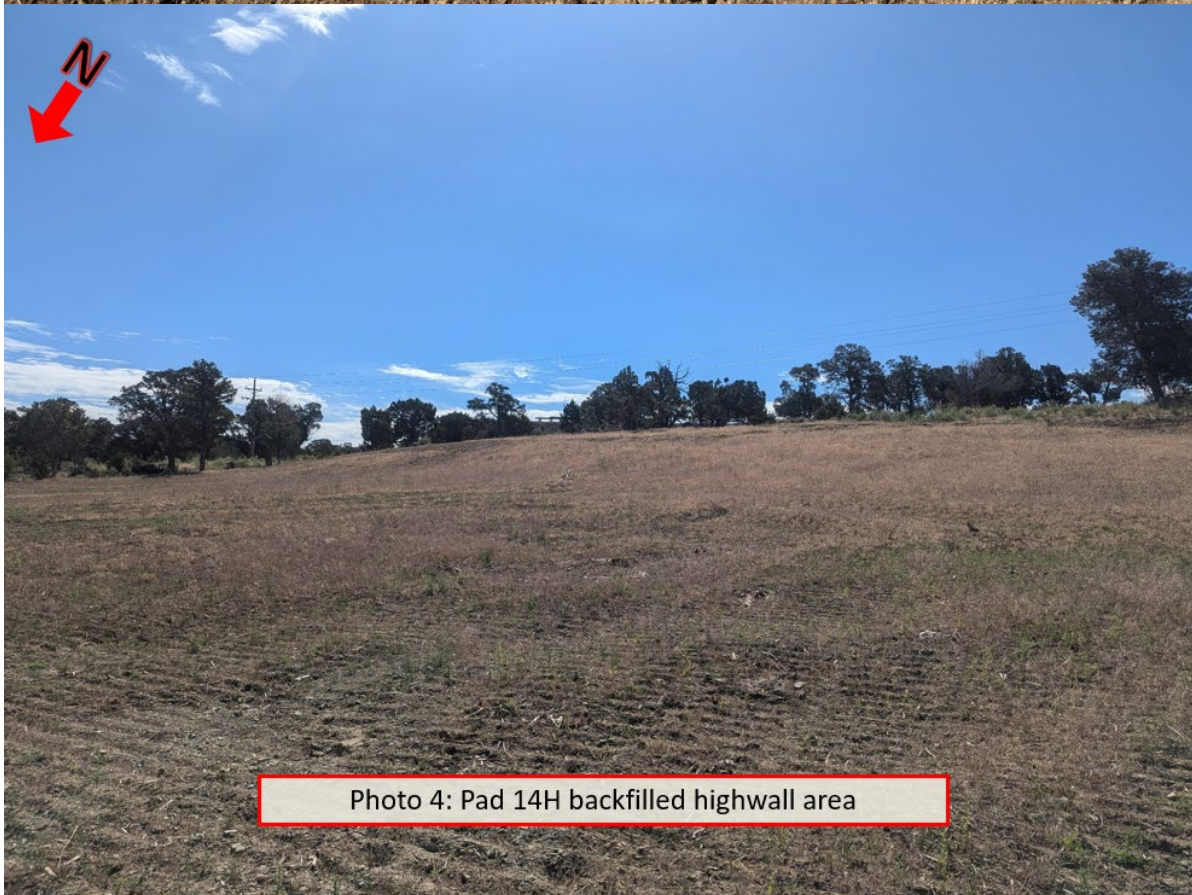
Pad 14H was reclaimed in the fall of 2023 (Photos Two – Four). This pad required a large amount of backfill on the southern side. Soil has settled over the winter and no signs of subsidence or a need for additional grading was observed. The pad appears to blend naturally with the surrounding areas. All slopes have been graded to a 3H: 1V or less and are easily traversable by livestock and wildlife.

Seeding of the 14H pad occurred in fall of 2023. Spring/early summer temperatures have remained lower than normal, and the monsoon season has begun. Thus far established vegetation is mostly annual weedy species, such as cheatgrass and Alyssum. Other warmer season weeds such as Kochia and Russian Thistle are beginning to pop. Very few desirable perennial grasses were observed. Continue to monitor throughout the summer. If a significant increase of desirable species is not noted, additional seeding may be required. Additionally utilizing effective timing and species selection for noxious weed treatment will be crucial for early establishment and long-term success.

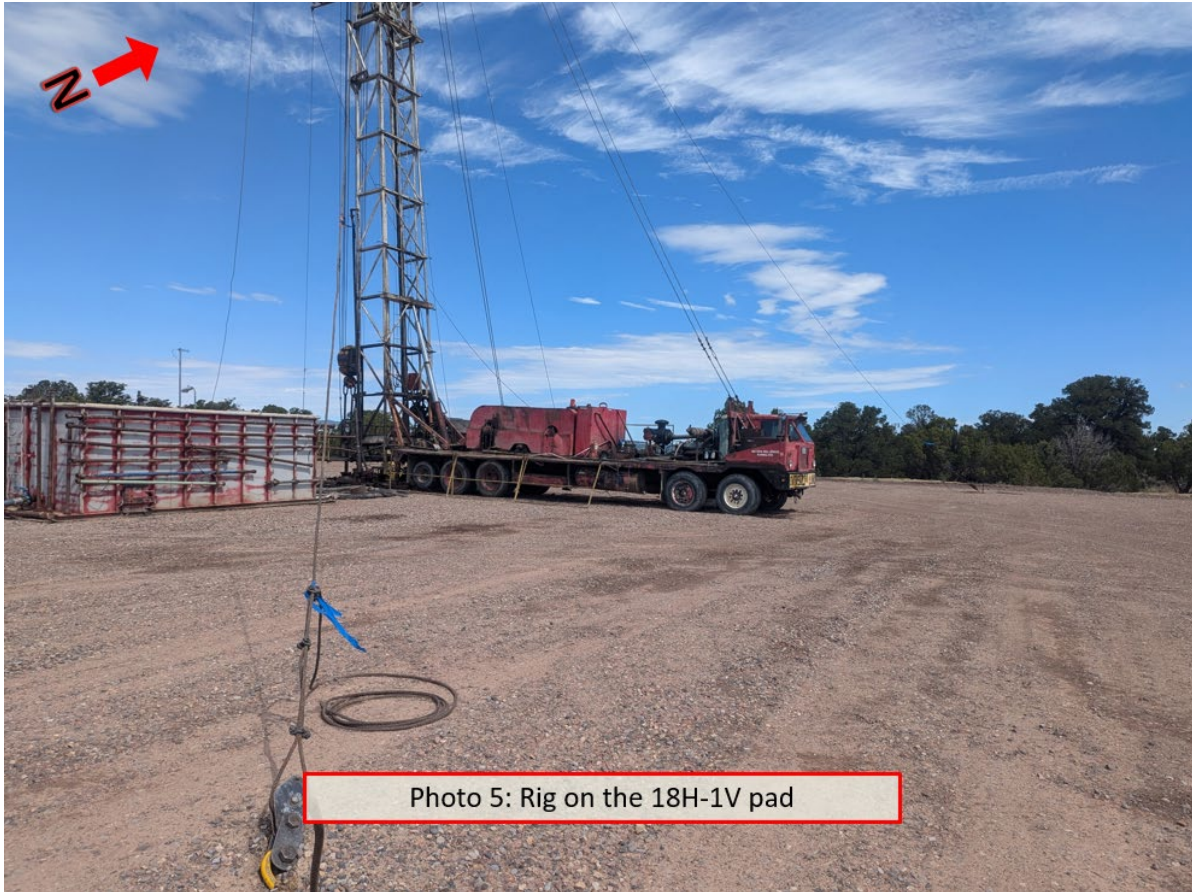
18H-1V is drilled but not connected. The pit remains open. A drill rig was on site. Adjacent to the rig were several large dark spots (Photos Five – Seven). It is unclear if this was wet soil from the recent rains or evidence of a spill. The area did smell like hydrocarbons however this is typical when drilling equipment is on site. The Operator needs to determine if the soil discoloration is the result of a spill. If it is a spill, all contaminated soil needs to be excavated and disposed of properly. Then the pad needs to be regraded. Please provide the Division with a summary of the measures taken on site and photo documentation.

Photo 5: Rig on the 18H-1V pad

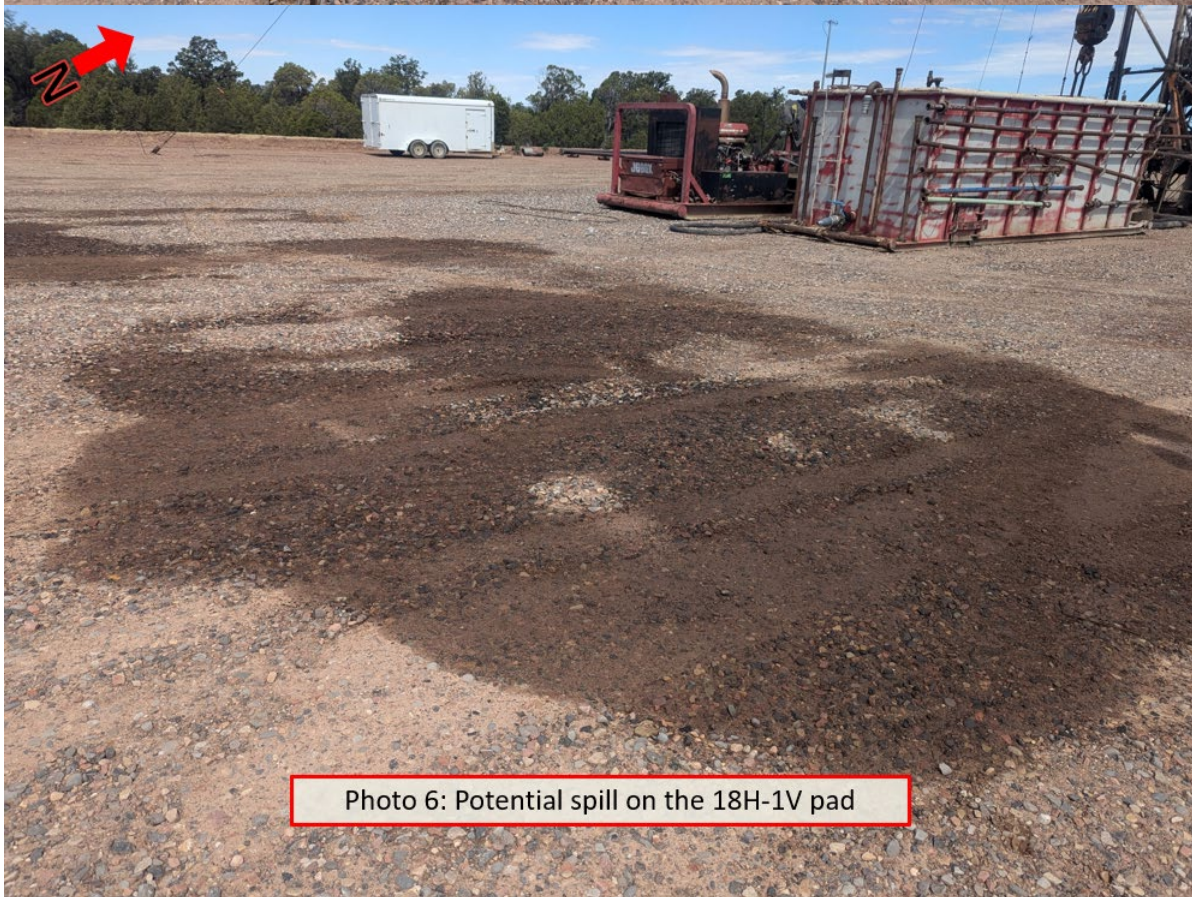
Photo 6: Potential spill on the 18H-1V pad

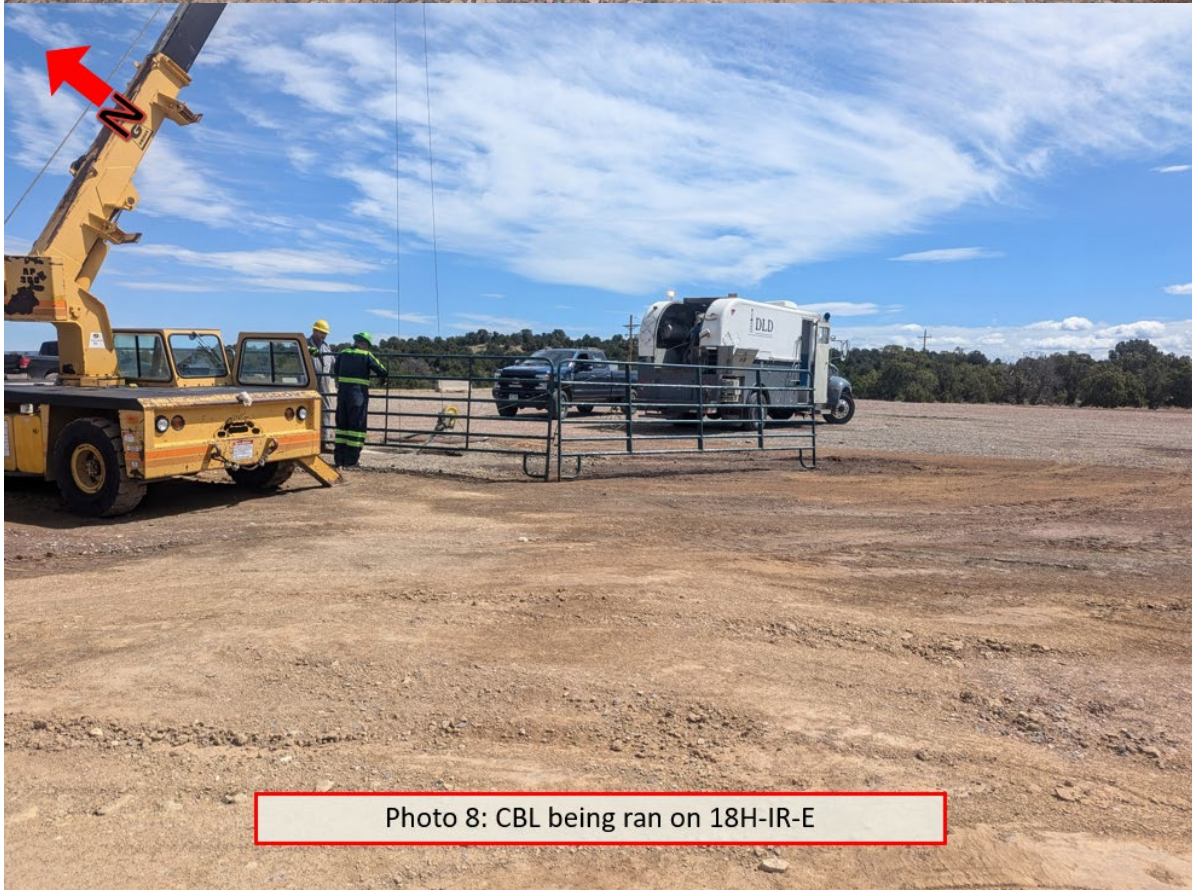
18H-IR-E was drilled however it ran into several complications during the drilling process and the well will not be completed. At the time of the inspection a cement bond log was being ran and the well is scheduled to be plugged and abandoned (Photo Eight). A replacement well will be drilled but details have not yet been finalized. The original pit is still open, Mr. Paris indicated that they will likely need to increase its size to

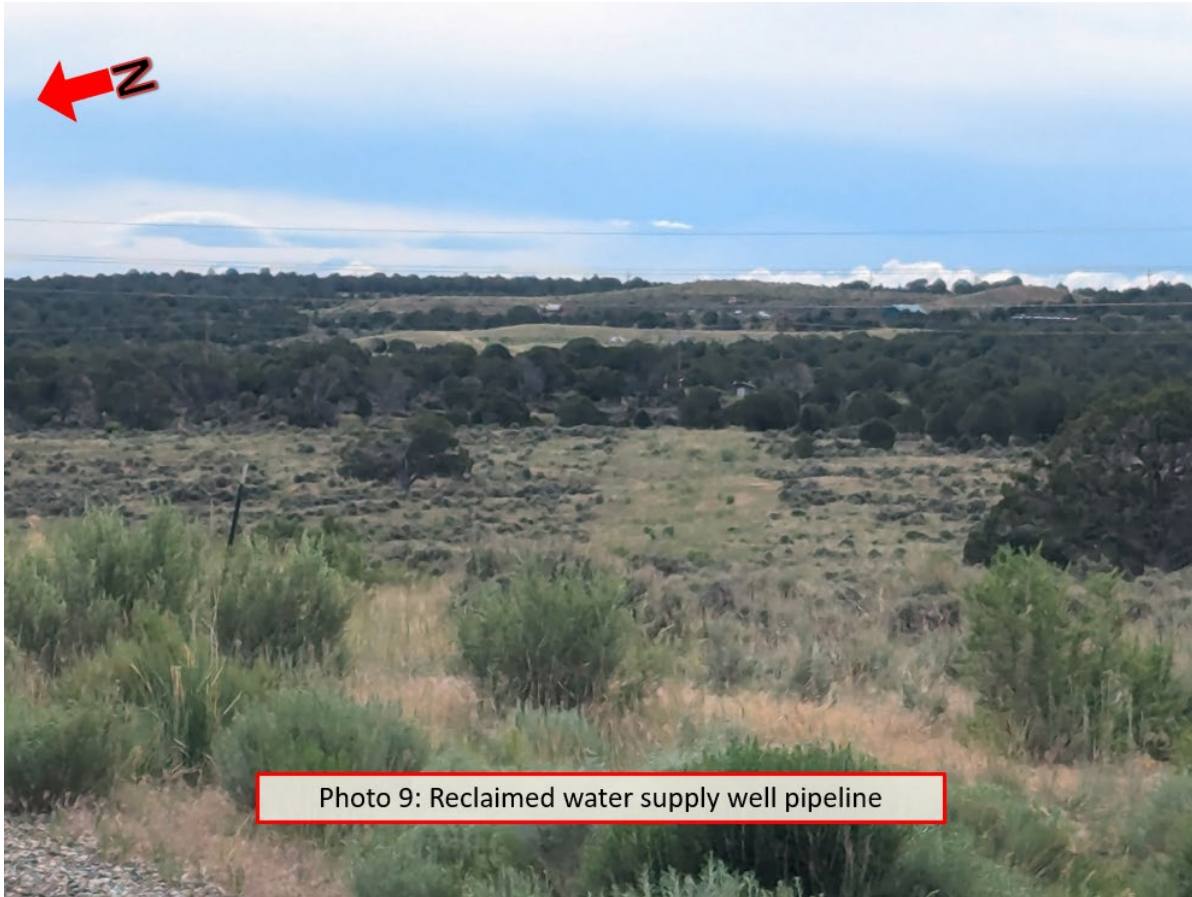
The pipeline between WSW-3 and WSW-4 was observed (Photo Nine). The wells and buildings remain in use and require further reclamation. The area overtop the buried pipeline has been reclaimed and naturally blends with the surrounding topography. This area has been classified as meeting ROD Goals per the Average Analysis Spreadsheet. Come final reclamation the pipeline will be plugged on either end with cement and left in place. No additional surface reclamation of the pipeline will be required.

Photo 9: Reclaimed water supply well pipeline

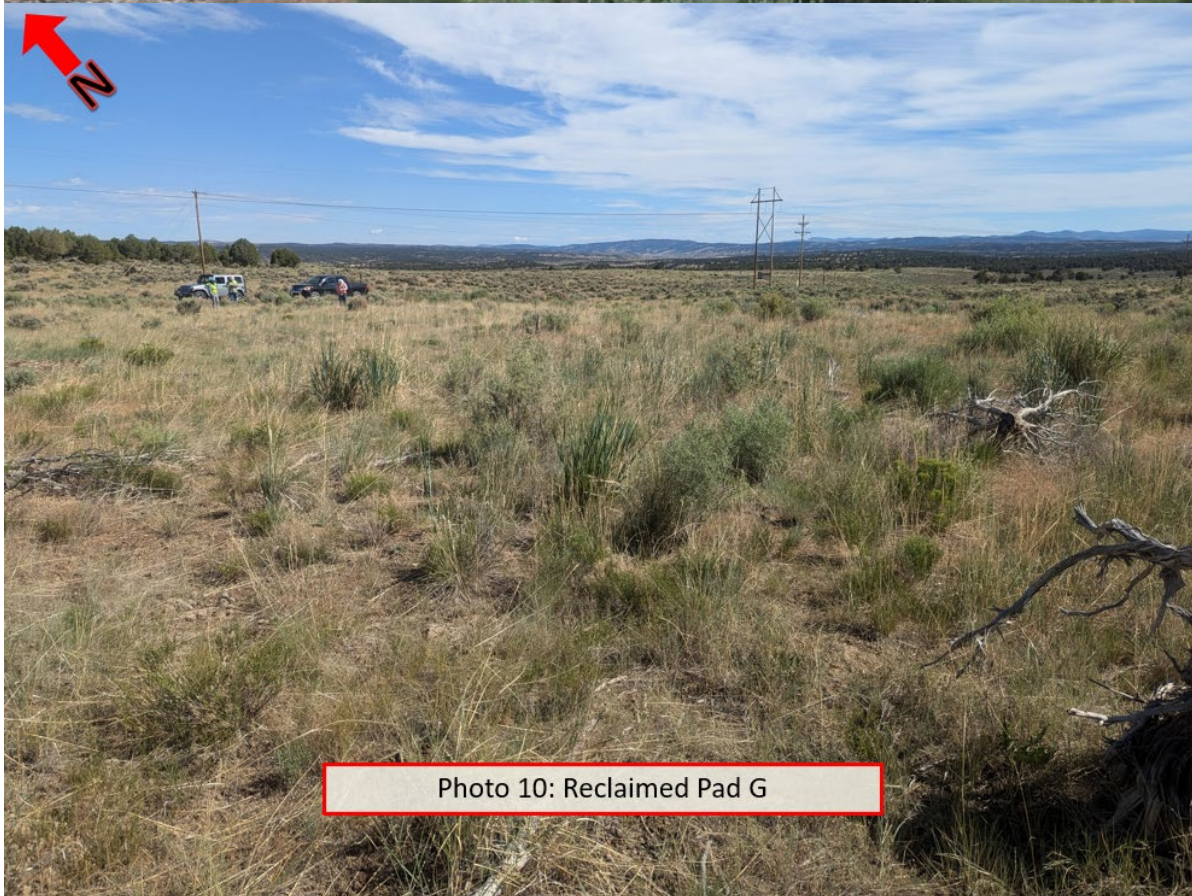
The G pad was constructed but no well was ever drilled and thus it was reclaimed. This pad has been successfully reclaimed (Photo Ten). All grading blends naturally and the vegetation establishment is comparable or better than the surroundings. No noxious weeds or erosional issues were observed.

Photo 10: Reclaimed Pad G
