New Horizon Mine, C-1981-008, SL-28 Inspection Report

PERMIT INFORMATION

Permit Number: C-1981-008 Mine Name: New Horizon Mine Operator: Elk Ridge Mining and Reclamation, LLC Operator Address: Mr. Tony Tennyson P.O. Box 628 27646 West 5th Avenue Nucla, CO 81424	County: Montrose Operation Type: Surface Permit Status: Active Ownership: Private
	Operator Representative Present: Tony Tennyson 4/10/2024 Jason Carver 5/29/2024
Operator Representative Signature: (Field Issuance Only)

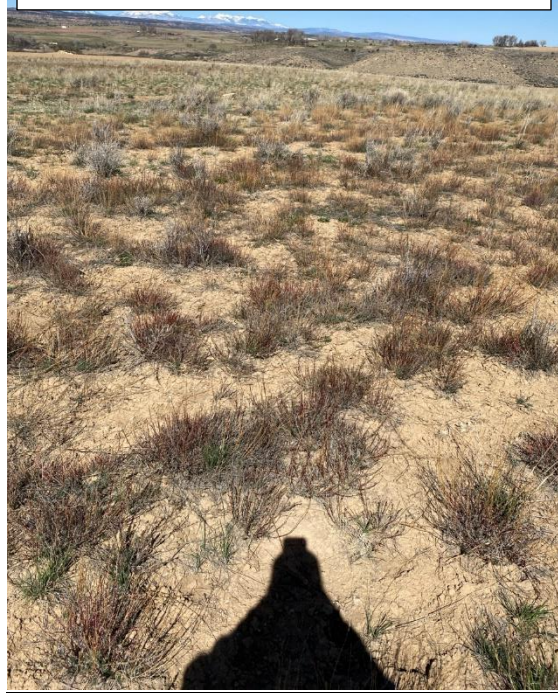
Photo 1: NH2004-01.

Seven exploration holes were requested for release with the application. Four of the exploration holes were located in the Section 36. The remaining three exploration holes were located in Section 1. All seven exploration holes were mined through and reclaimed when the mine pits were reclaimed. These wells included NH2004-01, NH2004-02, NH2004-03, NH2004-04, NH2004-05, NH2004-06 and NH2004-07. During the inspection, the Division used Field Maps with a georeferenced map of the New Horizon Mine to locate the seven exploration wells. Each location for the wells had been reclaimed and there was no exploration hole remaining. The sites for the exploration wells were stable and there were no erosional concerns. Due to the exploration holes being mined through. There were no markers on the surface. Please see Photos one through seven for the locations of the exploration wells. The exploration holes have been abandoned and reclaimed as per the C-1981-008 Permit Application requirements.

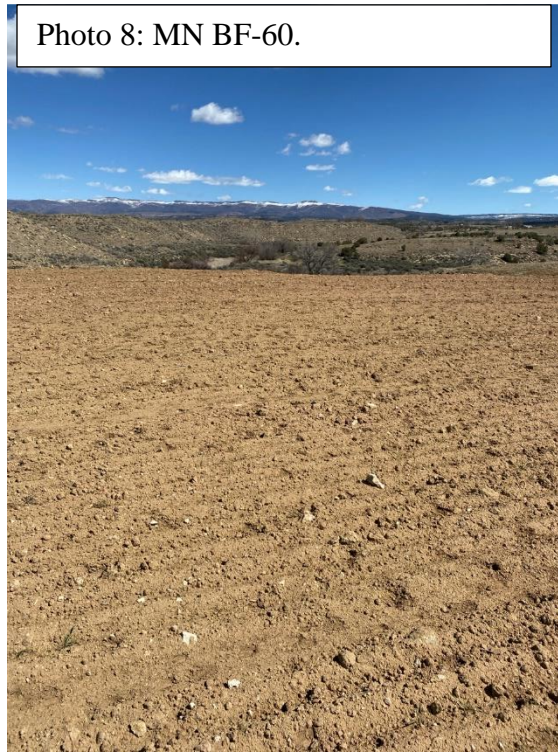
Photo 8: MN BF-60.

Backfill monitoring wells MW BF-60, MW BF-62 and MW BF64 were located in Section 36. Backfill monitoring well MW BF-66 was in Section 6 just east of 2700 Road. Backfill monitoring well MN BF-67 was in Section 31 just north of BB Road. The five wells were sealed and abandoned in November of 2023. The SL-28 application included the abandonment reports. The release request was just for the well casings and not the pads associated with the wells. The pads have been included in previous releases and/or will be included in future bond release requests. All three of the well casings were sealed by placing clean sand in the bottom of the well. The filling the well casing up to 5 feet below the surface with bentonite chips. The last 5 feet of the well casing was removed and then backfilled with native soil.

Wells MN BF-66 and 67 are located on private property that had recently been sold from ERM to new landowners the Friday before the April 10, 2024 inspection. The Division was notified of the sale during the April 10, 2024 inspection. The parcel that MN BF-66 was on was sold to Garvey and CO., LLC. The Parcel MN BF-67 was on was sold to Mr. James Fourney. The two landowners were modified by ERM of the requested bond release in letters dated April 22, 2024. The Division was unable to inspect the precise GPS point for these two locations on April 10th due to them being on private land. The Division inspected these two wells from the side of the roads. Each of the five sites of the monitoring backfill wells was stable and in good condition. There was no disturbance to the sites observed caused by the abandonment process for the wells. No cap or marker was left on the surface of the locations of the wells, indicating that the top five feet were backfilled with native soil. Both well casings were sealed by placing clean sand in the bottom of the well. The filling the well casing up to 5 feet below the surface with bentonite chips. The last 5 feet of the well casing was removed and then backfilled with native soil. No evidence of a monitoring well remained at the five sites. Please refer to photos eight through twelve for the backfill wells inspected on April 10, 2024.

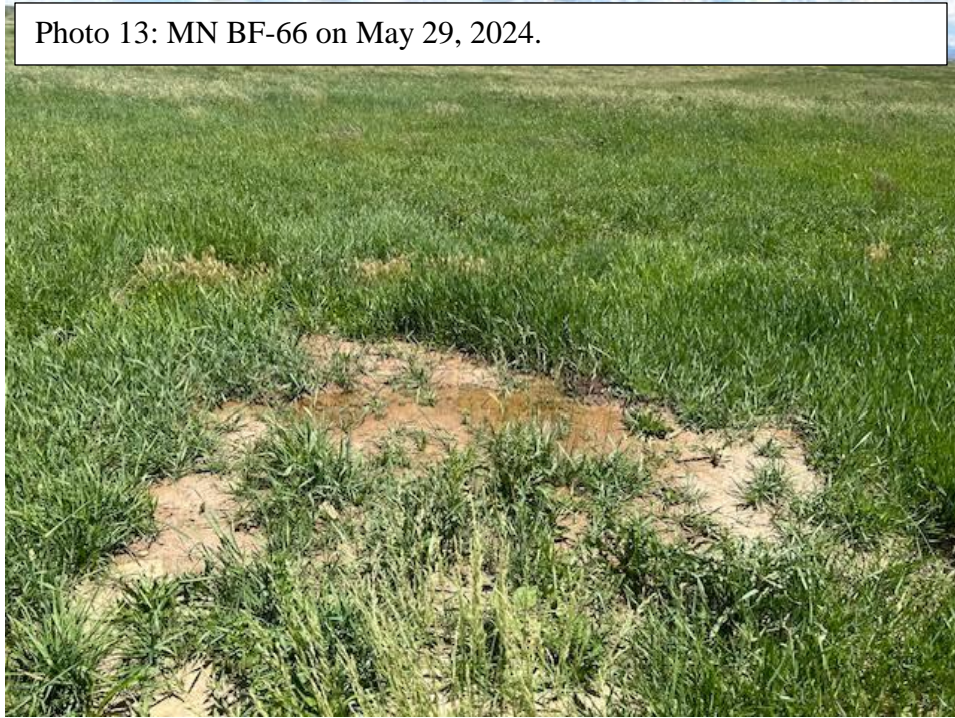
Photo 13: MN BF-66 on May 29, 2024.

The Division was able to get in touch with Garvey and CO., LLC and was granted permission by the landowner to access their land on the Division's May 29, 2024 inspection. The Division used Field Maps to locate the spot where MN BF-66 was located. The site was stable with no erosional features. The activities of sealing and abandoning the well did not impact the surface. No marker or casing were identified indicating that the five feet from the surface had the casing removed as written in the abandonment report. Please refer to Photo thirteen for MN BF-66 inspected on May 29, 2024.
