Bowie #1 inspection report

Permit Number: C-1981-038 Mine Name: Bowie No. 1 Mine Operator: Bowie Resources, LLC Operator Address: Mr. Basil R. Bear P.O. Box 1488 Paonia, CO 81428	County: Delta Operation Type: Underground Permit Status: Active Ownership: Private
	Operator Representative Present: None
Operator Representative Signature: (Field Issuance Only)

Inspection Start Date: June 26, 2024 Inspection Start Time: 11:55 Inspection End Date: June 26, 2024 Inspection End Time: 13:10		Inspection Type: Coal Partial Inspection Inspection Reason: Normal I&E Program Weather: Cloudy	
Joint Inspection Agency: None		Joint Inspection Contacts: 	
Post Inspection Agency: None		Post Inspection Contacts: 	
Inspector(s): Robert Zuber, P.E.	Inspector's Signature:

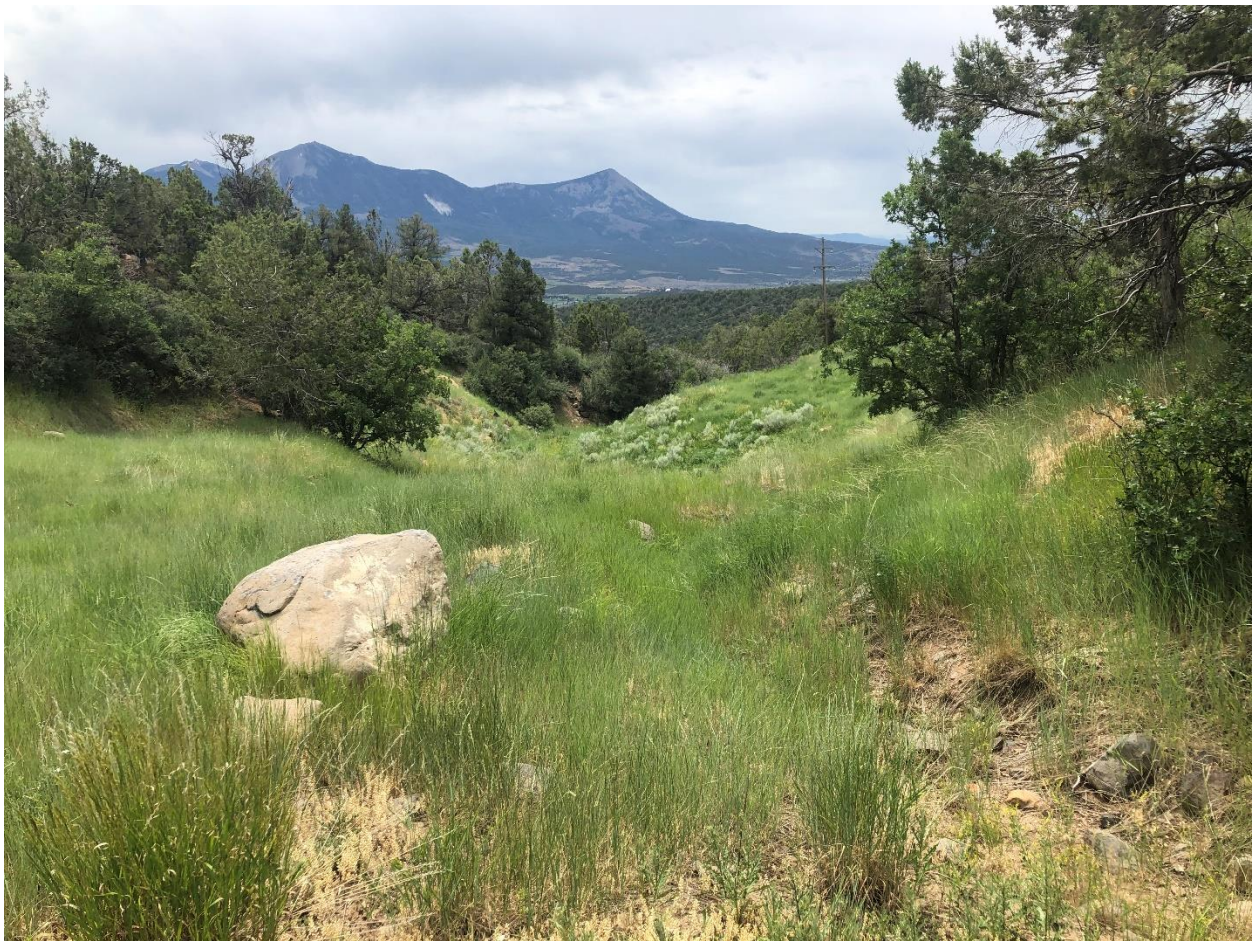
The reclamation in the area of Ponds 3 and 4 (East Mine) appeared to be good, with no erosion and very good vegetation cover. Thistle plants were observed as noted in the Revegetation section.

Reclaimed Pond 4 below the East Mine

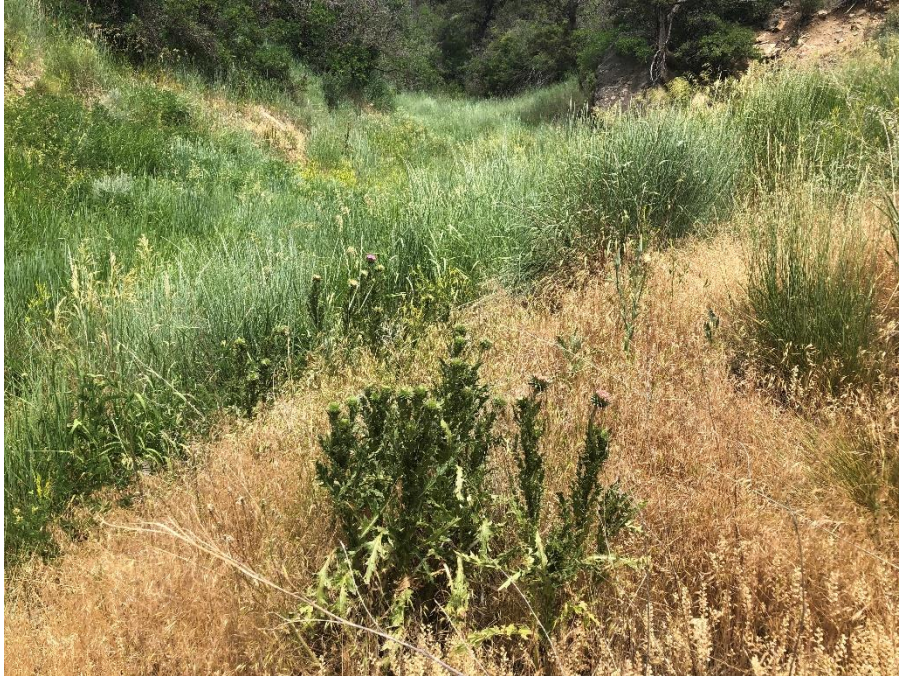
Thistle plants at reclaimed Pond 3

Noxious thistle plants were observed near the west end of the loadout and at the reclaimed area that was Pond 3 at the East Mine. These should be killed or removed.

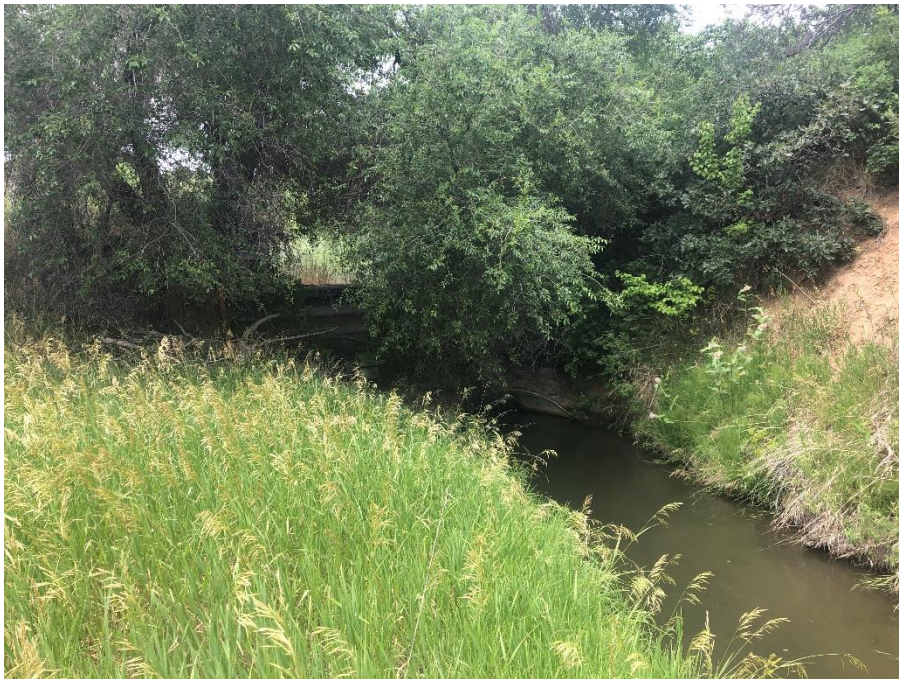
The irrigation ditch that flows under the loadout (the Farmers Ditch) was flowing full. No problems were identified with the large culvert that contains this ditch.

Culvert at the loadout (upstream end)

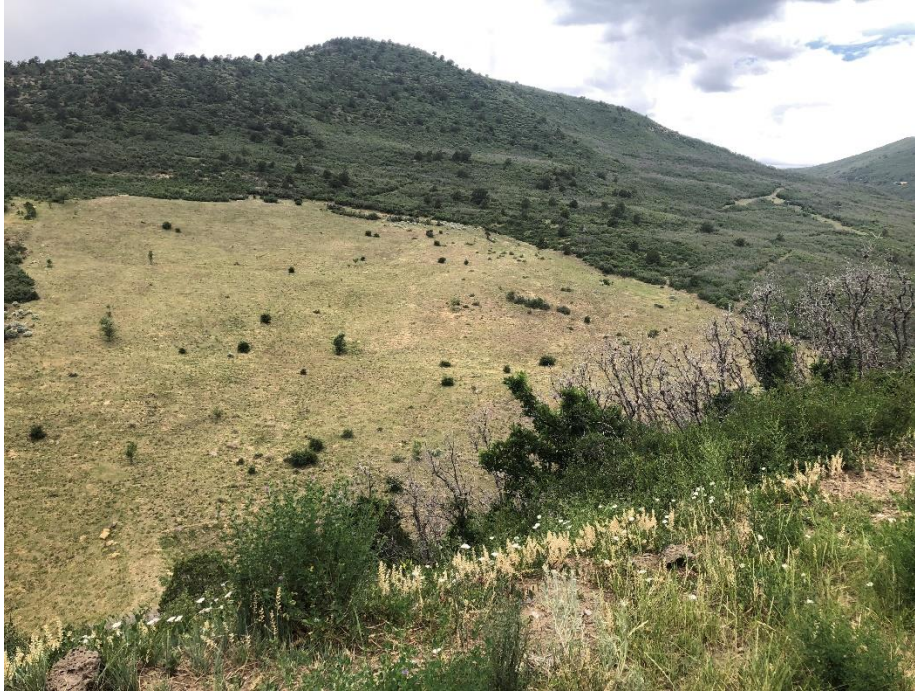
No erosion was seen at the West Mine, including the reclaimed road.

West Mine – reclaimed road in middle of photo

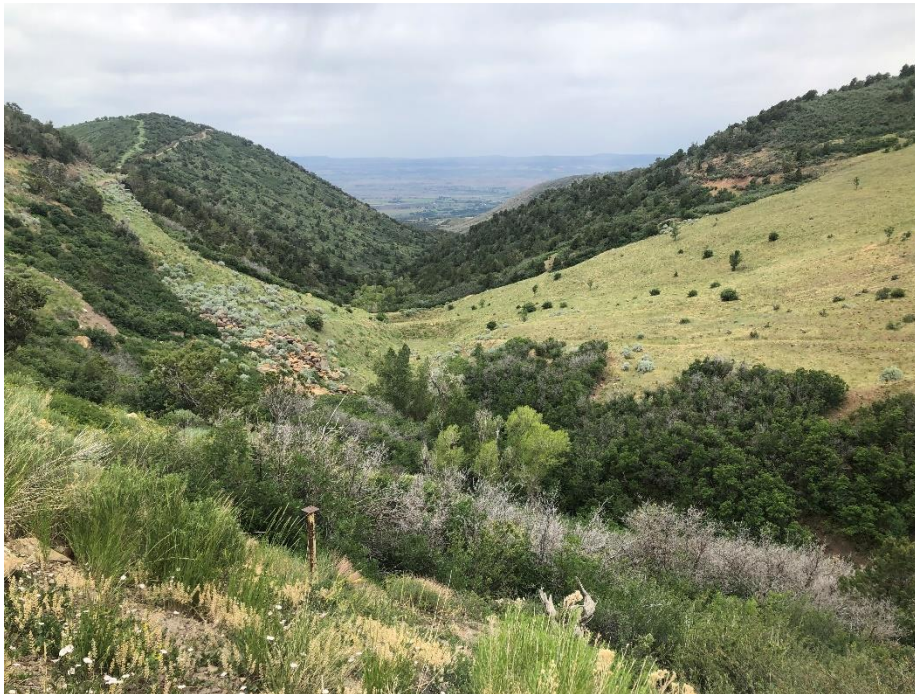
The ponds at the loadout, the Coal Storage Area (near Black Bridge Road), and the West Mine contained no water, and no problems were identified with these ponds.

West Mine ponds
