M1995097, Smuggler Mine Inspection Report

MINERALS PROGRAM INSPECTION REPORT

MINE NAME: Smuggler Mine	MINE/PROSPECTING ID#: M-1995-097	MINERAL: Silver, lead, zinc and	COUNTY: Pitkin
INSPECTION TYPE: Monitoring	WEATHER: Clear	INSP. DATE: June 11, 2024	INSP. TIME: 09:00
OPERATOR: Aspen Smuggler Mine LLC	OPERATOR REPRESENTATIVE: Chris Preusch	TYPE OF OPERATION: 110(2) - Hard Rock Limited Impact

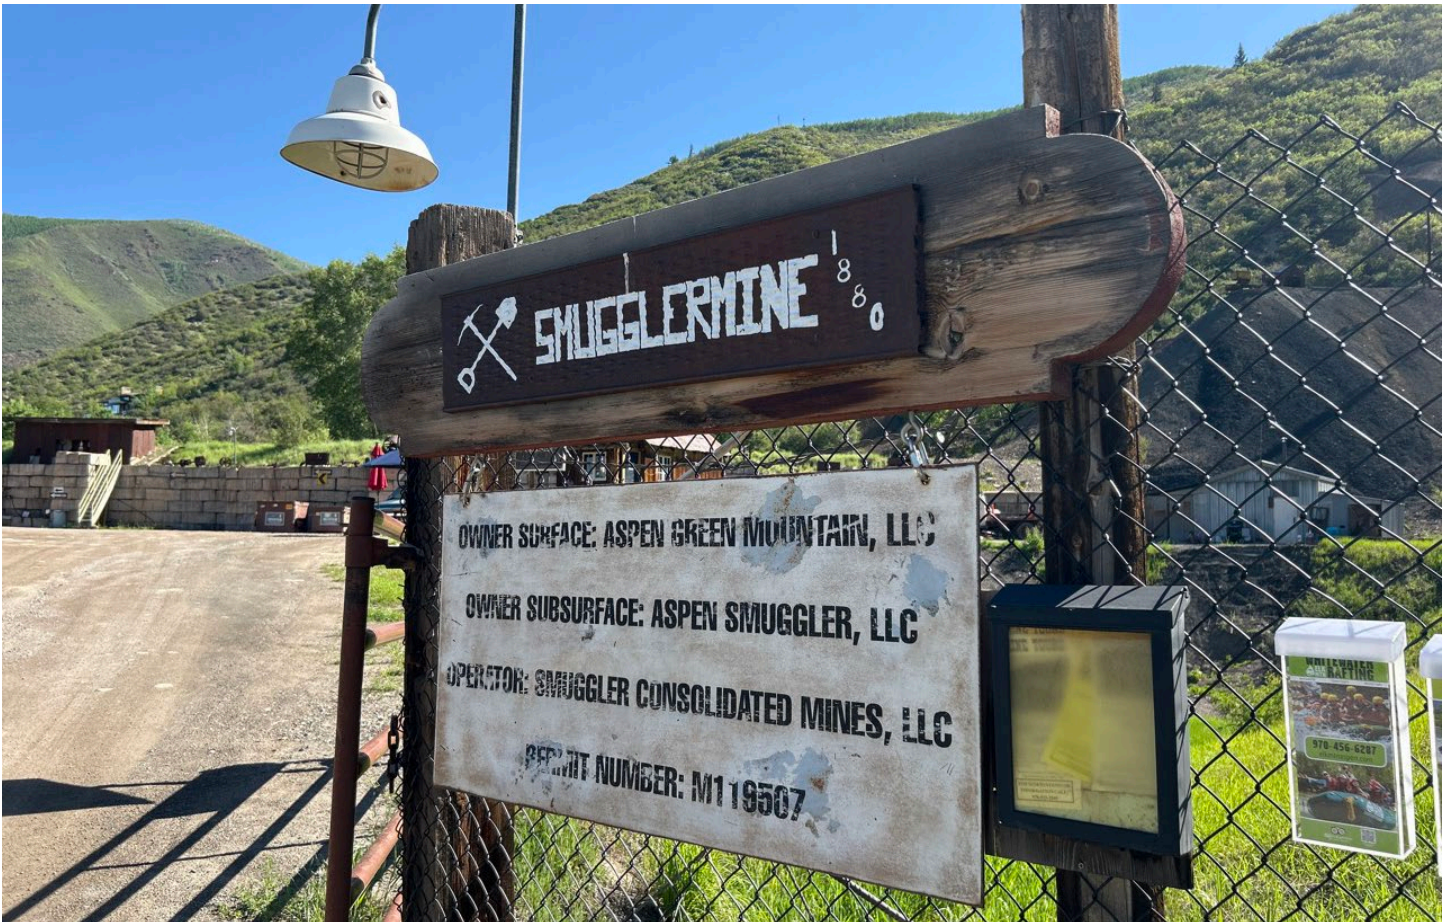
Figure 2: Entrance to the site (point 282)

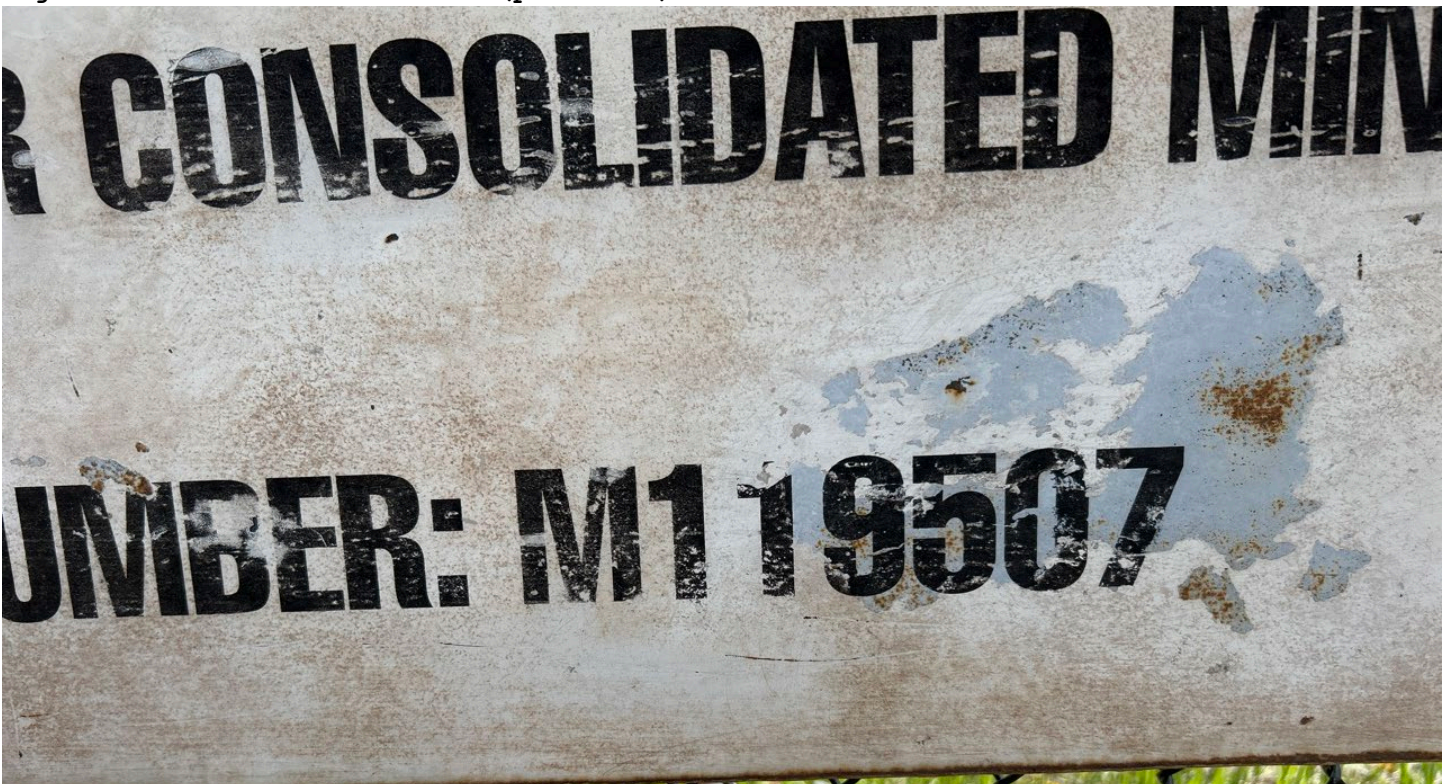
PROBLEM/POSSIBLE VIOLATION: Problem: The mine identification sign posted at the entrance of the mine site showed inaccurate information. This is a problem for failure to post a mine identification sign as required by Section 3.1.12(1) of the rule. The Operator shall, at the entrance of the mine site post a sign, which shall be clearly visible from the access road, with a minimum size equaling one hundred and eighty-seven (187) square inches, such as eleven (11) inches in height and seventeen (17) inches in width, with appropriate font size, with the following: the name of the Operator, a statement that a reclamation permit for the operation has been issued by the Colorado Mined Land Reclamation Board; and the permit number.

The Mine ID sign showed inaccurate information. A problem has been cited above.

Figure 3: Error on Mine ID sign

CORRECTIVE ACTIONS: The operator shall, at the entrance of the mine site, post a sign which shall be clearly visible from the access road with the following: the name of the operator (Aspen Smuggler Mine, LLC.), a statement that a reclamation permit for the operation has been issued by the Colorado Mined Land Reclamation Board; and the permit number (M-1995-097). The operator shall submit photo documentation that a proper sign has been posted by the corrective action date.

CORRECTIVE ACTION DUE DATE: 8/01/24

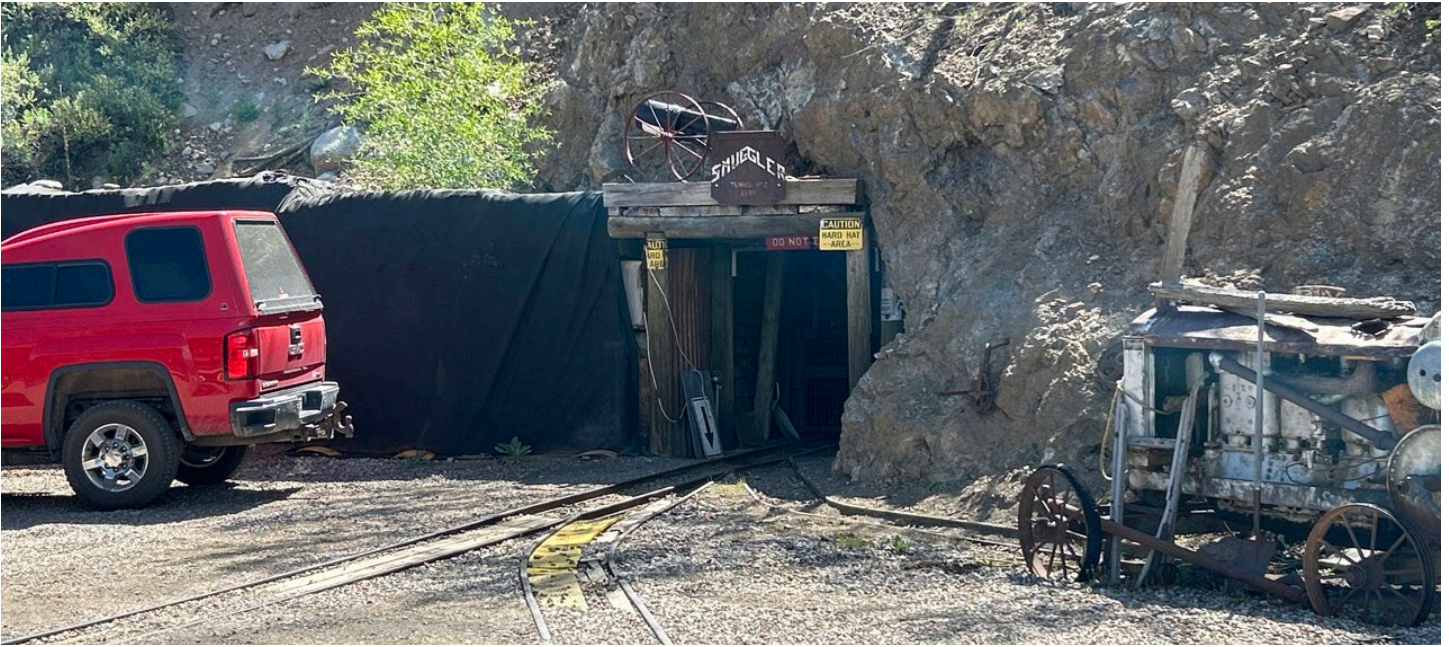
Figure 4: Entrance to Tunnel No. 2 (point 283)

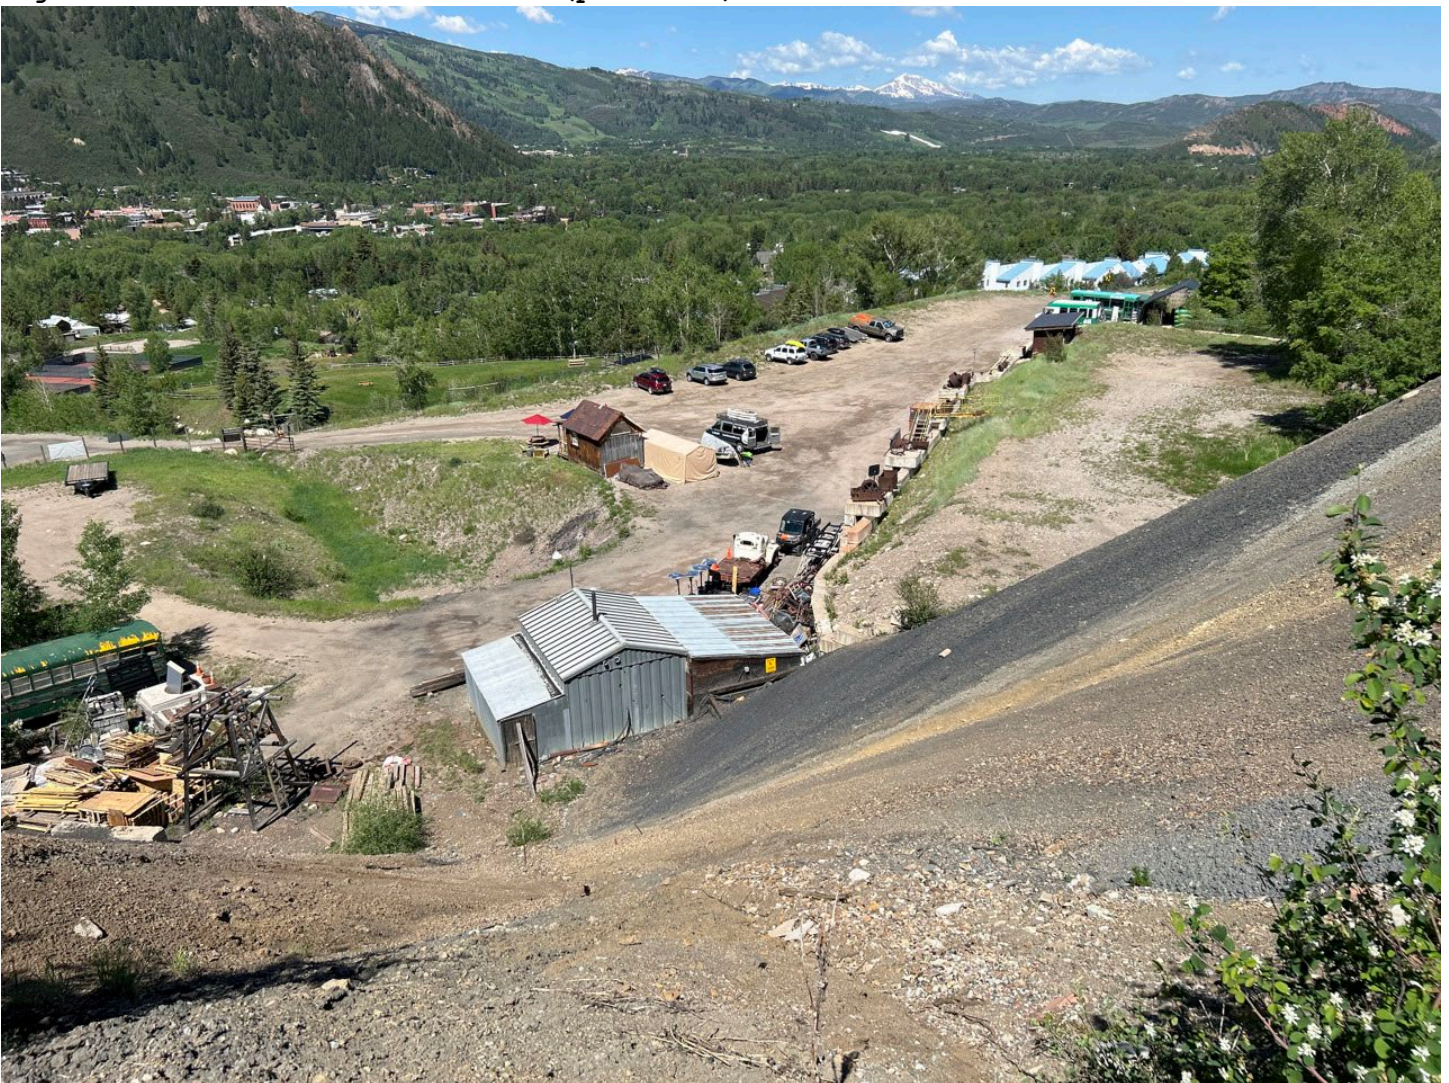
Figure 5: Overview of site from bench on No. 2 Dump (point 283)

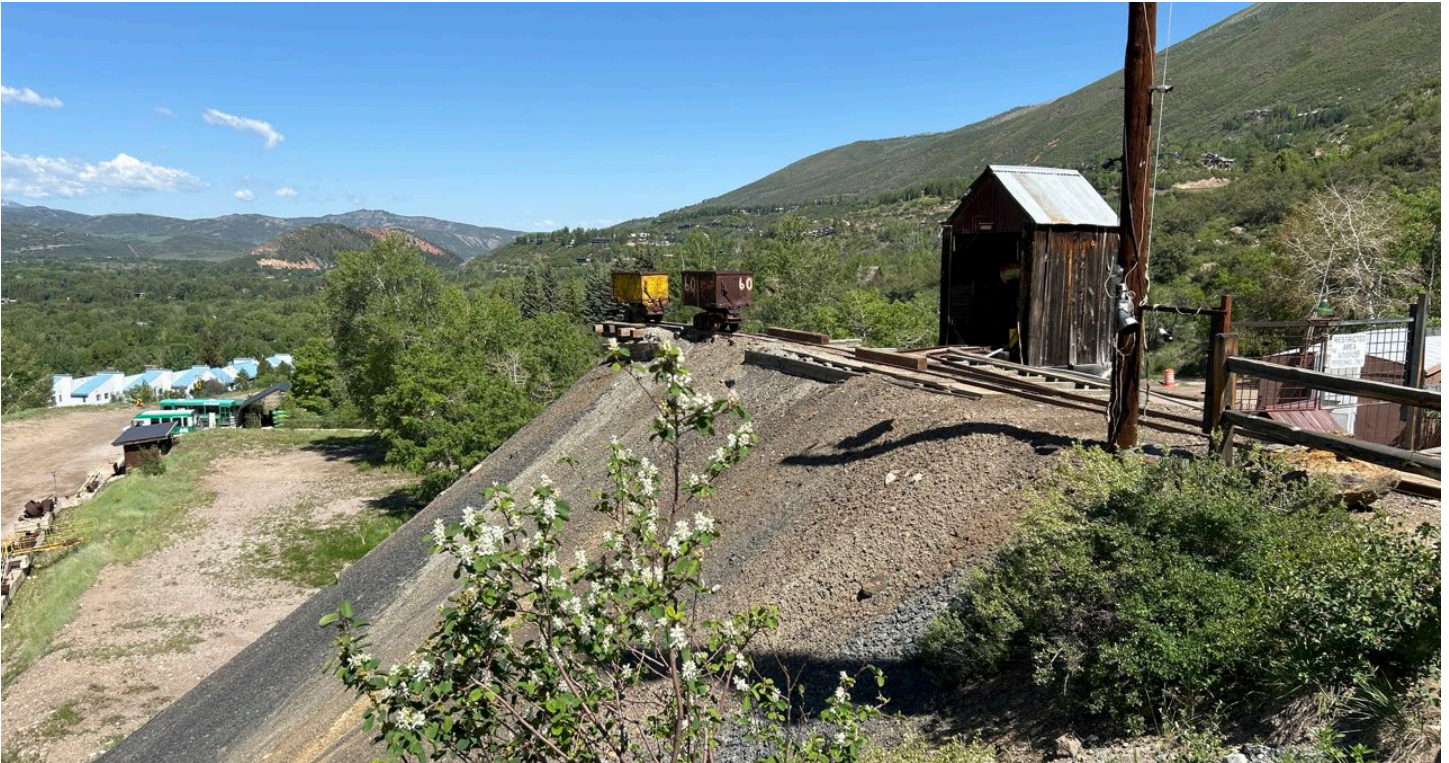
Figure 6: Tracks on bench on No.2 Dump (point 283)

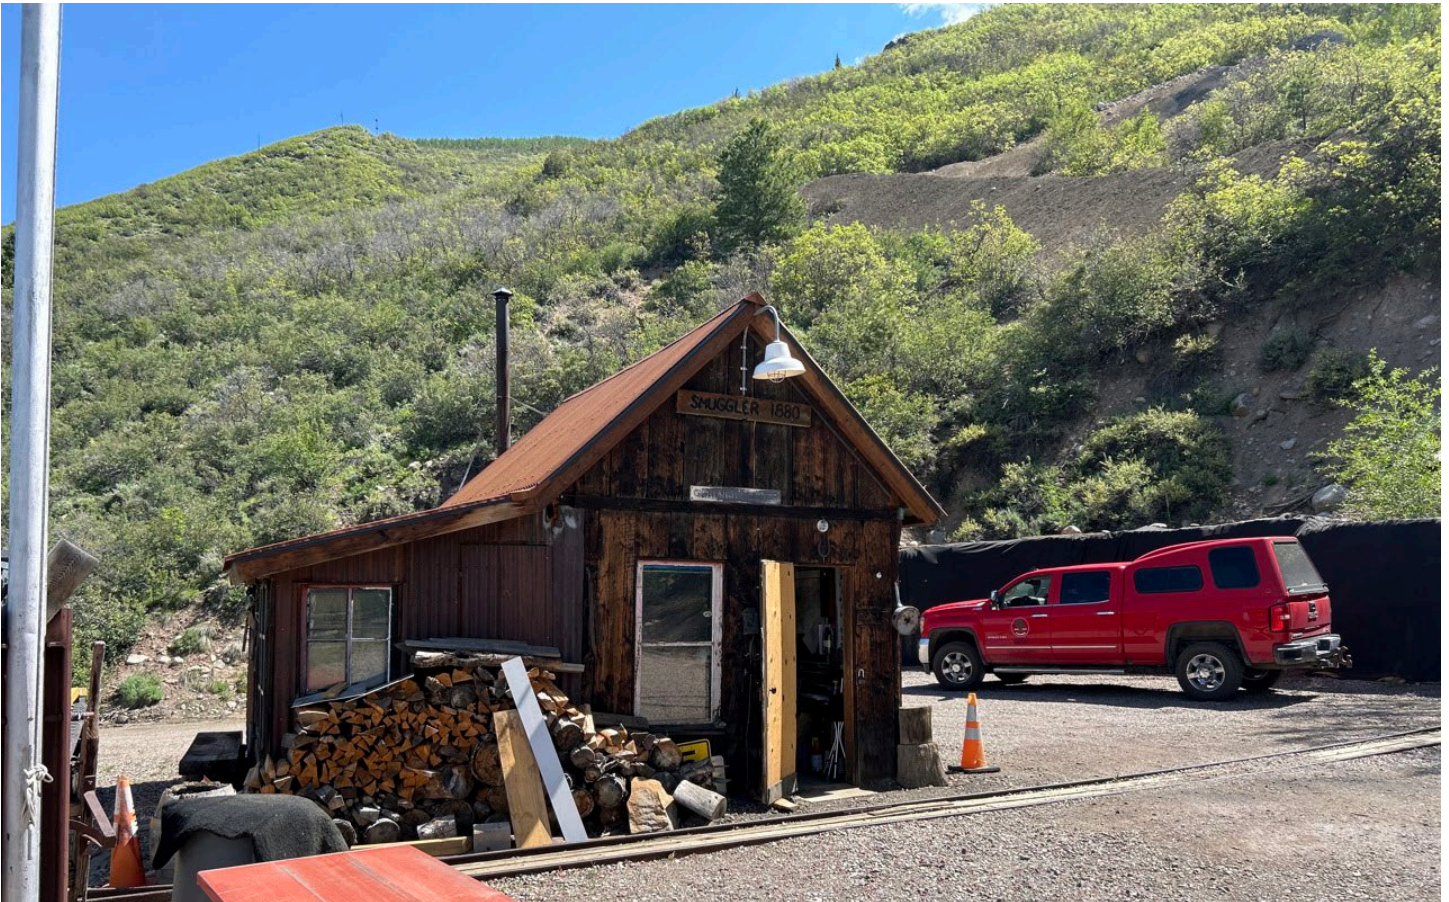
Figure 7: Office building (point 283)

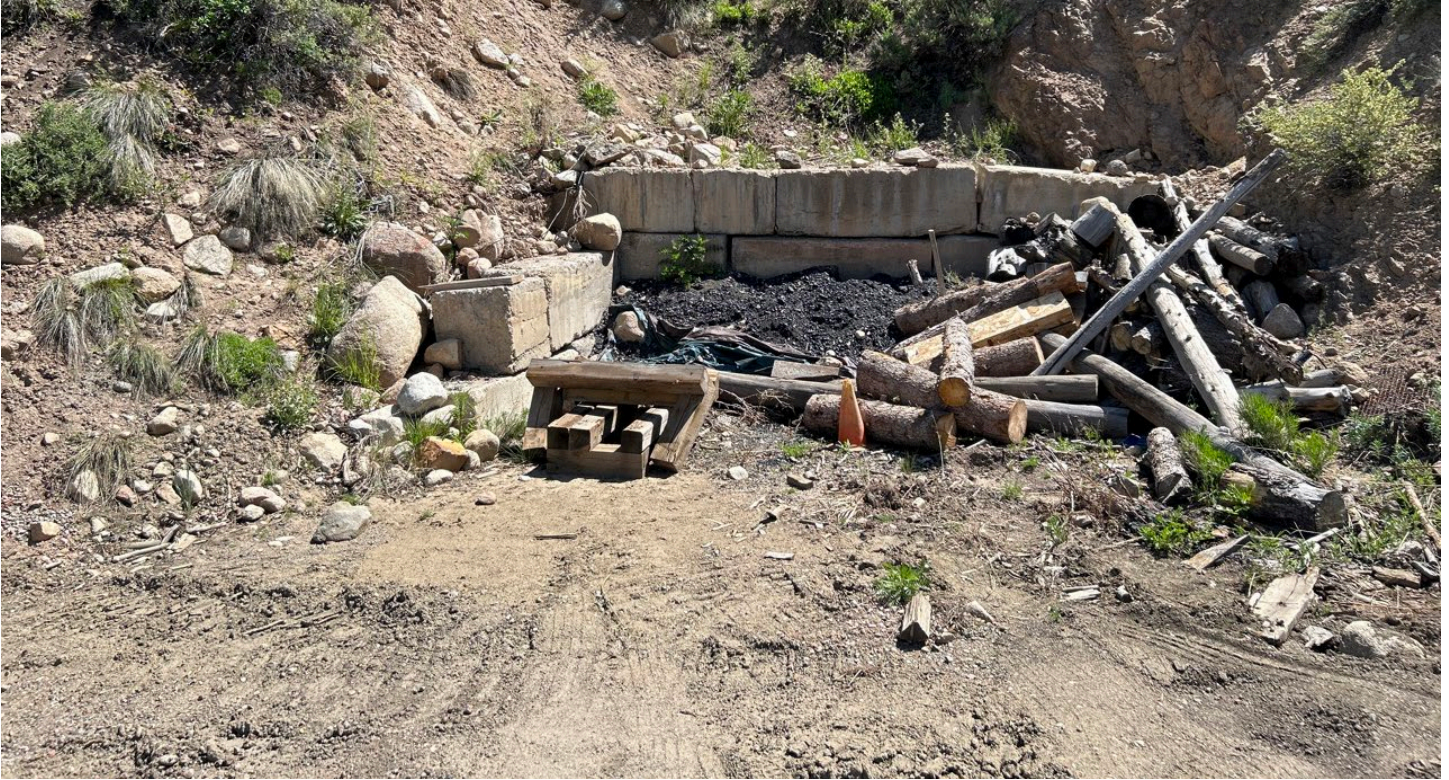
Figure 8: Waste collection area (point 284)

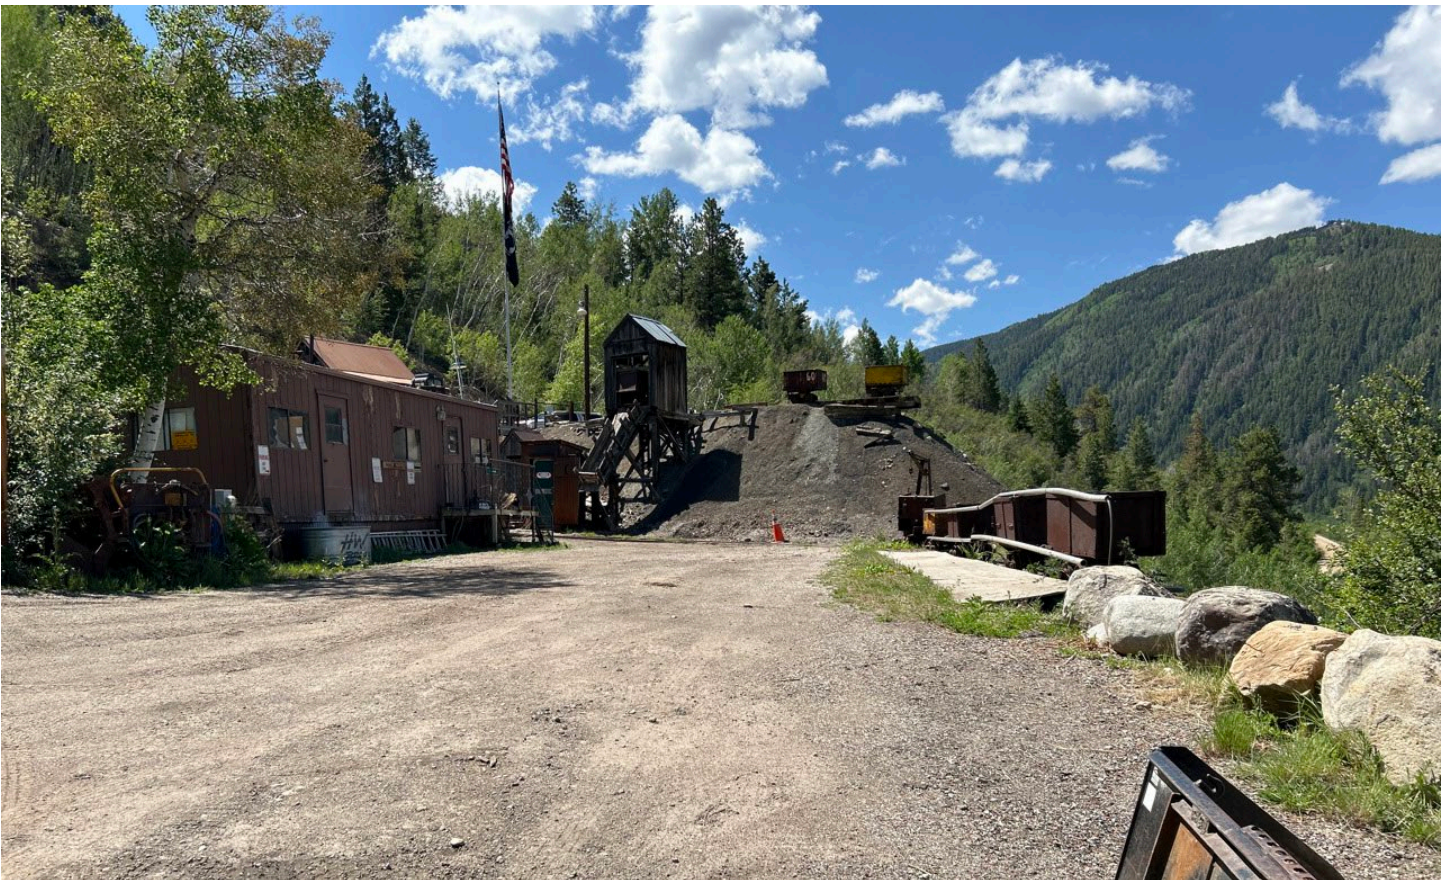
Figure 9: Middle bench (point 285)

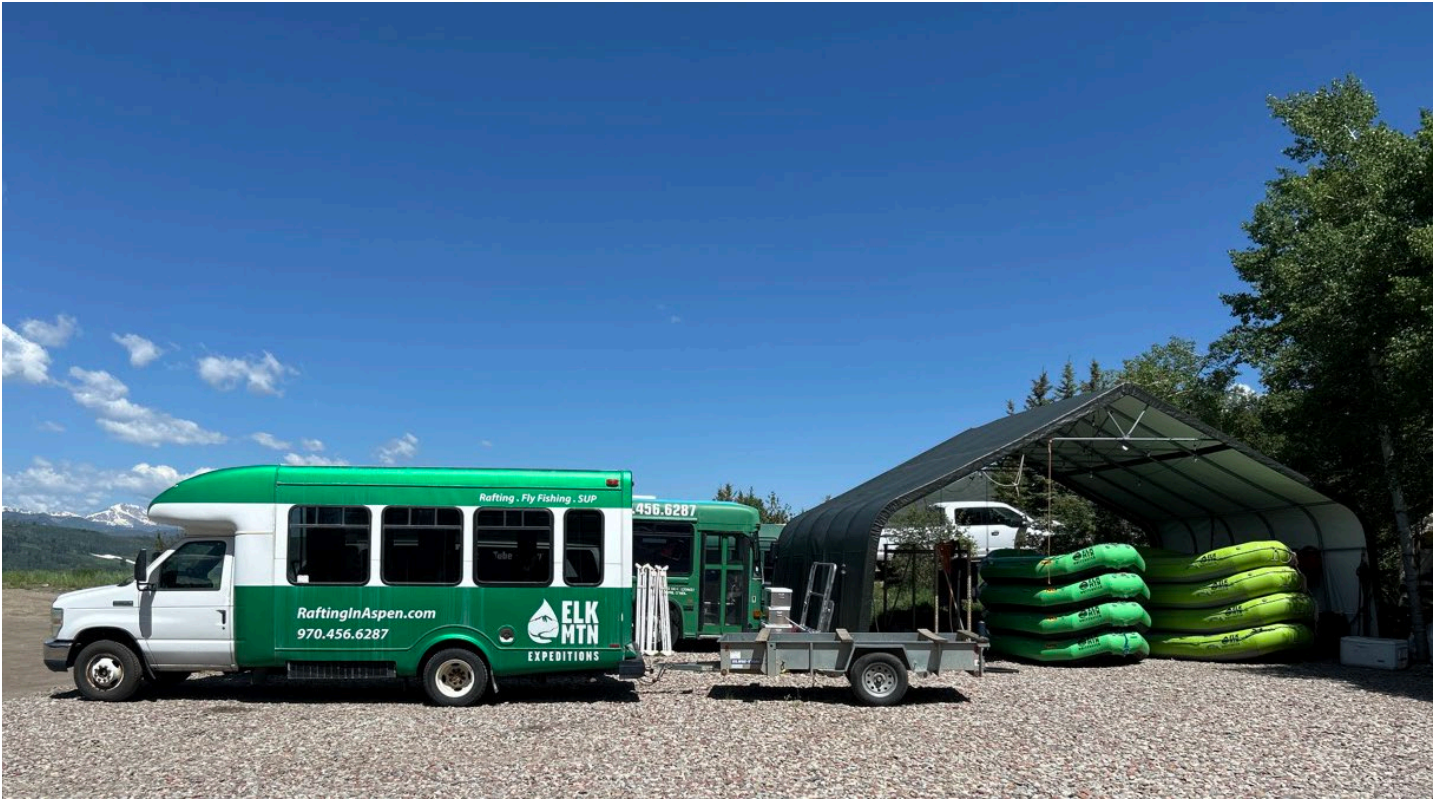
Part of the lower bench had been leased to a rafting company.

Figure 10: Part of lower bench leased to rafting company (point 286)

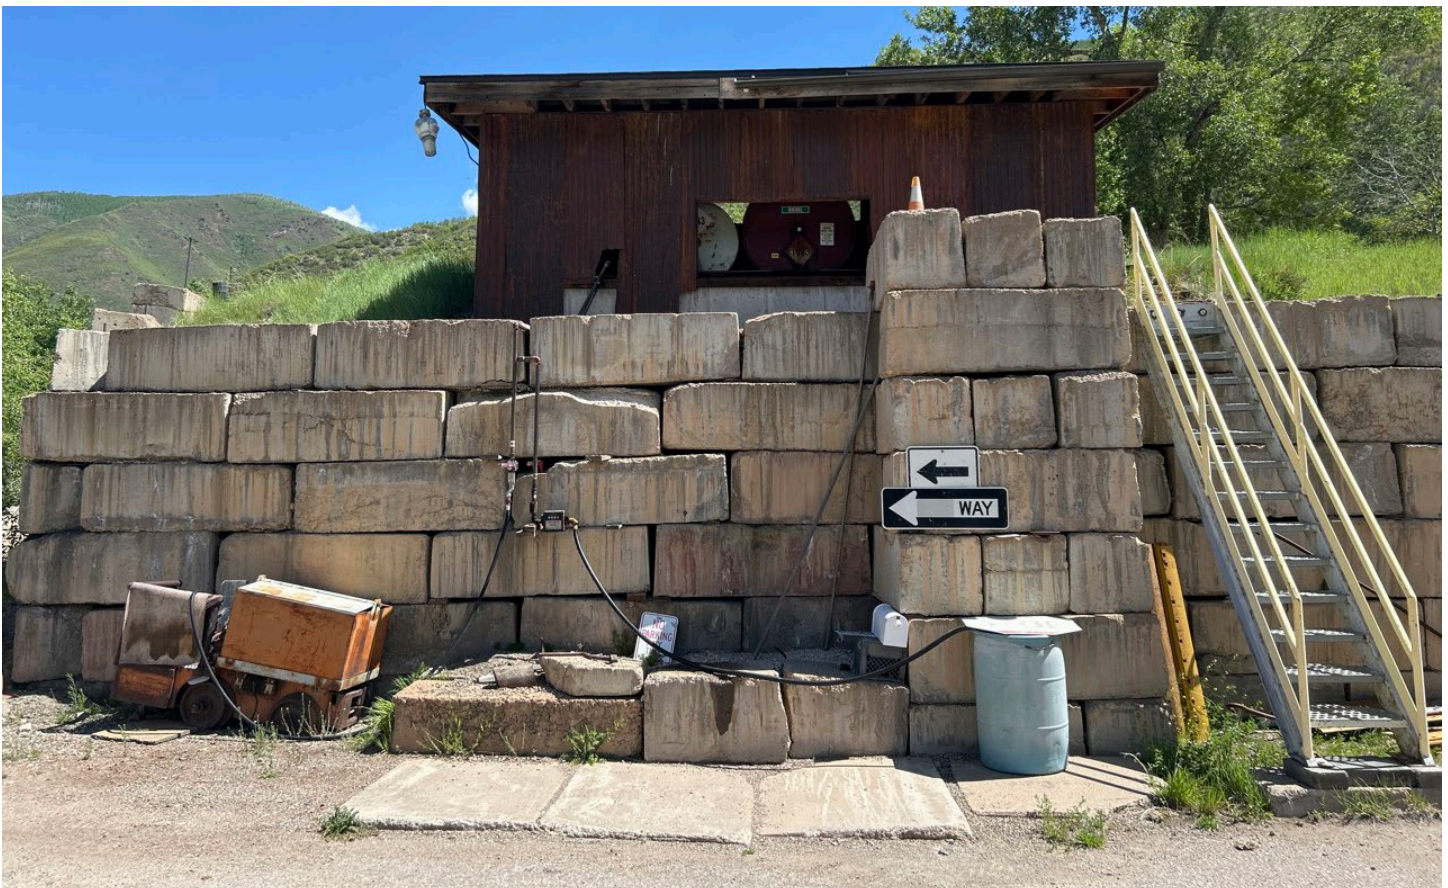
Figure 11: Fuel storage (point 287)

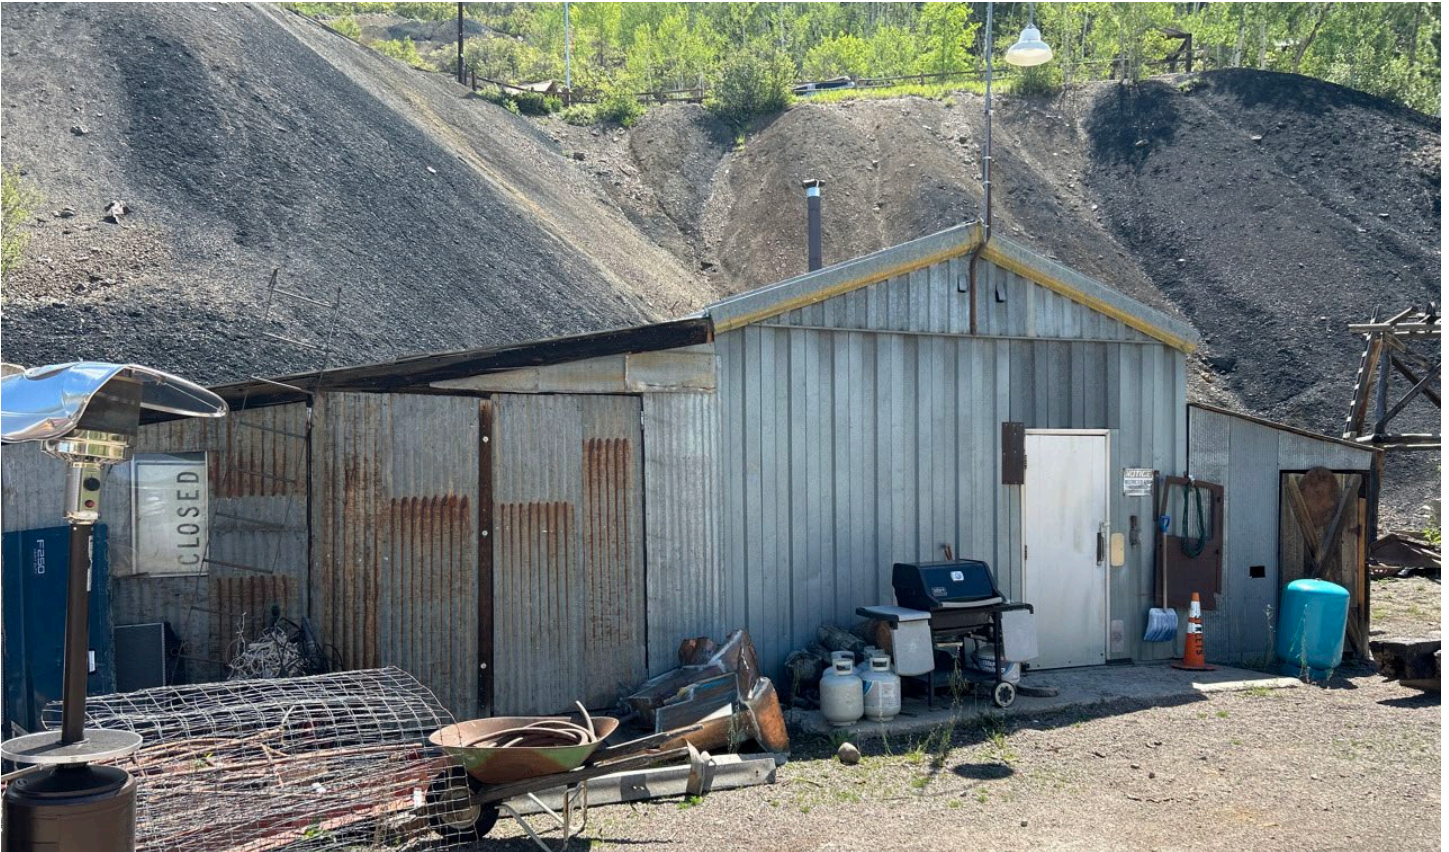
Figure 12: Storage shed on lower bench

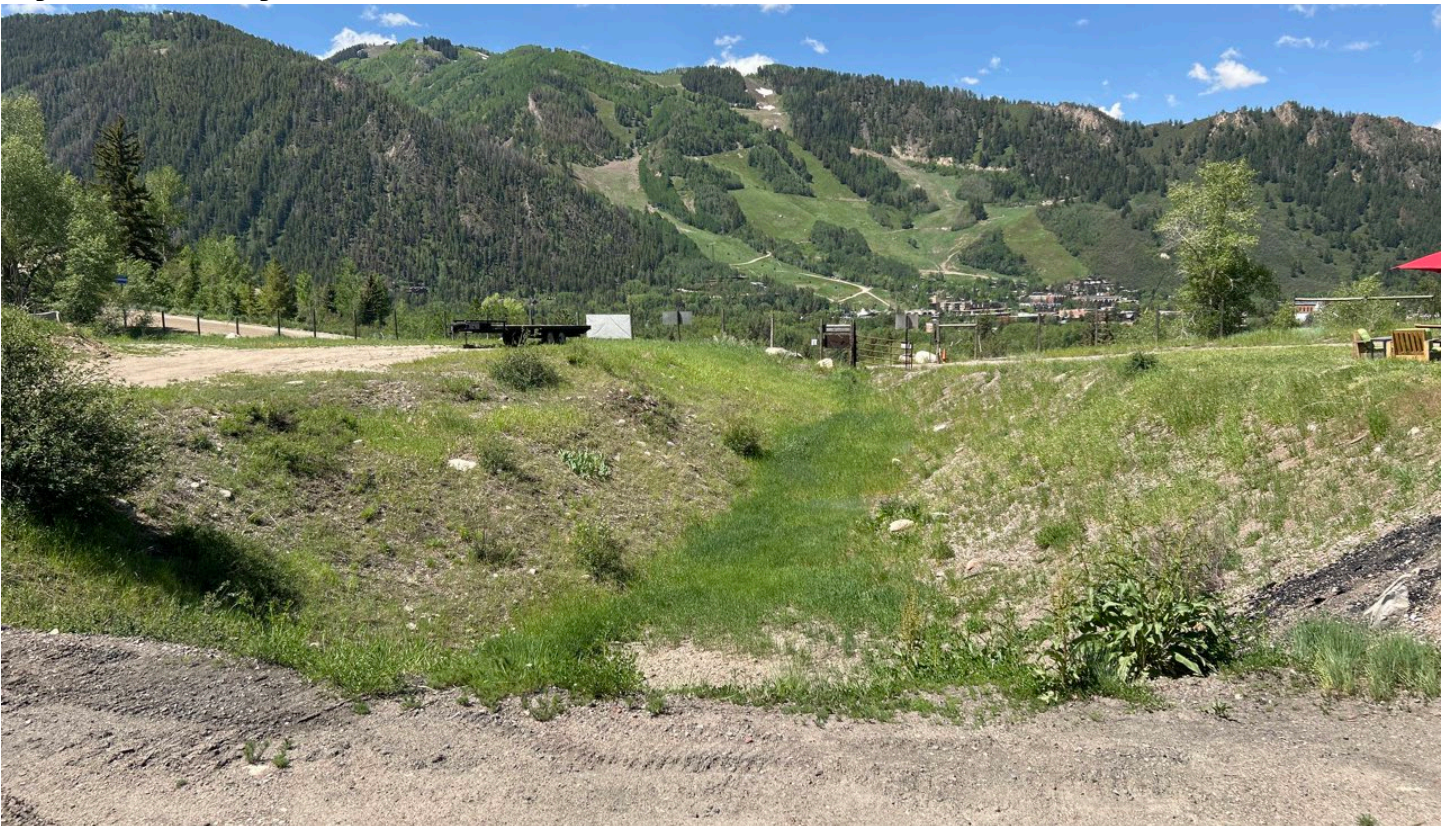
Figure 13: Stormwater containment area
