MINERALS PROGRAM INSPECTION REPORT
PHONE: (303) 866-3567

MINE NAME: Ross Pit	MINE/PROSPECTING ID#: M-1990-134	MINERAL: Gravel	COUNTY: Moffat
INSPECTION TYPE: Surety-Related Inspection	WEATHER: Clear	INSP. DATE: June 6, 2024	INSP. TIME: 08:00
OPERATOR: James H & Kathleen H Ross	OPERATOR REPRESENTATIVE: Bud Bower	TYPE OF OPERATION: 110c - Construction Limited Impact	
REASON FOR INSPECTION: Surety Release Requested	BOND CALCULATION TYPE: None	BOND AMOUNT: \$20,545.00	
DATE OF COMPLAINT: NA	POST INSP. CONTACTS: None	JOINT INSP. AGENCY: None	
INSPECTOR(S): Hunter Ridley	INSPECTOR'S SIGNATURE:

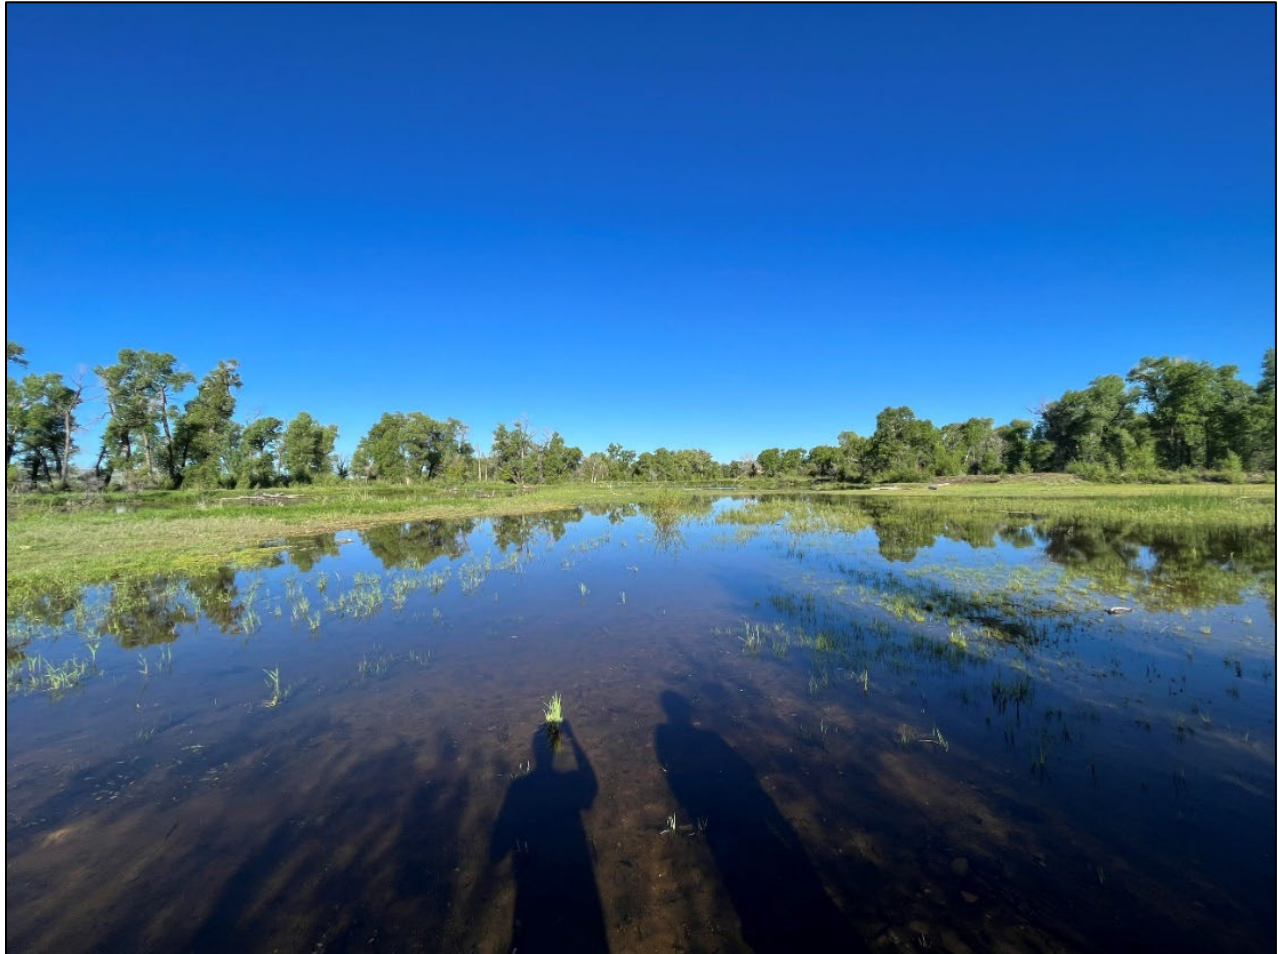
Reclamation Success: At the Division's last inspection, vegetation along ponds in 'Areas 1', '3' and '4' were well established and no issues were noted. These areas still exhibit mature establishment of acceptable reclamation vegetation (Photo 3). The ponds are lined with a majority native tree, shrub, grass, and forb species. The thistles which were concentrated in Area '2' at the Division's last inspection are no longer present and have instead been replaced by native vegetation (Photos 1 and 2).

Photo 1: View northwest of Area 2.

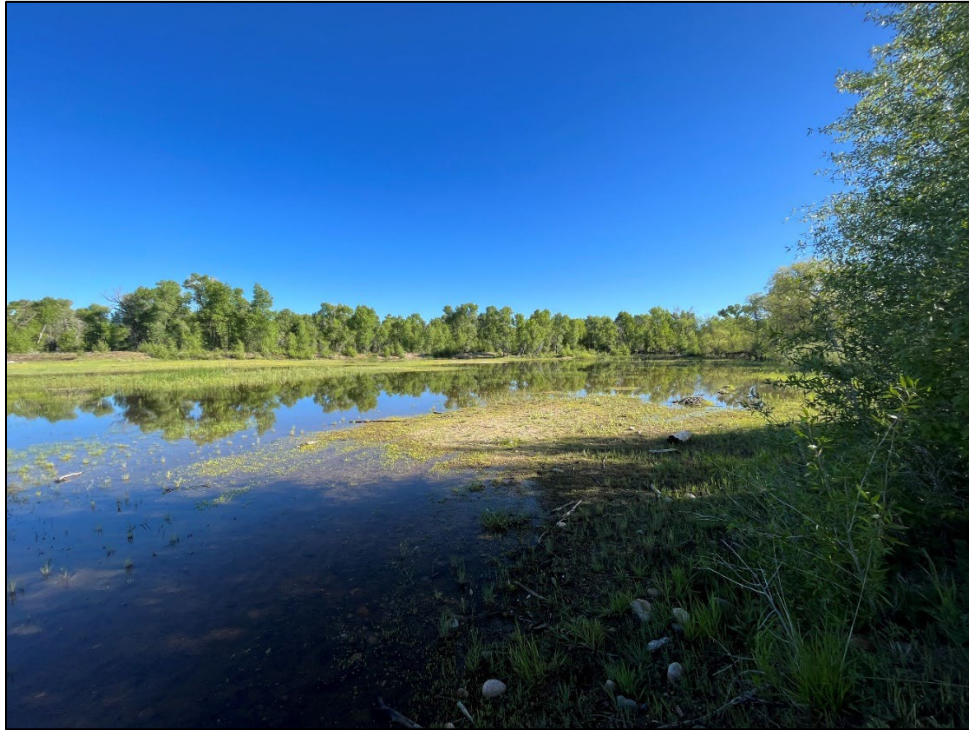
Photo 2: View northeast of Area 2.

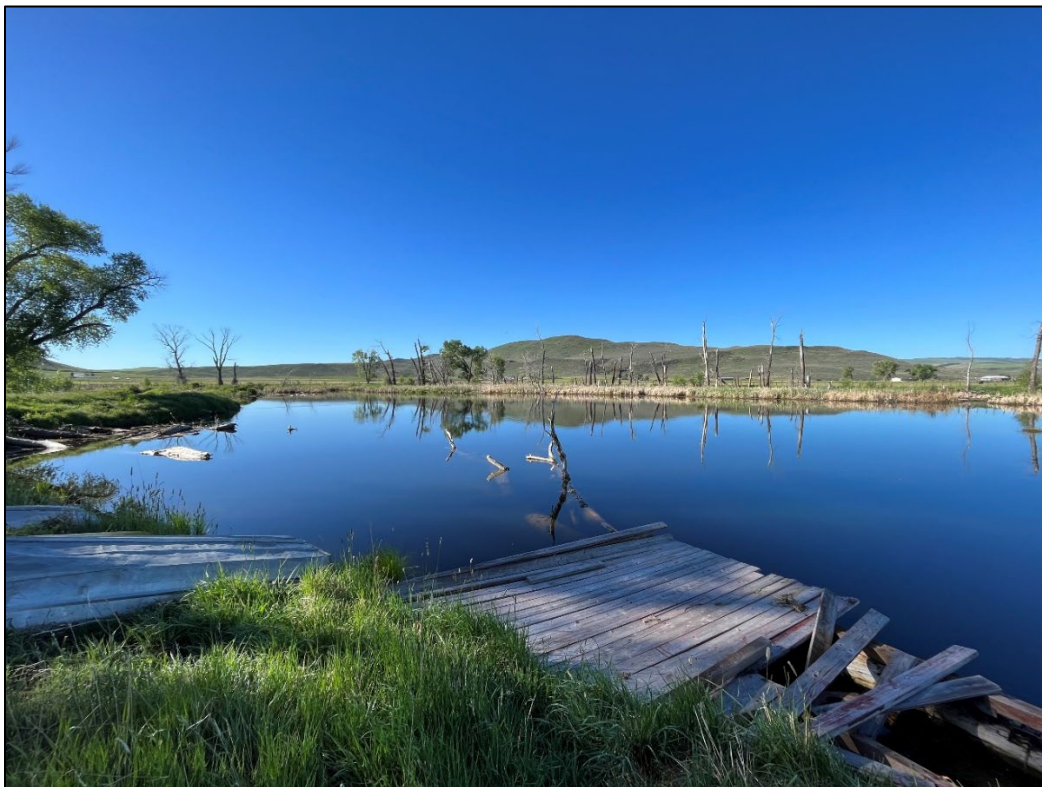
Photo 3: View south of Area 4.
