Inspection report for Bowie #2

Permit Number: C-1996-083 Mine Name: Bowie No. 2 Mine Operator: Bowie Resources, LLC Operator Address: Mr. Basil Bear P.O. Box 1488 Paonia, CO 81428	County: Delta Operation Type: Underground Permit Status: Active Ownership: Private
	Operator Representative Present: Ryan Wilson
Operator Representative Signature: (Field Issuance Only)

Inspection Start Date: June 26, 2024 Inspection Start Time: 09:30 Inspection End Date: June 26, 2024 Inspection End Time: 11:45		Inspection Type: Coal Partial Inspection Inspection Reason: Normal I&E Program Weather: Clear	
Joint Inspection Agency: None		Joint Inspection Contacts:	
Post Inspection Agency: None		Post Inspection Contacts:	
Inspector(s): Robert Zuber, P.E.	Inspector's Signature:

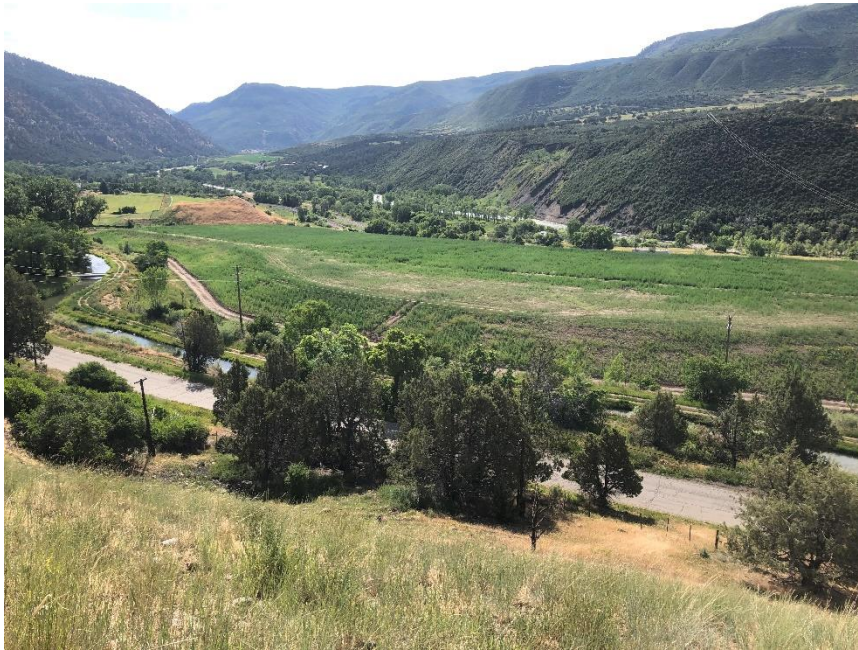
Gob Piles 1, 2, 3, and 4 appeared stable. No problem was identified at the repaired blow out on Gob Pile #4, which occurred in the spring of 2023. The east side of Gob Pile #3 is very steep (estimated to be 2.5H:1V) and needs additional grading work.

Gob Pile #3 from above

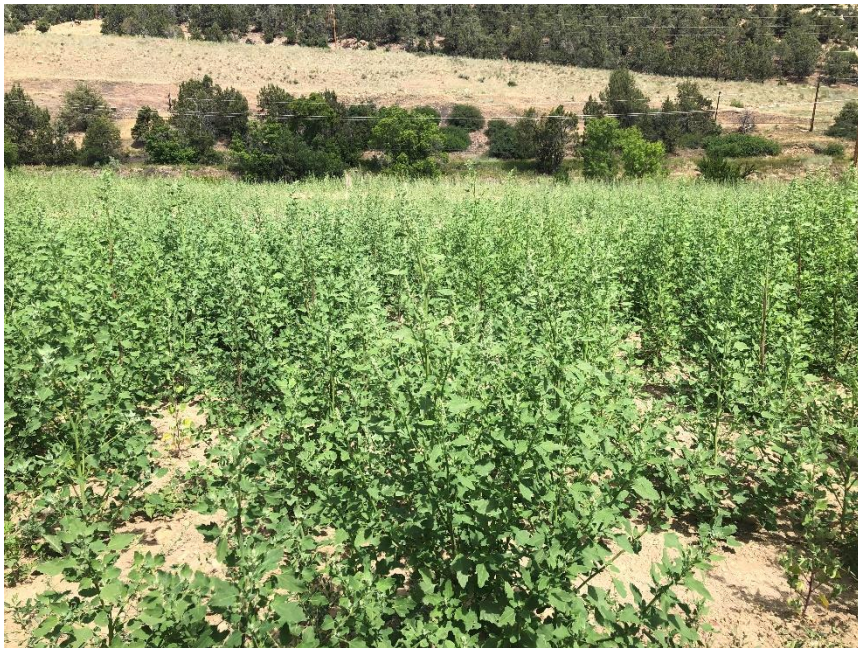
Gob Pile #3 was covered with a plant that appears to be lamb's quarter. This species is not noxious and will provide some erosion control prior to spreading topsoil and seeding this area with desirable reclamation species.

Lamb's quarter on Gob Pile #3

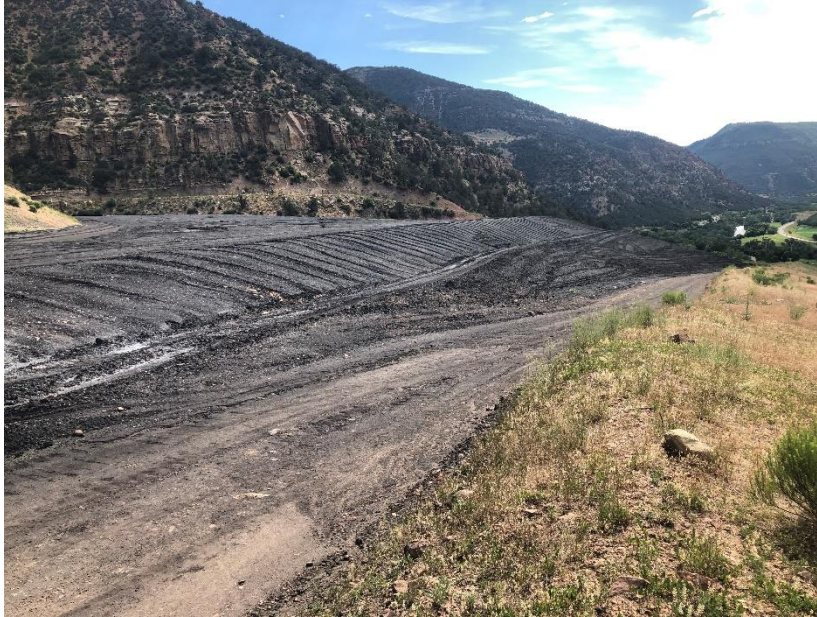
The upper slope of Gob Pile #2 has recently been graded and is less steep than it has been for several years. It appears to be flatter than 3H:1V. This follows the reclamation plan in Volume IX of the PAP. Some cover material has recently been spread on the graded slope.

Recent grading of slope on Gob Pile #2

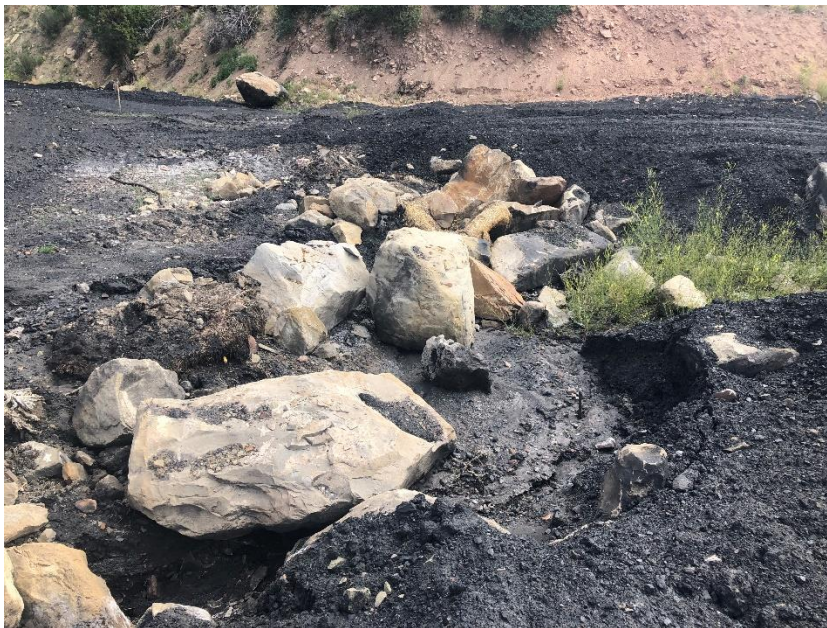
Disassembled BMPs on Gob Pile #2 – need to be reassembled when practical

No problems were identified with existing ditches, including the diversion ditches above Gob Pile #2. The ditch below the upper part of the pile has been moved; this should be documented with an as-built drawing when reclamation of the pile is completed. Also, the ditch that flows to the east from the upper portion of this pile needs to be rebuilt. BMPs to limit sediment loading off the top of the pile should be replaced as soon as practical.

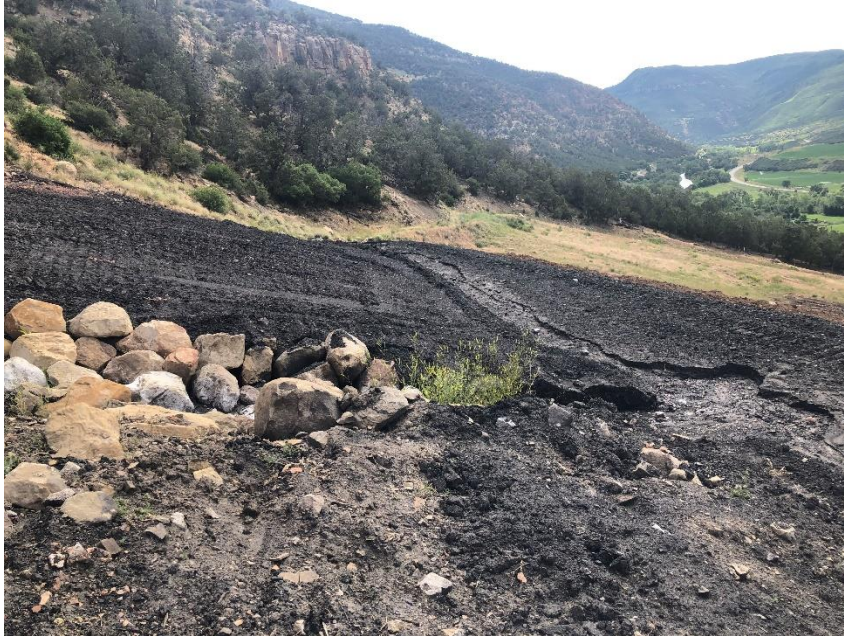
Ditch on Gob Pile #2 that needs to be constructed

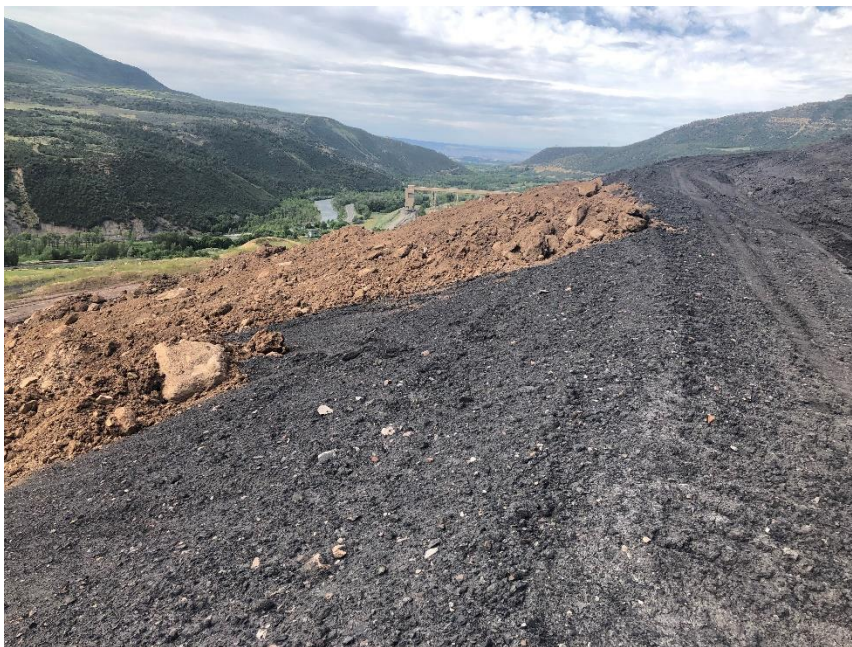
Placement of fill at Gob Pile #2

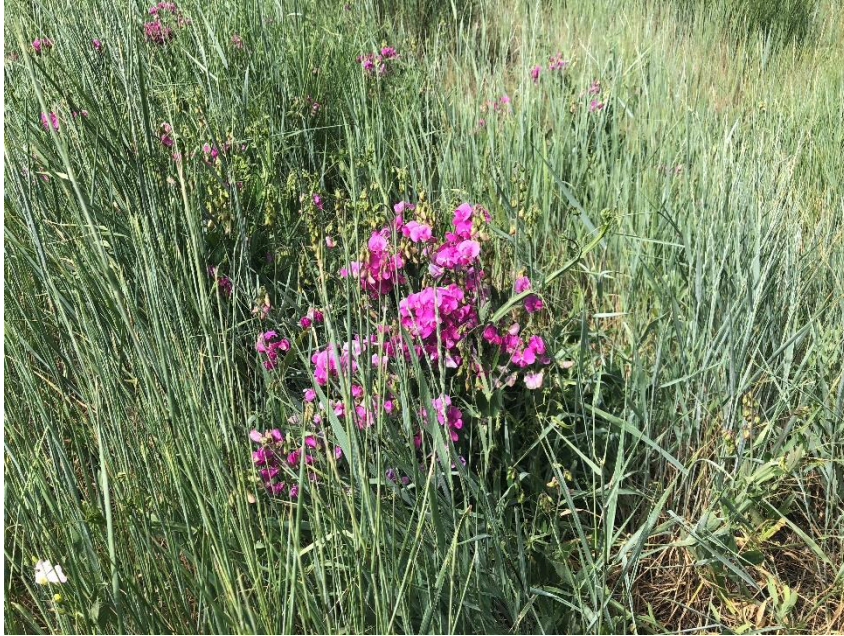
Near the northwest corner of Gob Pile #3, below the coal stockpile, and on Topsoil Stockpile A, perennial sweetpea was seen. It has a pink flower. This is not noxious but should be controlled if it spreads considerably.

Plant at Topsoil Stockpile A (perennial sweetpea) – control if it spreads significantly

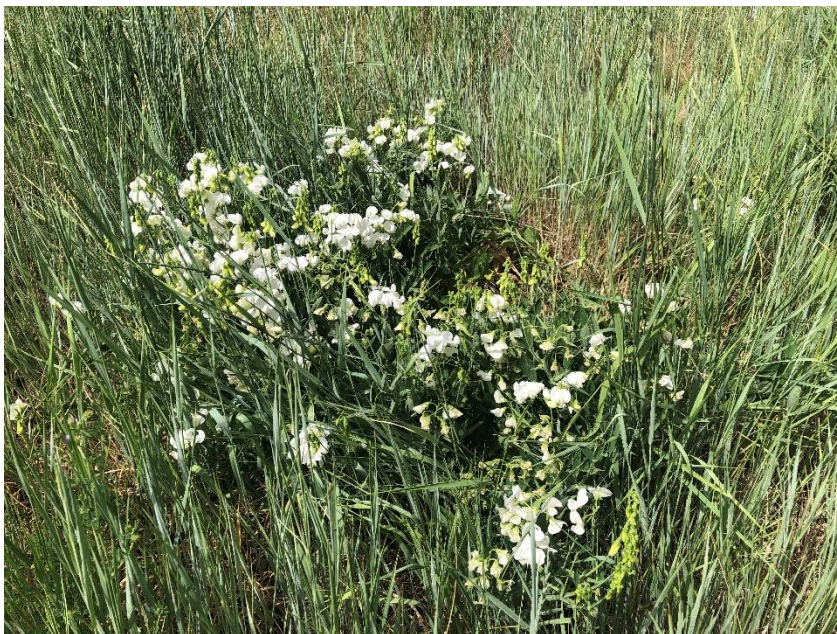
Plant at Topsoil Stockpile A (likely a member of pea family) – control if it spreads significantly

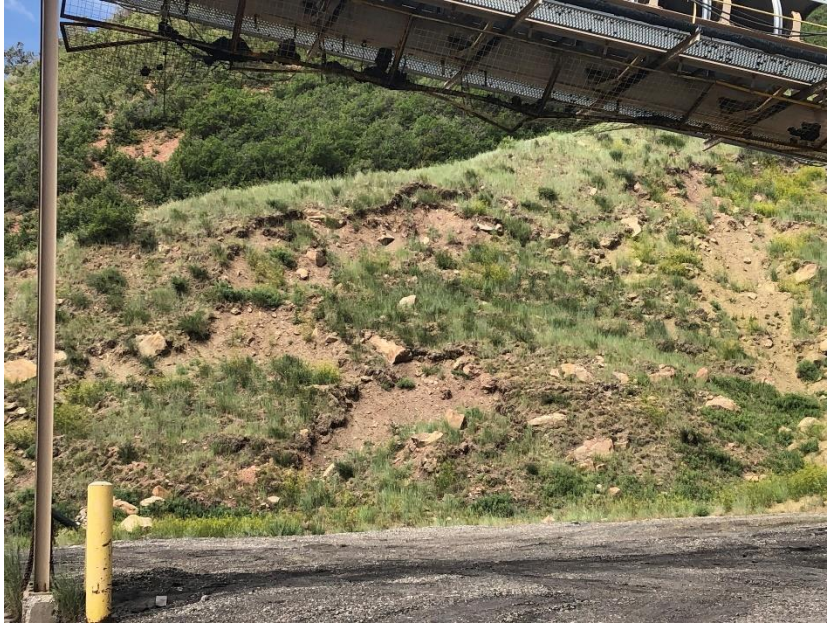
Slump at B Portal bench

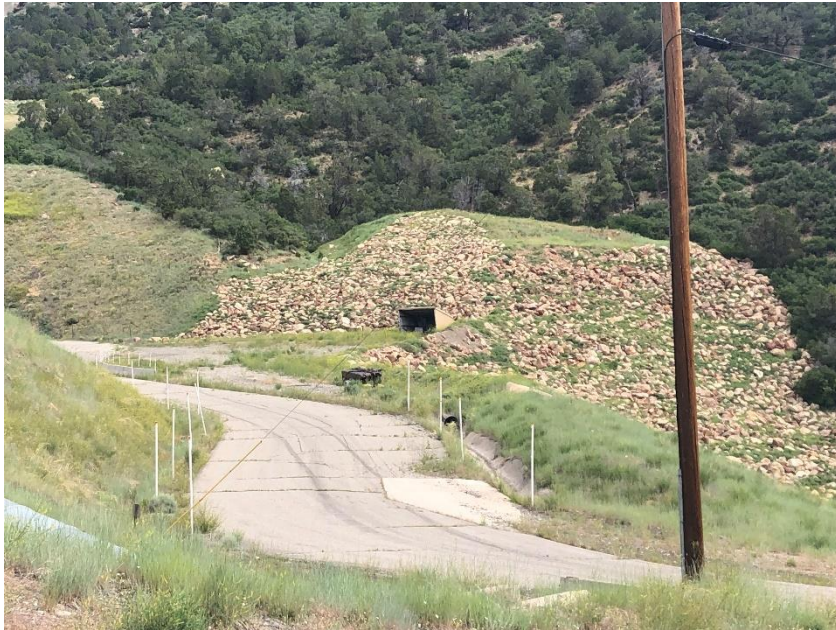
Soil stockpile near Curve 10

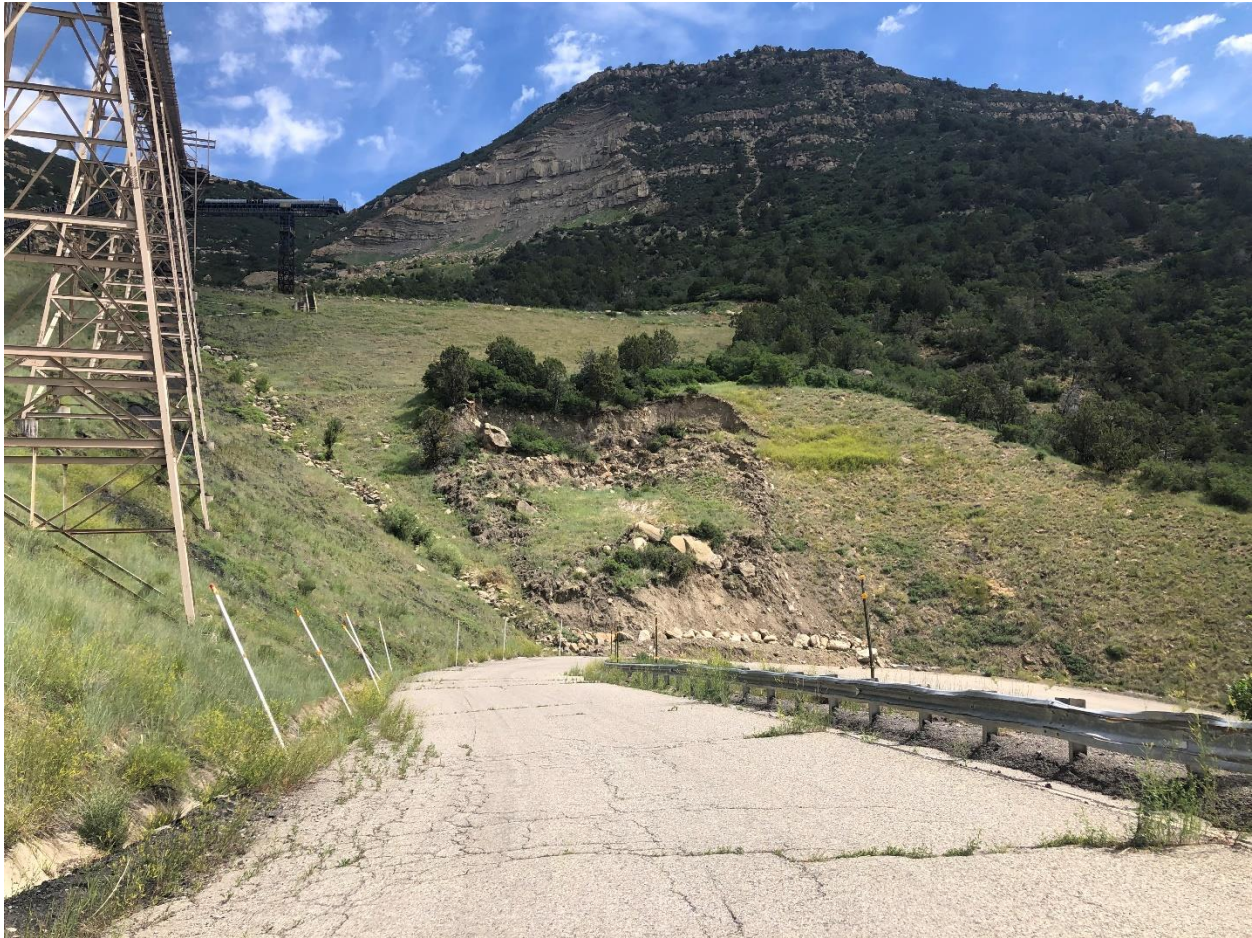
The road to the portals was in adequate condition. The slopes adjacent to this road are generally stable, except for the slide at Curve 10 (see Slides and Other Damage section).

No problems were seen on the slopes above and below the benches and other areas (e.g., the slope next to the old power plant). The slides above the B Portal Bench and Curve 11 (noted in the past) look stable. The slide above Curve Number 10 appears to have moved since the last inspection. This is an ongoing project for BRL.

Slide at Curve 10 – appears to still be moving
