MINERALS PROGRAM INSPECTION REPORT

MINE NAME: Colorado Moss Rock	MINE/PROSPECTING ID#: M-2011-039	MINERAL: Sandstone (silica, st quartzite)	COUNTY: Pueblo
INSPECTION TYPE: Monitoring	WEATHER: Clear	INSP. DATE: June 12, 2024	INSP. TIME: 11:07
OPERATOR: Premier Moss Rock, LLC	OPERATOR REPRESENTATIVE: N/A	TYPE OF OPERATION: 110c - Construction Limited Impact

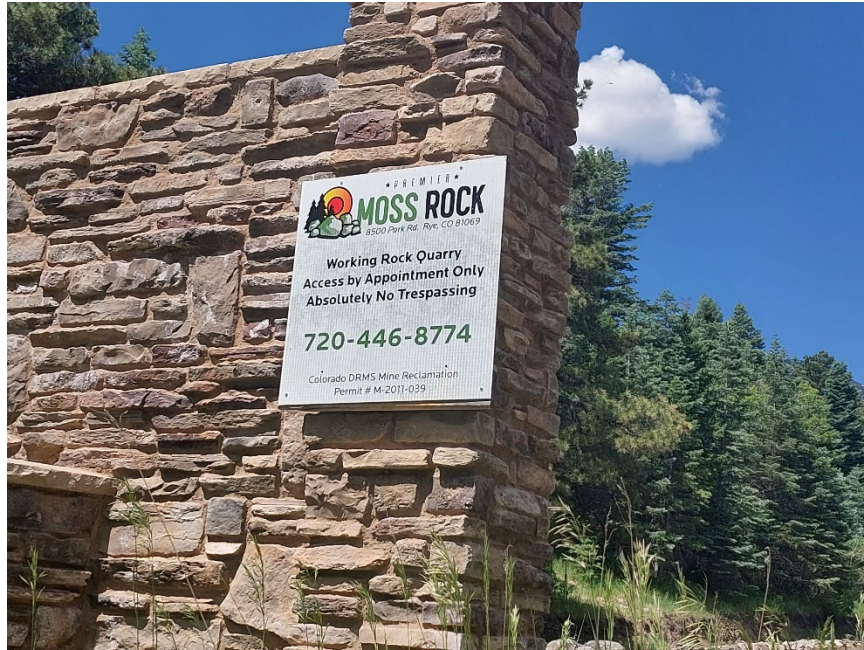
The mine sign is posted at the entrance of the permitted area, in accordance with Rule 3.1.12(1) (see Photo #1). Permit boundary markers were not posted in accordance with Rule 3.1.12(2). Three boundary markers were located at the time of the inspection. Two on the southwest portion of the staging area (see Photos #16 & #17), and one on the southwest corner of the rock picking area (see Photo #15); see the map below. No other boundary markers were observed. This is cited as a problem at the beginning of this report, see the citation for more information.

Photo #1: Mine sign in accordance with Rule 3.1.12(1).

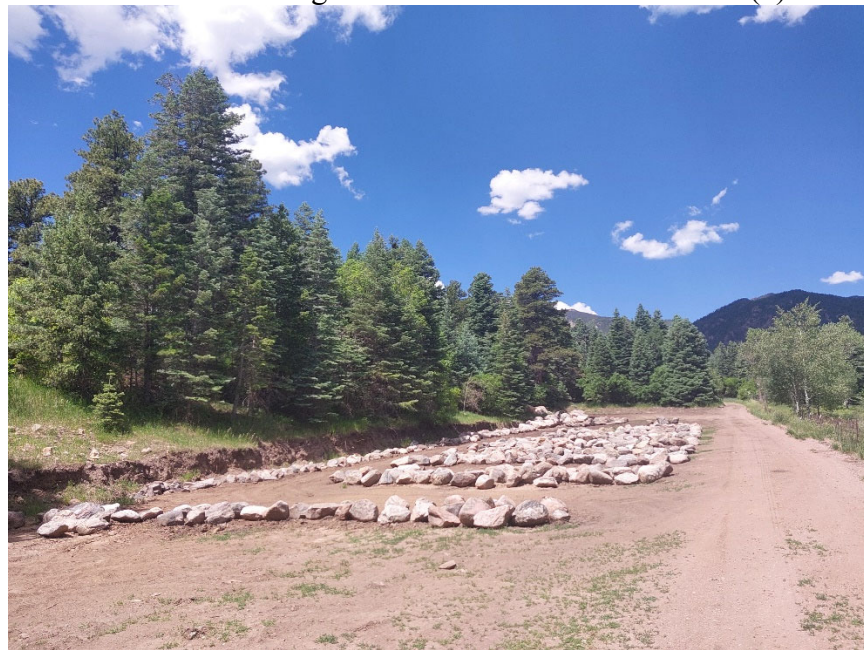
Photo #2: Staging area, looking west from the northeast, just east of the entrance.

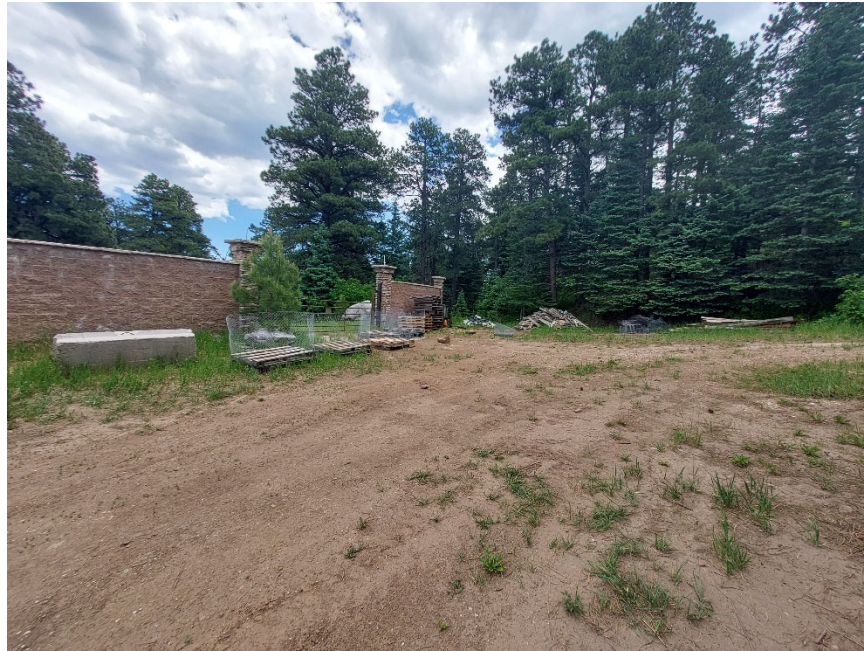
Photo #3: Staging area, looking east behind entrance gate and wall.

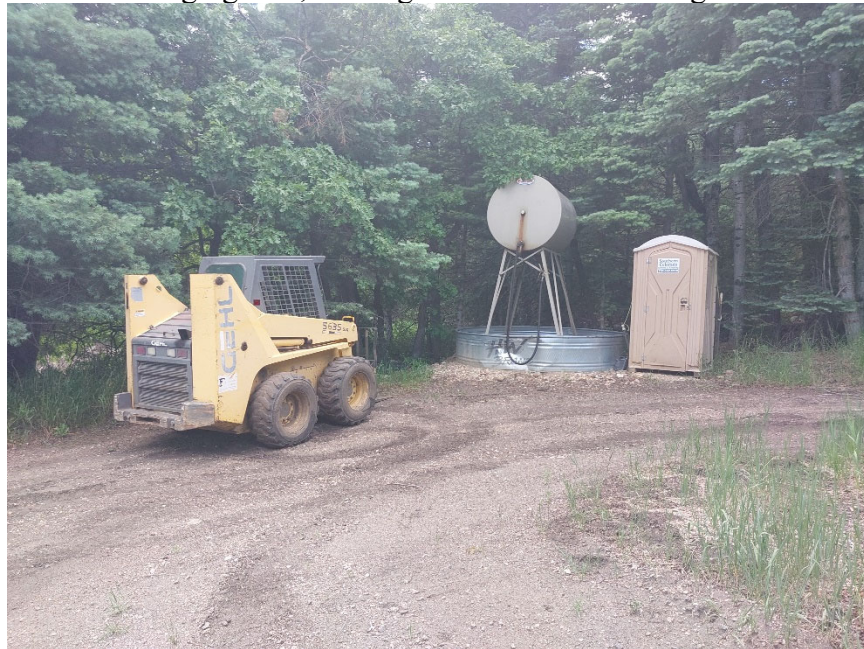
There is an elevated fuel tank with adequate secondary storage located on the west side of the staging area of the permit (see Photo #4).

Photo #4: Staging area at the west end, looking south at the skid steer, elevated fuel tank with secondary storage, and portable toilet.

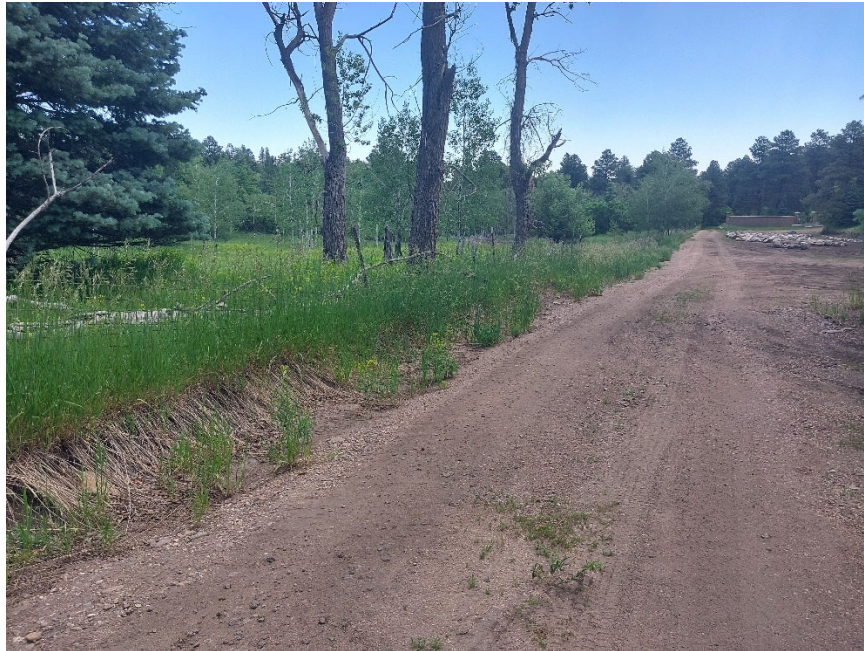
Photo #5: Staging area looking east from the northwest portion.

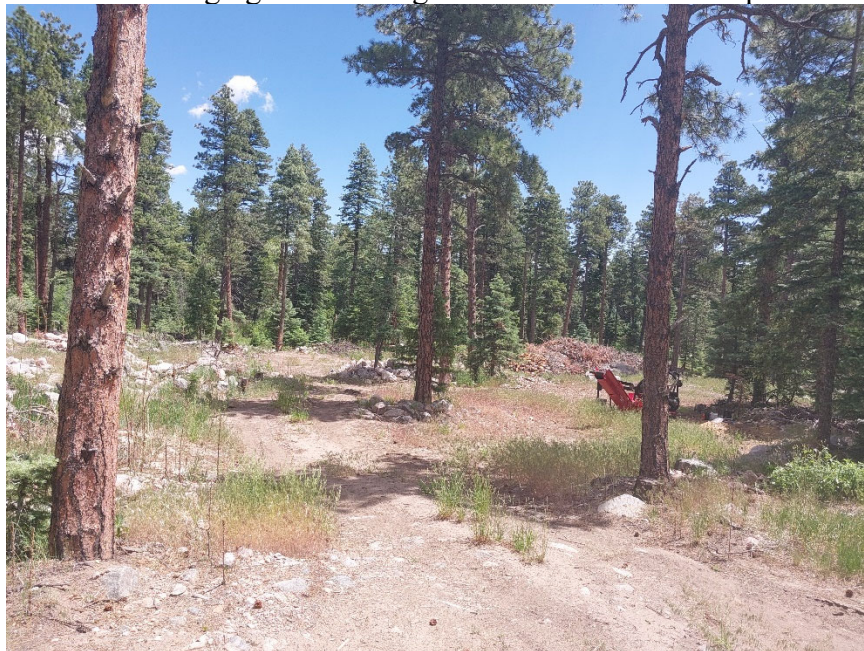
Photo #6: East end of the picking area, one of the access roads can be seen in the foreground with the wood chopper on the right side of the photo.

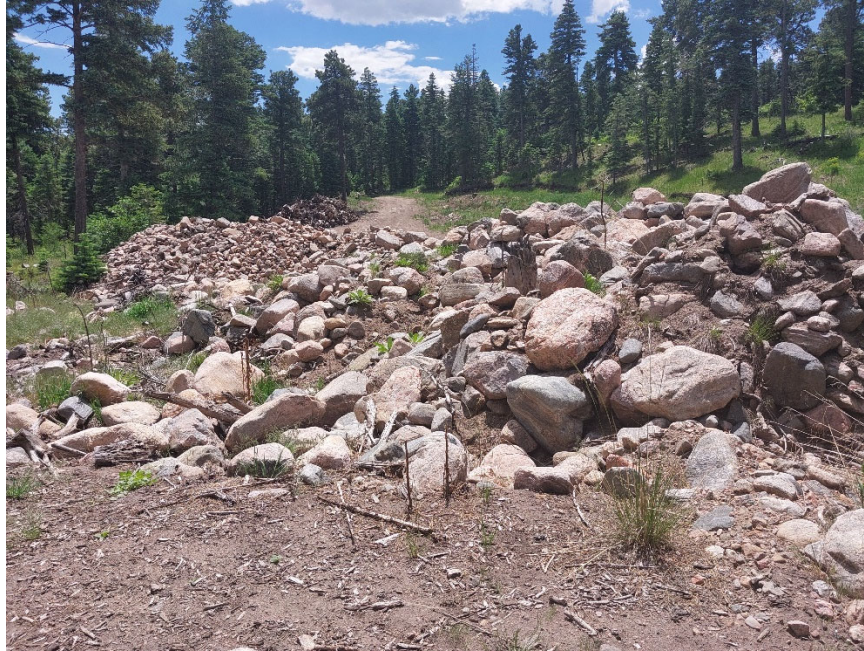
The general mining plan does appear to be followed. However, as noted in the May 2020 DRMS inspection report, there are some stockpiles of moss rock along the road between the staging area and the rock picking area. It is not clear if these disturbances are within the permit boundary.

Photo #7: Large stockpile west of the staging area, looking to the east, an access road can be seen in the background. It is unclear where the rock picking portion of the permit boundary is located with respect to the stockpile of material seen here.

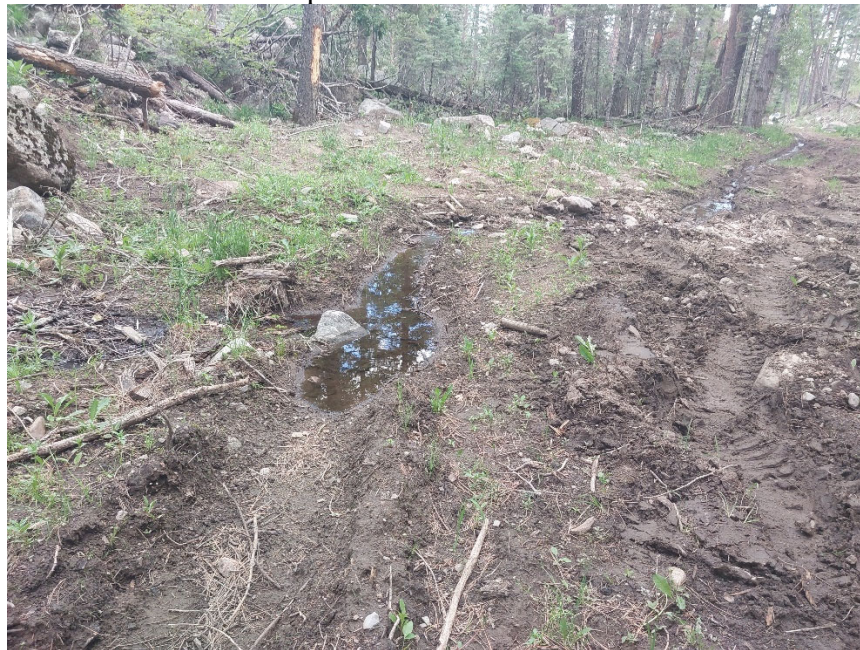
There was a small creek running through the permit area in the southwest portion of the picking area. It appeared that the development of the creek is from snowmelt and recent rains (see Photo #8). There does not appear to be an issue with the hydrologic balance in the area.

Photo #8: Within the rock picking portion of the permit boundary, looking east, the small stream that has developed can be seen following the rough road tracks.

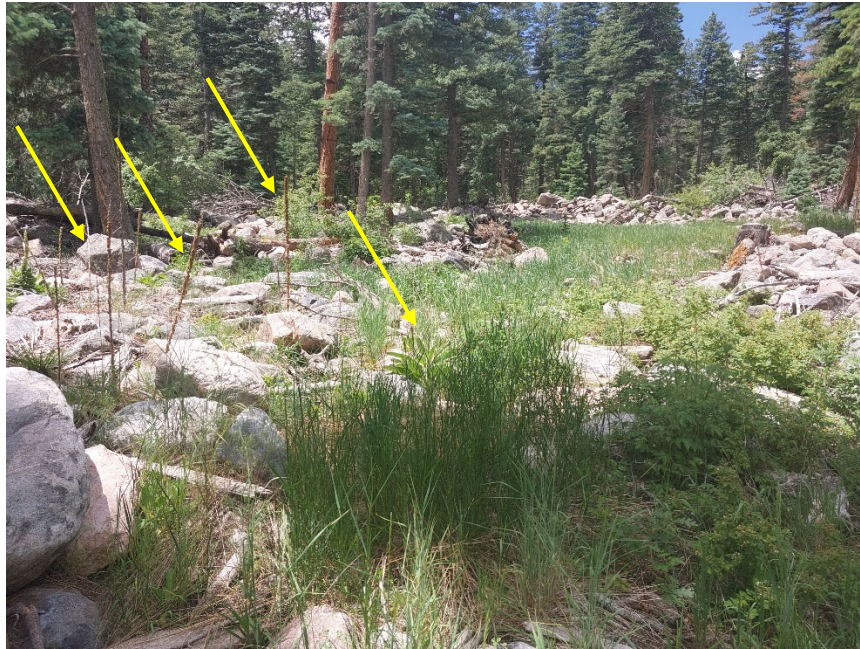
Thistles and common mullein were observed on site, sparsely dispersed throughout the area (see Photos #9 & #12). The Division recommends the Operator implement the approved weed control plan.

Photo #9: Within the rock picking portion of the permit boundary, looking west at various material stockpiles. Common mullein can be seen on the left side of the photo, yellow arrows are pointing to old and new growth.

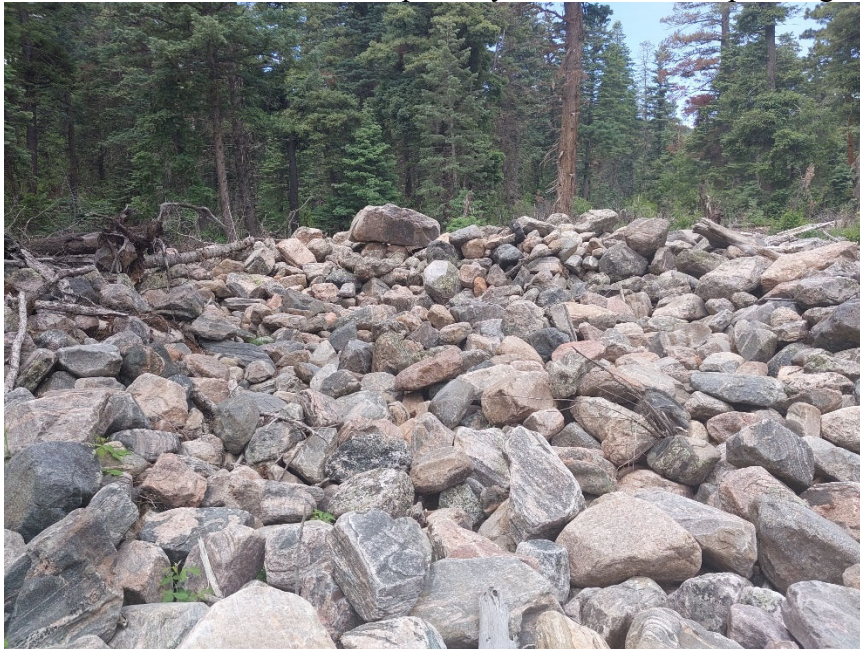
Photo #10: Within the rock picking portion of the permit boundary, at product material.

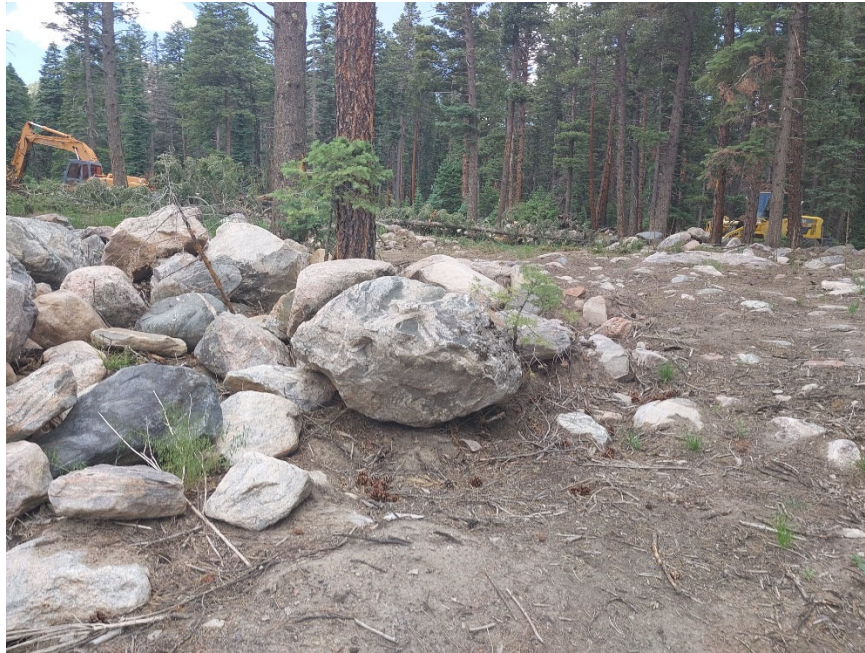
Photo #11: Within the rock picking portion of the permit boundary, looking to the east at the most recently worked area. The hydraulic excavator can be seen on the left side of the photo and the wheel loader on the right side, both in the background. Product and an access road can be seen in the foreground.

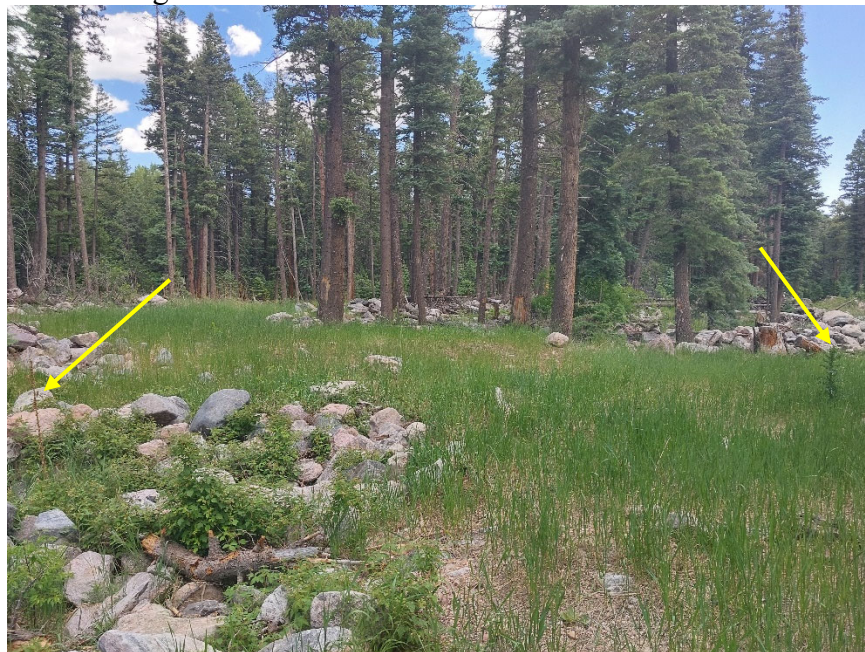
Photo #12: Within the rock picking portion of the boundary, on the west end looking west at a previous picking area. Re-vegetation looks good, common mullein and thistle can be seen, yellow arrows pointing at old growth of common mullein on the left and a new thistle on the right.

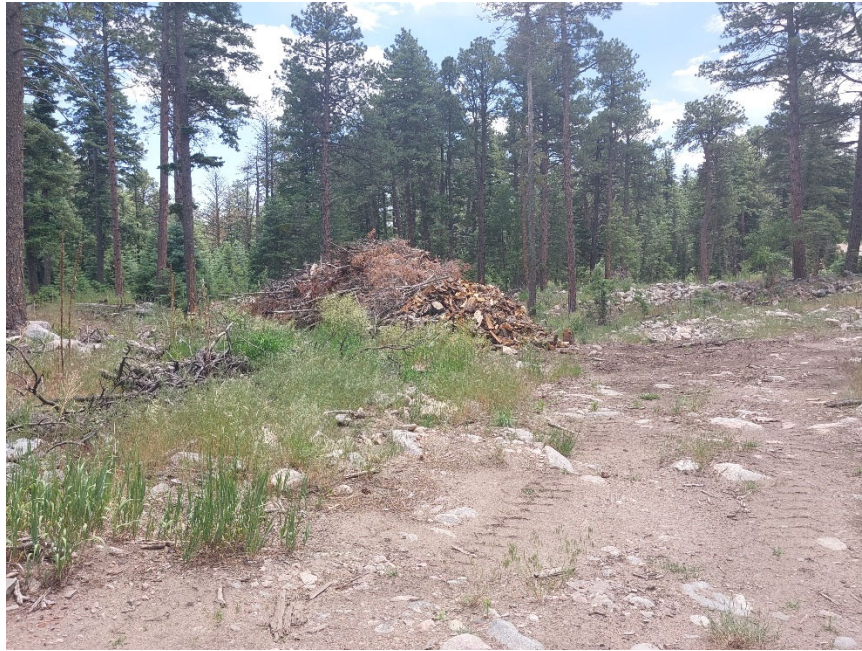
Photo #13: Within the rock picking portion of the permit boundary, wood material piled and kept separate from product materials.

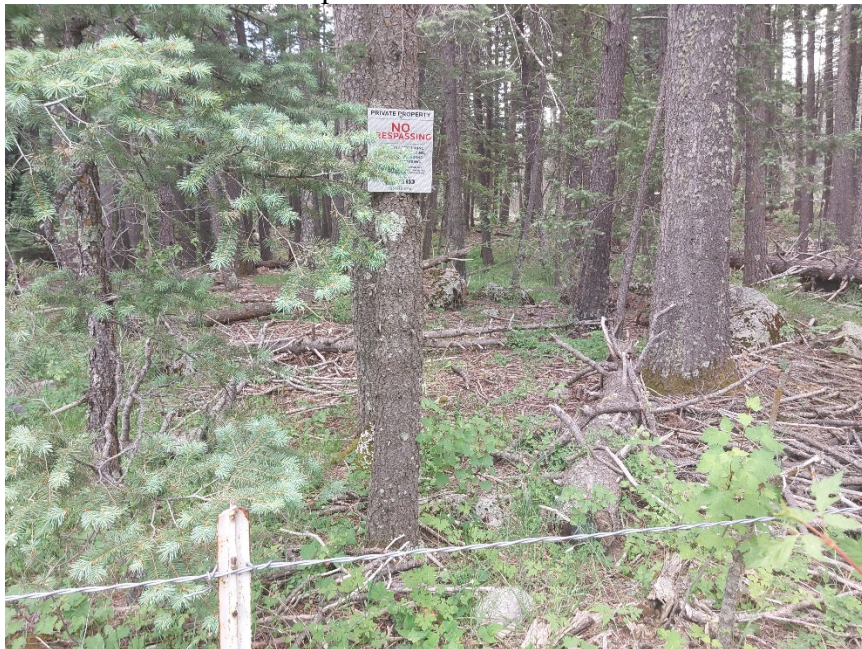
Photo #14: A "No Trespassing" posted on the west end of the rock picking portion of the permit boundary, viewed from the Greenhorn Creek trail, looking east.

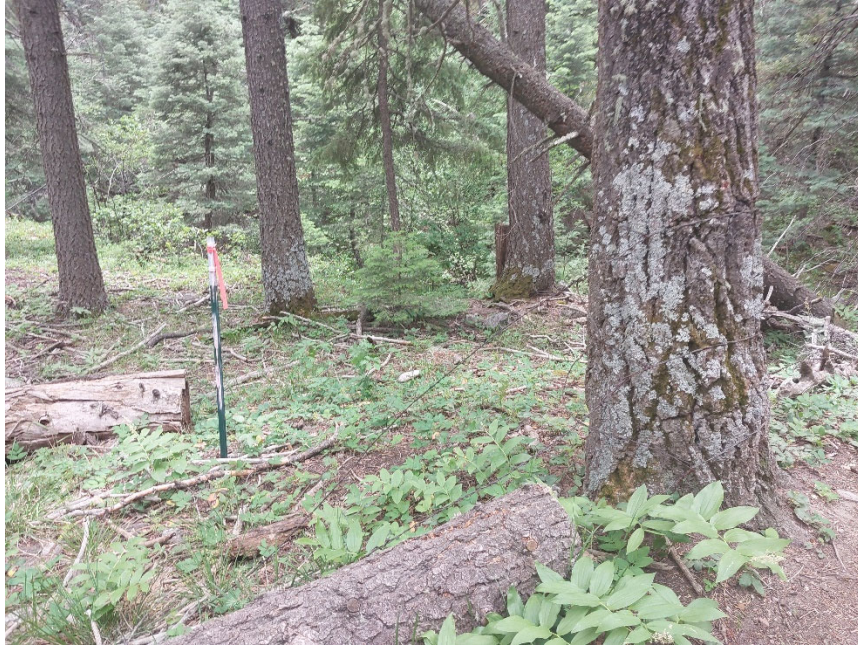
Three boundary markers marked with orange tape were observed on site, two at the west end of the staging area and one on the southwest corner of the rock picking area, no other boundary markers were observed. See the map at the end of this report for reference. This is cited as a problem at the beginning of this report. See the citation for more information about the required corrective action.

Photo #15: A permit boundary marker with orange tape located on the southwest end of the rock picking portion of the permit boundary.

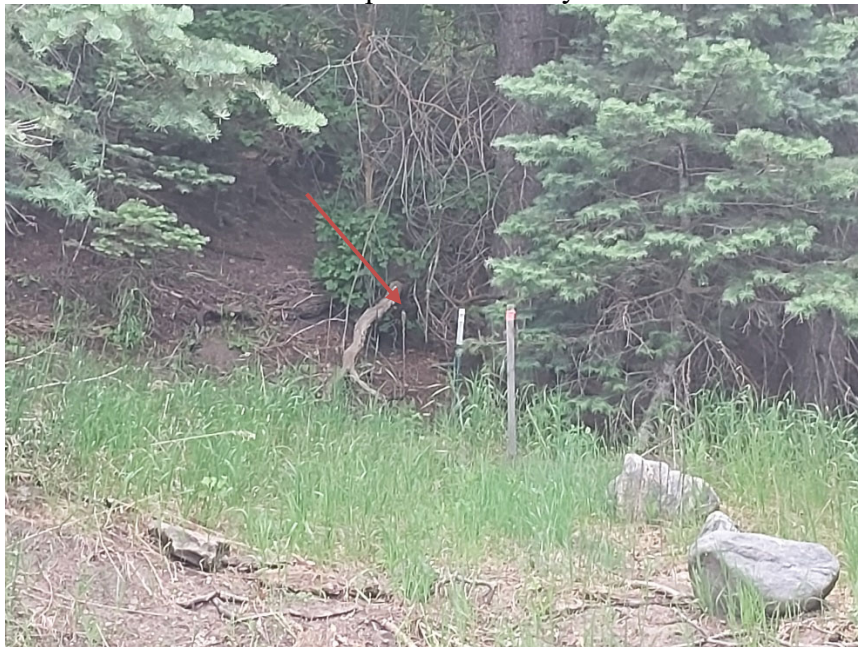
Photo #16: A permit boundary marker with orange tape located on the southwest end of the staging portion of the permit boundary.

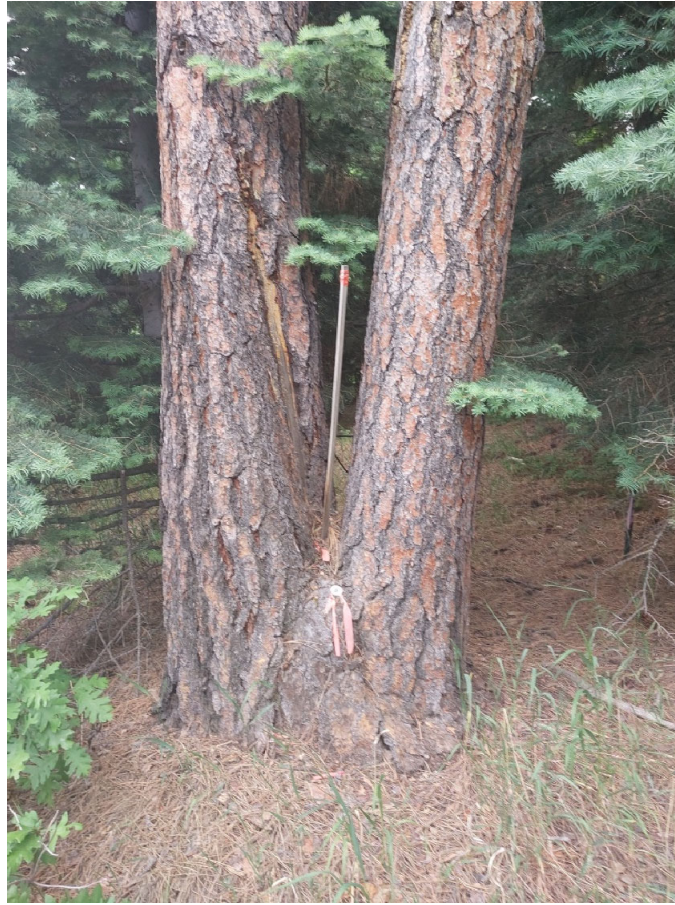
Photo #17: A permit boundary marker with orange tape located on the southwest end of the staging portion of the permit boundary.

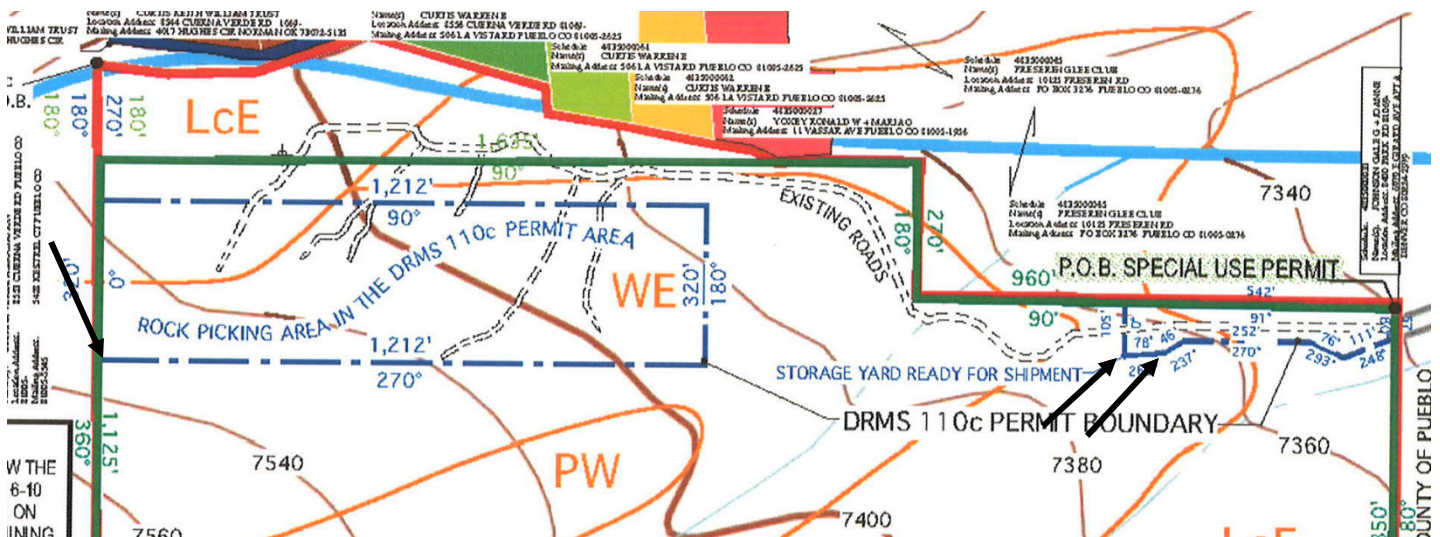
PROBLEM: The affected area boundary markers are missing or incorrectly placed. This is a problem for failure to maintain boundary markers around the affected area as required by Section 3.1.12(2) of the rule. Three permit boundary markers were observed, see the map at the end of this inspection report for the three that were located and verified, the remaining boundary markers were missing.

Reference Map: Permit boundary is shown in blue dashed line, permit boundary markers observed are where the black arrows are pointing to.

CORRECTIVE ACTIONS: The operator shall conduct a survey and replace the boundary markers in the correct location(s). The operator shall provide proof to the Division that this has been done along with GPS coordinates of the markers by the corrective action date.
