New Horizon Mine, C-1981-008, June Partial Inspection Report

PERMIT INFORMATION

Inspection Start Date: June 20, 2024 Inspection Start Time: 12:10 Inspection End Date: June 20, 2024 Inspection End Time: 13:30		Inspection Type: Coal Partial Inspection Inspection Reason: Normal I&E Program Weather: Cloudy	
Joint Inspection Agency: None		Joint Inspection Contacts: None	
Post Inspection Agency: None		Post Inspection Contacts: None	
Inspector(s): Clayton Wein	Inspector's Signature: <i>Clayton Wein</i>		Signature Date: 7/2/2024

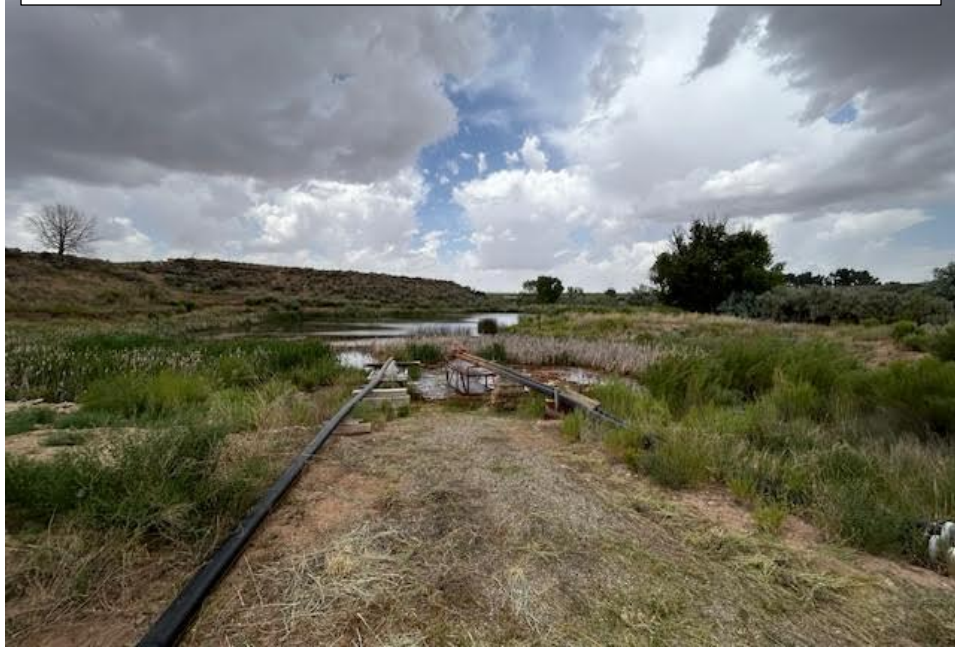
Pond 013 was receiving water from both of its inlet pipes (Photo 1). The amount of water impounded in the pond reached the primary discharge pipe and discharge was occurring. The embankment for the pond was stable and vegetated. There were no erosional concerns identified. The outlet for the pond was clear of obstructions.

Photo 1: Pond 013 Inlet looking to the west.

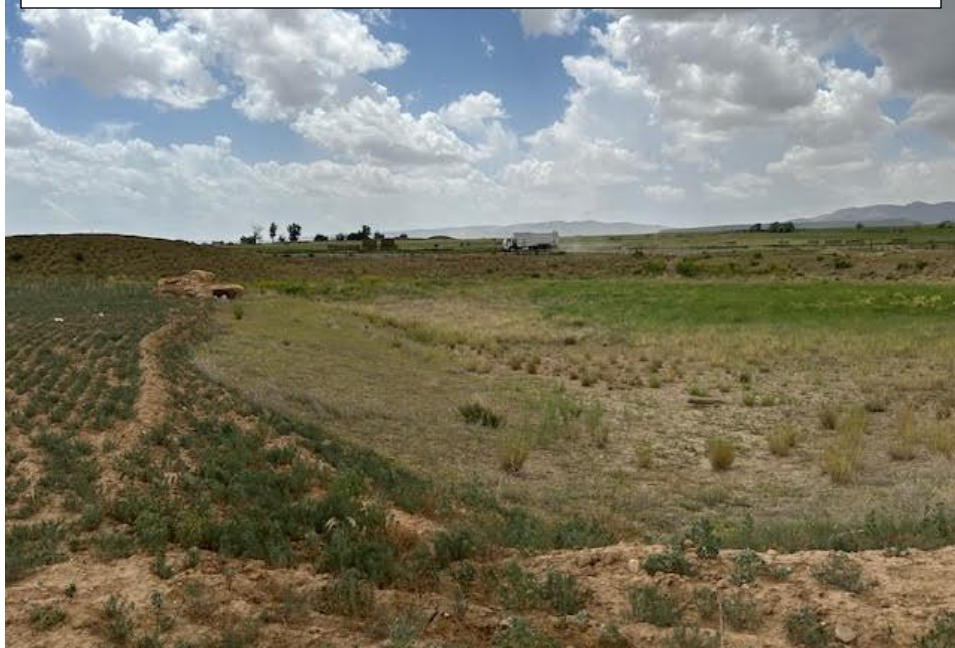
Pond 016 was dry during the inspection (Photo 2). The embankment for the pond was vegetated and stable. No erosional features were observed. The outlet for the pond was clear of debris.

Photo 2: The eastern portion of Pond 016.

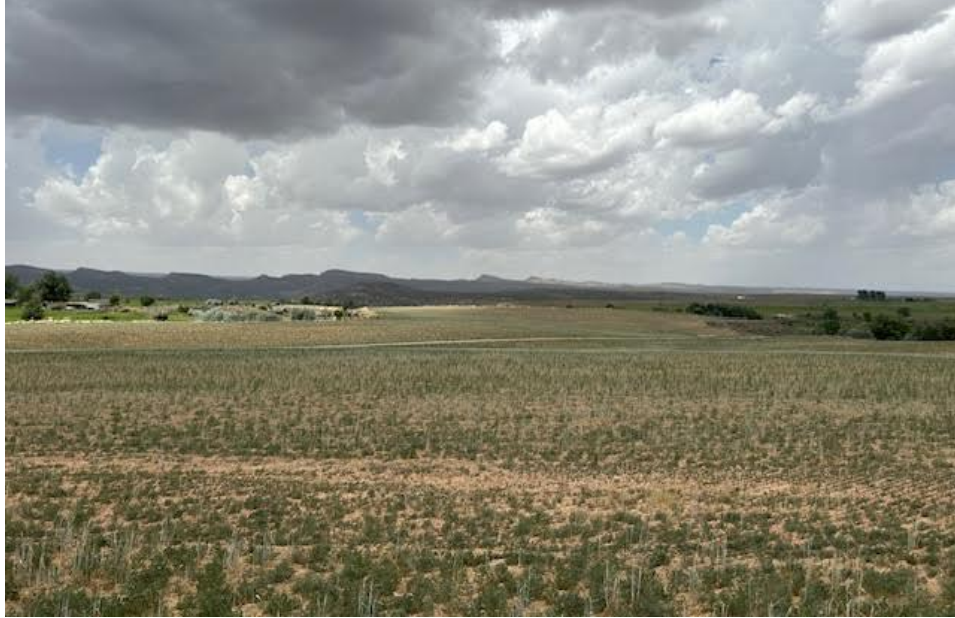
The Primary focus of this inspection was to check the relatively new reclamation located within Section 36. Parcels DP-18, DP-20 (Photo 3 and 4), DP-21 (Photo 3), PF-1 (Photo 5) and IP-12 were backfilled, topsoiled, graded and seeded in late 2023. DP-21 is located on the west side of the Johnson Access Road. Vegetation was beginning to grow in well for the first season. There were minimal areas observed with sparse vegetation. DP-21 was stable and there were no indications of erosional features. DP-20 is located on the east side of the Johnson Access Road. The reclamation was observed to be stable with vegetative cover. No indications of erosional features were observed. Vegetative growth was doing well for the first season. DP-18 is located to the northeast of DP-20. The reclamation had no indications of instability or erosion. The parcel was covered with new vegetative growth. PF-1 is located on the east side of DP-20. The prime farmland parcel was stable with vegetative cover. There were no erosional features. Vegetation on the parcel was growing well for its first season. IP-12 is located on the east side of PF-1. The irrigated pasture had no indications of erosion or instability. The first season of vegetation was starting out well.

Photo 3: DP-20 is in the foreground of the photo and DP-21 is in the distance towards the middle of the Photo.

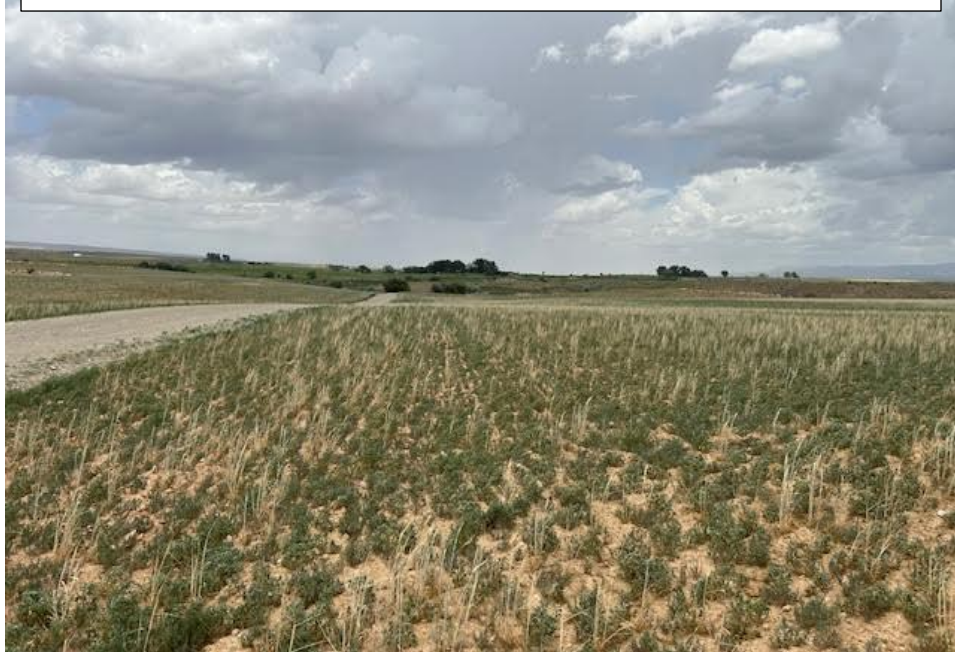
Photo 4: The southern portion of DP-20.

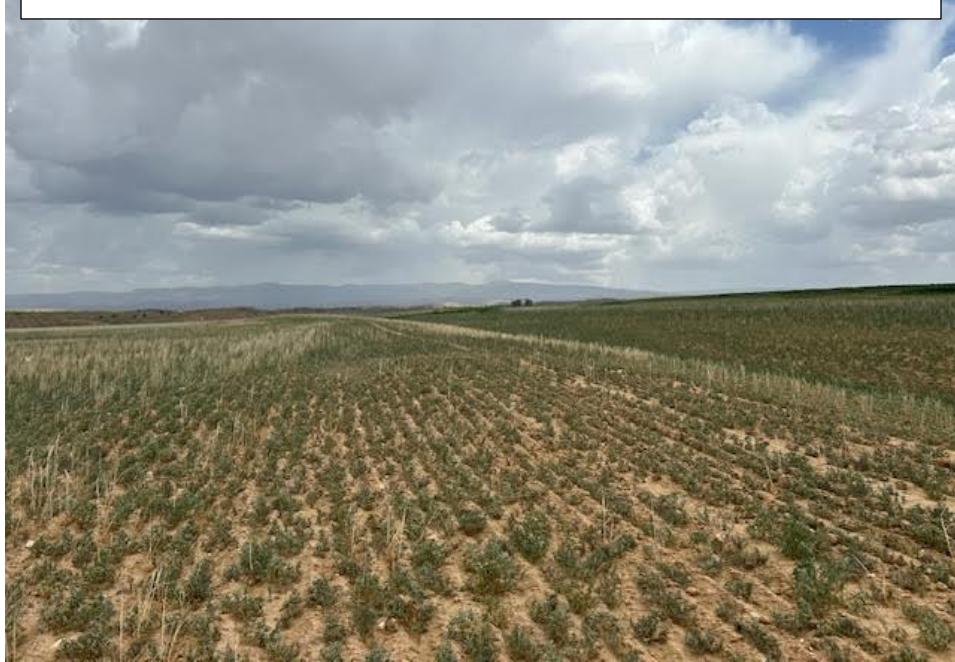
Photo 5: PF-1's western portion meeting the boundary of DP-20.

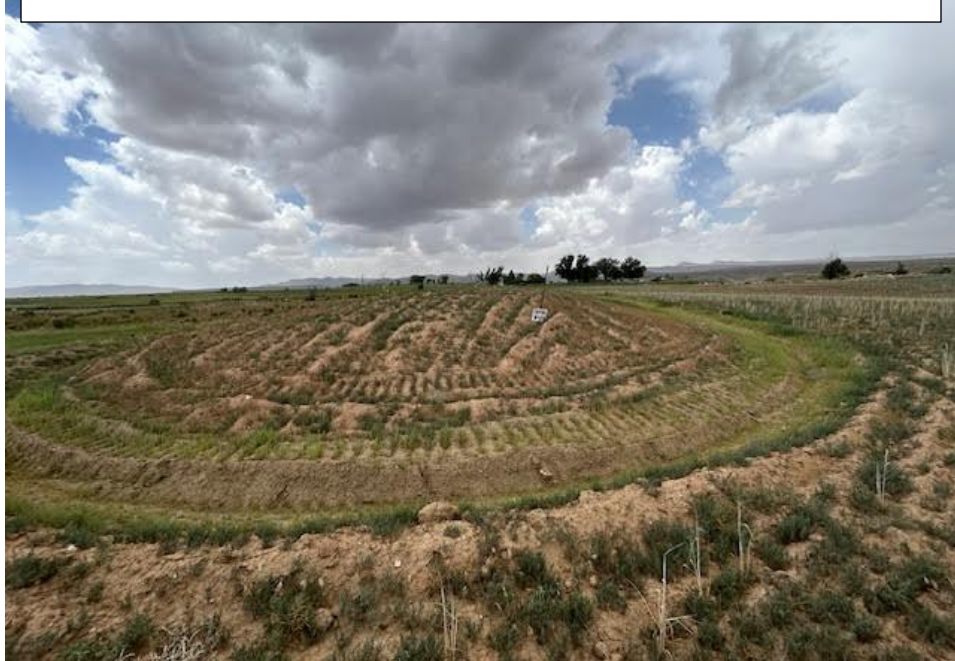
Topsoil Pile 16 was also visited. The pile was stable with vegetative cover (Photo 6). There were no erosional features observed. The perimeter ditch was dry and stable. The ditch had no debris in it. There was no loss of topsoil resource observed.

Photo 6: Topsoil Stockpile 16.
