MINERALS PROGRAM INSPECTION REPORT
PHONE: (303) 866-3567

MINE NAME: Gleason Pit	MINE/PROSPECTING ID#: M-1983-159	MINERAL: Sand and gravel	COUNTY: Montrose
INSPECTION TYPE: Monitoring	WEATHER: Clear	INSP. DATE: July 2, 2024	INSP. TIME: 10:30
OPERATOR: Glacier Ridge Aggregates Corp.	OPERATOR REPRESENTATIVE: Michael Kimball	TYPE OF OPERATION: 112c - Construction Regular Operation	
REASON FOR INSPECTION: Normal I&E Program	BOND CALCULATION TYPE: Complete Bond	BOND AMOUNT: \$30,975.00	
DATE OF COMPLAINT: NA	POST INSP. CONTACTS: None	JOINT INSP. AGENCY: None	
INSPECTOR(S): Dustin Czapla	INSPECTOR'S SIGNATURE:

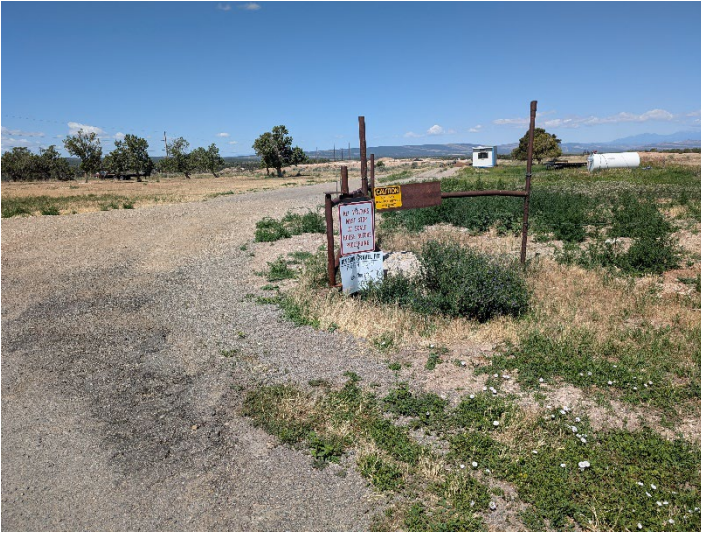
Adequate mine identification signage was noted at the entrance to the site.

Mine ID at site entrance

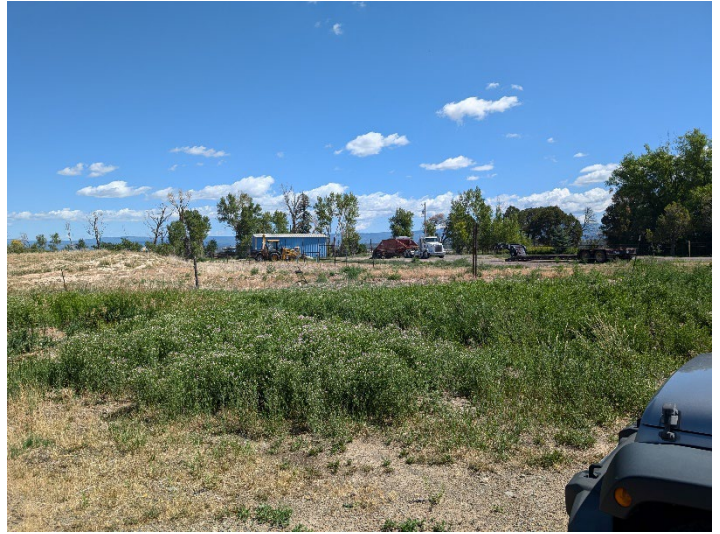
The scale and scalehouse are still located at the entrance to the site. A knapweed infestation is beginning in this area and the operator was informed that these noxious weeds would need to be treated. Much of the junk that was stored on the south side of the scalehouse has been removed.

Knapweed near scalehouse

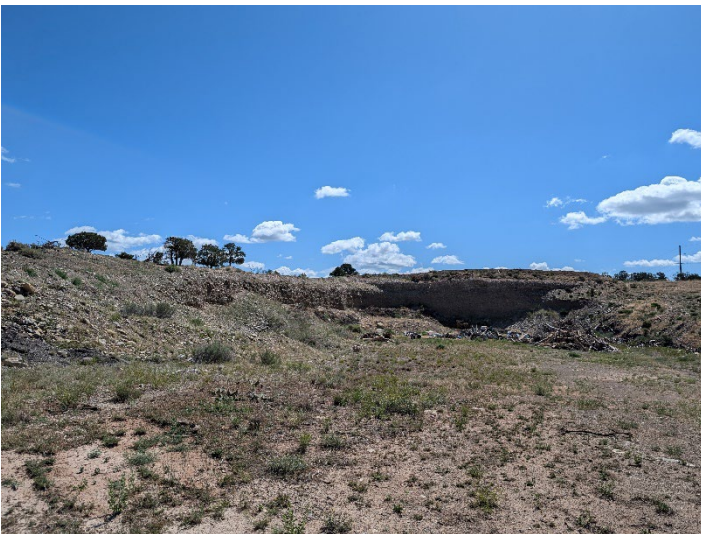
The existing highwalls were left at random grades, from near vertical to 3H:1V. A near vertical highwall exists on the south side of the access road in the east side of the pit. Highwalls around the power poles are approximately 0.5H:1V. The operator is currently extracting from the 0.5H:1V slope area in the central part of the north pit wall and the slope is being reduced in the process. The west and north slopes are graded from 2H:1V to 3H:1V.

HW on south side of access road, east end of pit

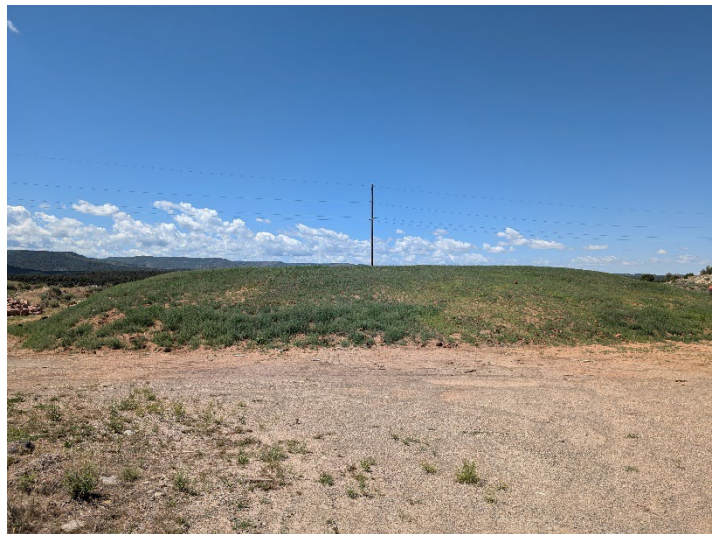
Topsoil stockpile southeast side of pit floor

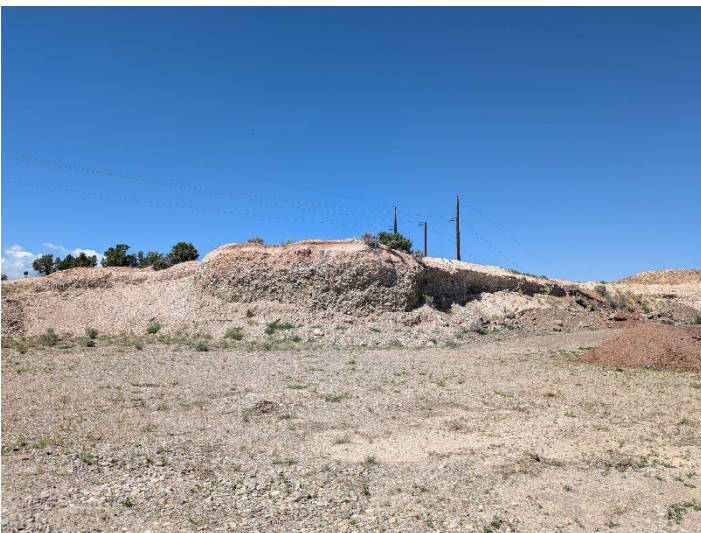
Highwall around power poles SW end of pit

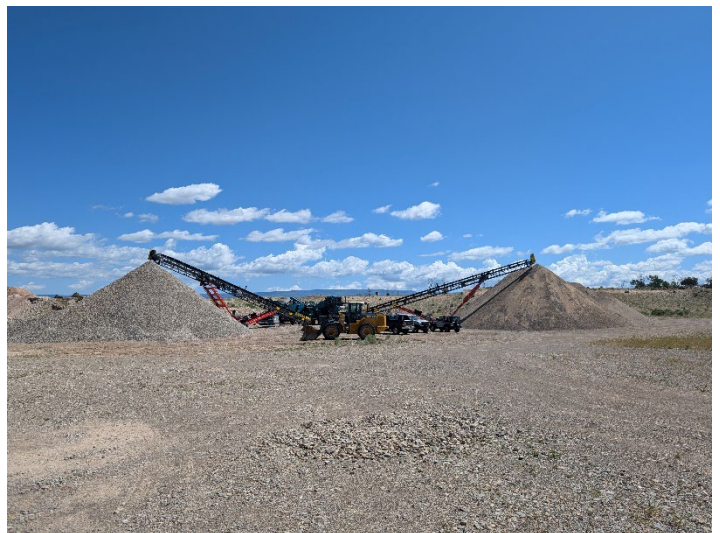
This permit was transferred to Glacier Ridge Aggregates Corp. on May 2, 2024. Mining has resumed at the site. A crusher has been placed on site and excavation was occurring on the north side of the pit.

Crushing/stockpile area north/central part of pit

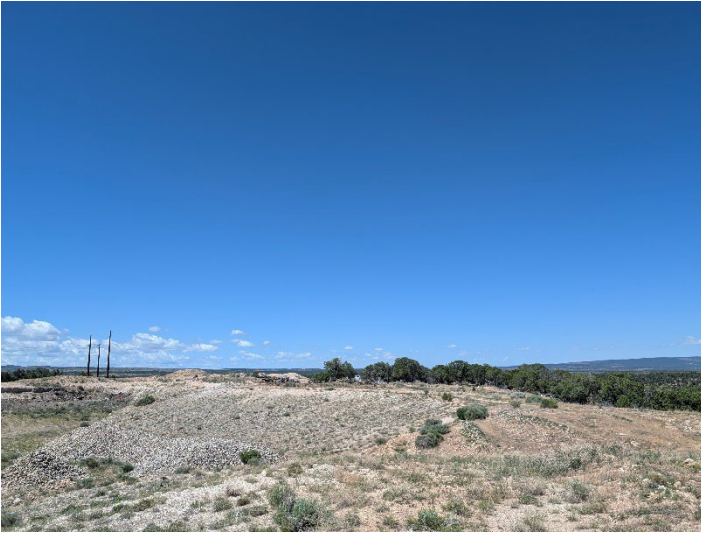
3:1 slope NW end of pit

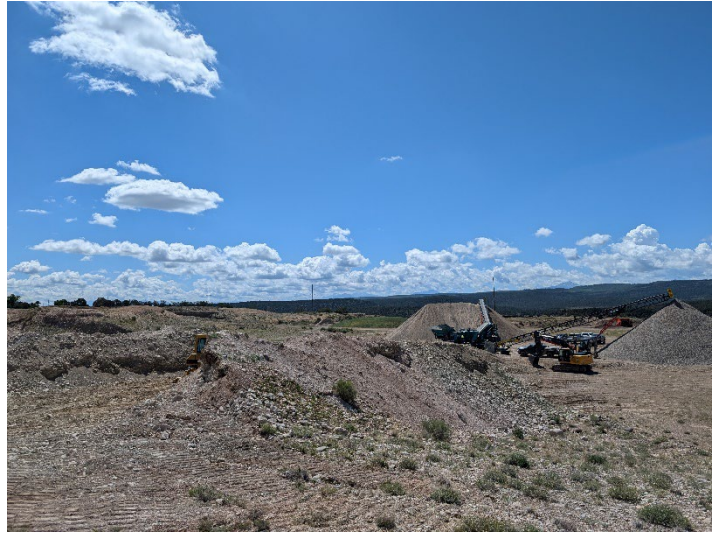
Mining area north/central part of pit

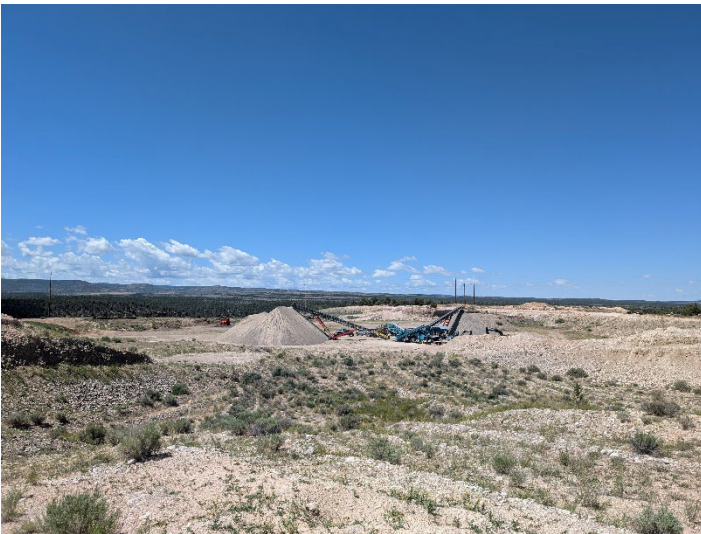
Looking down 3:1 slope east side of mining area

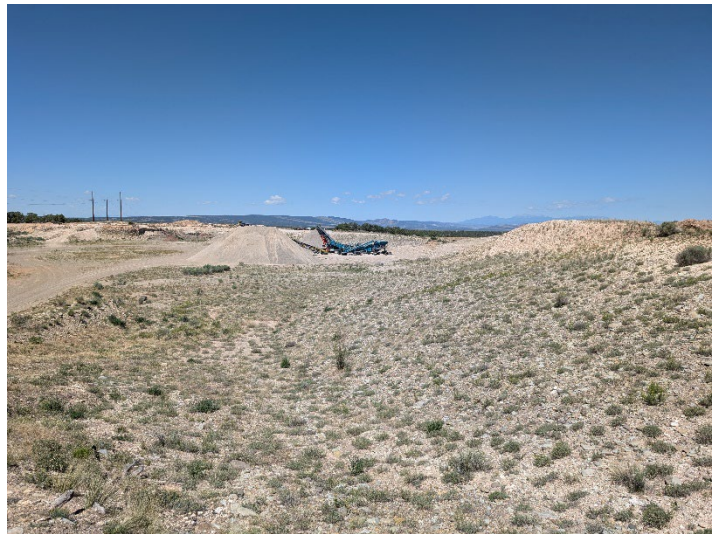
3:1 slope north side of access road
