MINERALS PROGRAM INSPECTION REPORT
PHONE: (303) 866-3567

MINE NAME: Wedding Bell Project (Groundhog Area)	MINE/PROSPECTING ID#: P-2021-008	MINERAL: Vanadium and uranium	COUNTY: San Miguel
INSPECTION TYPE: Monitoring	WEATHER: Clear	INSP. DATE: June 5, 2024	INSP. TIME: 12:23
OPERATOR: Standard Minerals Inc.	OPERATOR REPRESENTATIVE: Tony Adkins	TYPE OF OPERATION: MP - Mineral Prospecting	
REASON FOR INSPECTION: Normal I&E Program	BOND CALCULATION TYPE:	BOND AMOUNT: \$2,000.00	
DATE OF COMPLAINT: NA	POST INSP. CONTACTS: None	JOINT INSP. AGENCY: U.S.BLM	
INSPECTOR(S): Lucas West	INSPECTOR'S SIGNATURE:

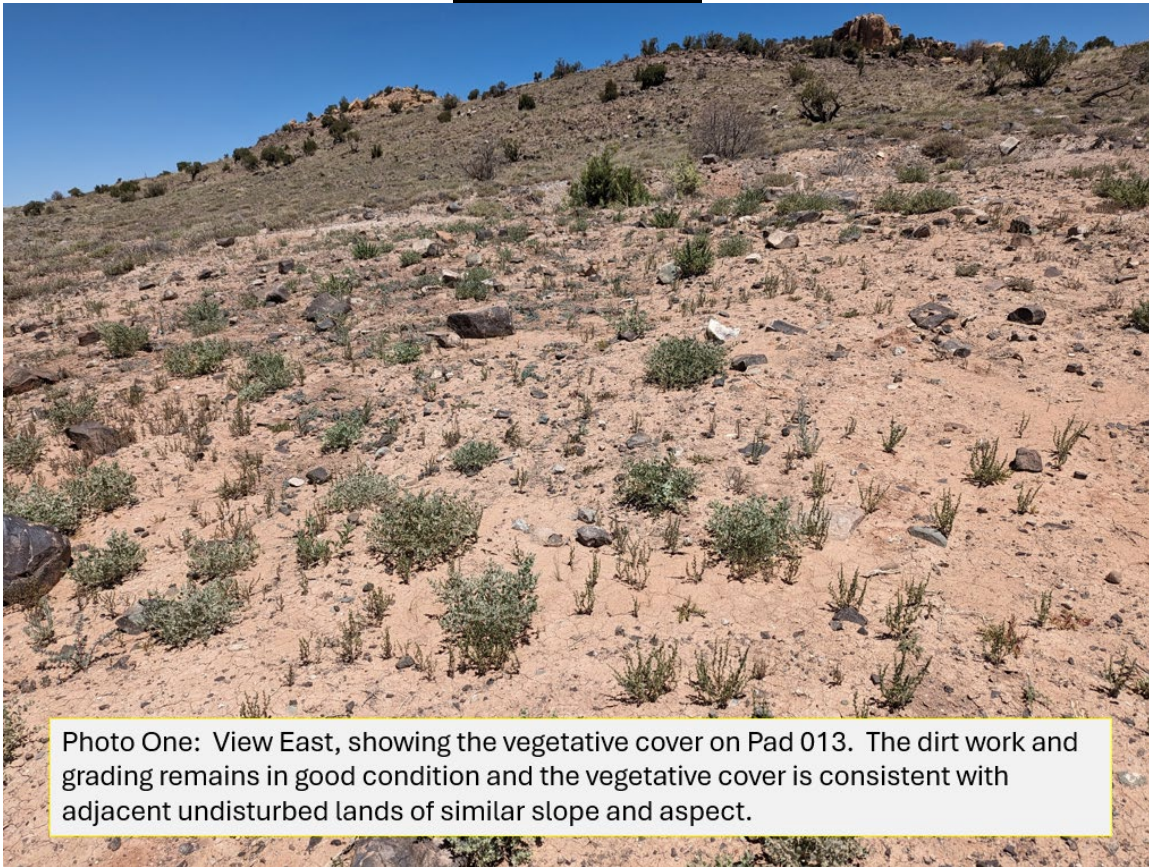
During the inspection the access road and both pads were observed. The access road and Pad 012/012a were still in excellent condition and no issues were noted. The main focus of this inspection centered on the vegetative cover on Pad 013. Pad 13, seen in Photos One and Two, still exhibits positive drainage and no erosion was noted. The vegetative cover has made significant improvement since the Division's previous inspection. The vegetation is a little sparse, however given the surrounding area, aspect and available growth media, the vegetative cover is considered acceptable. During the inspection, the BLM representative agreed that the reclamation efforts are now considered acceptable.

Photo One: View East, showing the vegetative cover on Pad 013. The dirt work and grading remains in good condition and the vegetative cover is consistent with adjacent undisturbed lands of similar slope and aspect.

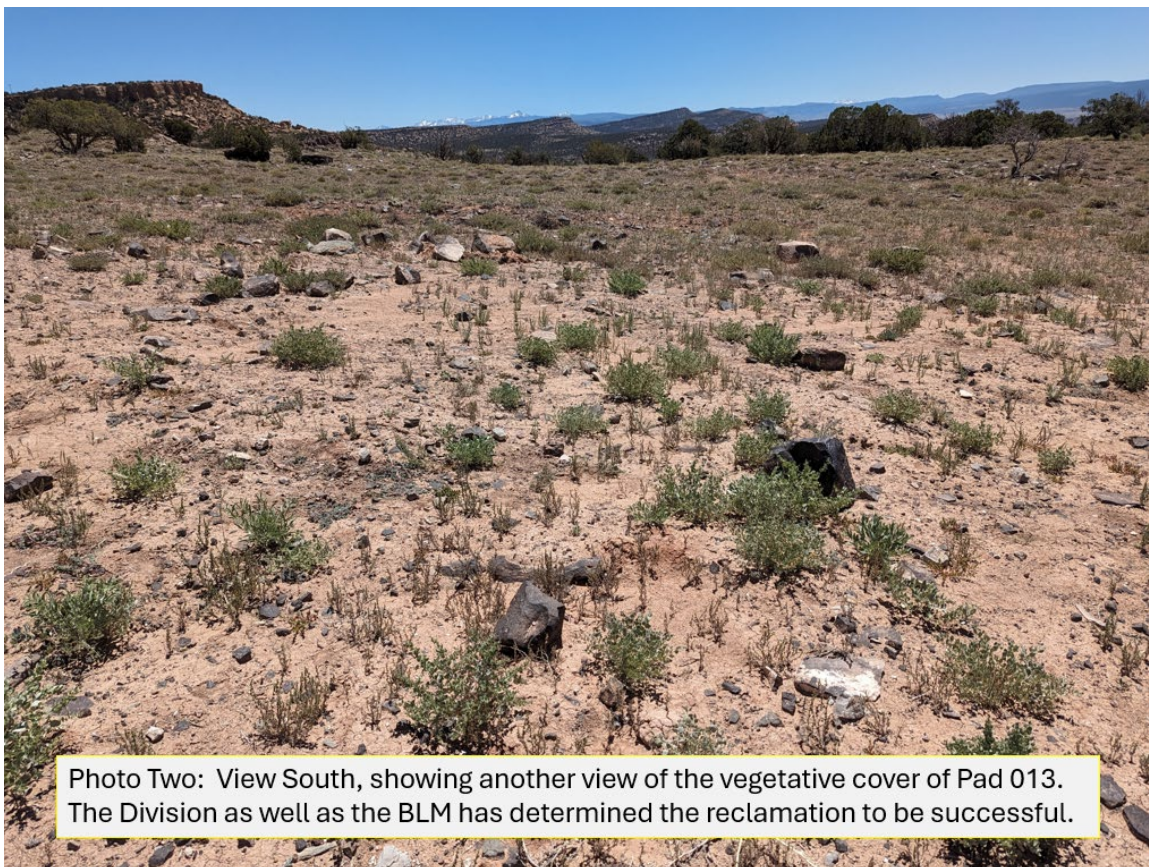
Photo Two: View South, showing another view of the vegetative cover of Pad 013. The Division as well as the BLM has determined the reclamation to be successful.
