MINERALS PROGRAM INSPECTION REPORT
PHONE: (303) 866-3567

MINE NAME: Wedding Bell Project (Section 23 Area)	MINE/PROSPECTING ID#: P-2021-009	MINERAL: Uranium and vanadium	COUNTY: San Miguel
INSPECTION TYPE: Monitoring	WEATHER: Clear	INSP. DATE: June 5, 2024	INSP. TIME: 10:30
OPERATOR: Standard Minerals Inc.	OPERATOR REPRESENTATIVE: Tony Adkins	TYPE OF OPERATION: MP - Mineral Prospecting	
REASON FOR INSPECTION: Normal I&E Program	BOND CALCULATION TYPE:	BOND AMOUNT: \$2,000.00	
DATE OF COMPLAINT: NA	POST INSP. CONTACTS: None	JOINT INSP. AGENCY: U.S.BLM	
INSPECTOR(S): Lucas West	INSPECTOR'S SIGNATURE:

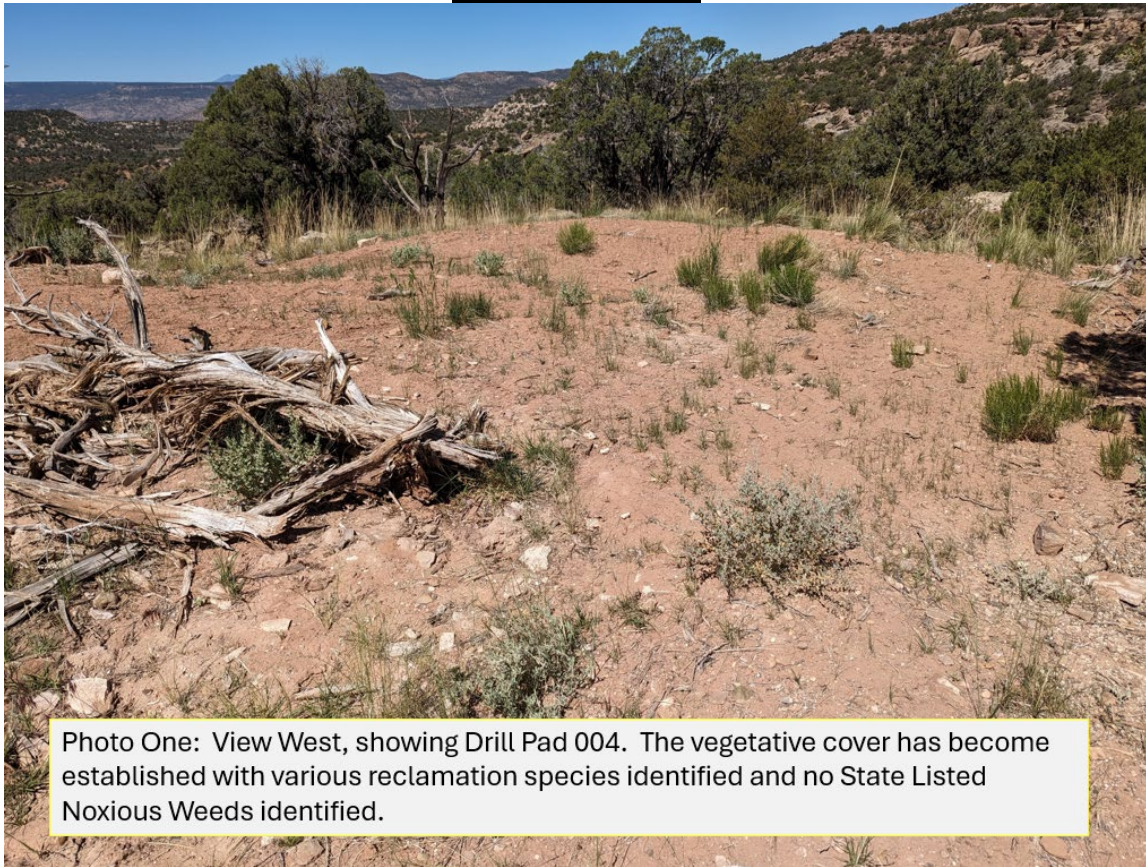
Photo One: View West, showing Drill Pad 004. The vegetative cover has become established with various reclamation species identified and no State Listed Noxious Weeds identified.

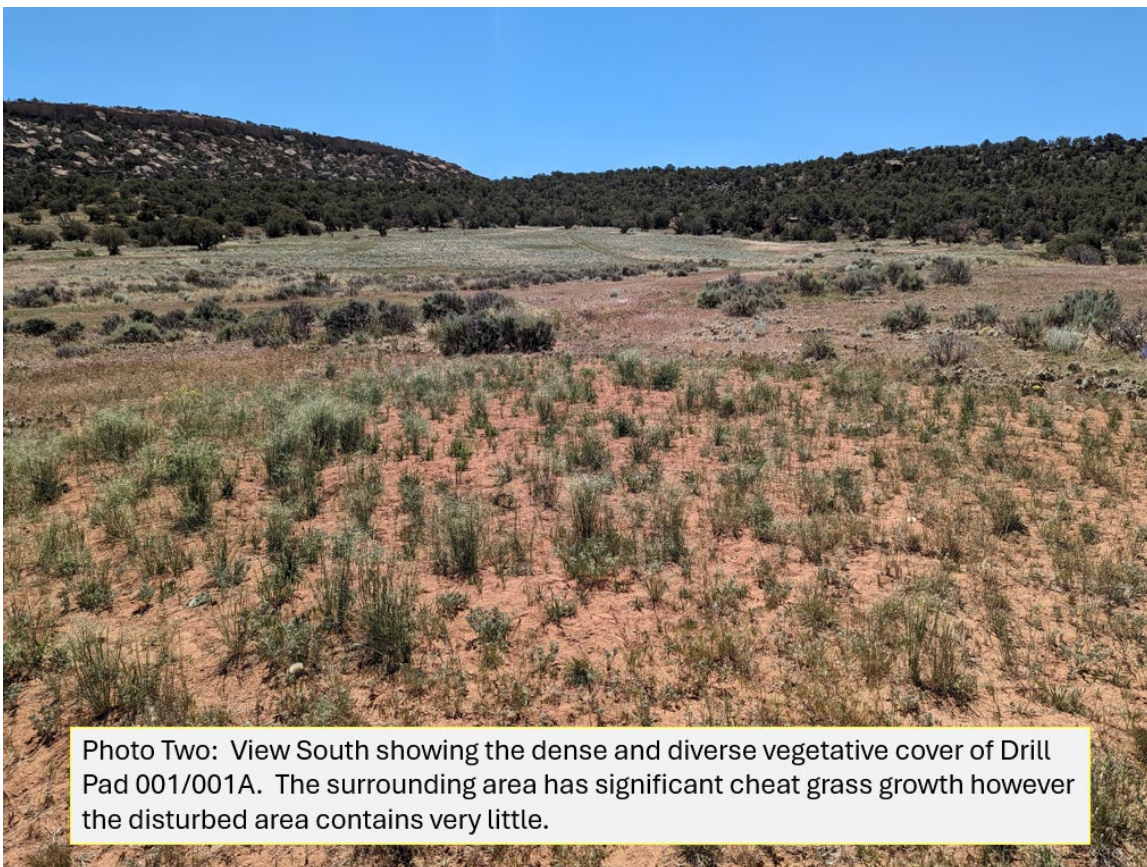
Photo Two: View South showing the dense and diverse vegetative cover of Drill Pad 001/001A. The surrounding area has significant cheat grass growth however the disturbed area contains very little.
