MINERALS PROGRAM INSPECTION REPORT
PHONE: (303) 866-3567

MINE NAME: Wedding Bell Project (Rim Rock Area)	MINE/PROSPECTING ID#: P-2021-010	MINERAL: Unknown commodity	COUNTY: Montrose
INSPECTION TYPE: Monitoring	WEATHER: Clear	INSP. DATE: June 5, 2024	INSP. TIME: 12:47
OPERATOR: Standard Minerals Inc.	OPERATOR REPRESENTATIVE: Tony Adkins	TYPE OF OPERATION: MP - Mineral Prospecting	
REASON FOR INSPECTION: Normal I&E Program	BOND CALCULATION TYPE:	BOND AMOUNT: \$2,000.00	
DATE OF COMPLAINT: NA	POST INSP. CONTACTS: None	JOINT INSP. AGENCY: U.S.BLM	
INSPECTOR(S): Lucas West	INSPECTOR'S SIGNATURE:

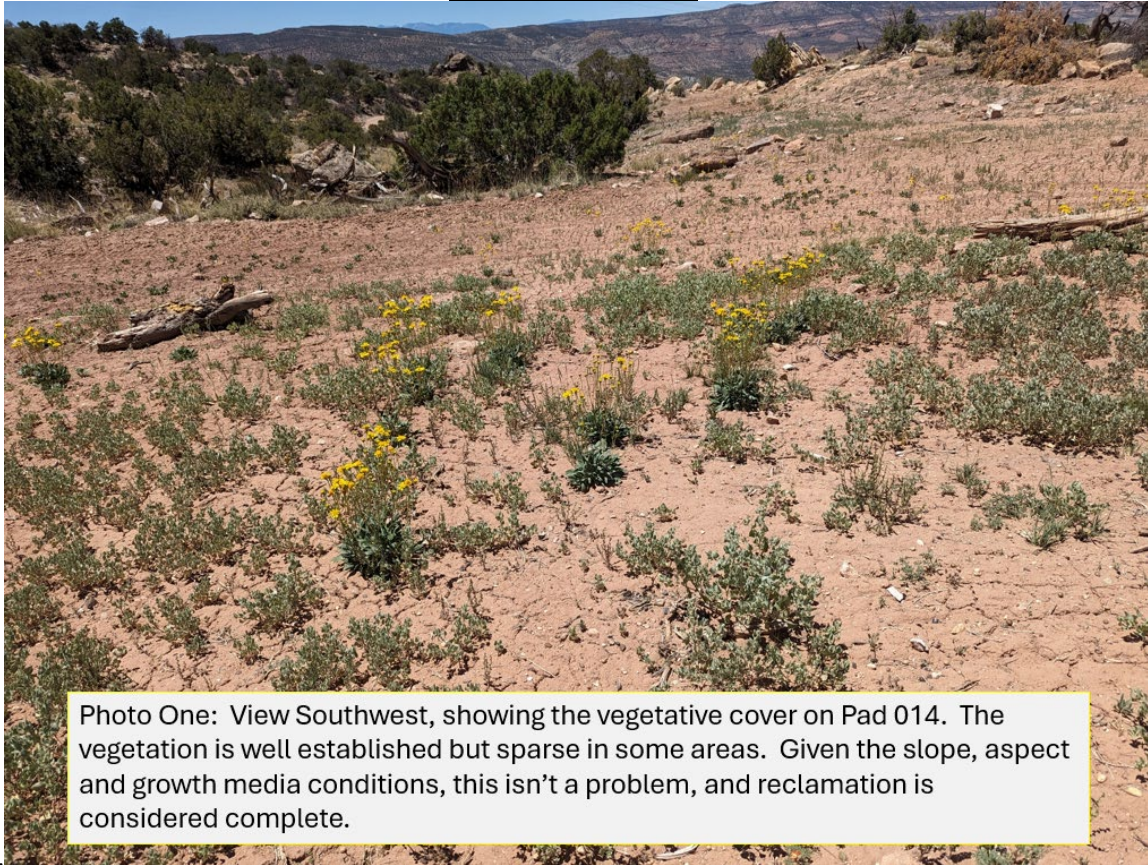
Both pads required reinspection for vegetation success. Pad 14 was observed and can be seen in Photo One. The grading and earth work has held well, and no evidence of settling, slumping or erosion was noted. The vegetation is more well established and reclamation species were identified. Although sparse, given the areas slope, aspect and availability of growth media, the existing vegetative cover is considered sufficient for reclamation. On site discussions with the BLM agreed, that Pad 14 is considered acceptable. Pad 15 was also observed and can be seen in Photo Two. The pad shows no signs of settling, slumping or erosion however the vegetation is severely lacking. This area is suffering from a widespread infestation of Halogeton, that dominated the disturbed ground. Halogeton is a List C noxious weed and does not require eradication, however the overwhelming presence of the species is hindering the reclamation species. Few reclamation species were identified during the inspection. Discussions with the Operator indicate that all manner of weed control efforts have been employed, and at this point consultation with a weed management company may be required.

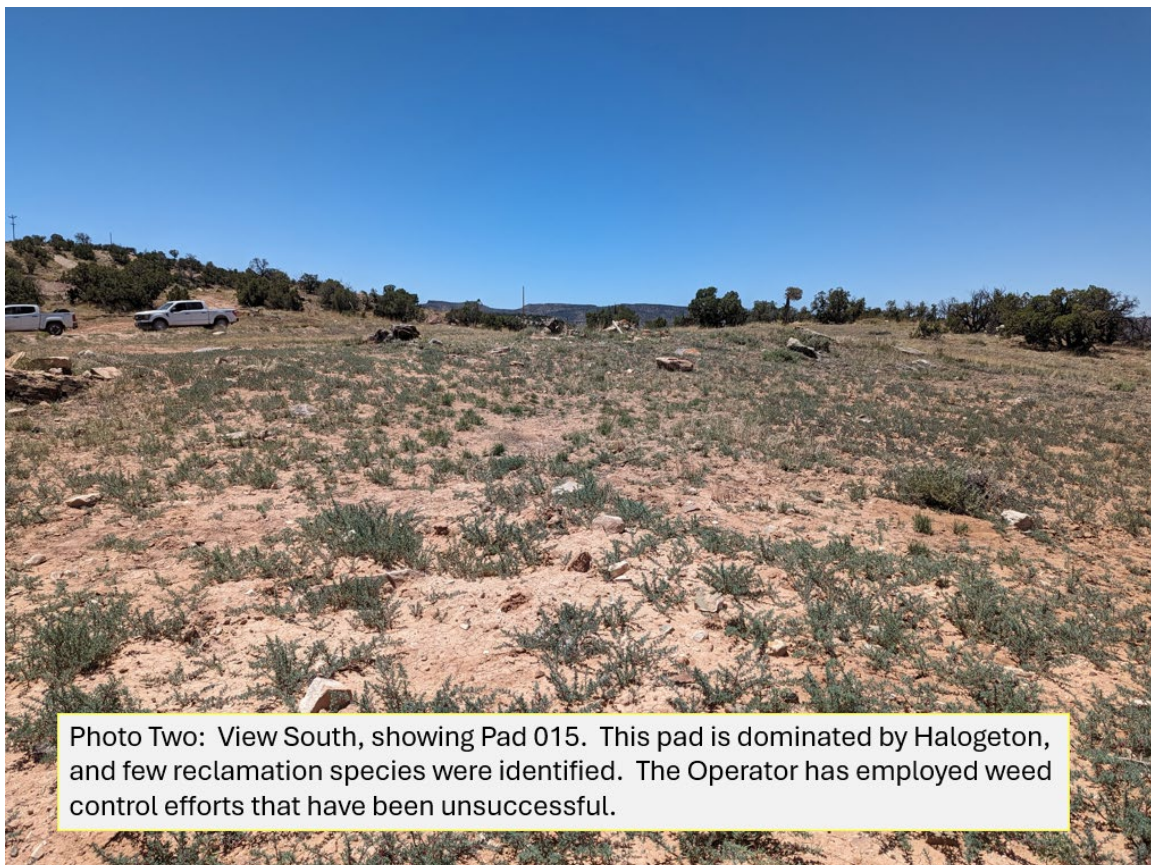
Based on the observations made during the inspection, the Division has determined that only the reclamation of Pad 15 remains to be achieved. All other disturbances are considered reclaimed. The Division will adjust the records in the process of reviewing the recently submitted NOI Modification to expand the drilling program.
