MINERALS PROGRAM INSPECTION REPORT
PHONE: (303) 866-3567

MINE NAME: Harley Pit #2	MINE/PROSPECTING ID#: M-1986-147	MINERAL: Sand, gravel and borrow material	COUNTY: Logan
INSPECTION TYPE: Monitoring	WEATHER: Clear	INSP. DATE: February 13, 2024	INSP. TIME: 11:00
OPERATOR: McAtee Construction Company	OPERATOR REPRESENTATIVE: Jeff Harms	TYPE OF OPERATION: 112c - Construction Regular Operation	
REASON FOR INSPECTION: Normal I&E Program	BOND CALCULATION TYPE: Complete Bond	BOND AMOUNT: \$117,150.00	
DATE OF COMPLAINT: NA	POST INSP. CONTACTS: None	JOINT INSP. AGENCY: None	
INSPECTOR(S): Nikie Gagnon	INSPECTOR'S SIGNATURE:

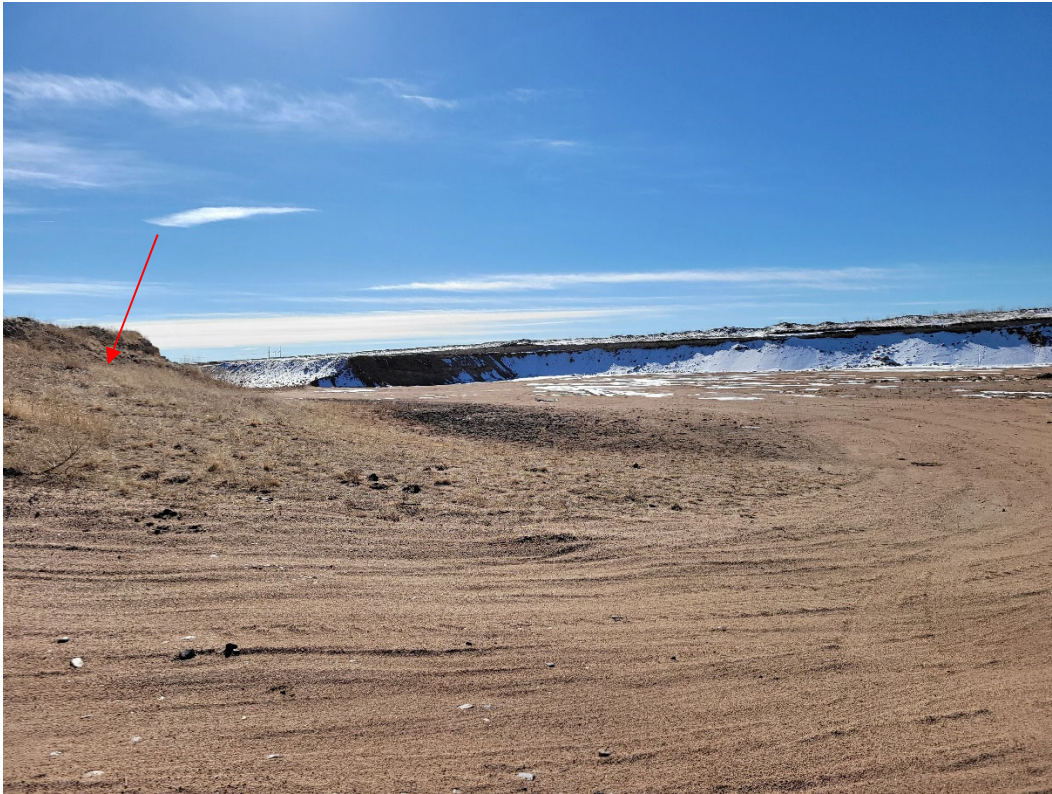
Photo 1: Looking southeast across the pit floor. A vertical highwall runs along the south side of the pit. Vegetated topsoil pile observed noted by arrow.

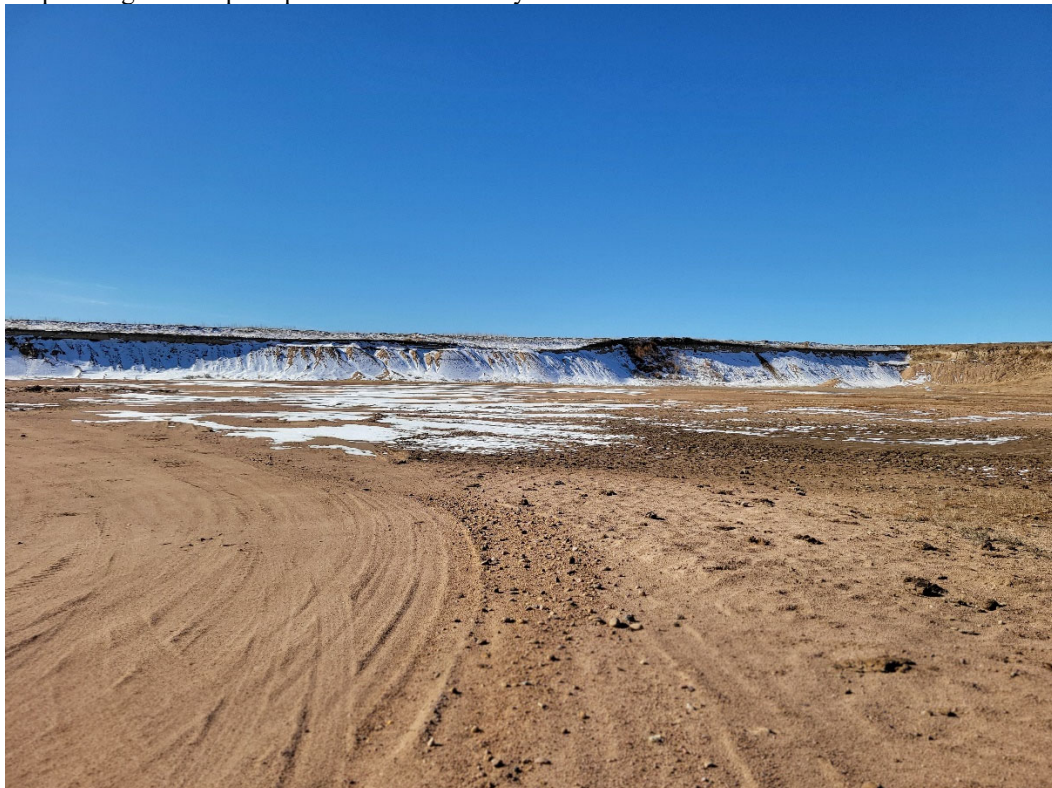
Photo 2: Looking southwest across the pit floor towards the highwall runs along the south side of the pit.

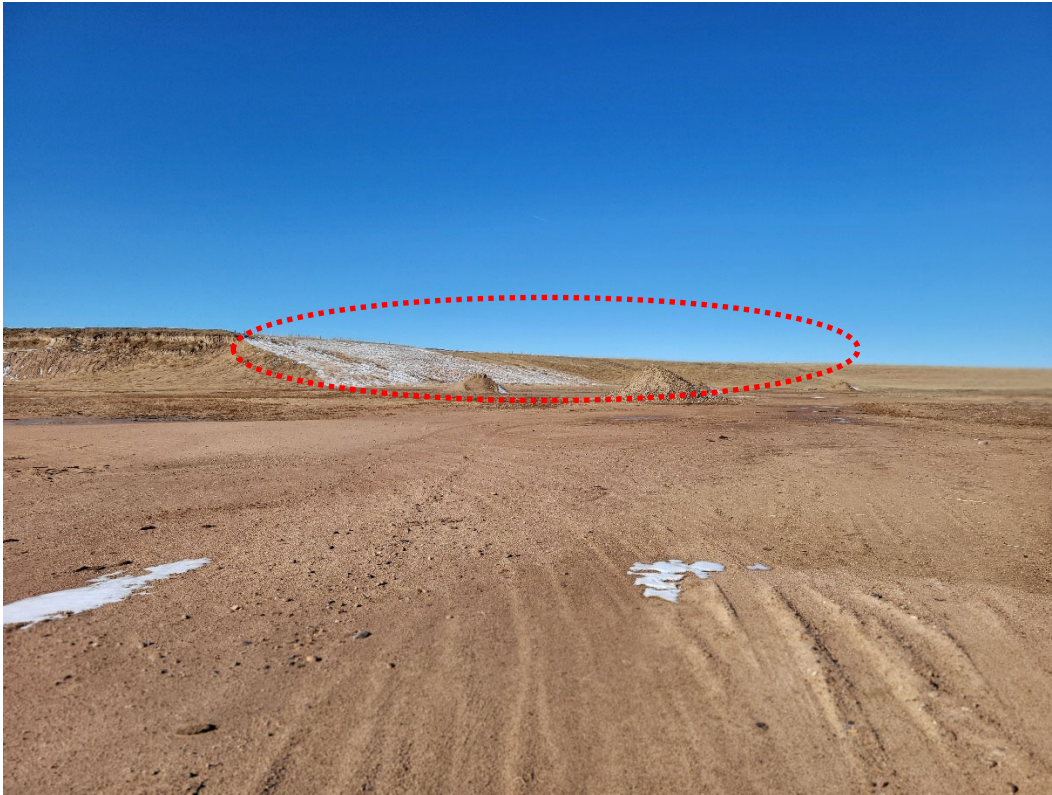
Photo 3: Looking west. Area circled topsoiled and seeded. Stockpiled material stored on the pit floor.

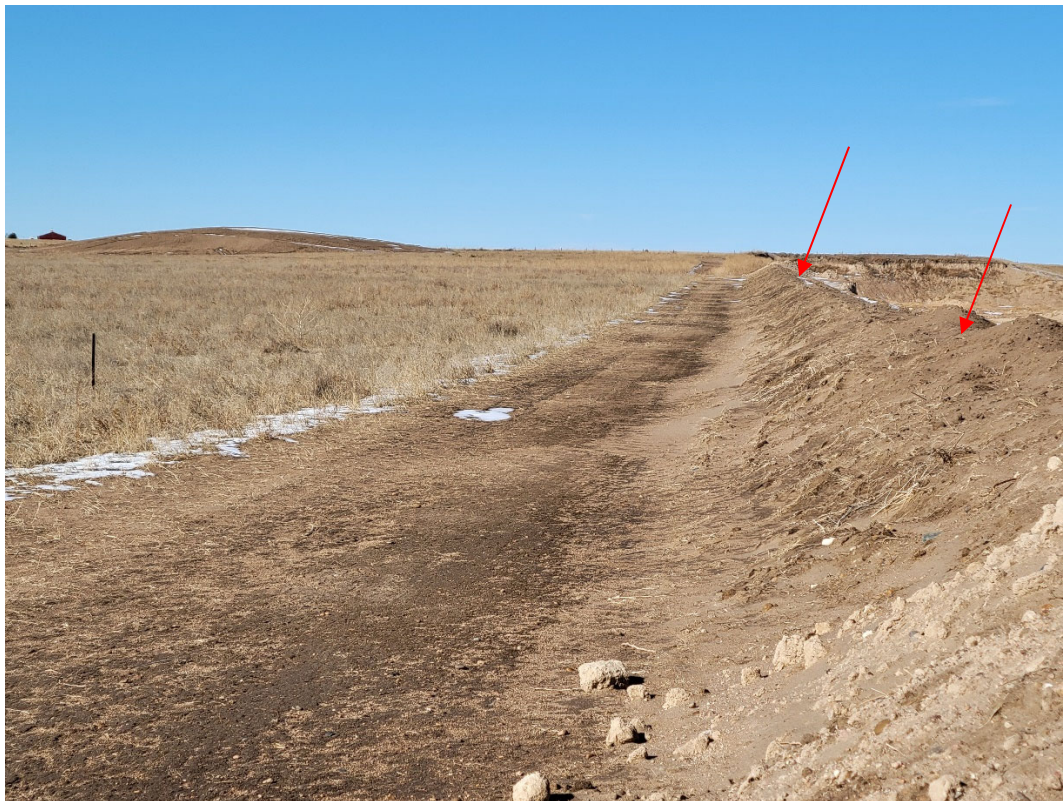
Photo 4: Looking west above the highwall on the south side. Overburden stored in berms (arrows) for future use in reclamation.

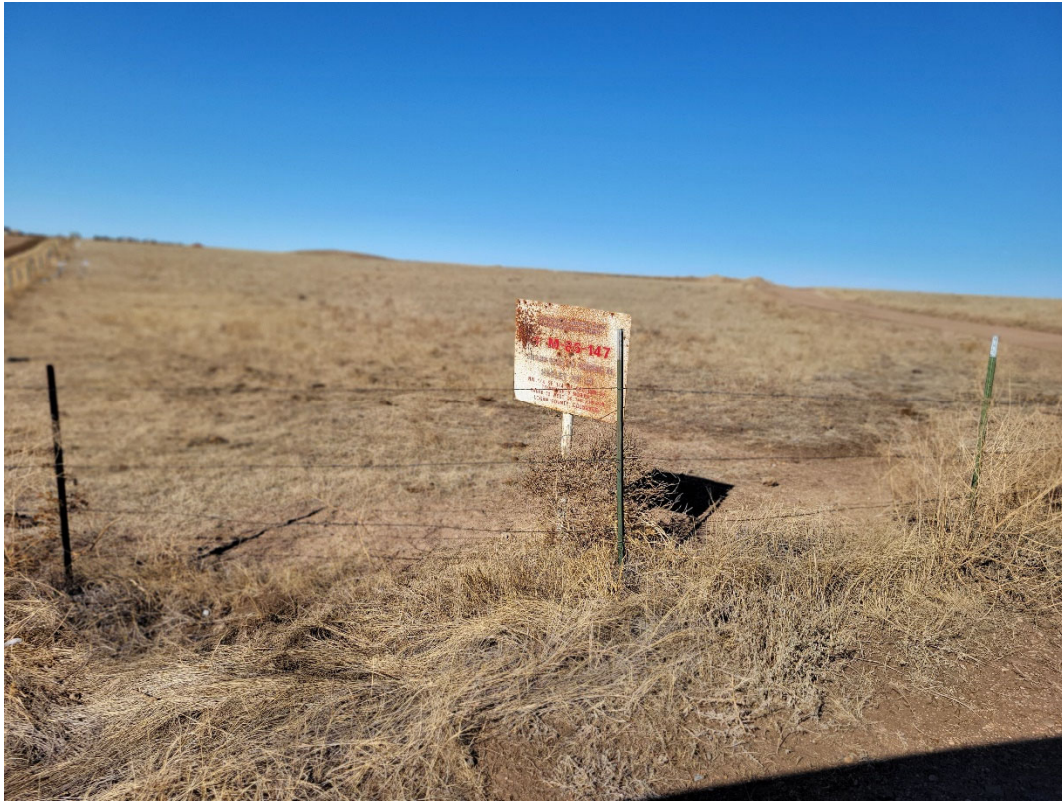
A mine sign is posted at the mine entrance facing CR 40. The permit number and mine name is legible however, the operator should replace or repaint the sign soon to remain in compliance with Construction Materials Rule 3.1.12 (1). The permit boundaries are marked by posts in the corners of the permit boundary and a barbed wire fence runs along the south side.

Photo 5: Mine sign posted at the entrance to the site.
