**MINERALS PROGRAM INSPECTION REPORT**  
**PHONE: (303) 866-3567**

<b>MINE NAME:</b> Sweet Valley Pit	<b>MINE/PROSPECTING ID#:</b> M-2024-015	<b>MINERAL:</b> Sand and gravel	<b>COUNTY:</b> Weld
<b>INSPECTION TYPE:</b> Preoperation Inspection	<b>WEATHER:</b> Cloudy	<b>INSP. DATE:</b> June 27, 2024	<b>INSP. TIME:</b> 08:00
<b>OPERATOR:</b> Central Colorado Water Conservancy District	<b>OPERATOR REPRESENTATIVE:</b> JC York	<b>TYPE OF OPERATION:</b> 112c - Construction Regular Operation	
<b>REASON FOR INSPECTION:</b> Preoperation Inspection	<b>BOND CALCULATION TYPE:</b> None	<b>BOND AMOUNT:</b> n/a	
<b>DATE OF COMPLAINT:</b> NA	<b>POST INSP. CONTACTS:</b> None	<b>JOINT INSP. AGENCY:</b> None	
<b>INSPECTOR(S):</b> Brock Bowles	<b>INSPECTOR'S SIGNATURE:</b>

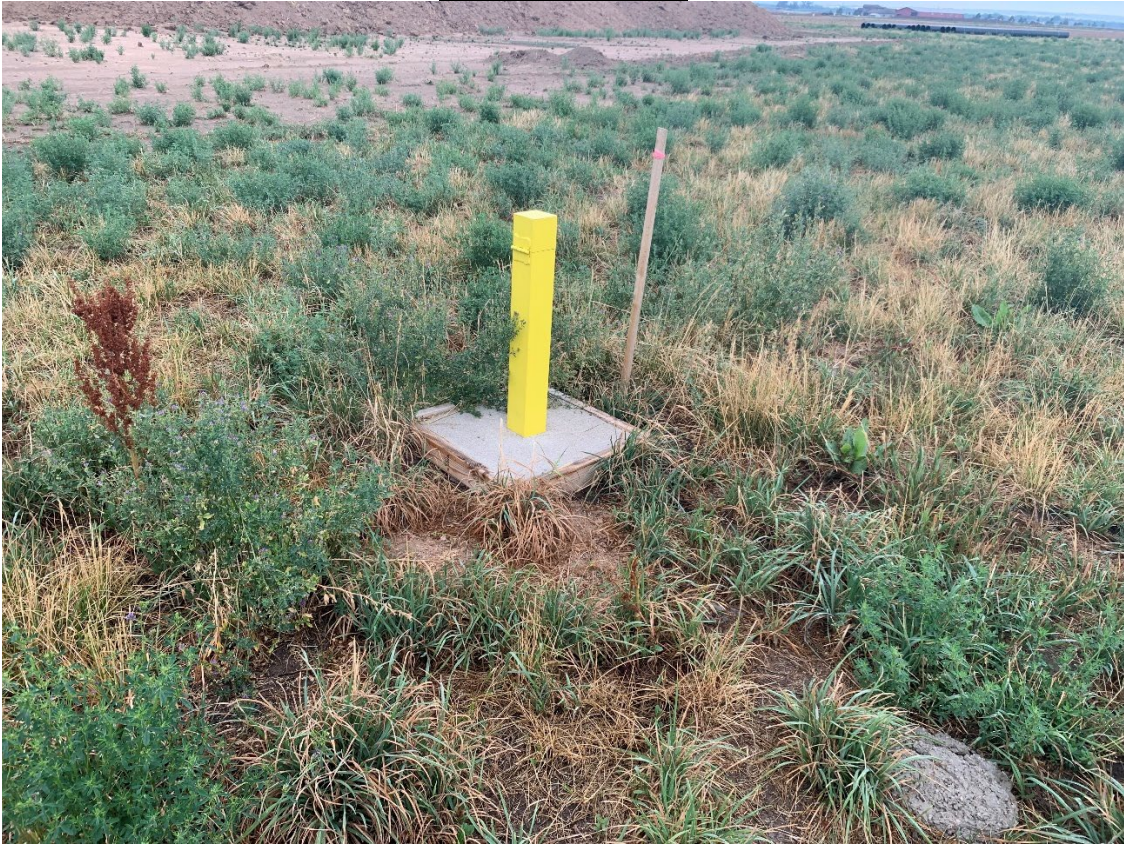
Four monitoring wells had been installed on each corner of the proposed permit boundary. Well MW-1 is in the northwest corner, MW-2 in the northeast, MW-3 (photo 1) in the southeast corner north of the residential buildings and MW-4 in the southwest.

Photo 1 – Monitoring well MW-3 in the southeast corner.

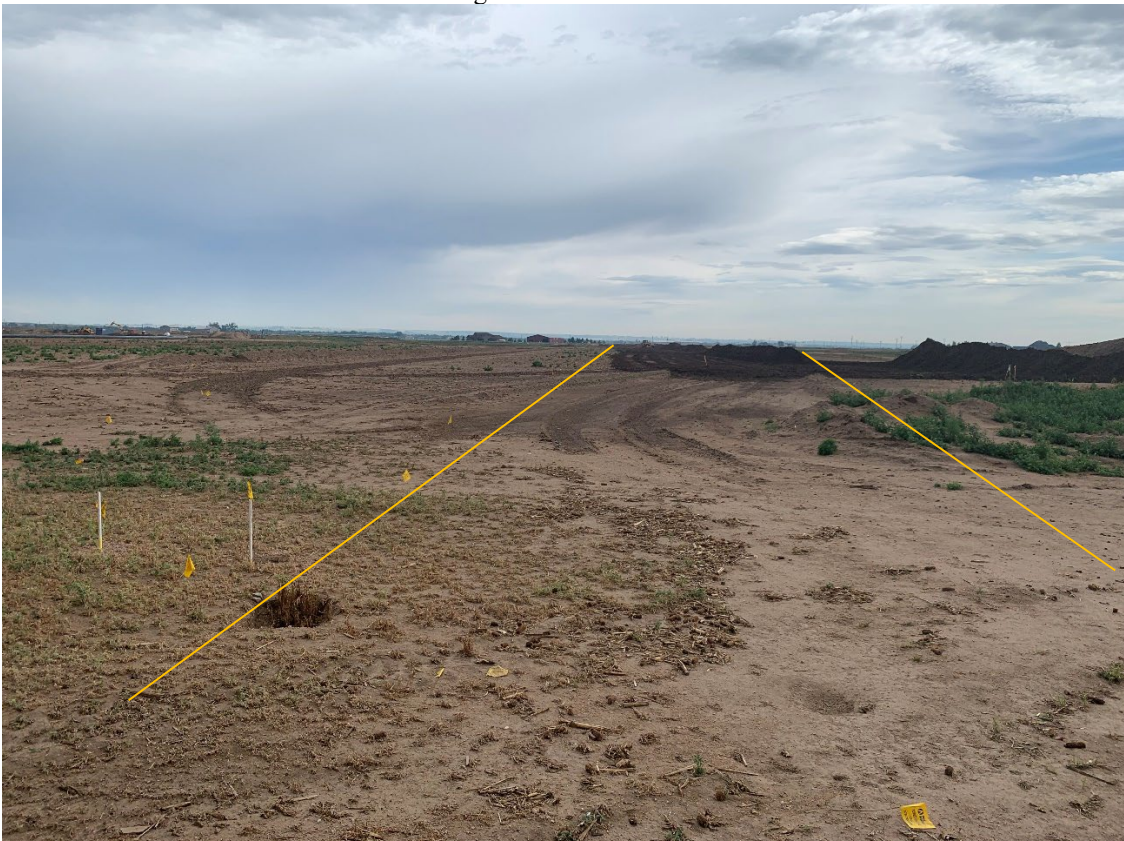
Suncor was installing a new gas line in the Suncor ROW (photo 2). The ROW is within the eastern half of the permit area and is situated north to south. The ROW will not be mined.

Photo 2 – Suncor ROW (approximate), facing north.

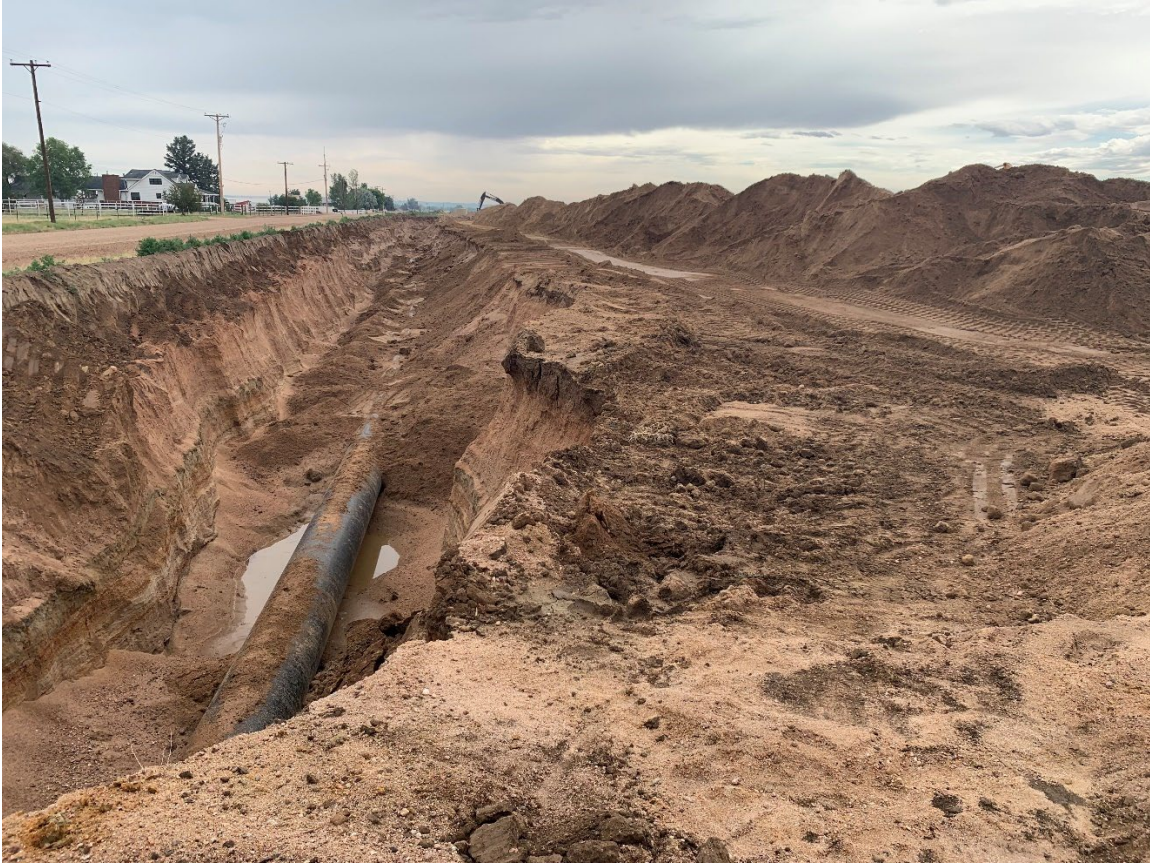
CCWCD is in the process of installing a 36" buried water line on the west and south perimeter of the proposed permit area (photos 3 and 4). The water line will be used to manage water levels in the proposed ponds described in the permit application. The waterline is being installed before the slurry wall to minimize any potential damage to the slurry wall.

Photo 3 – Buried water pipeline on western boundary of proposed permit area.

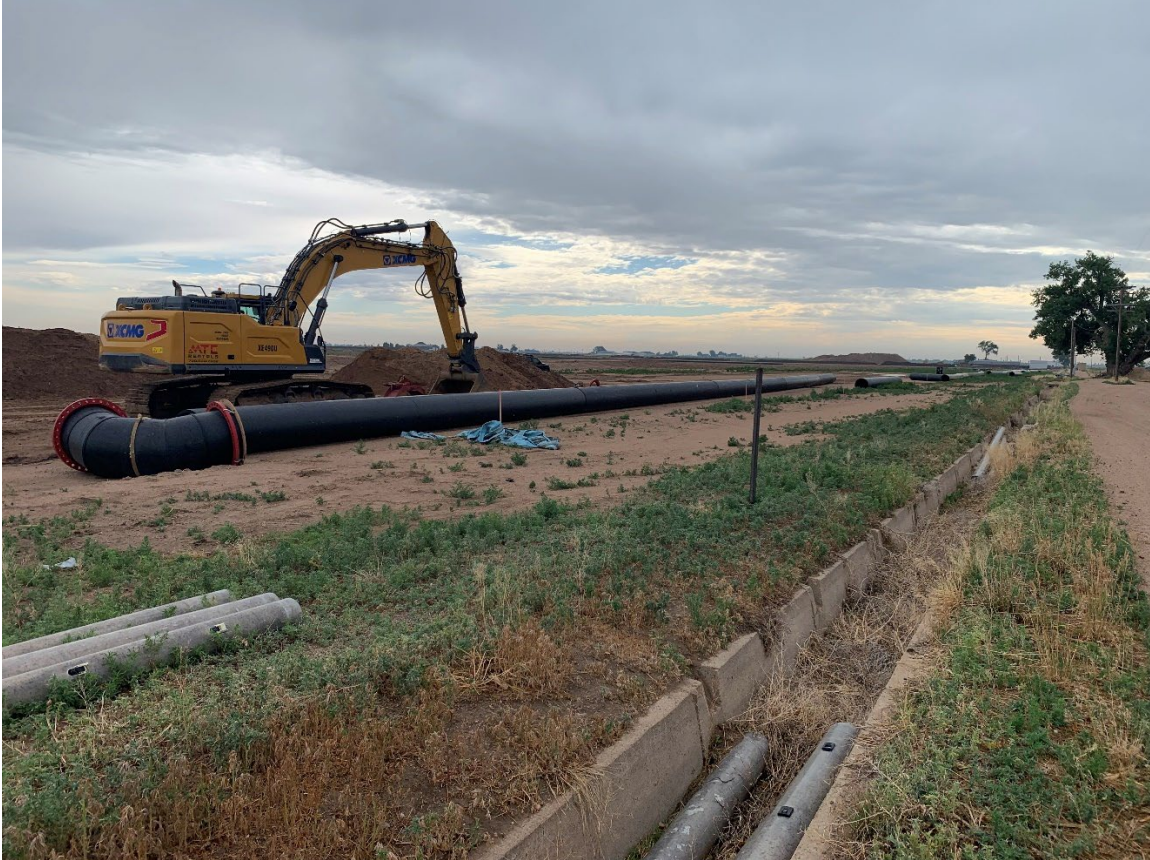
Photo 4 – Pipeline staged on southern boundary of proposed permit area.

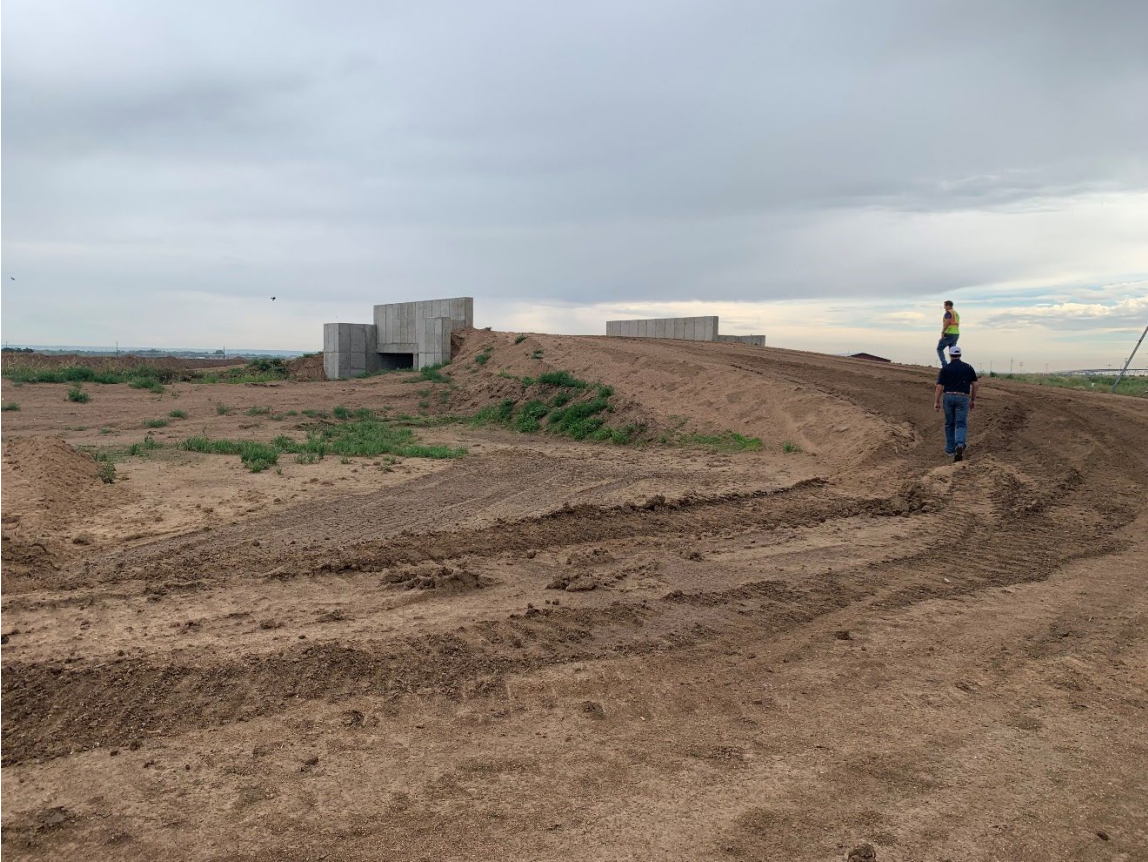
A boxed culvert was installed over the Western Mutual Ditch (photo 5). The culvert connects the northern and southern sections of the permit area that is bisected by the Western Mutual Ditch. The culvert will remain for the life of mine.

Photo 5 – Boxed culvert installed over the Western Mutual Ditch.

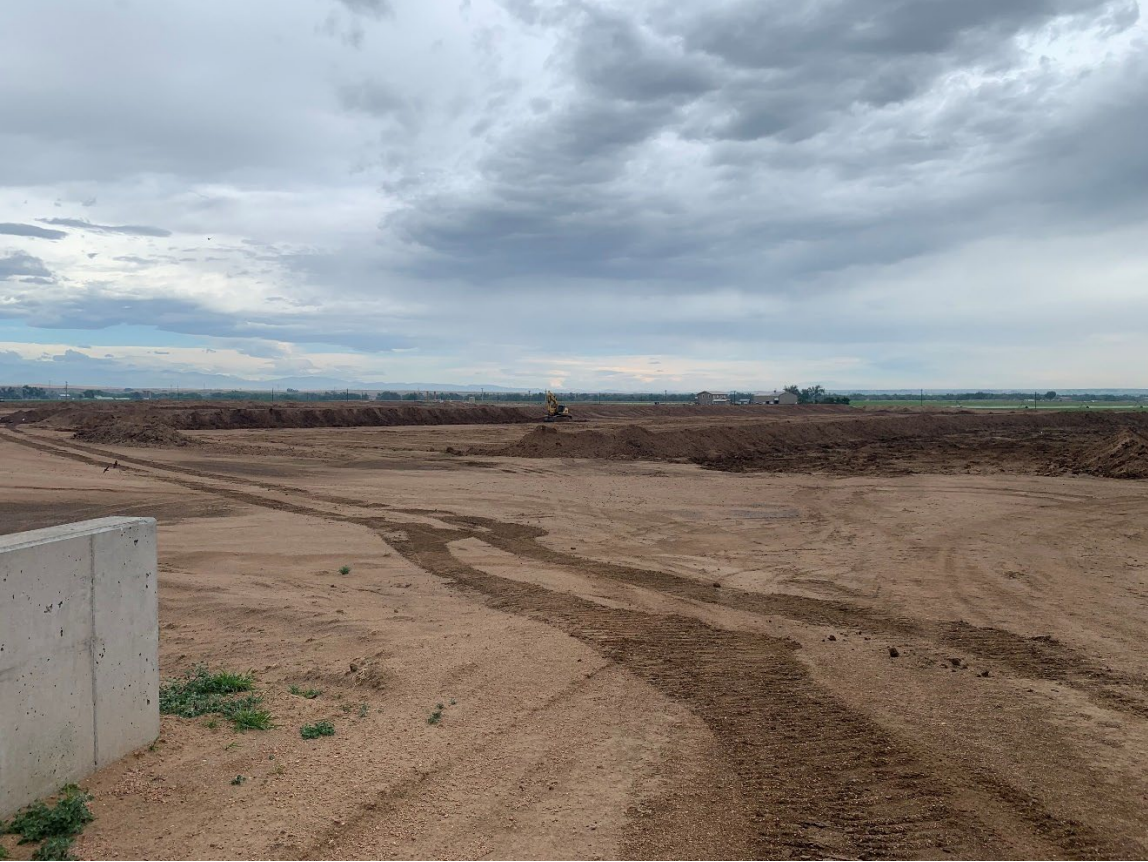
The topsoil had been salvaged from the northern section of the proposed mine site (photo 6). The salvaged topsoil has been placed in the southeastern corner of the property (photo 7). The topsoil needed to be removed to allow for salvaging of subsoil for use in the slurry wall construction. The subsoil needed for the slurry wall construction is being stacked in a row next to where the wall is proposed to be constructed (photo 8).

Photo 6 – Topsoil had been salvaged from the northern section of the proposed permit area.

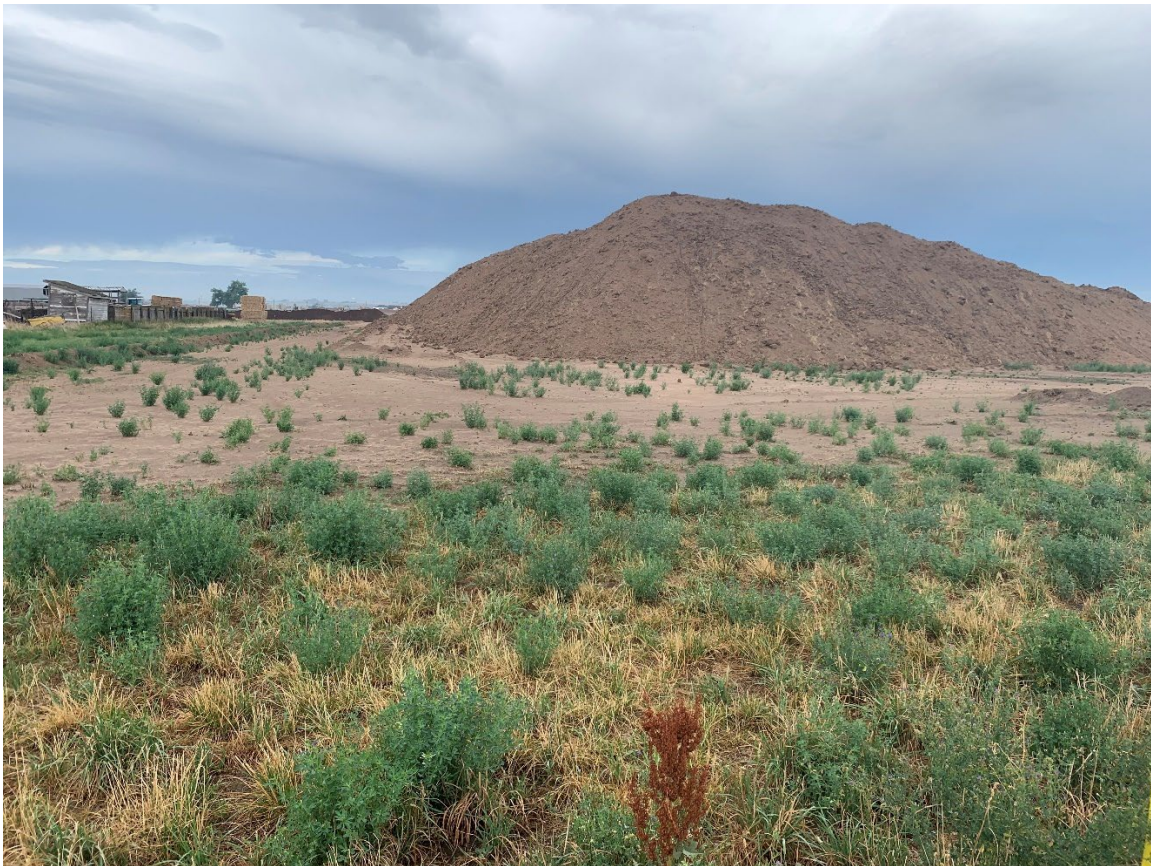
The operator is aware of the law that material is not allowed to leave the property until the mining permit has been issued and a reclamation bond has been received by DRMS. It does not appear that material has been removed from the property. The topsoil pile in the southeast corner of the property is substantial in size, comparable to the area where the topsoil had been salvaged. No haul trucks and no loading area was seen on the property.

Photo 7 – Topsoil stock pile in the southeast corner of the proposed permit area.

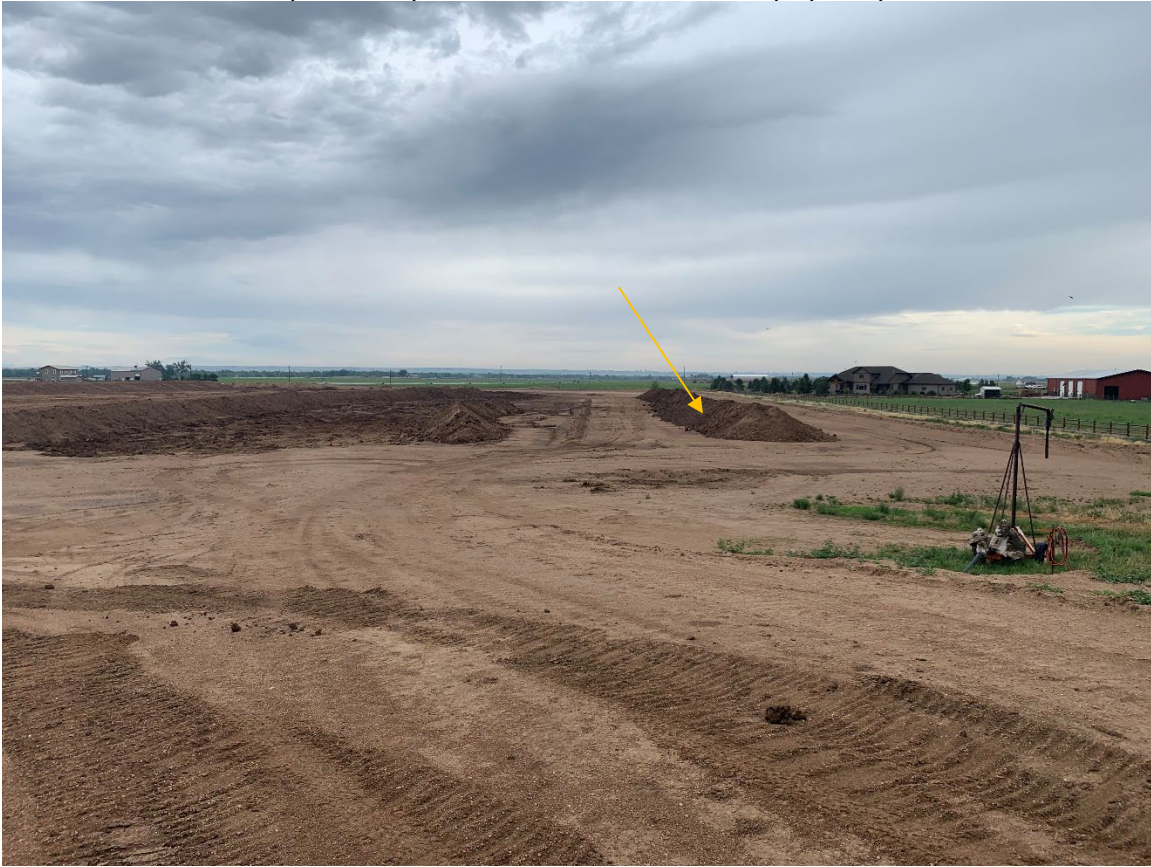
Photo 8 – Salvaged soil for slurry wall construction stacked in rows.

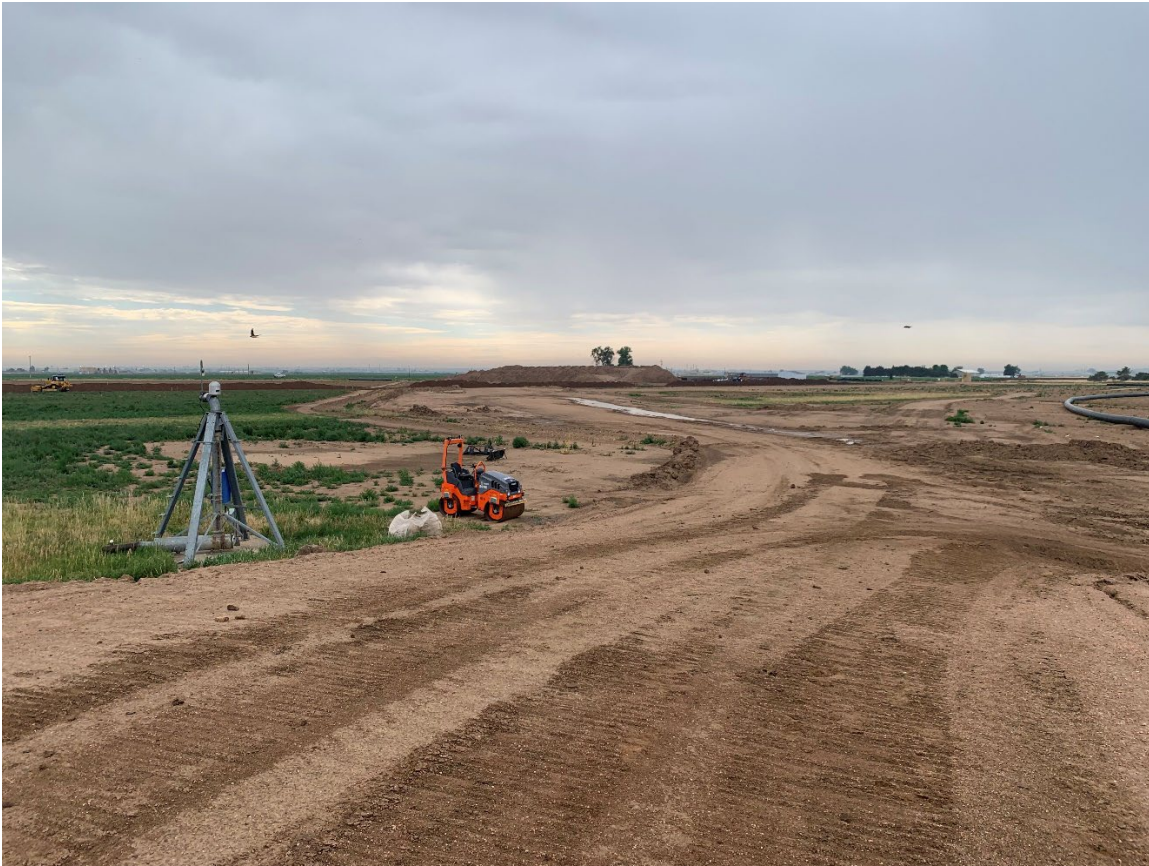
The irrigation pivot had been disassembled. The actual center pivot tower was still in place (photo 9) but the tower sections were stacked in the northeast corner of the property.

Photo 9 – Irrigation center pivot on left and topsoil stockpile center of photo. Photo is facing southeast.

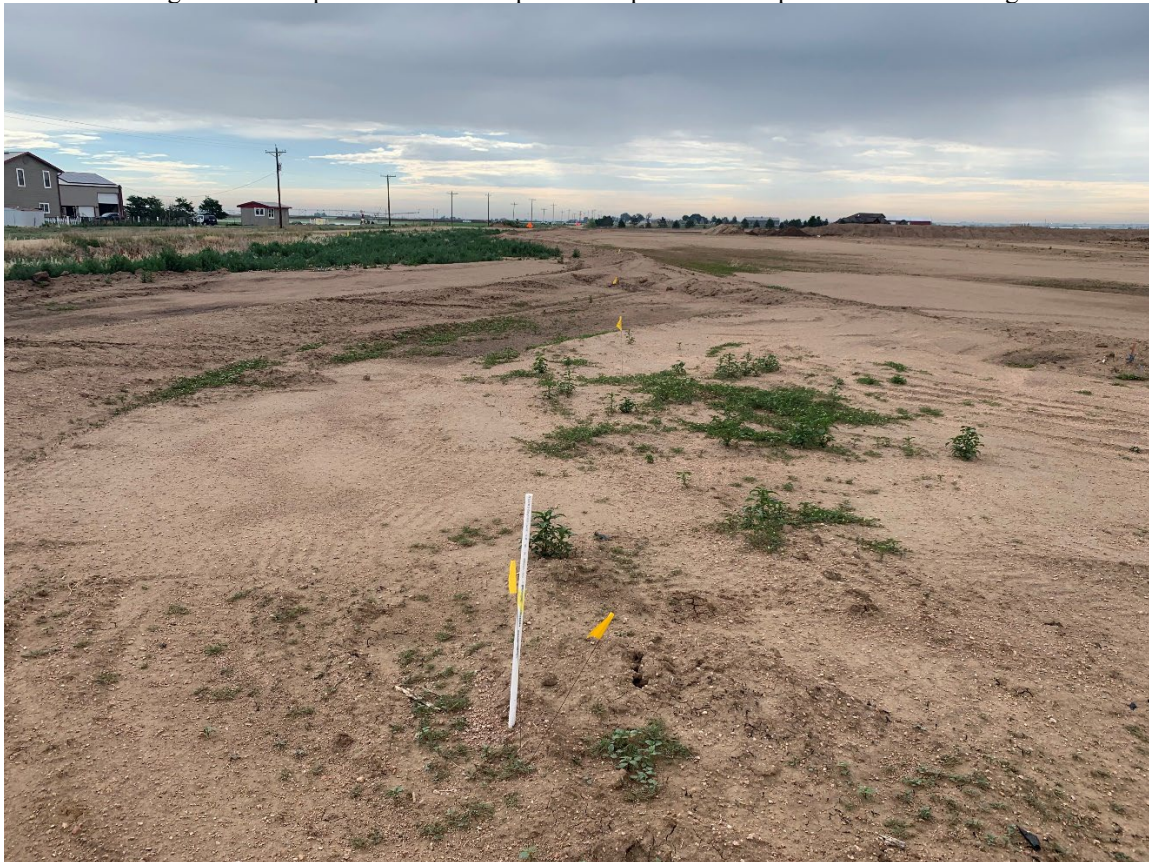
All gas lines were marked with yellow flags (photo 10).

Photo 10 – Exiting gas lines were marked with yellow flags.
