<b>Permit Number:</b> C-1981-015 <b>Mine Name:</b> Fruita No 1 & 2 <b>Operator:</b> Dorchester Coal Company <b>Operator Address:</b> Greg Lewicki 9054 South Forrest Drive Highlands Ranch, CO 80126	<b>County:</b> Mesa <b>Operation Type:</b> Underground <b>Permit Status:</b> Revoked <b>Ownership:</b> Private
	<b>Operator Representative Present:</b>  NA Revoked Mine Permit
<b>Operator Representative Signature:</b> (Field Issuance Only)

<b>Inspection Start Date:</b> June 24, 2024 <b>Inspection Start Time:</b> 10:00 <b>Inspection End Date:</b> June 24, 2024 <b>Inspection End Time:</b> 10:50		<b>Inspection Type:</b> Coal Complete Inspection <b>Inspection Reason:</b> Normal I&E Program <b>Weather:</b> Clear	
<b>Joint Inspection Agency:</b>  None		<b>Joint Inspection Contacts:</b>  None	
<b>Post Inspection Agency:</b>  None		<b>Post Inspection Contacts:</b>  None	
<b>Inspector(s):</b>  Clayton Wein	<b>Inspector's Signature:</b>  <i>Clayton Wein</i>		
	<b>Signature Date:</b> 7/2/2024

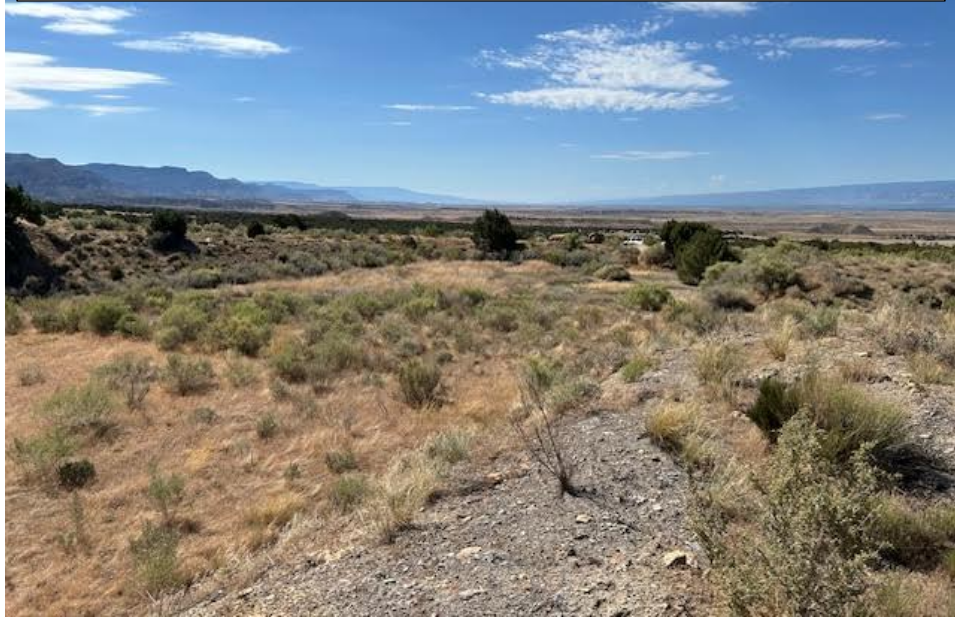
The sediment pond is located in the southern portion of the permit area and will remain as a permanent feature. The pond was dry at the time of the inspection. The embankment was stable with vegetation (Photo 1). There were no erosional features observed. The outlet for the pond is armored with riprap. The outlet was stable with no obstructions. The riprap was in good condition.

Photo 1: The sediment pond. Photo 1 was taken looking to the south.

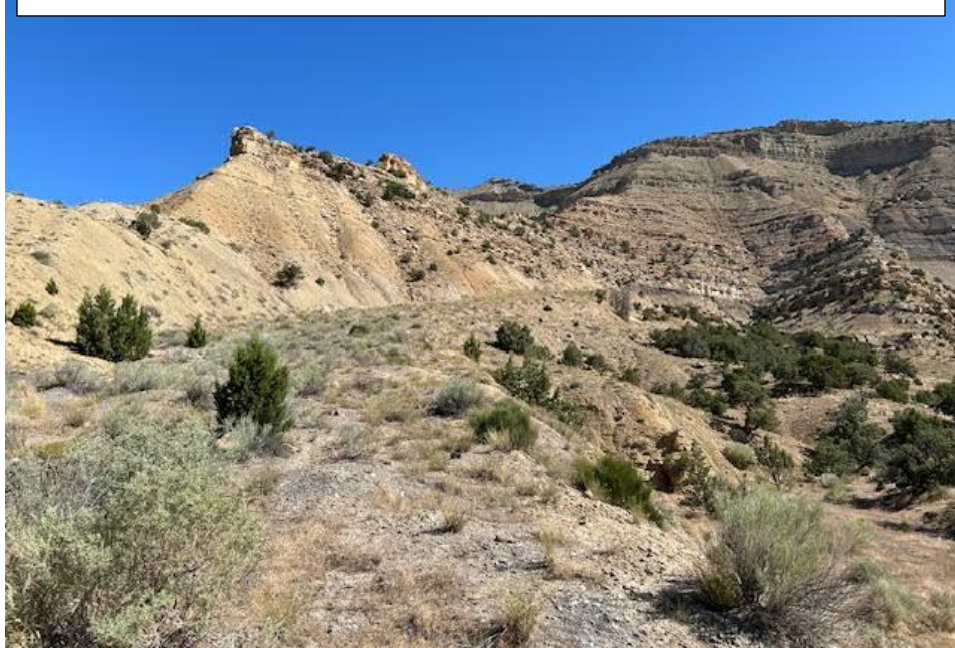
Photo 2: The base of the reclaimed haul road.

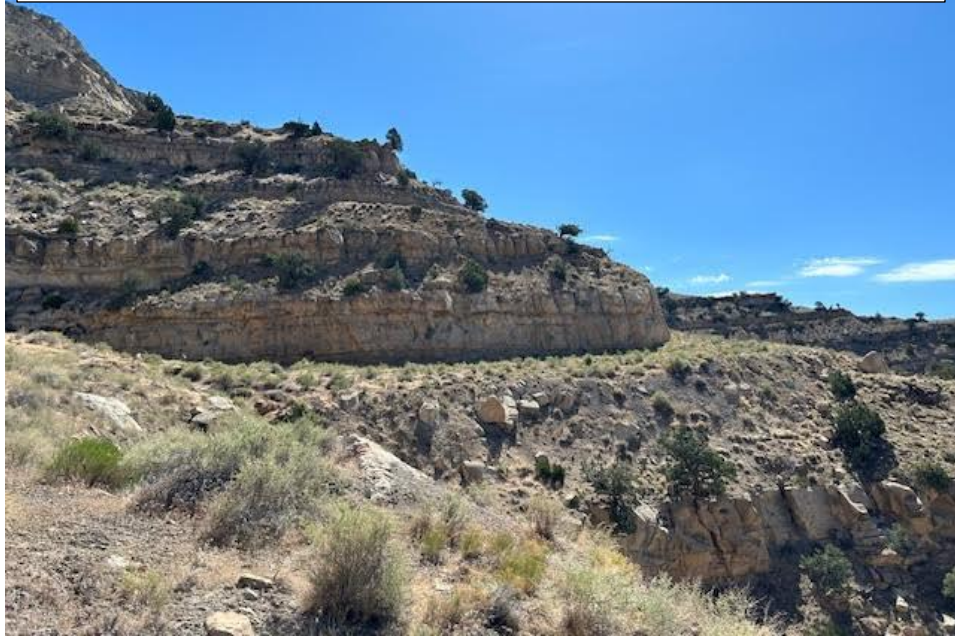
All portions of the mine have been reclaimed and year 9 and year 10 vegetation sampling have been completed. The Division is completing the analysis of the data. The reclaimed haul road was stable with vegetative cover. There were no erosional concerns identified during the inspection. Old erosional rills, noted in previous Division inspection reports, have become self-stabilized. The rills are no longer enlarging and transport runoff to the natural drainage leading into the sediment pond. Vegetative cover has filled in and covers the lower (Photo 2), middle (Photo 3) and upper portions of the reclaimed haul road. The portals bench was also vegetated and stable.

Photo 3: A portion of the middle of the reclaimed haul road.

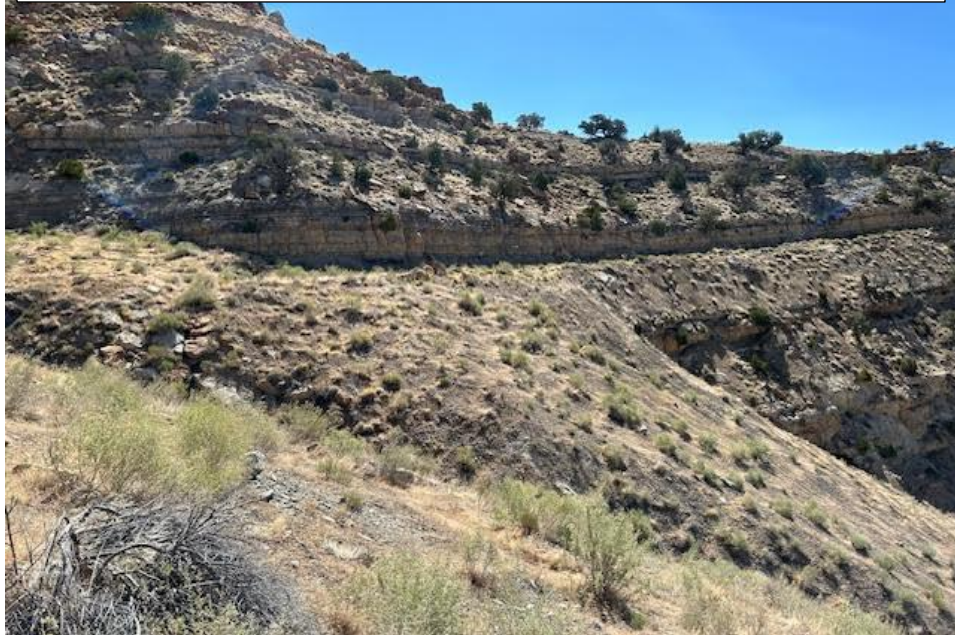
There were no erosional features identified. The south side of the bench is a steep slope with an armored channel that extends from the reclaimed bench down to the drainage below. This drainage then continues into the sediment pond. The south face of the bench was stable with some vegetation on it (Photo 4). The more sparse vegetation is likely due to a combination of the steep slope and the southern exposure. The face of the slope had no new erosional features on it. The armored channel remained in good condition and was unobstructed. The backfilled portals were covered with no erosional features (Photo 5). The backfill material was stable with vegetative cover.

Photo 4: The southern face of the portals bench.

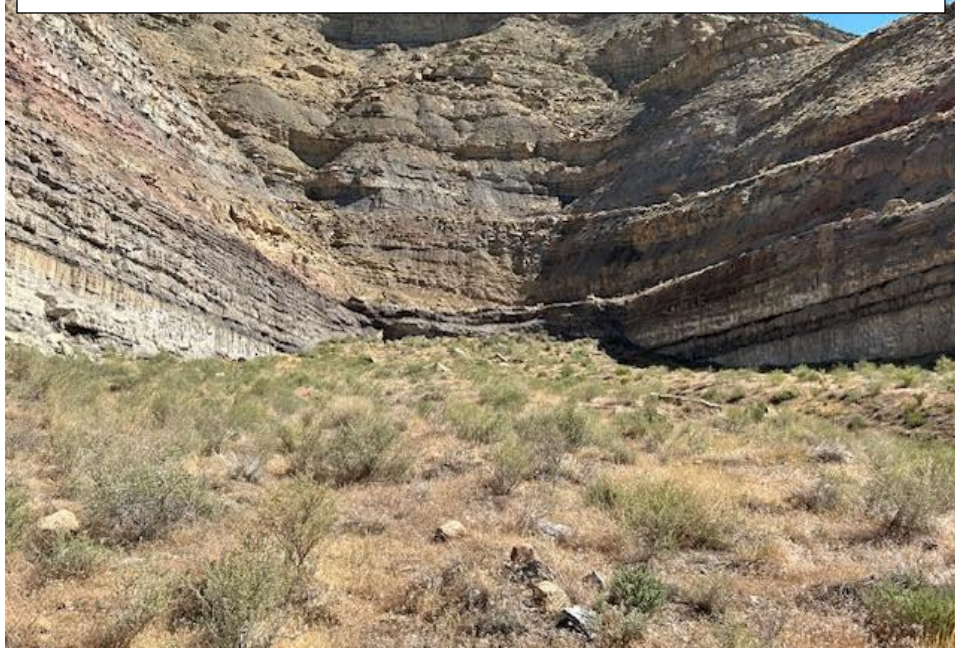
Photo 5: The reclaimed portals bench and backfilled portals.
