Re: GCC Energy, LLC, King II Mine
CDRMS Permit # C-1981-035
Stoner Engineering: Quarterly Inspection: Refuse Pile 2nd Quarter 2024

Date: July 5, 2024

Re: King Coal I – Quarterly Waste Pile/Embankment Inspection

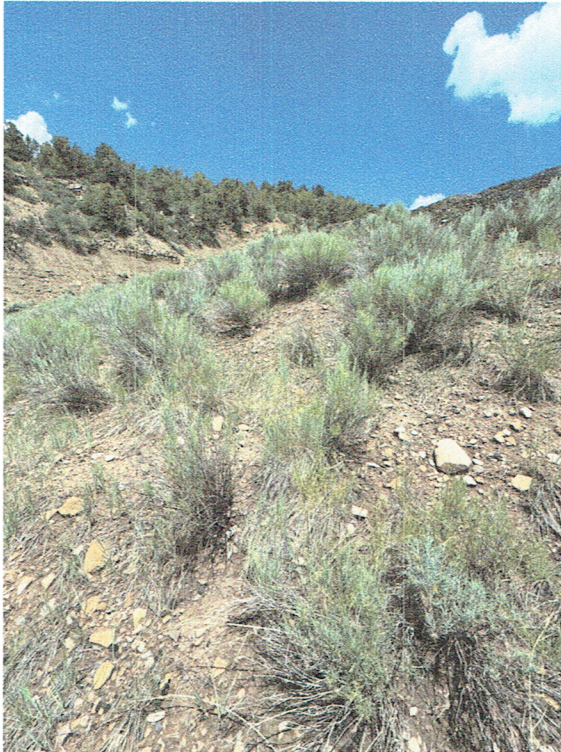
The face of the upper waste embankment pile was found to be in generally good shape (see Pic. 1). There were no signs of instability or sloughing observed on the main waste embankment pile at the time of the inspection.

Pic. 1 –Face of the main waste embankment pile in good condition.

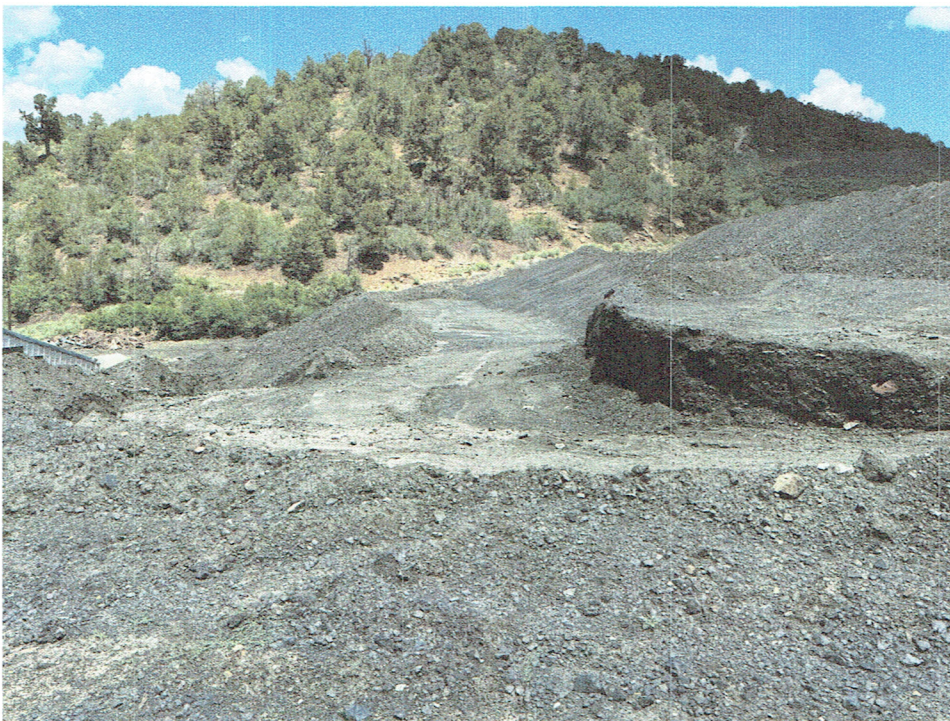
There appears to have been some placement of additional fill material to the face of the lower waste pile. Fill material appears to have been brought up to roughly three-quarters of the height of the lower waste pile with an equipment access from the west side of the pile (see Pic. 2). Berming along the top of the lower pile, where the equipment access is located, was insufficient at the time of the storm to direct all surface flows to the west side of the lower pile (see Pic.3). A portion of the flows was able to flow down the equipment access to the face of the pile and resulted in erosion to the face of the lower waste pile (see Pic. 4). The erosion took place south of the abandoned bath house located at the base of the lower waste pile. The face of the lower waste pile needs to be replaced and recompact around the eroded location. The equipment access at the top of the lower waste pile needs to be improved to ensure that surface runoff can not bypass the treated water ditch (Reach 10) along the west side of the pile.

Pic. 2 – Equipment access, lower waste pile, for fill placement.

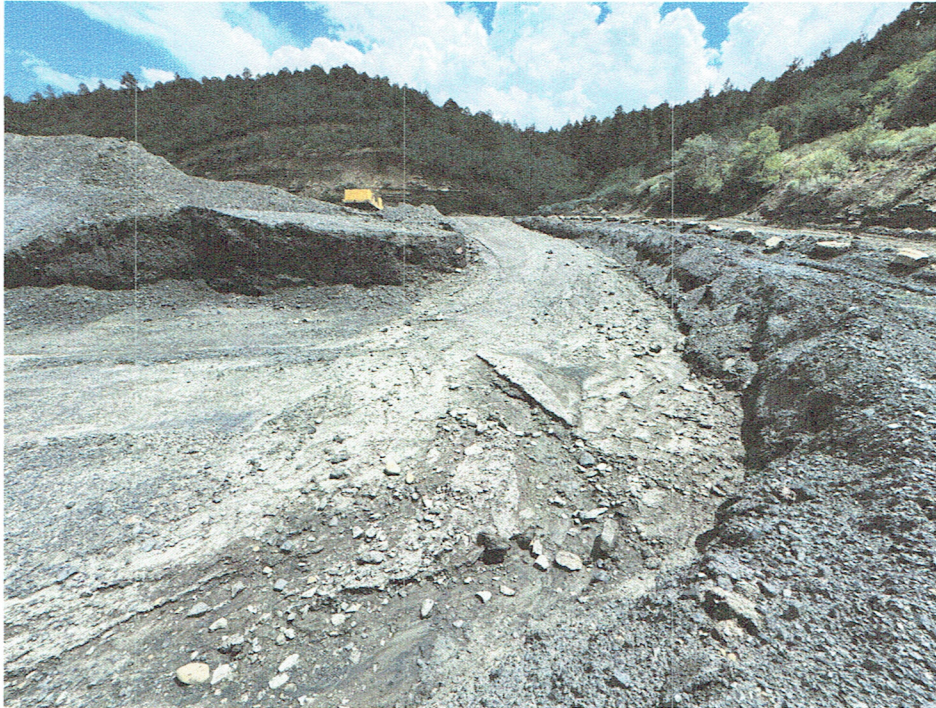
Pic. 3 – Erosion from surface runoff at equipment access of lower waste pile.

The upper waste embankment pile level appears to be unchanged since the previous inspection. The lower waste pile has had additional material installed along the face as well as stockpiled on the top. The grading of the upper waste embankment piles appears to direct surface runoff away from the face of the piles and the required berming is in place. The grading of the lower waste pile generally directs runoff away from the face however, there is a portion near the equipment access for the ongoing fill placement where surface runoff was able to reach the face. The grading near the equipment access needs to be improved to ensure future storm events do not result in runoff reaching the face of the embankment pile.

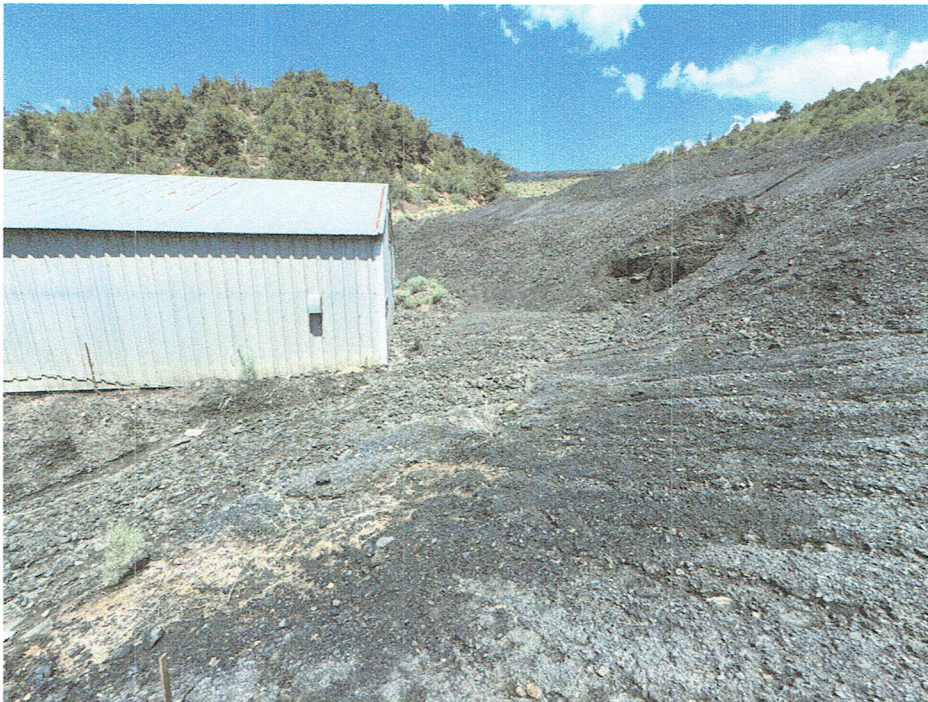
The face of the upper and lower waste embankments appeared to be in good condition except as noted on the lower pile. There were no signs of instability or sloughing observed on either waste embankment pile at the time of the inspection. The slope of the top of the existing pile is close to that defined in the Waste Bank Design produced by Don May, 1997.

Pic. 4 – Erosion of face of lower waste pile south of old bath house.
