Re: GCC Energy, LLC, King II Mine

Stoner Engineering: Quarterly Inspection: King I'UbX'=Water

King Coal I – Quarterly Water Quality Improvements Inspection

King Coal II - Quarterly Water Quality Improvements Inspection

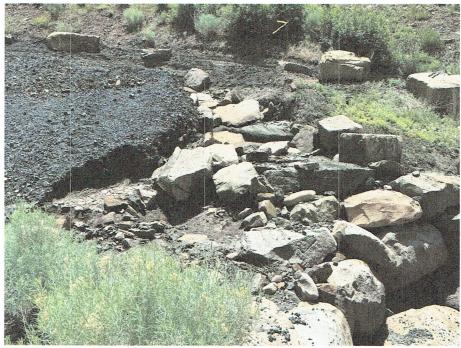
Pic. 1 – Lower portion of Reach 10 at base/stilling basin of lower pile.

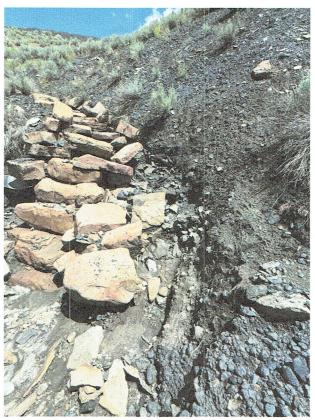
Pic. 2 – Reach 10 at culvert under haul road, base of main waste pile.

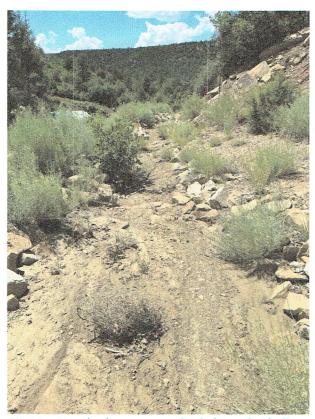
The clear water ditch (Reach 1) experienced some sedimentation as a result of runoff down the steep side slopes. While the flow velocity in the upper portion of Reach 1 did not allow significant sedimentation to accumulate, the lower section of Reach 1 along the lower waste pile did experience higher levels of sedimentation as a result of the lower velocity through this section (see Pic. 4).

Pic. 4 – North clear water ditch (Reach 1), flatter slope along lower waste pile.

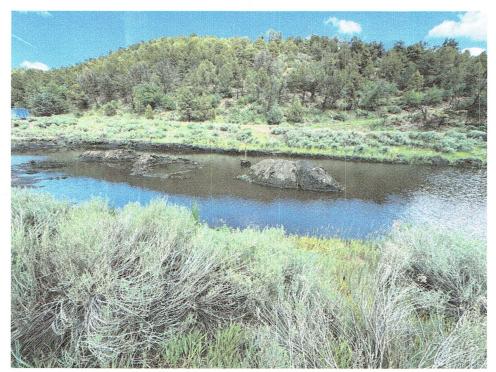
The site experienced a storm event on 6/27 which the Colorado Climate Center storm gauge at Fort Lewis registered almost 0.6 inches of rain. The storm produced intense rainfall over s short period of time. The water quality pond held more water than during the previous inspection (see Pic. 1). The elevation at the bottom of the pond could not be determined due to water within the pond. The current water levels make it difficult to assess the state of the sediment removal operations. It appears that some sediment had been removed has taken place since the previous inspection. Removal of sediment from the pond is on hold due to current water levels. Excess sediment should be removed from the detention pond as soon as site/weather conditions allow. The water is no longer isolated to the north side of the pond due to the recent storm event. Water currently stands around the outlet structure (see Pic. 2).

Pic. 1 – Water level in the detention pond after storm event.

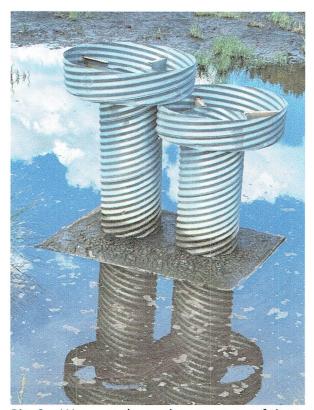
Pic. 2 – Water at the outlet structure of the pond.

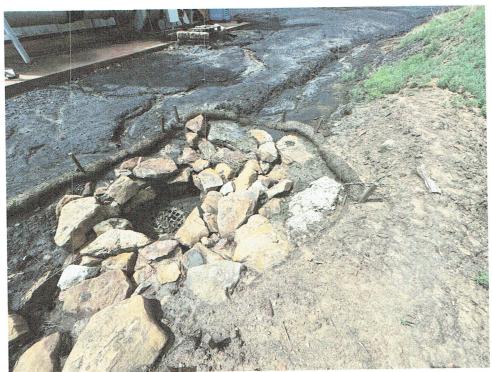
The erosion control structures for the treated water ditch located south of the scale house was found to be in good condition. The inlets located around the conveyor and coal storage piles were also found to be in remarkably good condition given the recent storm event (see Pic. 3). The clear water ditch along the west side of the site had been cleaned since the previous inspection and was free of sediment and also showed no signs of damage as a result of the storm event (see Pic. 4). All ditches should be inspected and repaired as necessary, especially after storm events.

Pic. 3 Inlet east of coal pile near northeast corner of coal operations.

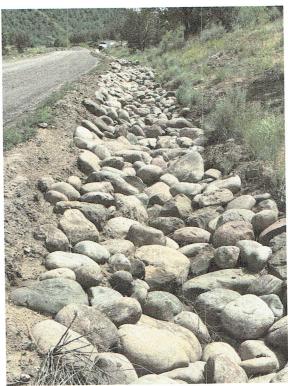
Pic. 4 -West clear water ditch.
