M1997026 CarolAnn Pit, June 2024 Inspection Report

MINERALS PROGRAM INSPECTION REPORT

MINE NAME: Carol Ann Pit	MINE/PROSPECTING ID#: M-1997-026	MINERAL: Sand and gravel	COUNTY: Eagle
INSPECTION TYPE: Monitoring	WEATHER: Clear	INSP. DATE: June 14, 2024	INSP. TIME: 13:00
OPERATOR: Carol Ann Pit LLC	OPERATOR REPRESENTATIVE: Bob Newby, Mason Ewing	TYPE OF OPERATION: 112c - Construction Regular Operation

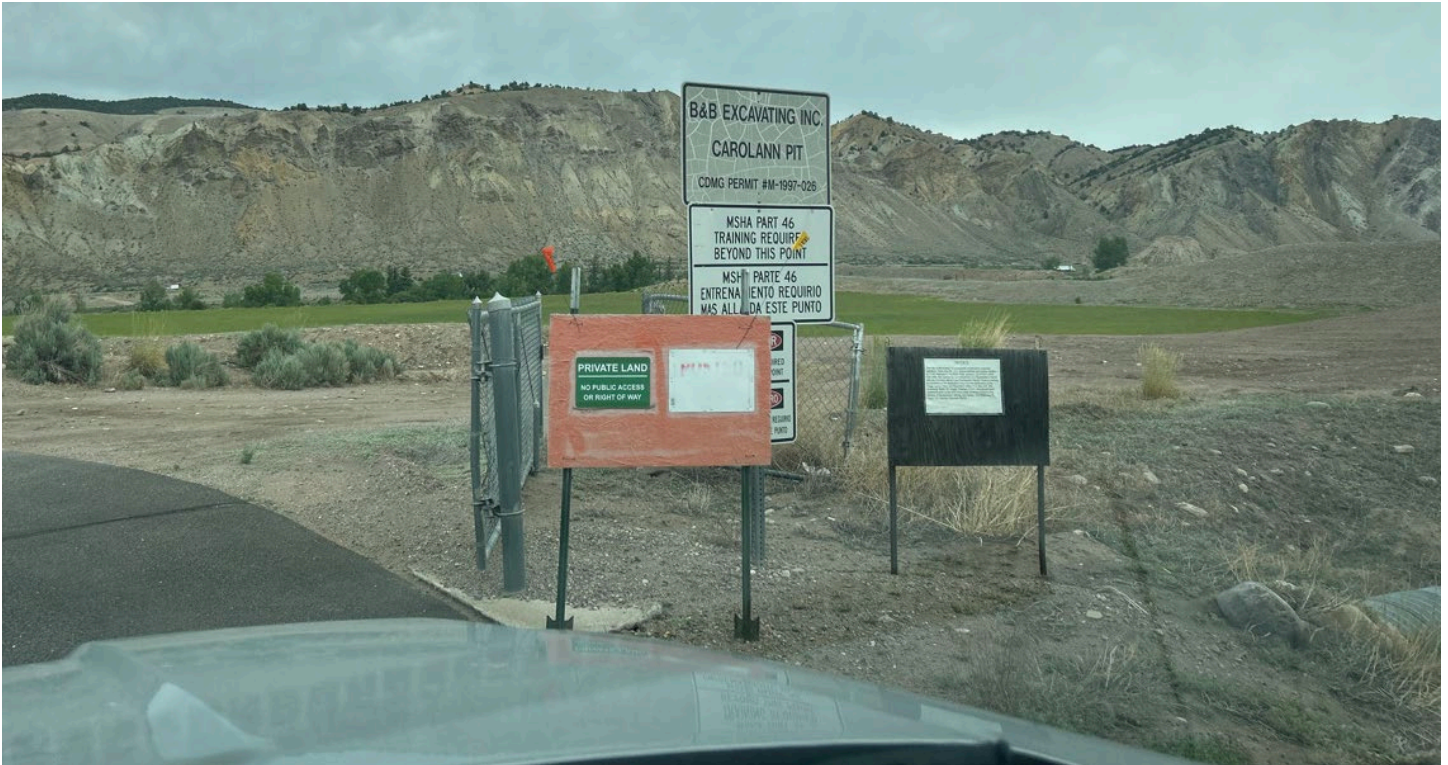
Figure 2: Mine ID Sign (292)

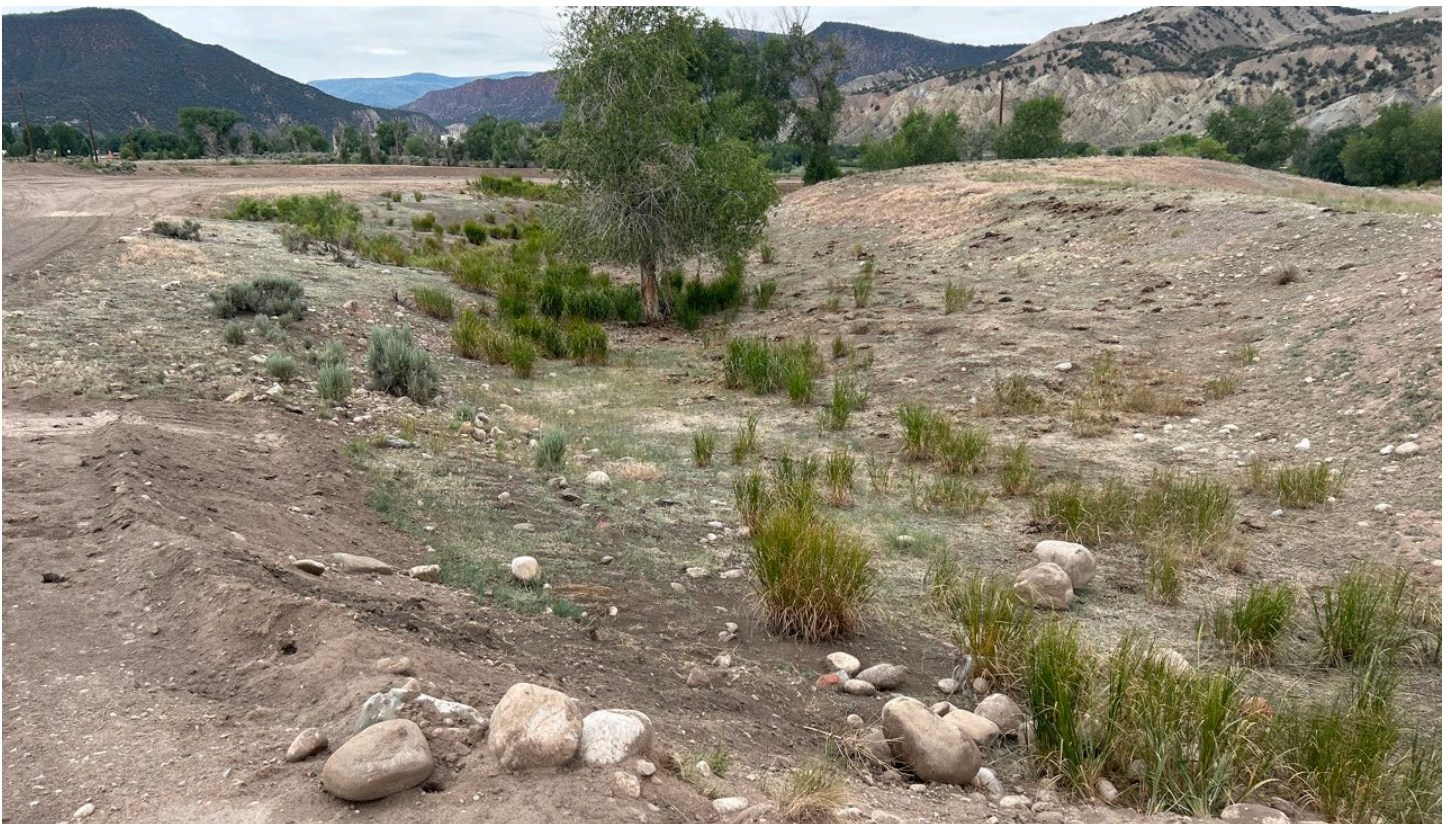
Figure 3: Natural drainage (293)

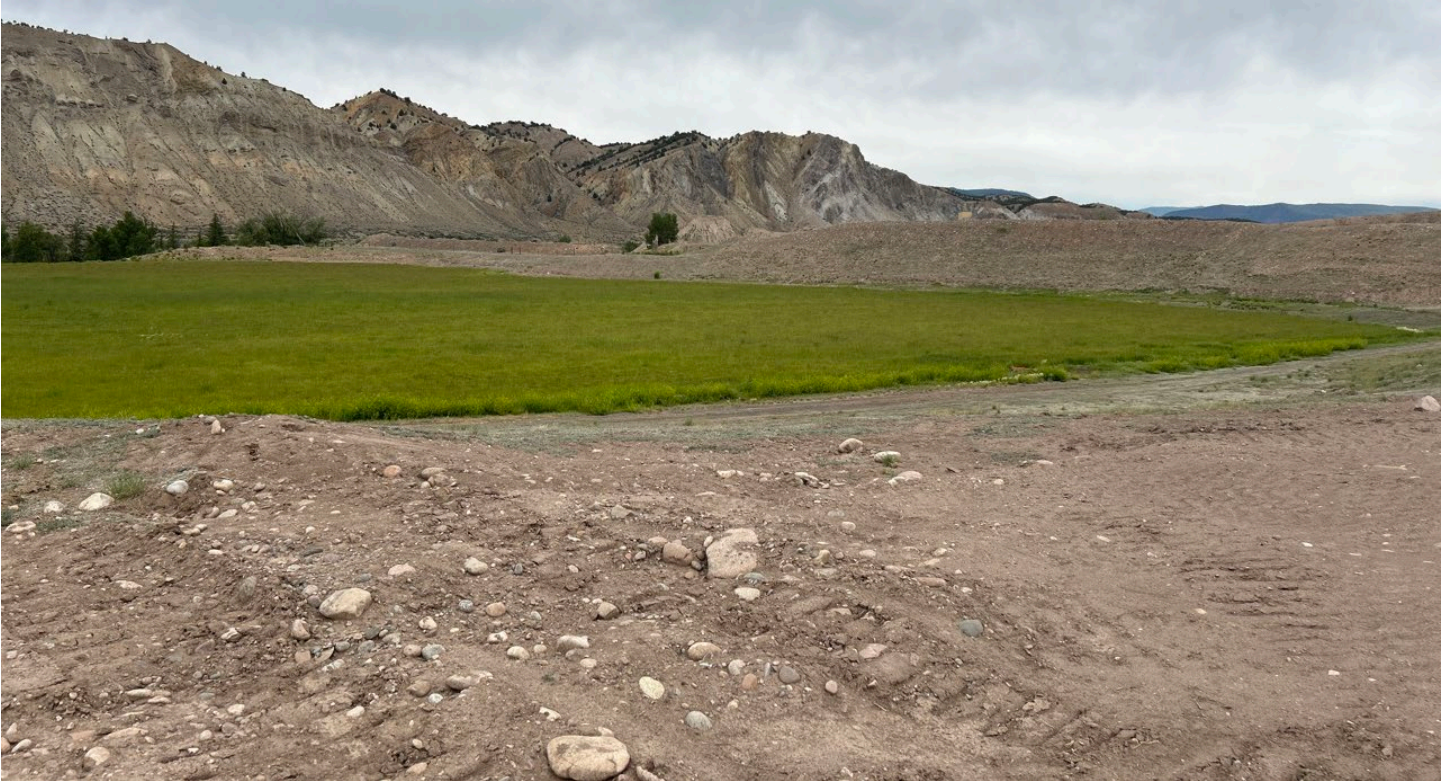
The eastern part of the site had previously been reclaimed to irrigated pastureland. It is clear from photos taken during the inspection as well as publicly available aerial imagery that hay is successfully being raised on the land.

Figure 4: Pasture on eastern part of site (293)

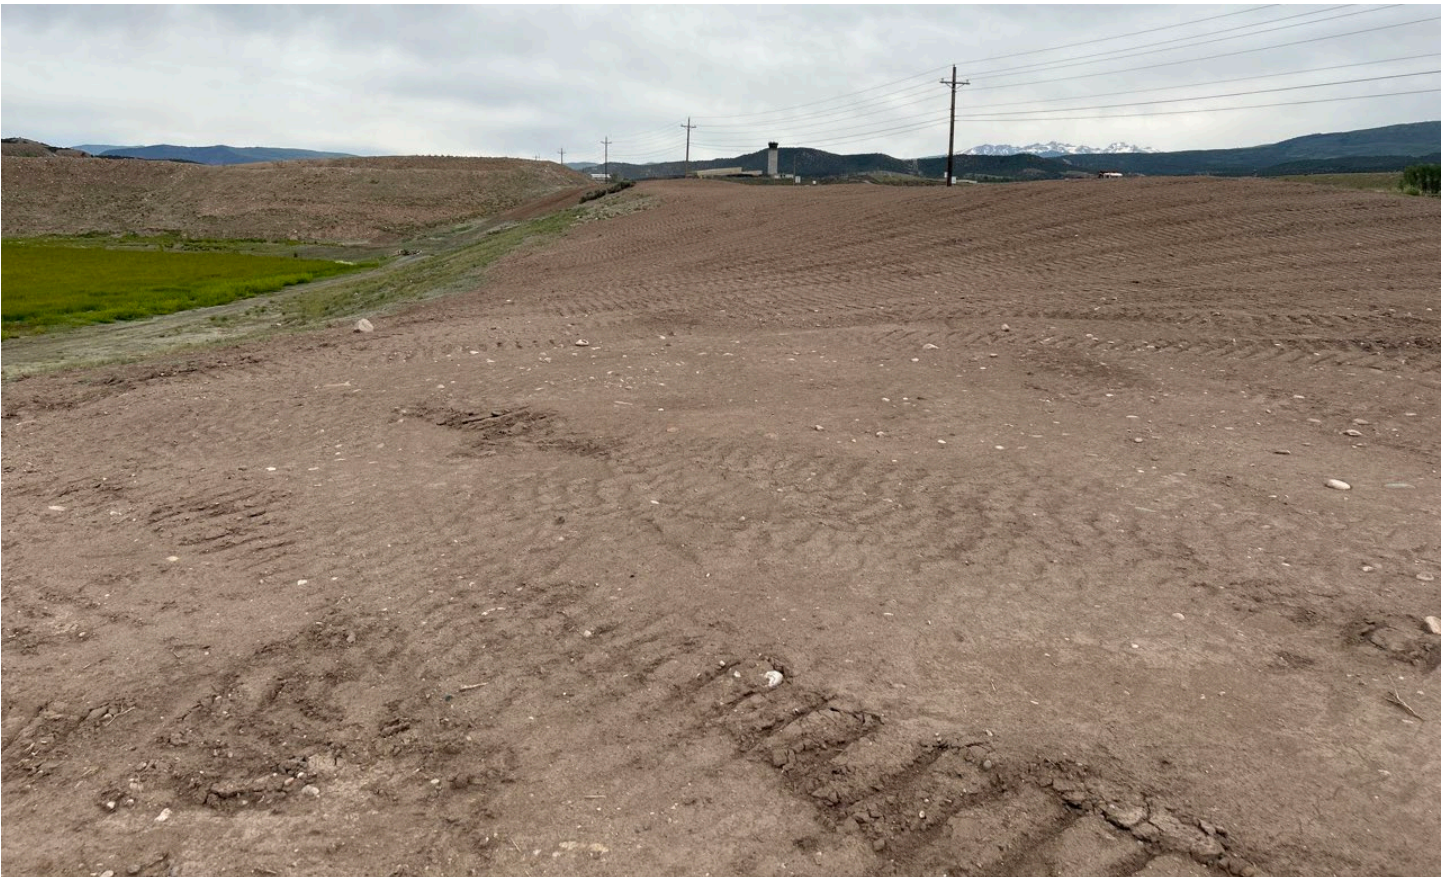
Backfilling and grading of the site had been completed (according to the original reclamation plan). Slopes were gentle and regular, with no highwalls.

Figure 5: Regraded slope to south of pasture (293)

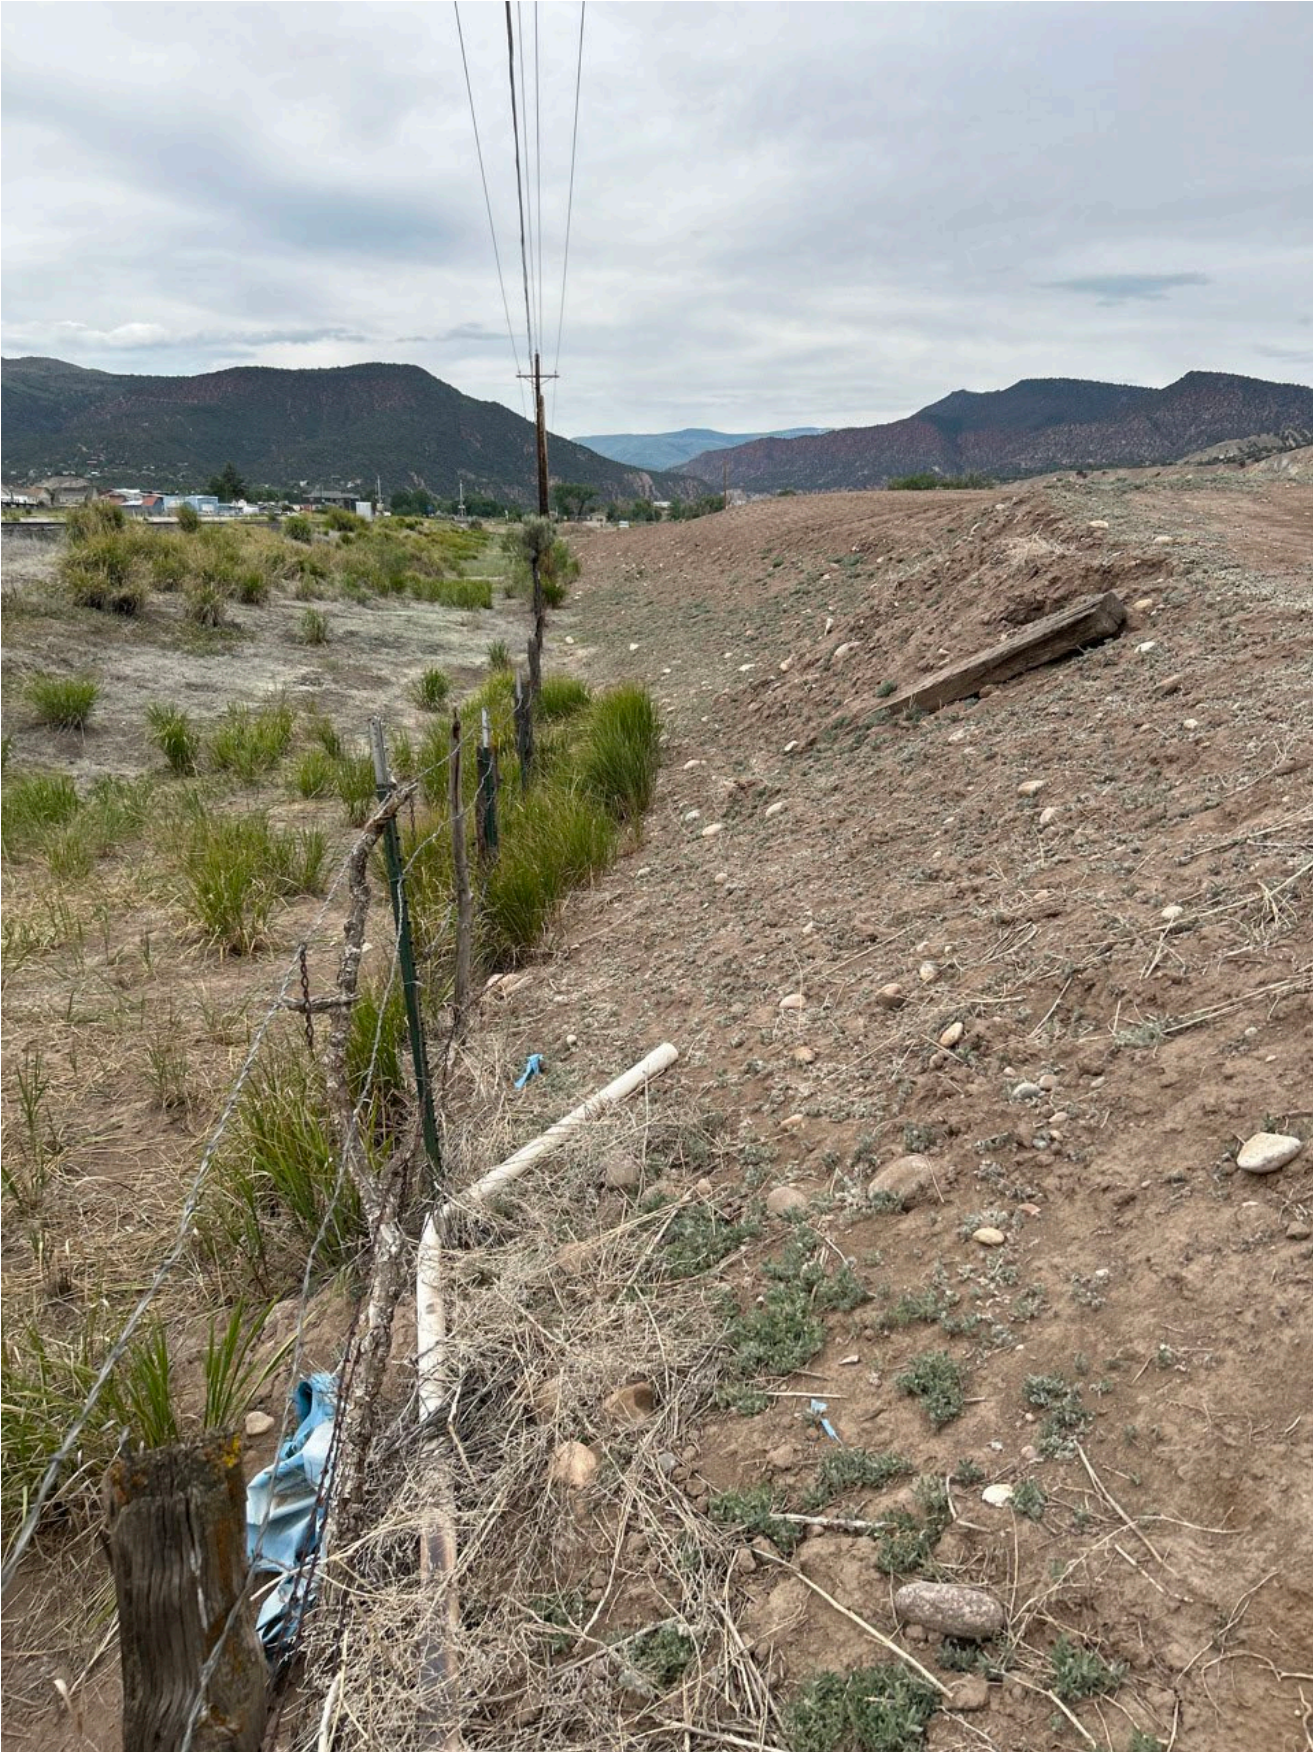
Figure 6: Southeast corner of permit area, looking west (294)

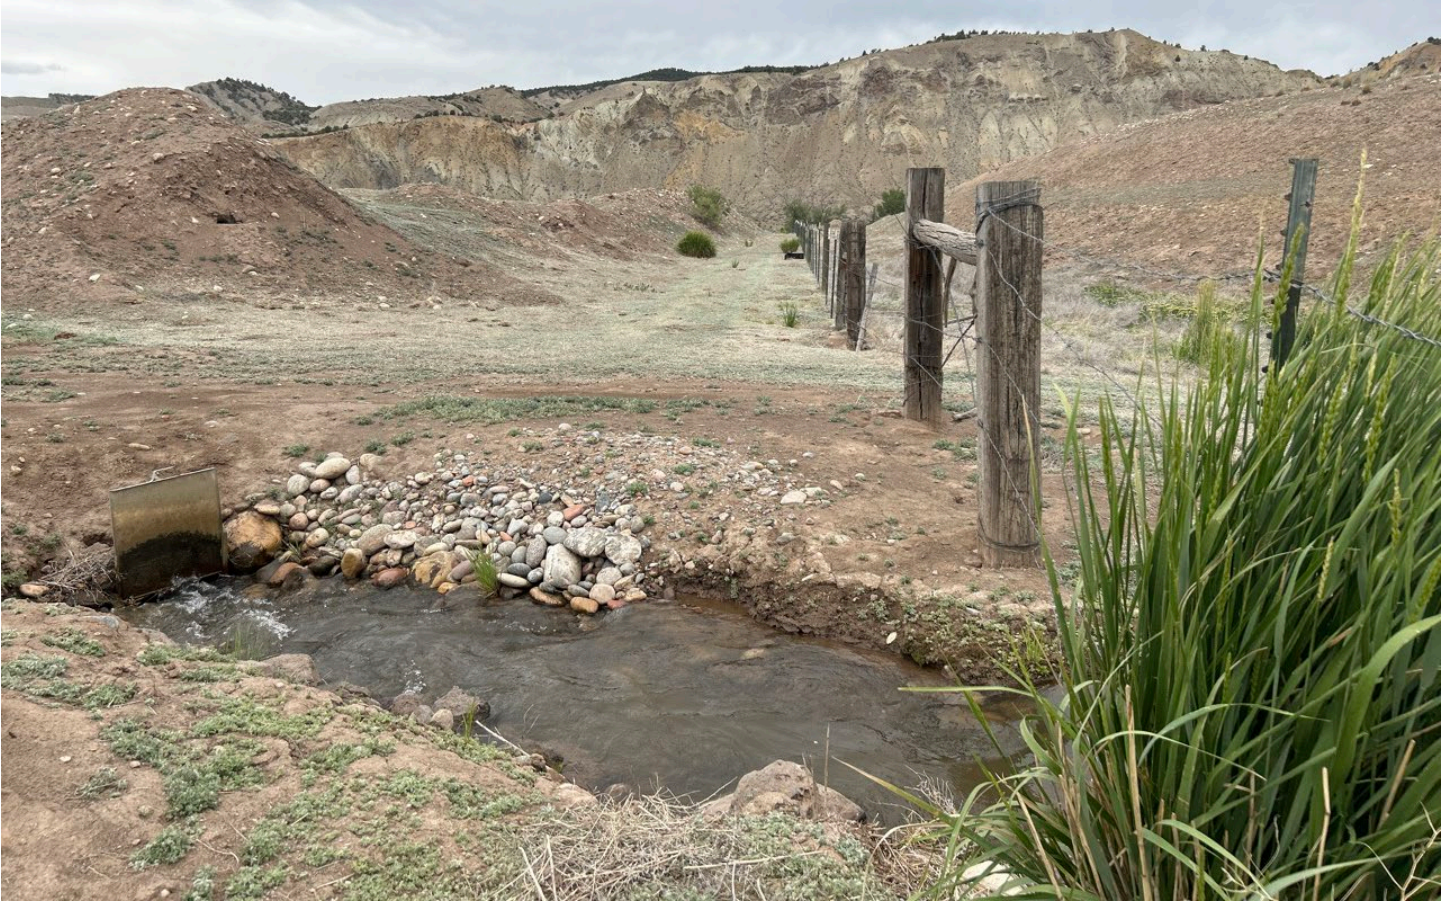
Figure 7: Southeast corner of permit area, looking south (294)

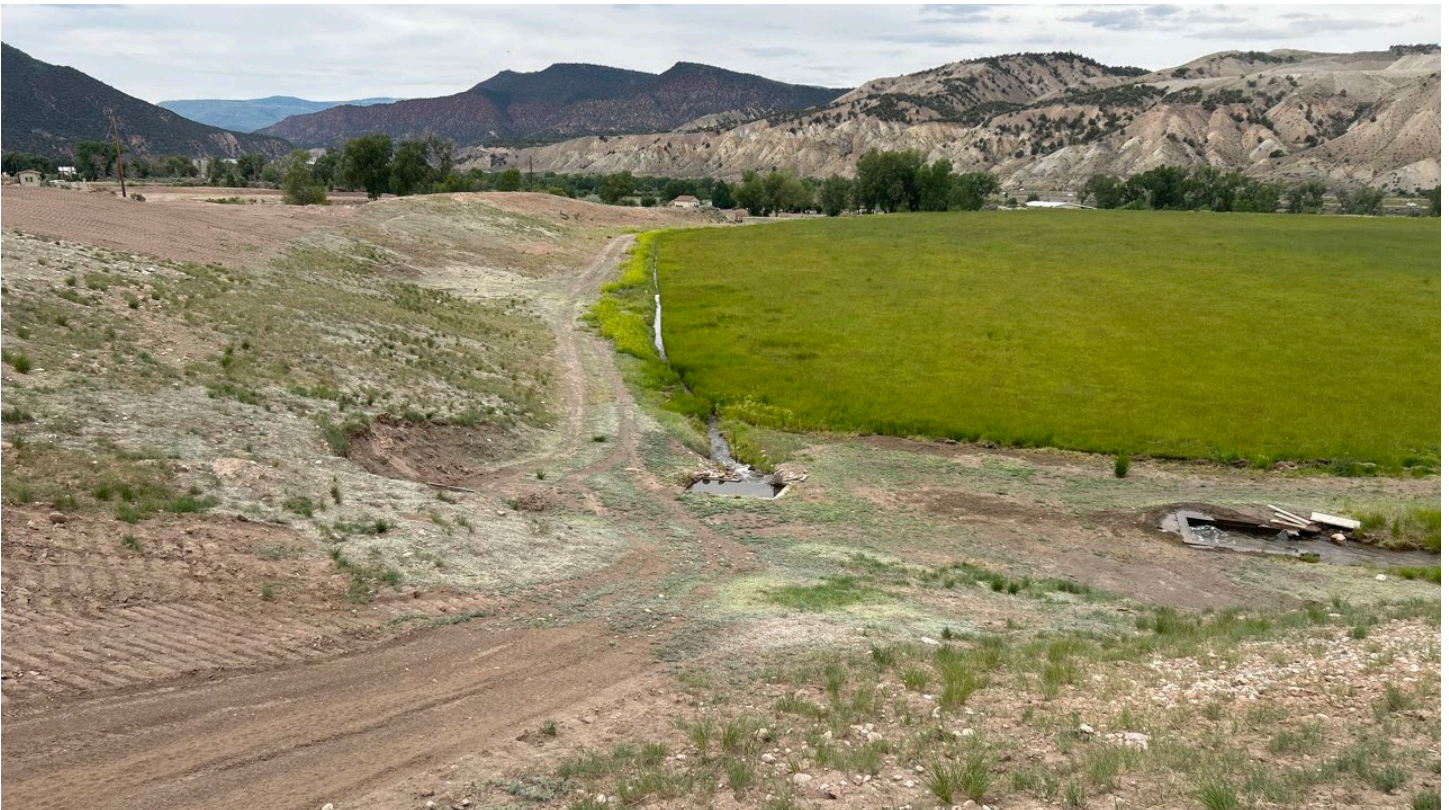
Figure 8: Irrigated pasture (295)

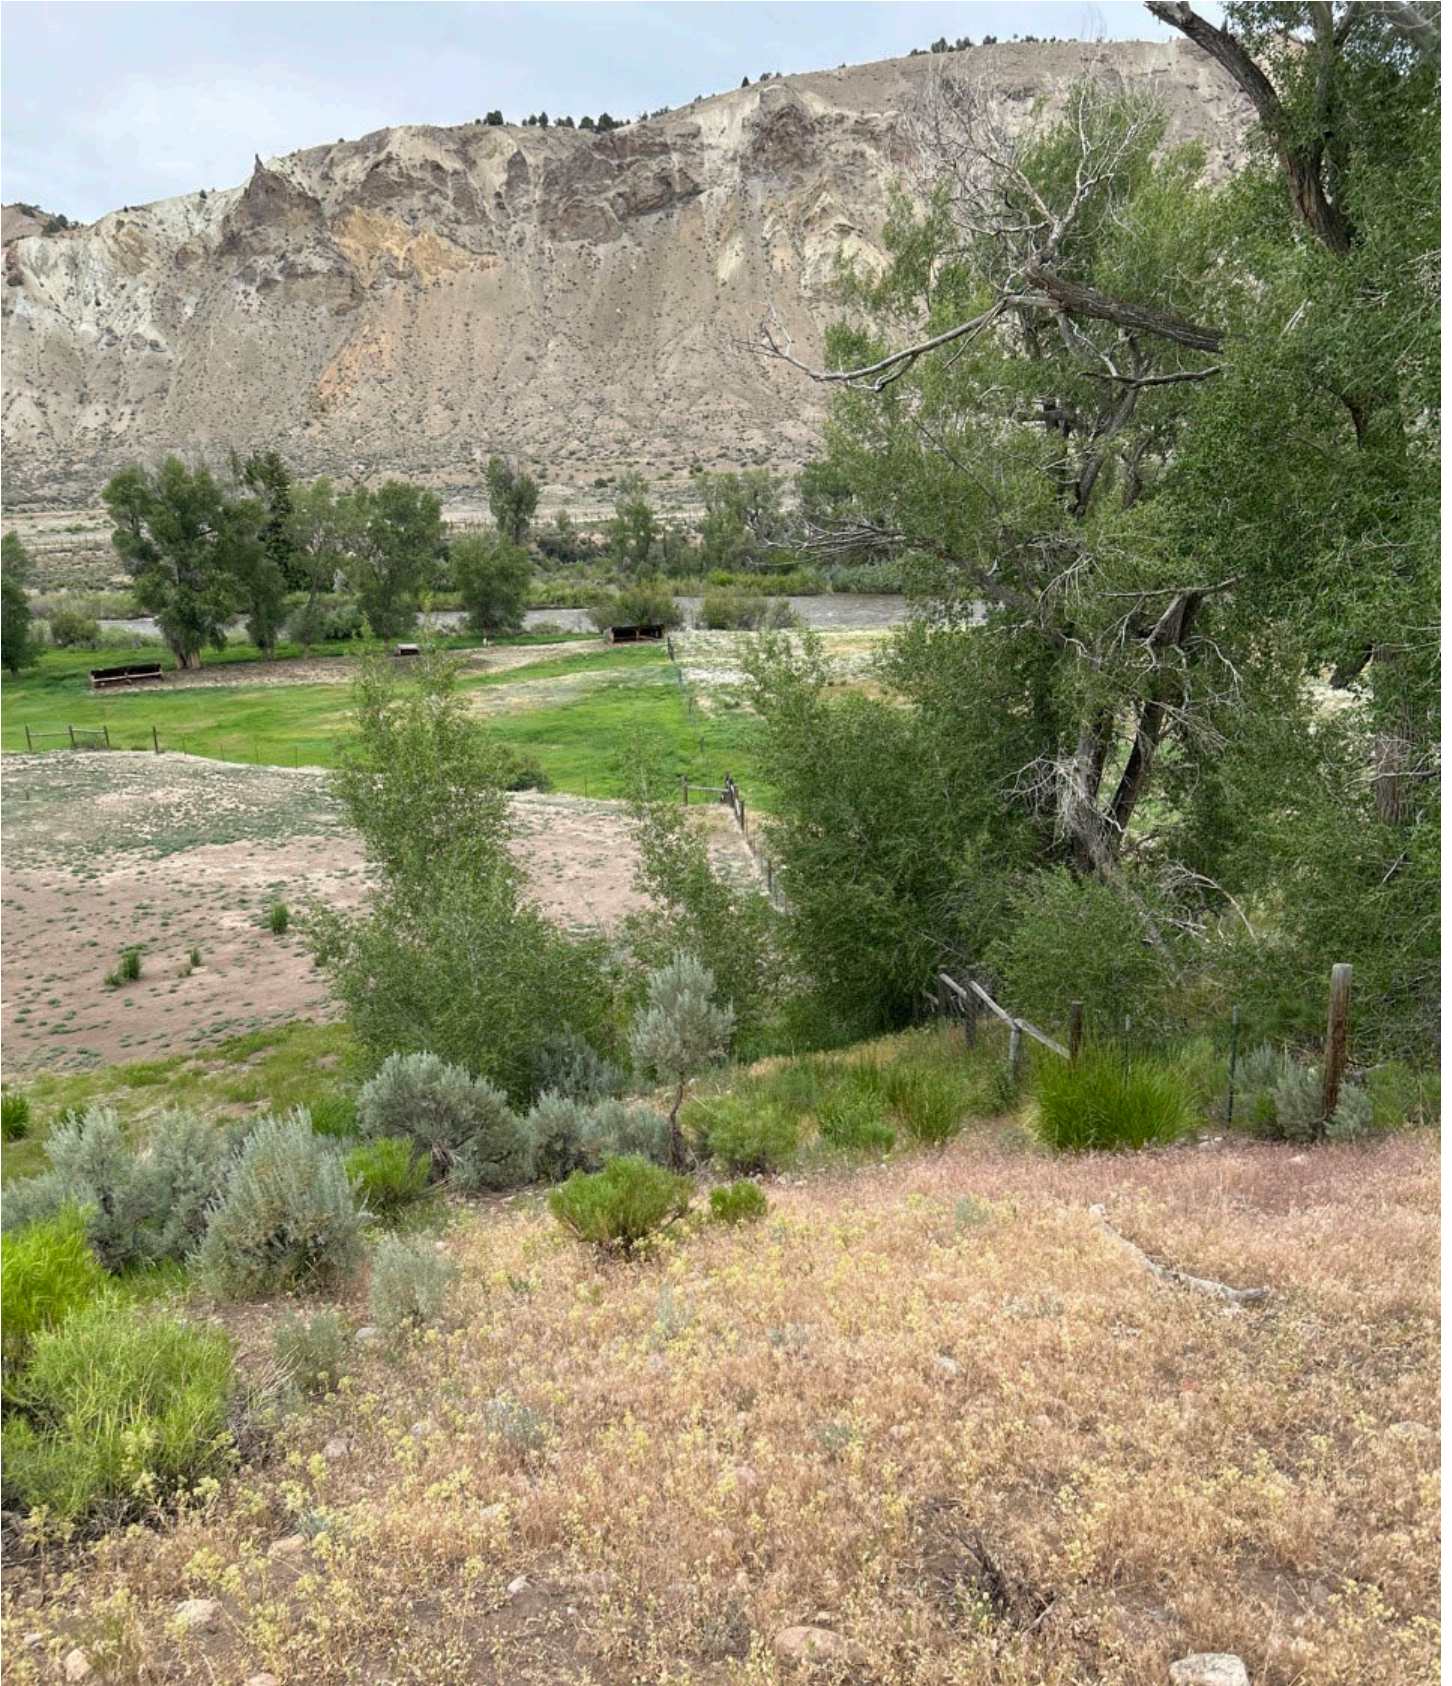
Figure 9: Northeast corner of permit area, looking north towards Eagle River (296)

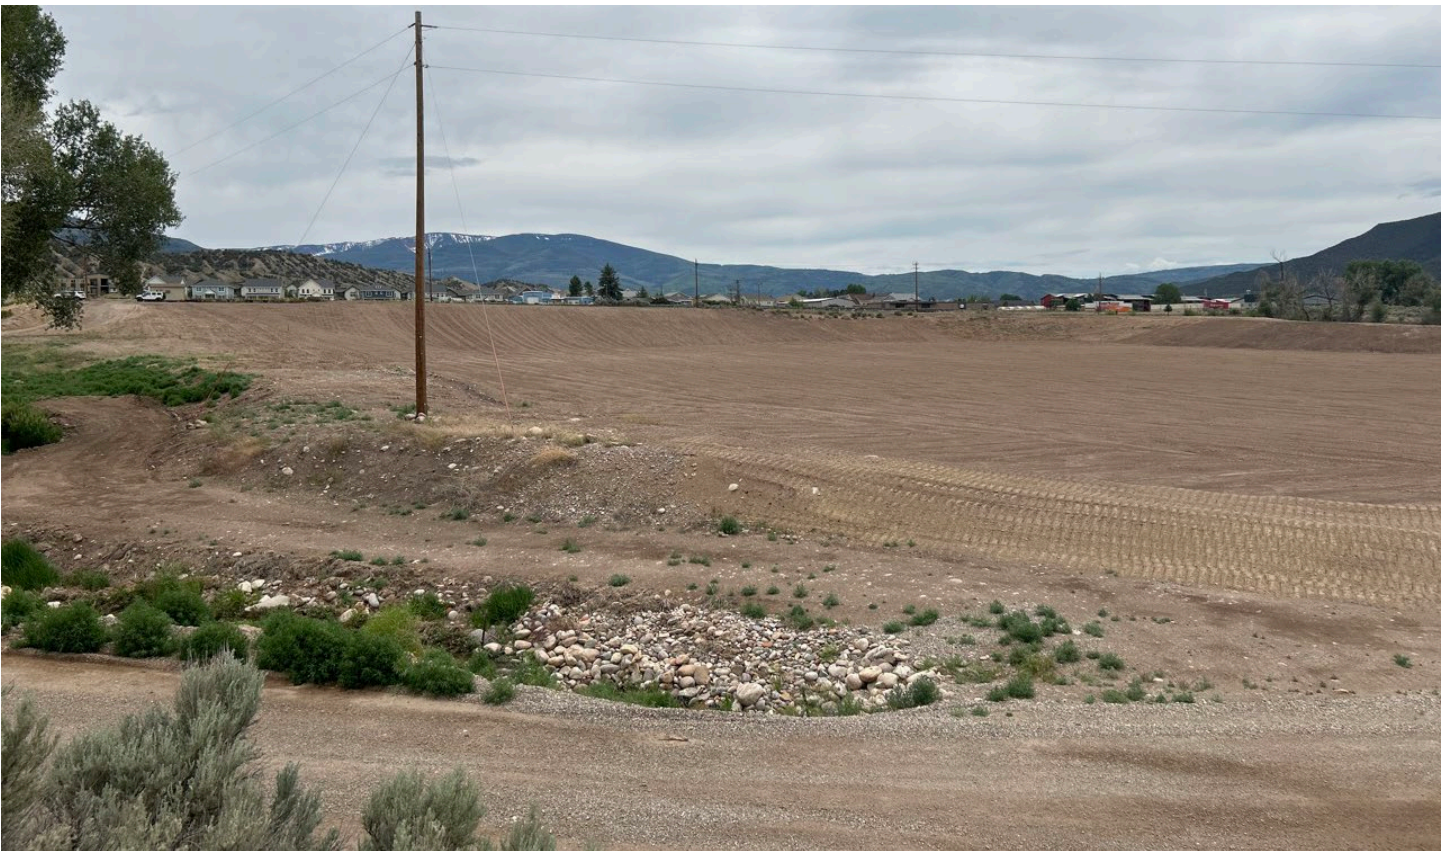
Figure 11: Western pit (298)

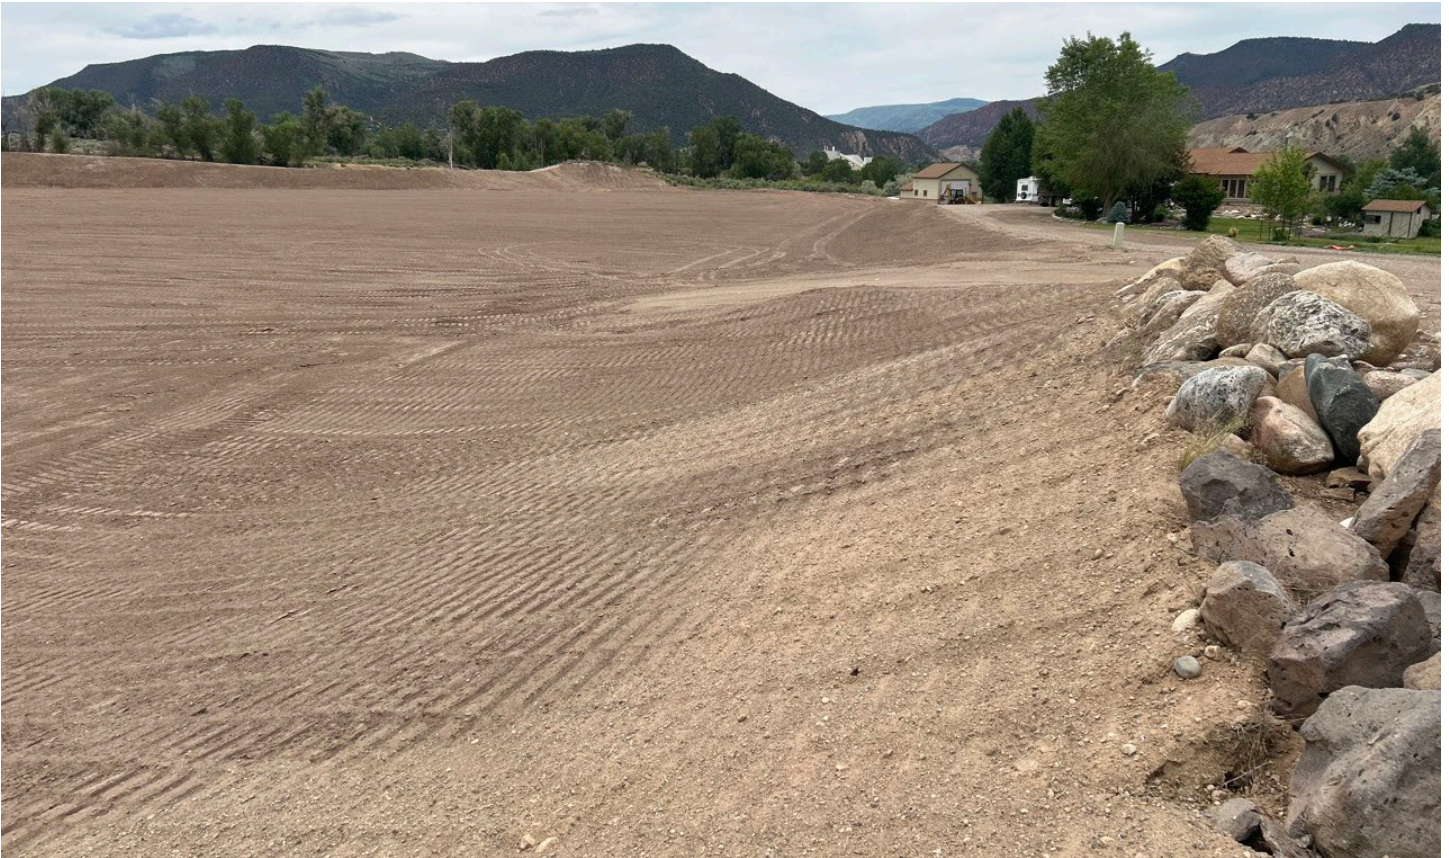
Figure 12: Northern edge of western pit (299)

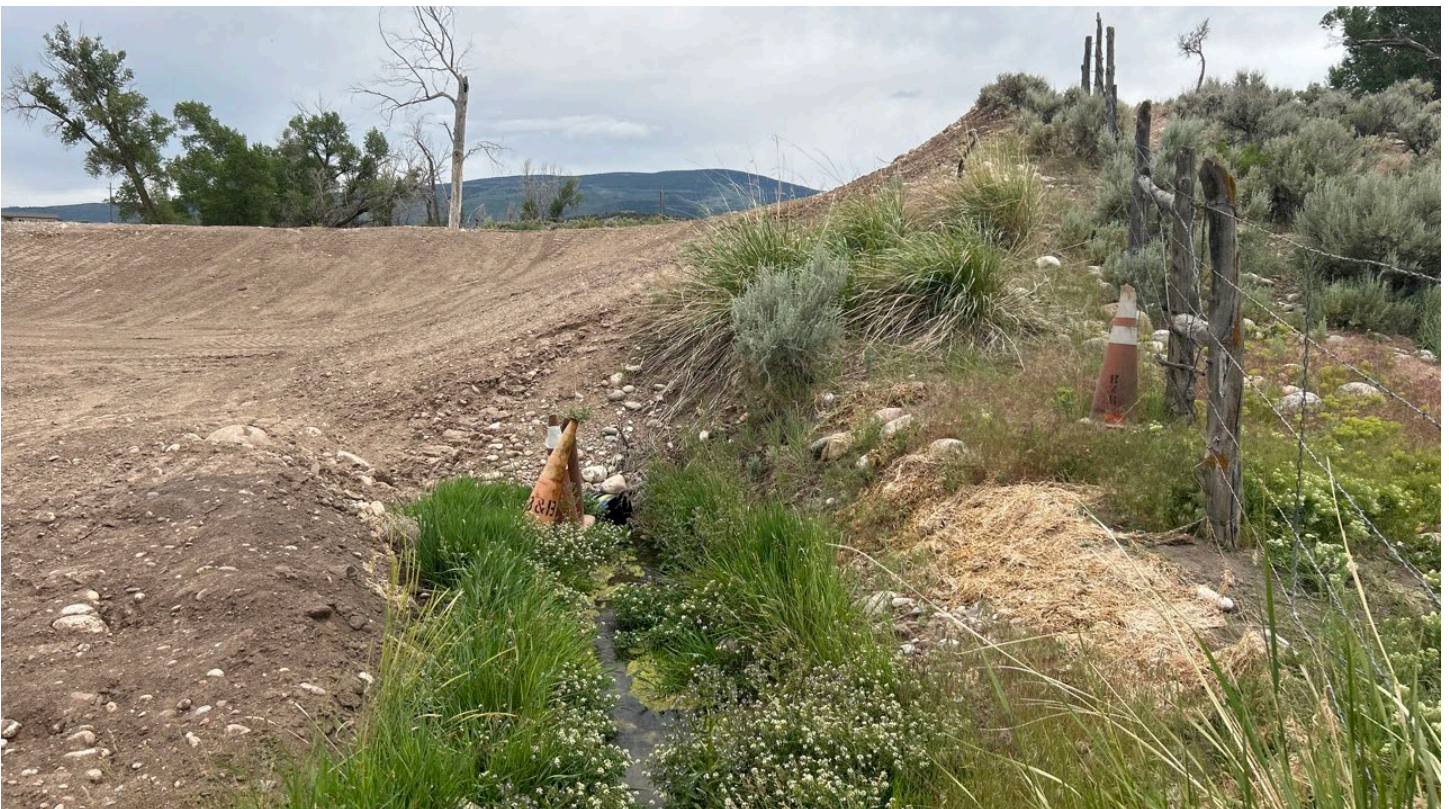
Figure 13: Western permit boundary (300)

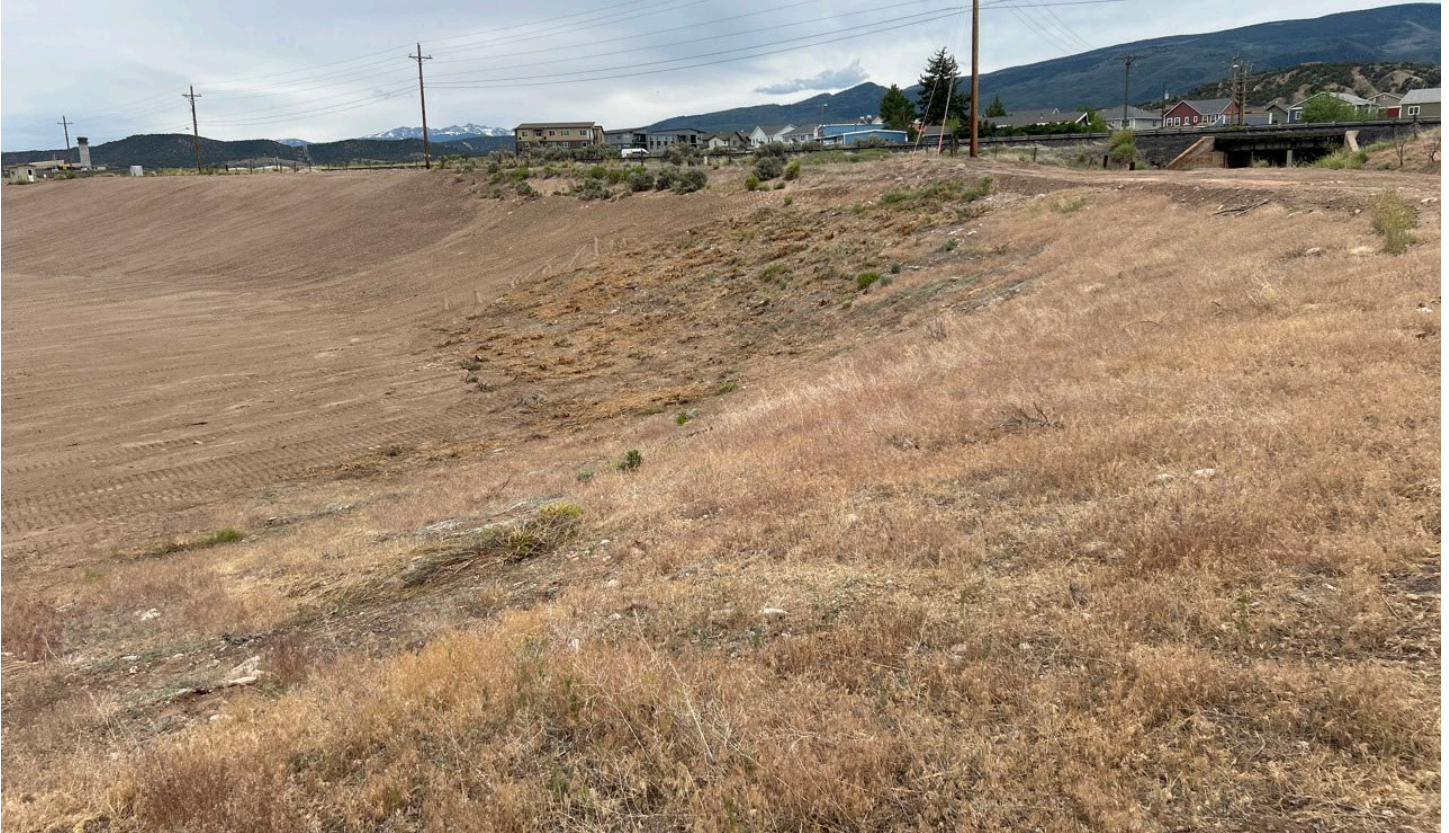
Figure 14: Northwest of permit area (302)

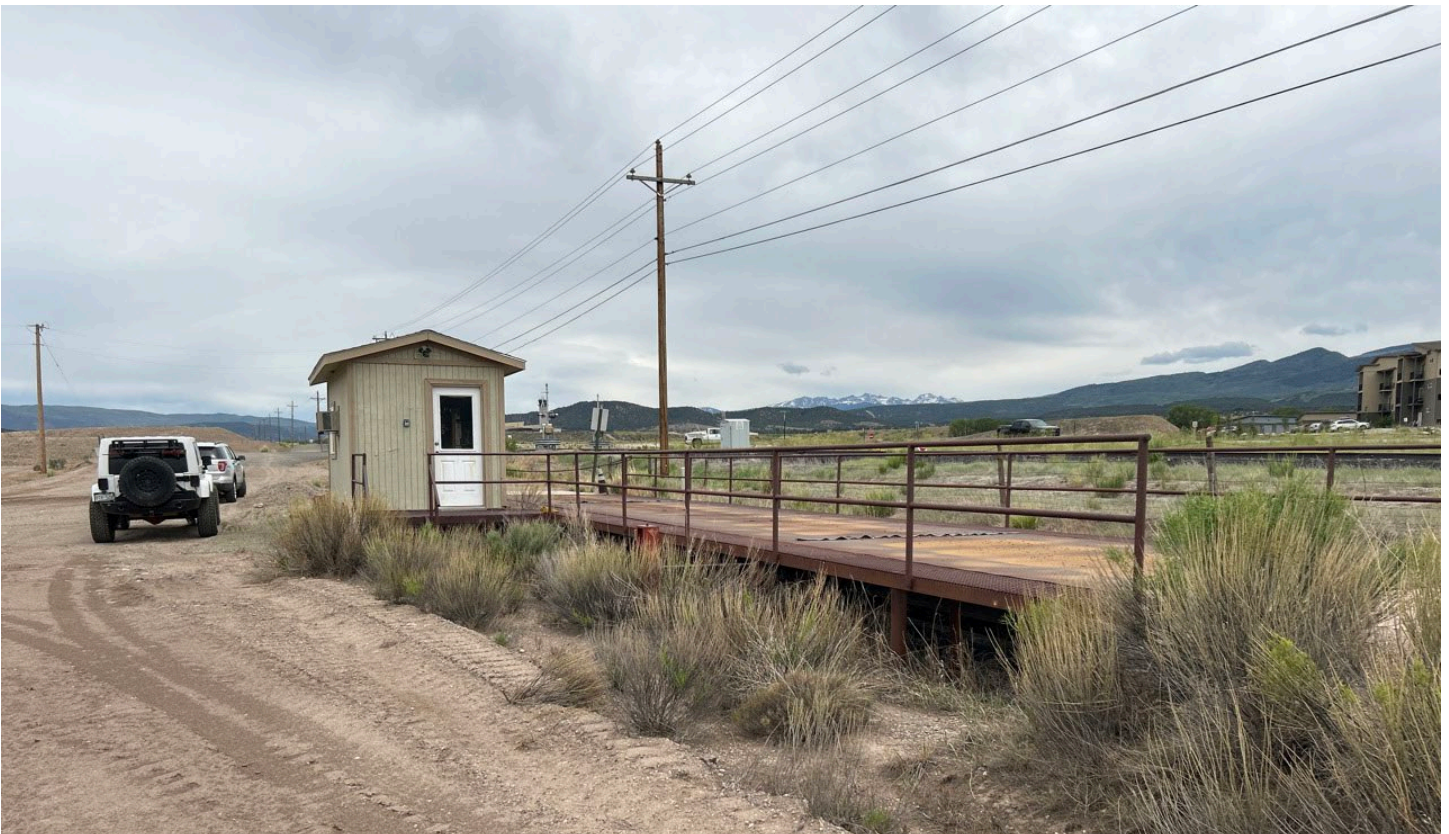
Since there is no longer an industrial/commercial post-mining land use for the site, the truck scale and building will need to be removed, and their foundations demolished, before the site will be eligible for bond release.

Figure 15: Truck scale (303)
