## Hooper Pit, Permit No. M-2020-024, Inspection Problem Abated

# MINERALS PROGRAM INSPECTION REPORT PHONE: (303) 866-3567

MINE NAME:	MINE/PROSPECTING ID#:	MINERAL:	COUNTY:
Hooper Pit	M-2020-024	Sand and gravel	Saguache
INSPECTION TYPE:	WEATHER: Clear	INSP. DATE:	INSP. TIME:
Monitoring		August 10, 2023	07:50
OPERATOR:	<b>OPERATOR REPRESENTATIVE:</b>	TYPE OF OPERATION:	
APC Southern Construction Co., LLC	Jim MacDonald	111 - Construction by Goverment Agency

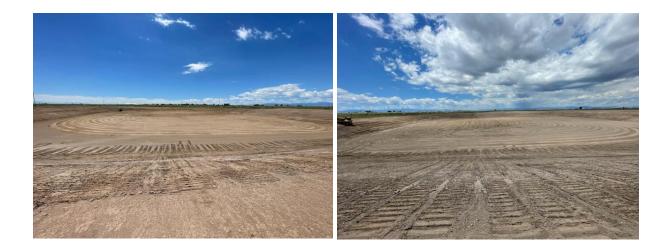
On July 10, 2024, the Division received photos of the pit backfilled to at least two feet above the groundwater surface. This satisfies the corrective action and it is considered abated.

Oldcastle SW Group, Inc dba APC Southern Construction Co. completed additional reclamation activities to cover and reduce groundwater exposure at the Hooper Pit on June 28, 2024. These activities' purpose is to finalize close out of the Hooper Pit M-2020-024 with the Division of Reclamation Mining and Safety. APC Southern has back filled the pit at least two feet above groundwater surface exposure and regraded slopes in a manner that restores to general drainage pattern of the site.
