## C1980007, West Elk Mine, July Inspection Report

### PERMIT INFORMATION

### INSPECTION INFORMATION

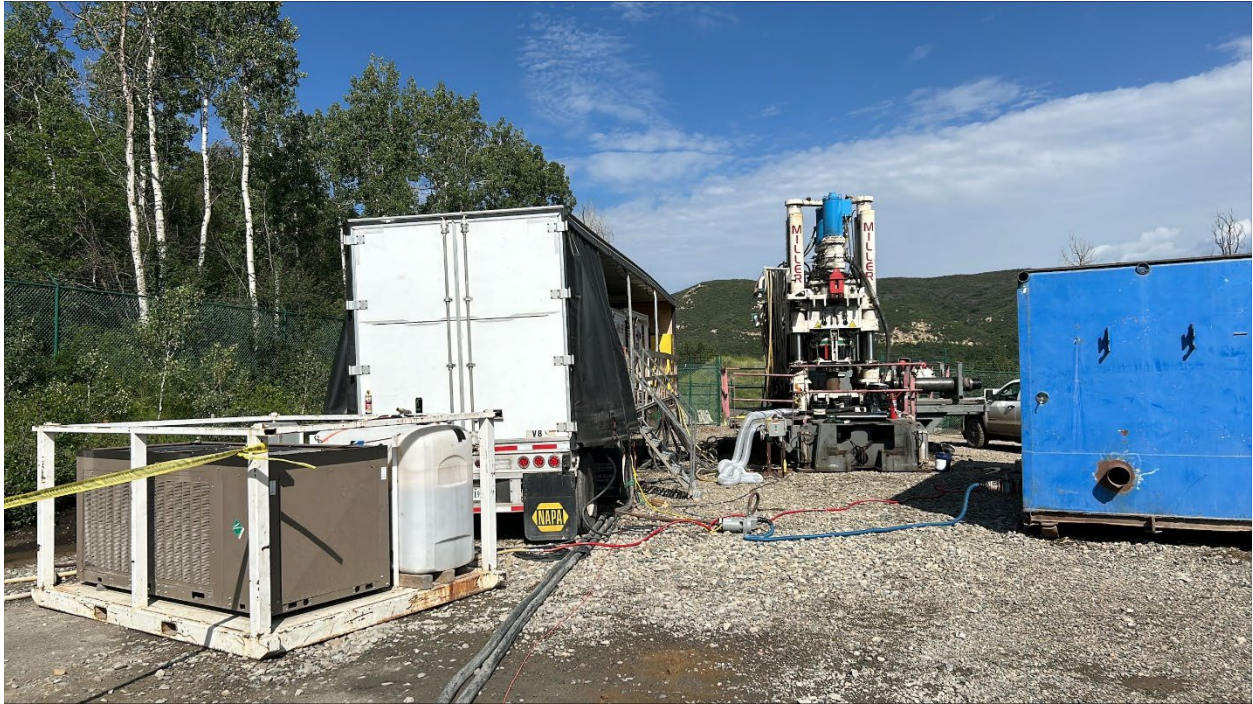
Colt Young, with Miller Contracting of Illinois, was operating a raisebore drill rig on the Deer Creek Shaft pad. The rig was to be used to construct a 22' diameter shaft between the B-seam and the E-seam. At the time of the inspection, the drill steel had just reached the floor of the B-seam through the pilot hole (which had previously

been constructed and cased by RACS). Work was going on underground to assemble the reamer, and reaming was anticipated to begin the following day.

*Figure 1: Raisebore drill rig on Deer Creek Shaft pad*

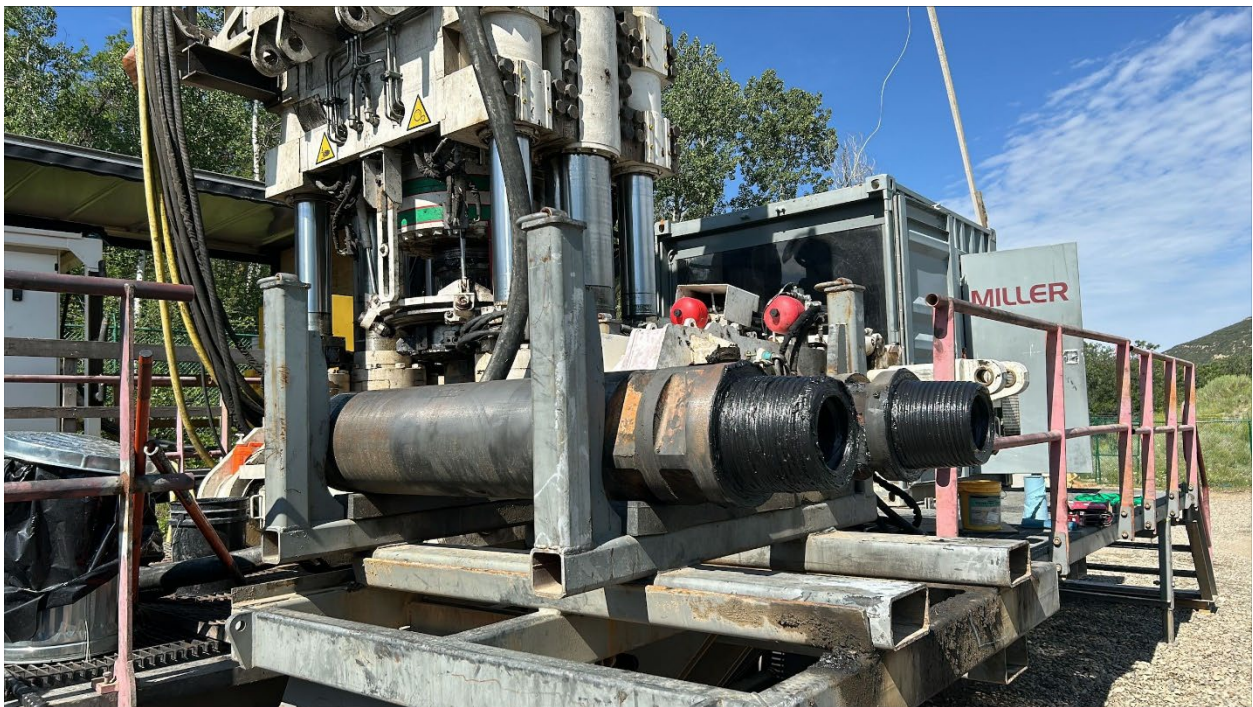
The rig itself is apparently one of only four in the United States. The drill steel used is 10 7/8" in diameter, and in 5' lengths. The torque that the assembled joints can handle is apparently the limiting factor on the diameter of shaft that can be constructed. Reaming was anticipated to take two weeks of constant operation (two 12-hour shifts, with a crew of two underground, and an operator on the surface). The bit will rotate at just 2 1/2 - 3 RPM during operation. The waste will fall into the mine workings, where a scoop will load it into a feeder and it will be conveyed out of the workings, in the same way that development material from continuous mining sections is handled.

*Figure 2: Drill steels and rig*

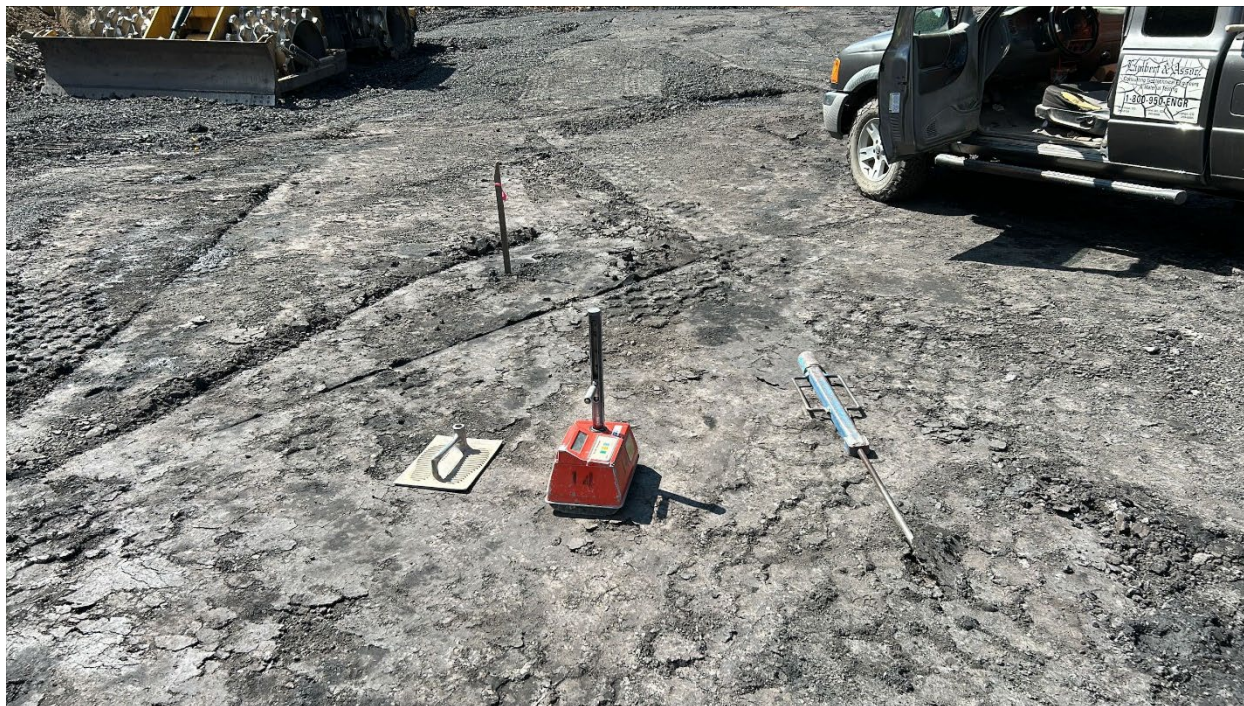
A contractor with Lambert and Associates was on site at the time of the inspection, carrying out compaction tests on the RPEE.

Figure 3: Compaction testing equipment on RPEE

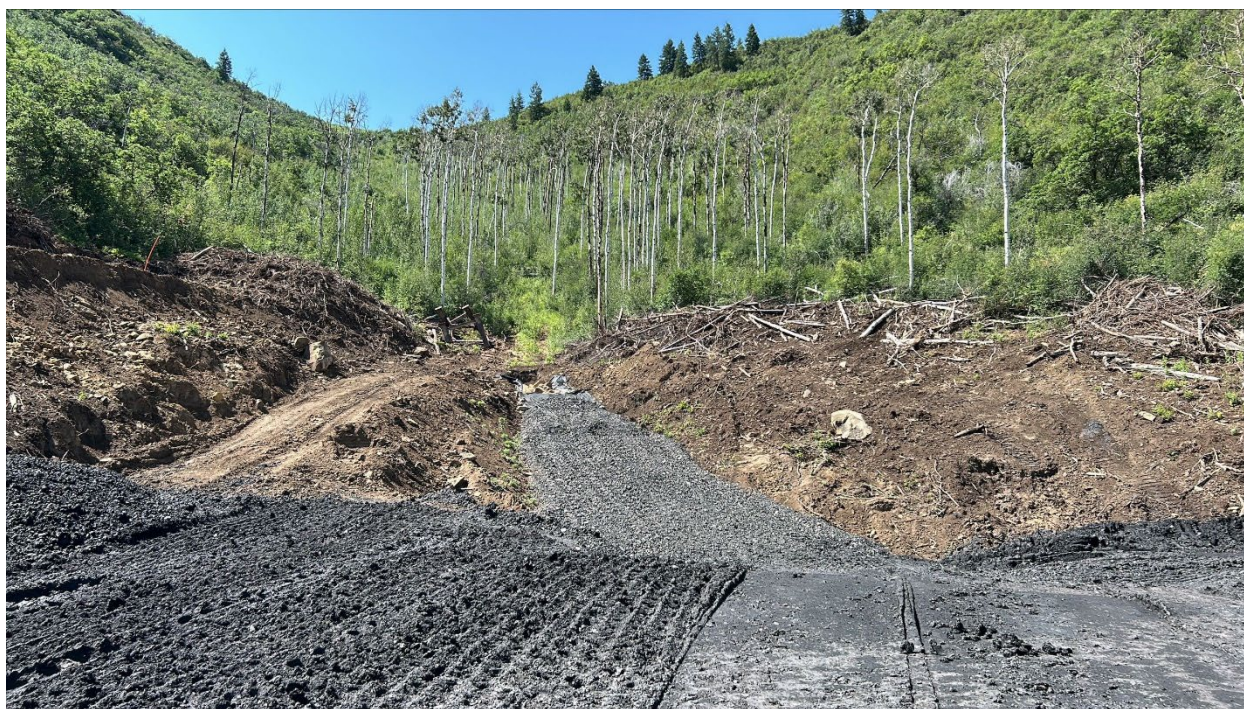
Topsoil on the eastern edge of the pile had been stripped, and the underdrain had been extended. The topsoil was not expected to be stockpiled, but transported directly to the front of the pile to reclaim the graded outslopes.

Figure 4: View to the south, showing extension of underdrain

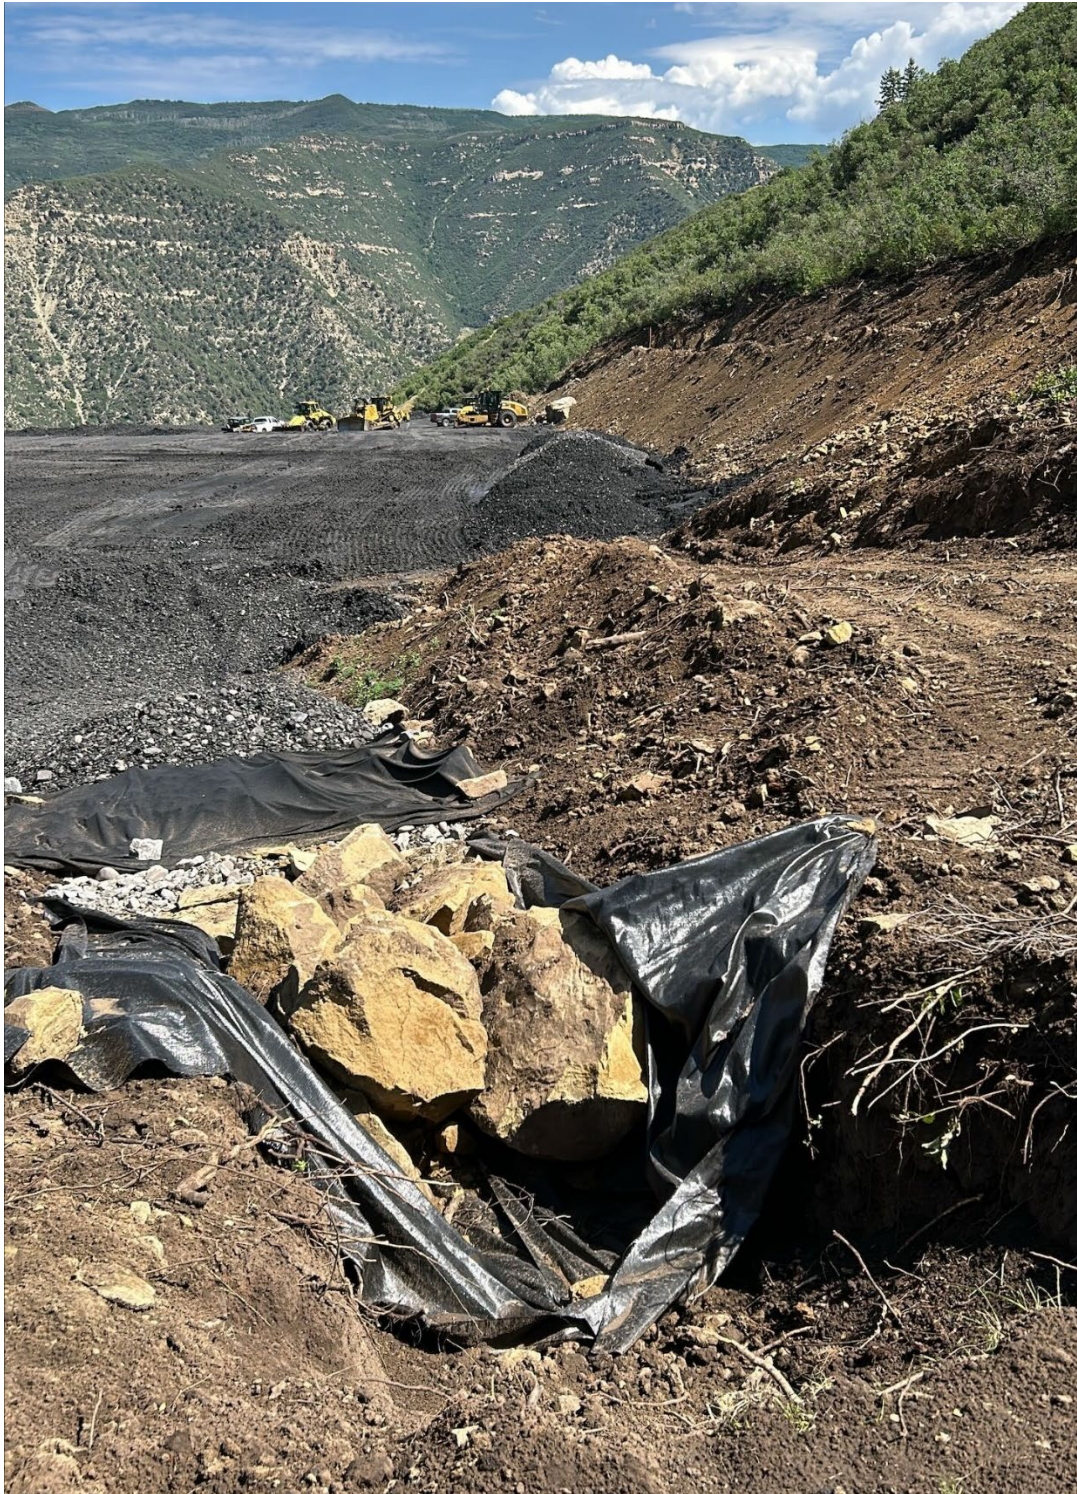
*Figure 5: RPEE underdrain*

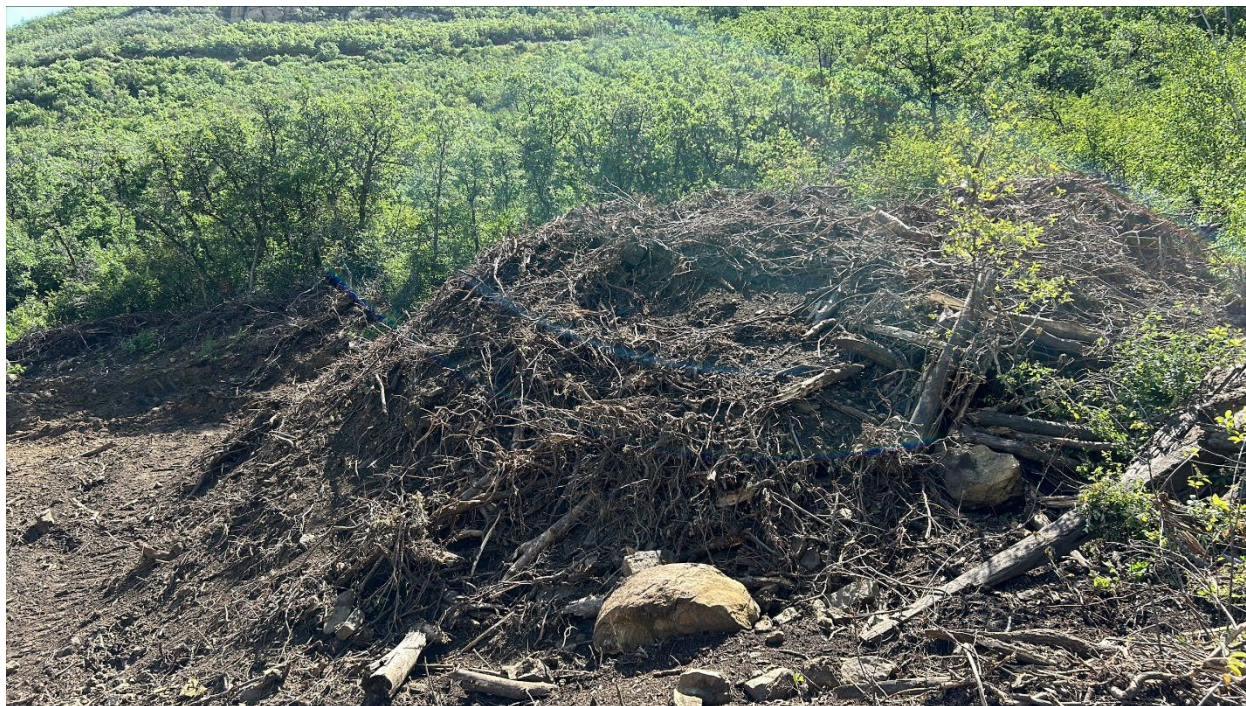
*Figure 6: Vegetation grubbed prior to topsoil stripping*

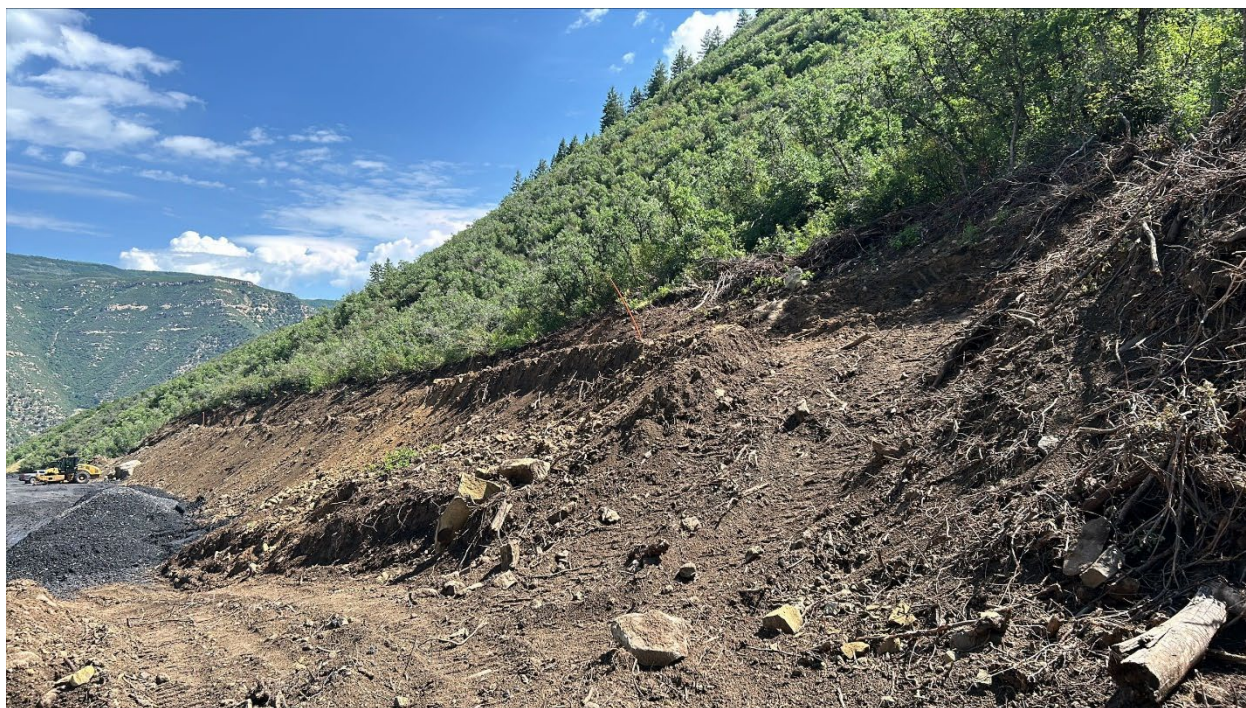
*Figure 7: Stripped topsoil on eastern edge of RPEE*

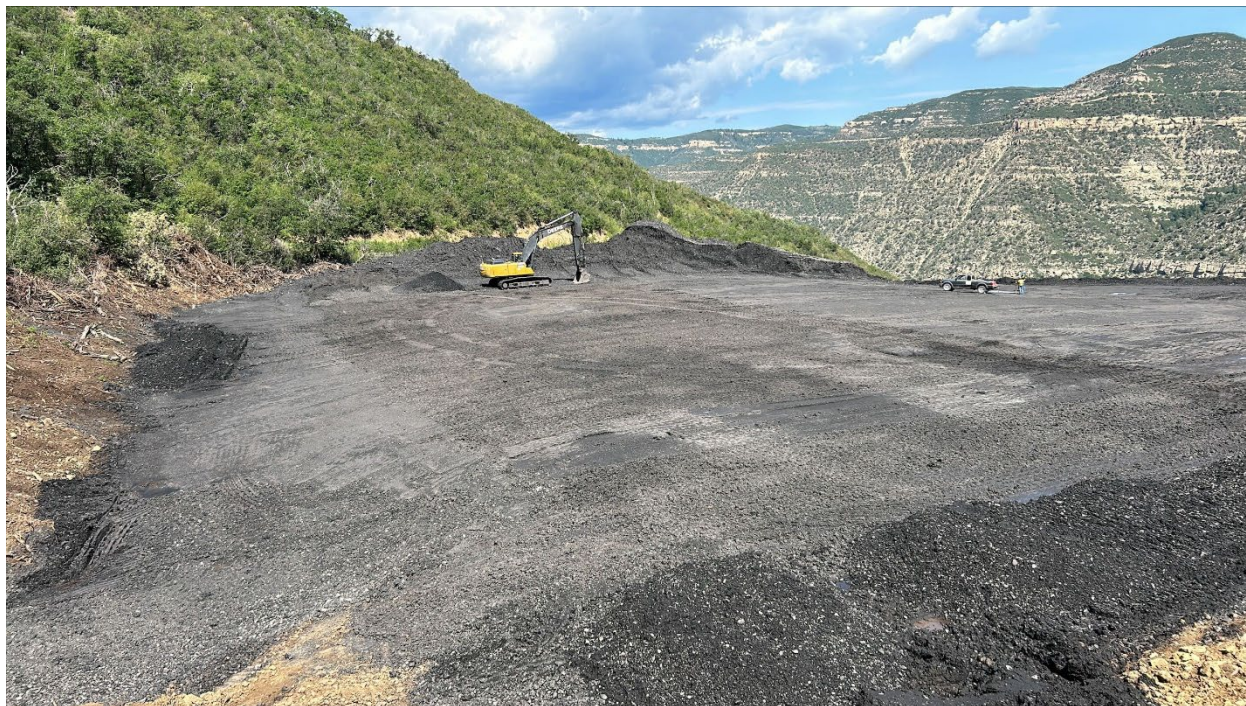
Refuse was being generated at the time of the inspection. New refuse continued to be temporarily stockpiled on the RPE. Some new refuse was being transported to the RPEE, but the work to spread, dry and compact material that had been transported before the winter was still in progress and was the priority. Most of that material had been dealt with, but a substantial stockpile remained on the western edge of the RPEE.

*Figure 8: View to the northwest across the RPEE, showing stockpiled material remaining to spread and compacted*

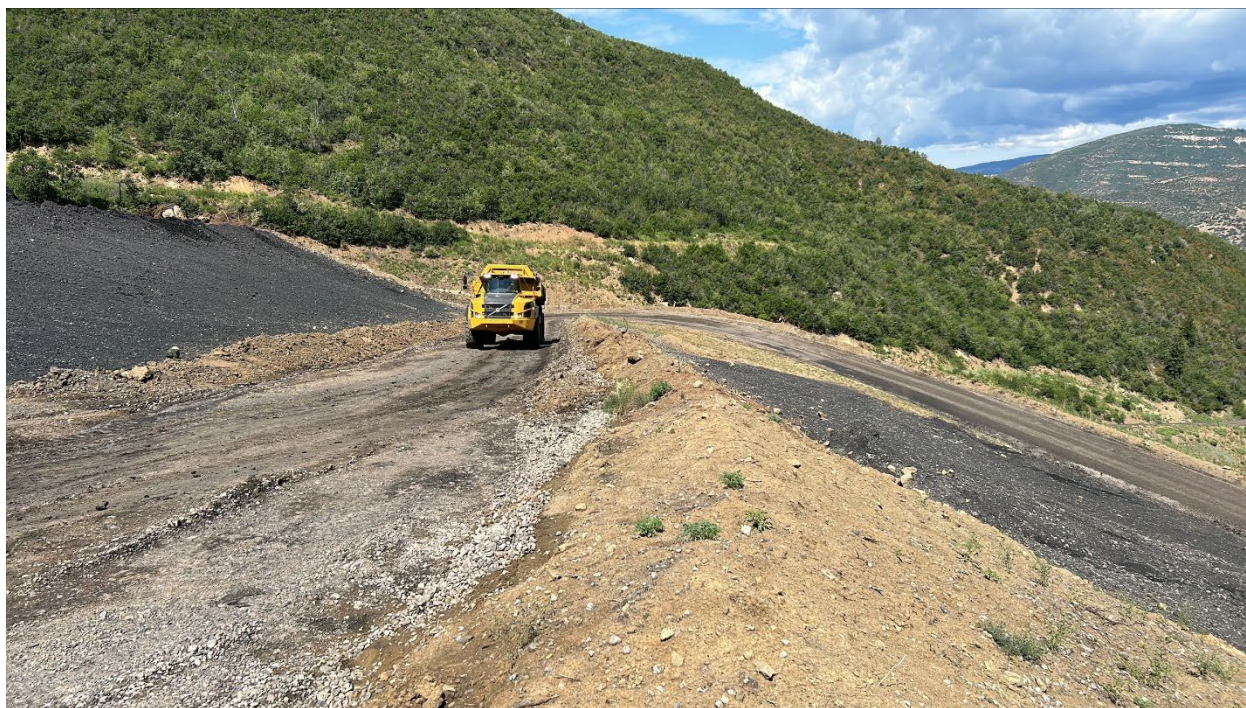
*Figure 9: New material being transported to RPEE*

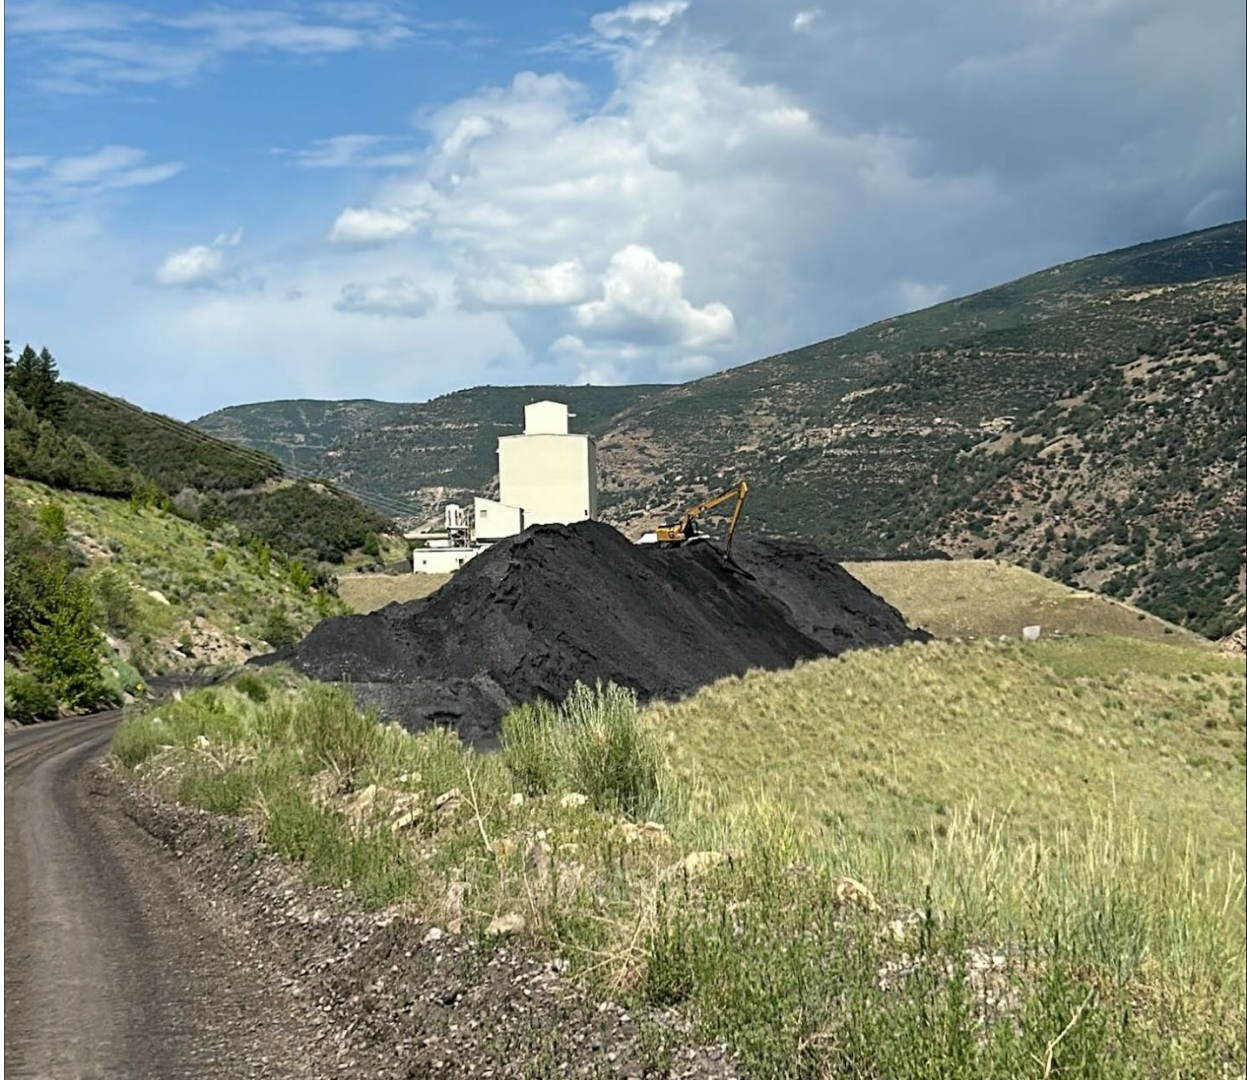
*Figure 10: Temporary stockpile on RPE*

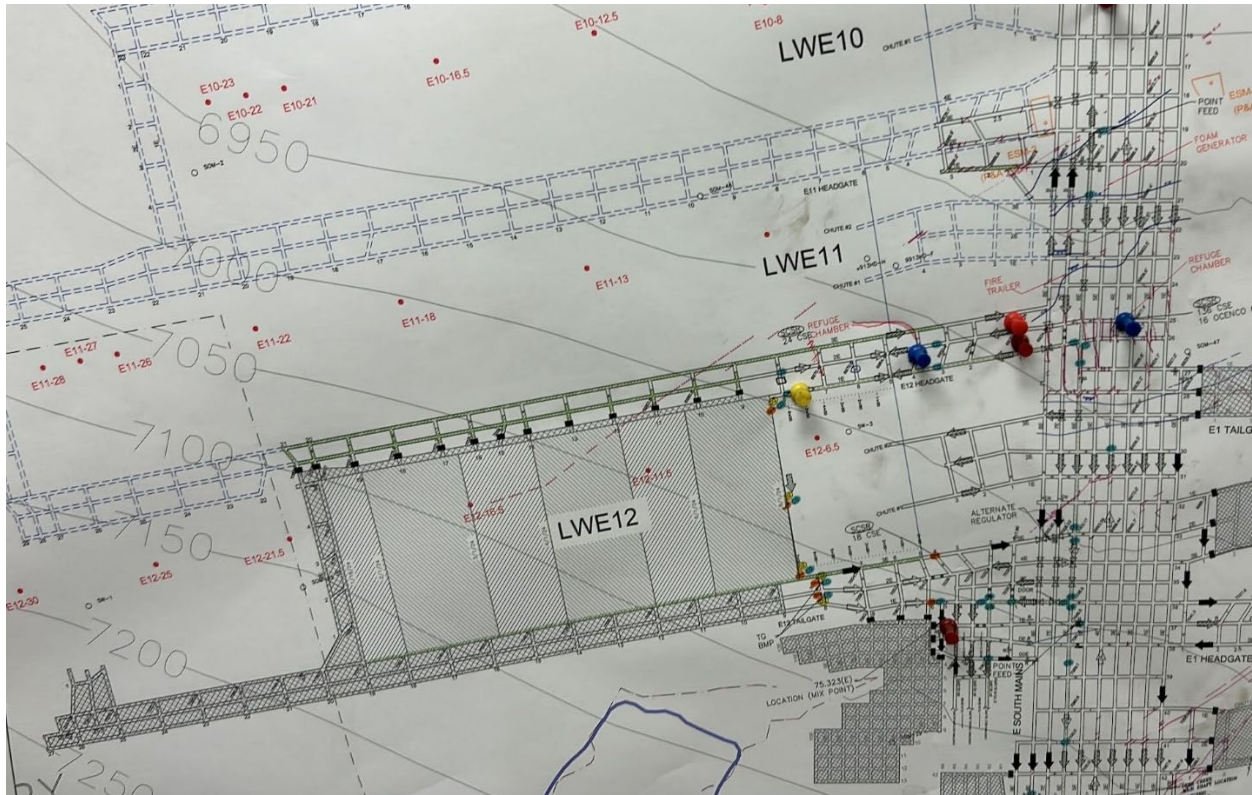
Longwall mining of the LWE12 panel was in progress, between crosscuts 9 and 8 on the headgate. A longwall move to LWE16 was scheduled for August 19th.

Figure 11: Mine map showing longwall progress

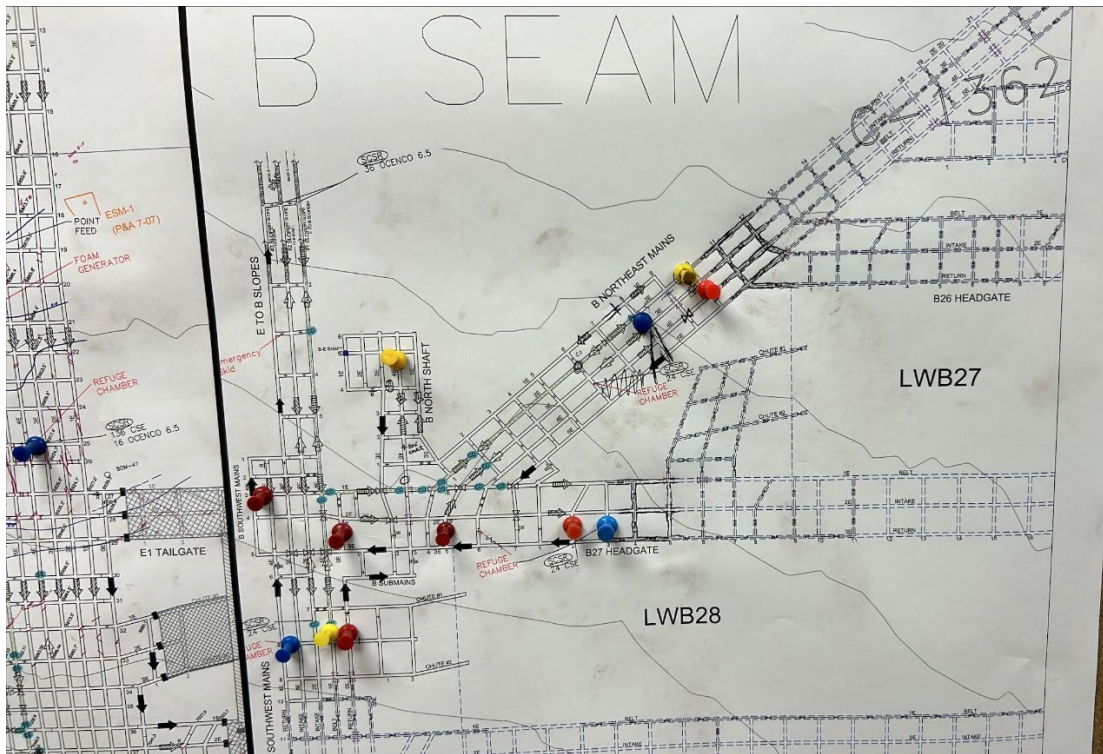
Development of the B Northeast Mains and the B27 headgate was in progress.

Figure 12: Mine map showing development progress in B-seam

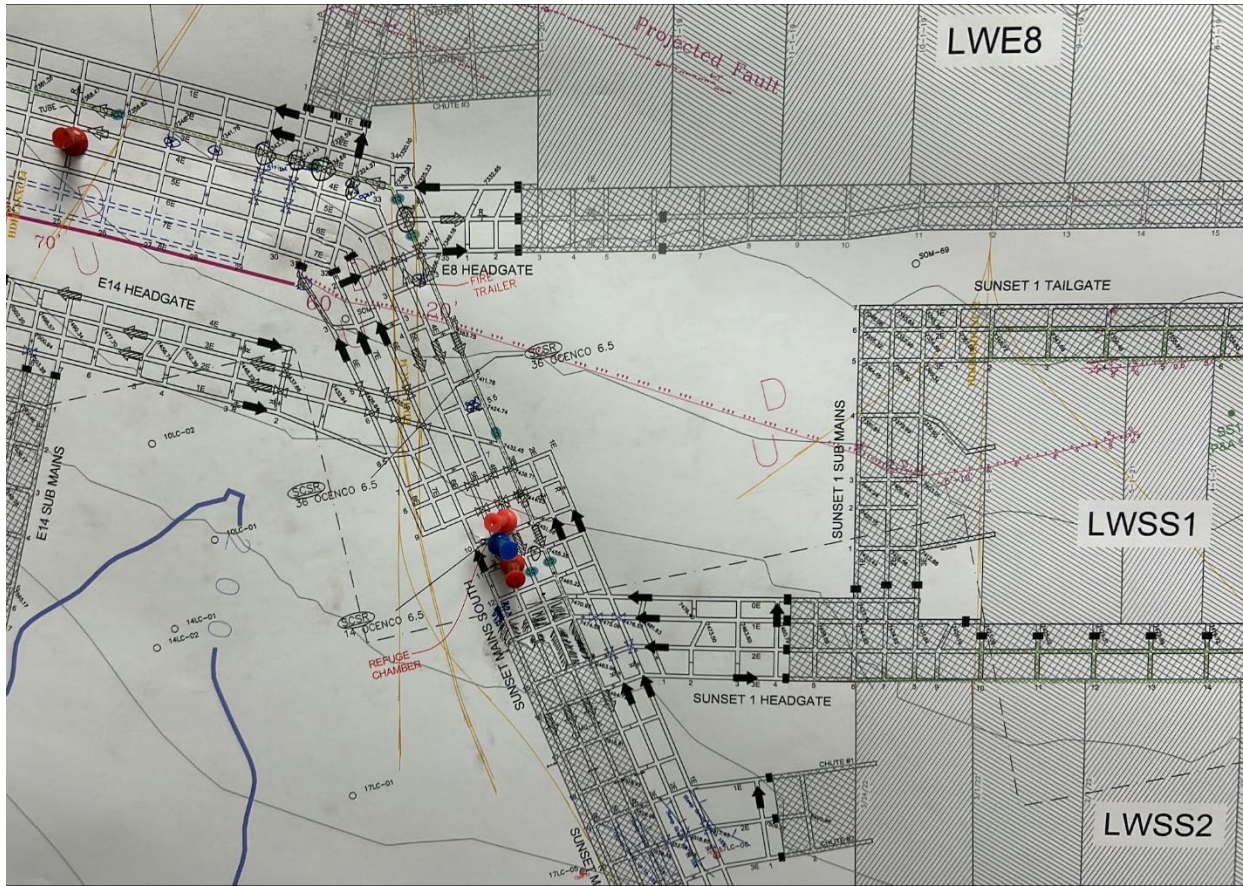
Pillaring of the Sunset Mains South was in progress, at around crosscut 12. The work was being done by contractors with Phoenix Mining.

Figure 13: Mine map showing pillaring progress in Sunset Mains South
