New Horizon North Mine, C-2010-089, June 2024 Bond Compliance Inspection Report

PERMIT INFORMATION

Permit Number: C-2010-089 Mine Name: New Horizon North Mine Operator: Elk Ridge Mining and Reclamation, LLC Operator Address: Mr. Tony Tennyson P.O. Box 628 27646 West 5th Avenue Nucla, CO 81424	County: Montrose Operation Type: Surface Permit Status: Active Ownership: Private
	Operator Representative Present: Mindy Sickles
Operator Representative Signature: (Field Issuance Only)

Inspection Start Date: June 20, 2024 Inspection Start Time: 11:15 Inspection End Date: June 20, 2024 Inspection End Time: 12:10	Inspection Type: Coal Partial Inspection Inspection Reason: Surety Related Weather: Cloudy	
Joint Inspection Agency: None	Joint Inspection Contacts: None	
Post Inspection Agency: None	Post Inspection Contacts: None	
Inspector(s): Clayton Wein	Inspector's Signature: <i>Clayton Wein</i>	Signature Date: 7/18/2024

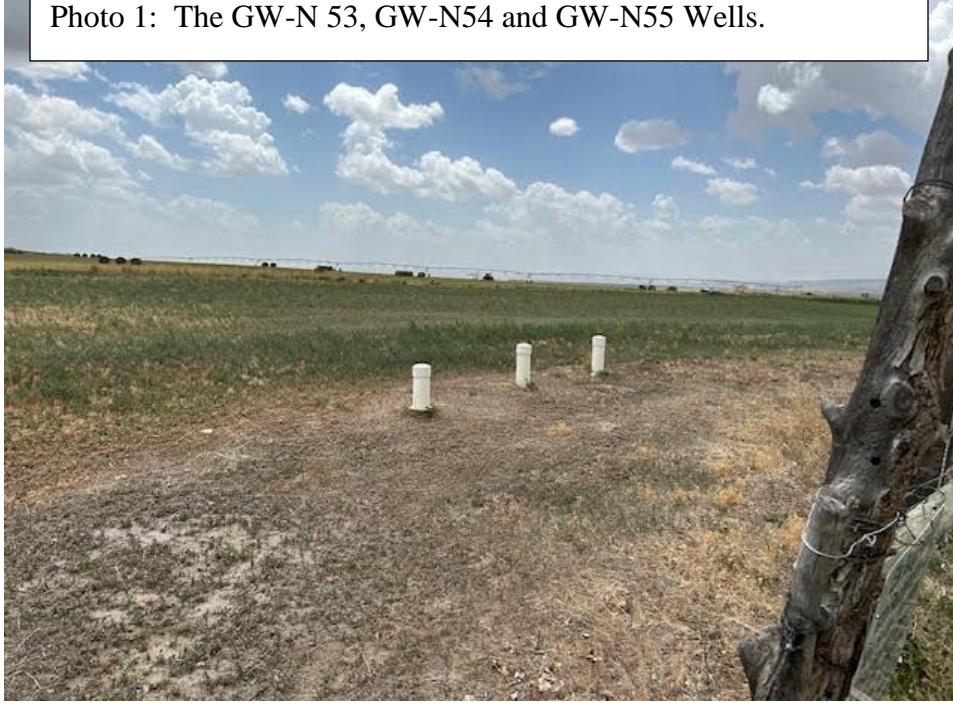
There are three groundwater monitoring Locations within the permit boundary. Each location consists of a cluster of three monitoring wells each. The first cluster is located in the northeast portion of the permit area. Wells GE-N50, GW-N51 and GW-N52 were stable and in good condition. Each of the well's PVC pipe was easily identified. Each well casing had a PVC cap on it. The second cluster of wells, GW-N53, GW-N54 and GW-N55, is located in the central western portion of the permit area (Photo 1). The PVC Wells were easy to locate and in good condition. Each well casing had a cap covering the well. The third cluster of monitoring wells, GW-N56, GW-N 57 and GW-N58, are located in the southwest corner of the permit area. All three PVC wells were in good condition. The PVC caps were all intact.

Photo 1: The GW-N 53, GW-N54 and GW-N55 Wells.

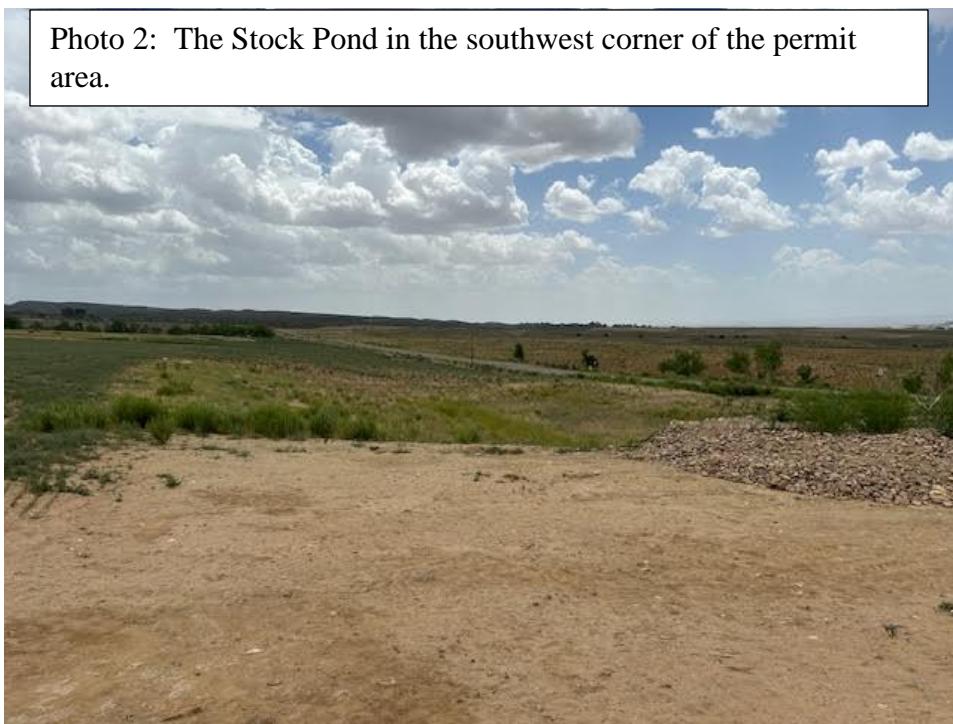
Pond 001 was reclaimed and reduced in size to a stock pond as per the approved post mining-land use (Photo 2). The embankments for the stock pond remained similar to that of previous Division inspections. The documented rills had not enlarged. The stock pond was stable.

Photo 2: The Stock Pond in the southwest corner of the permit area.

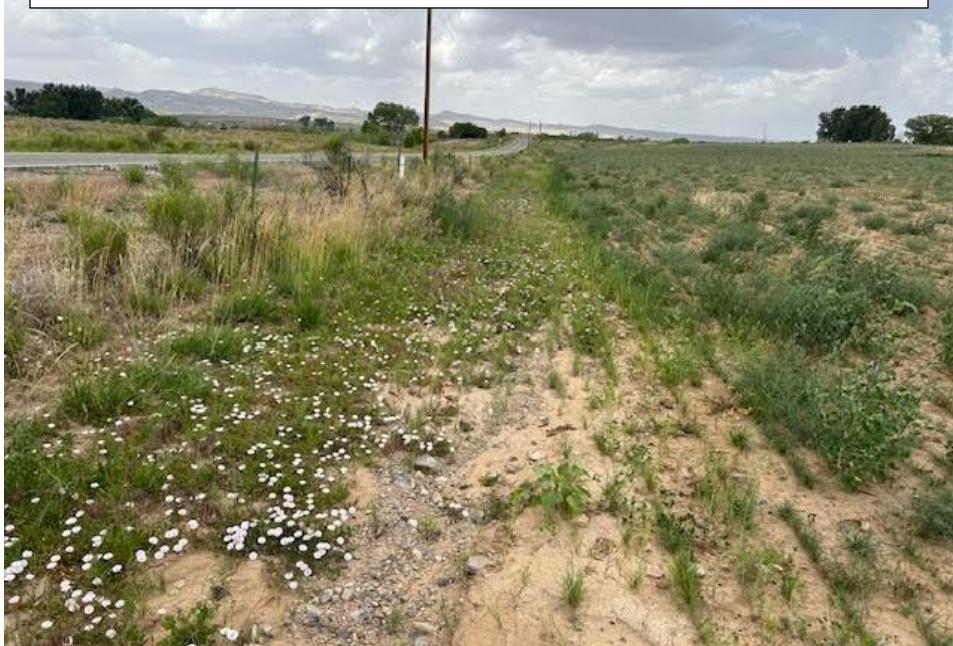
The western (Photo 3), southern (Photo 4) and eastern sections of the mine permit area were Phase I reclaimed in 2023. SL-04 approved the Phase I release of these areas. The reclamation was backfilled, graded, topsoiled and seeded. Vegetation on the newly reclaimed areas was filling in well and helping stabilize the area. The post mining land use approved for these areas is dryland pasture. There were no off site impacts observed.

Photo 3: The southern permit area Phase I reclamation.

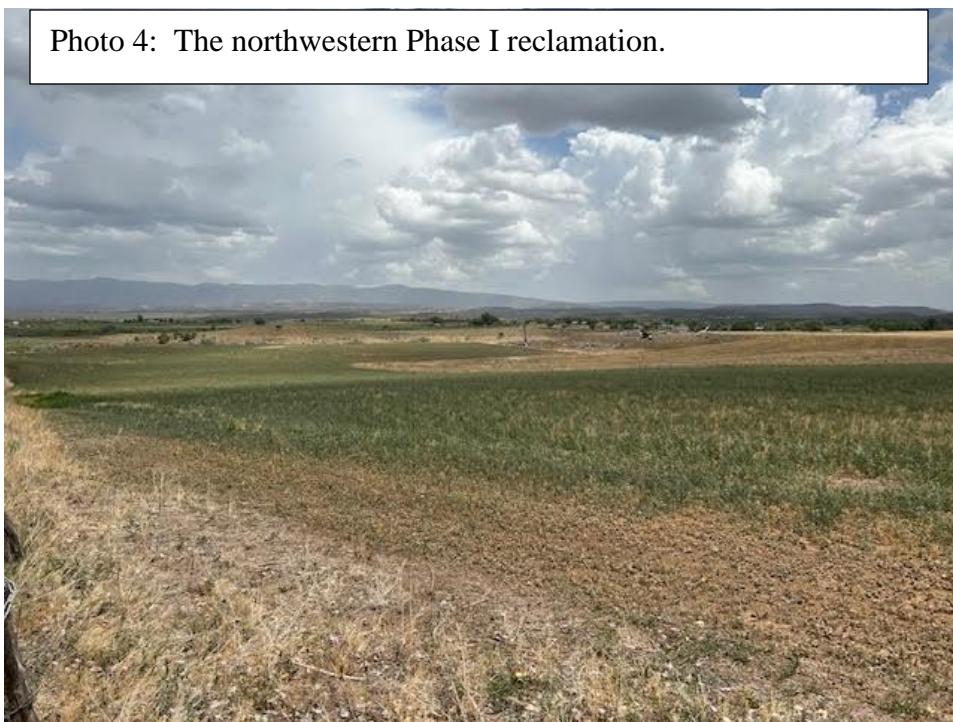
Photo 4: The northwestern Phase I reclamation.

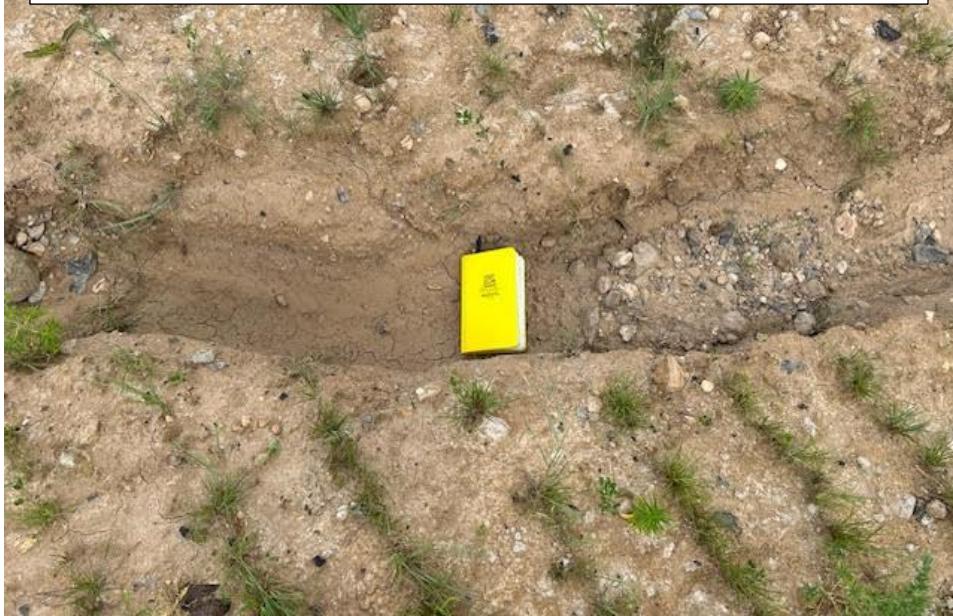
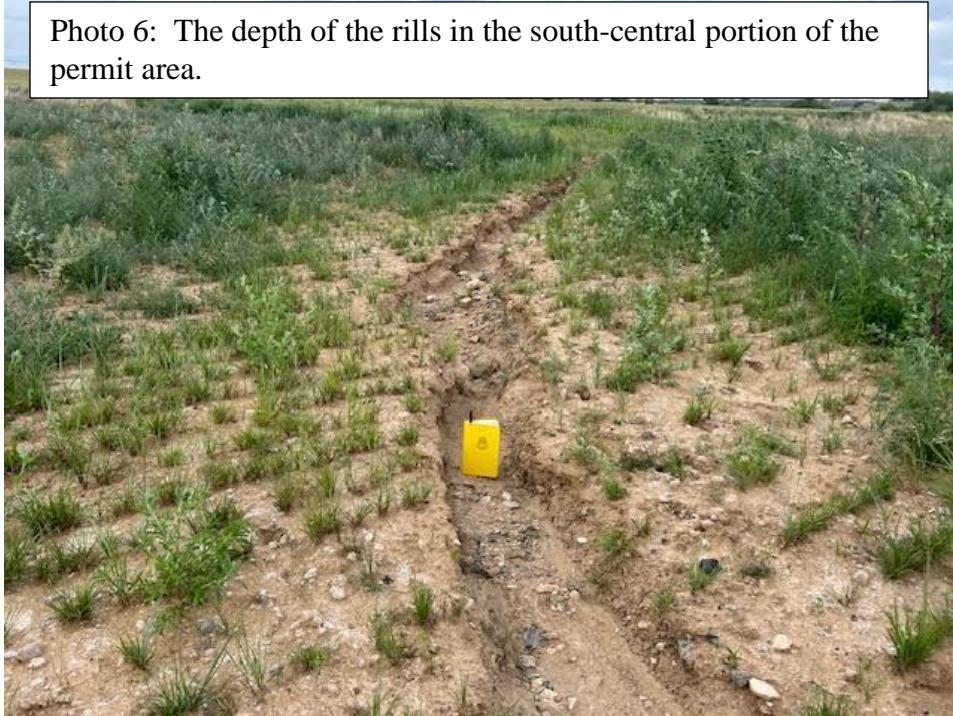
In the middle of the southern reclamation a couple of large rills have formed. The rills were documented in the Division's May 2024 Inspection Report. Since May the rills had enlarged and lengthened (Photos 5 and 6). The cause of the rills was identified to be runoff from the irrigated pasture located at the center of the permit area. A center pivot waters the irrigated area. The rills formed in a low spot and continued from north to south and then turn west right before the permit boundary. Water transported in the rills appeared to flow to an armored inlet of a culvert that goes underneath AA Road. This culvert is approved as a permanent post mining feature to allow runoff to flow under AA Road and into a drainage on the south side of the road. Since the date of the June 20, 2024 inspection, the operator has placed waddles above the rills to help reduce erosion for the duration of the irrigation season. After irrigation season, the operator will submit a revision to the division to propose a permanent solution to repair the rills and implement a permanent feature to allow the future irrigation runoff to flow across this area.

Photo 5: The width of the rills located in the south-central portion of the permit area.

Photo 6: The depth of the rills in the south-central portion of the permit area.

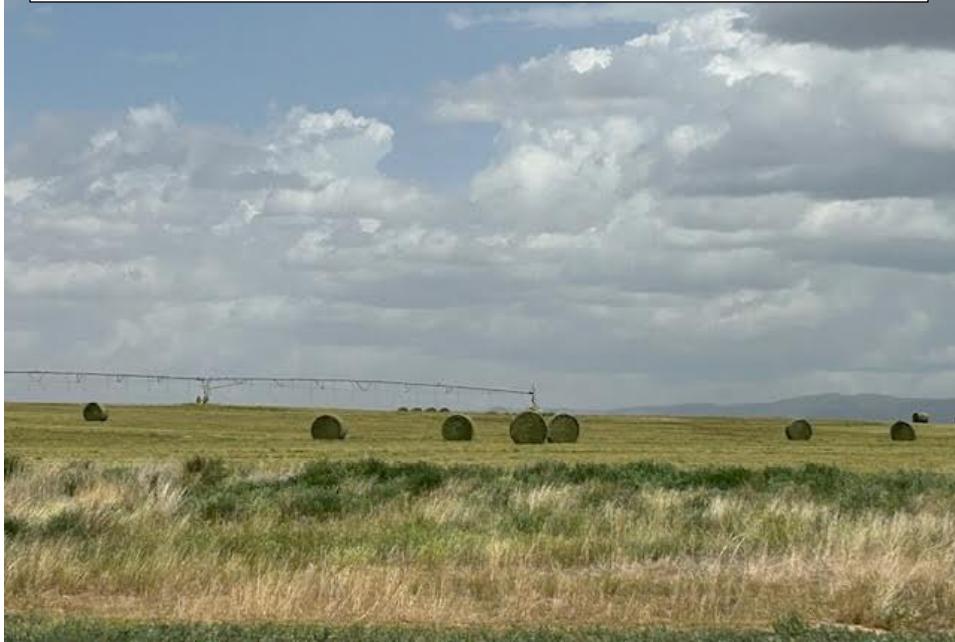
The middle of the permit area reclaimed to irrigated pasture was stable with no erosional features observed. The hay grown on the pasture this season had been cut and baled (Photo 7).

Photo 7: The irrigated pasture at the center of the permit area.

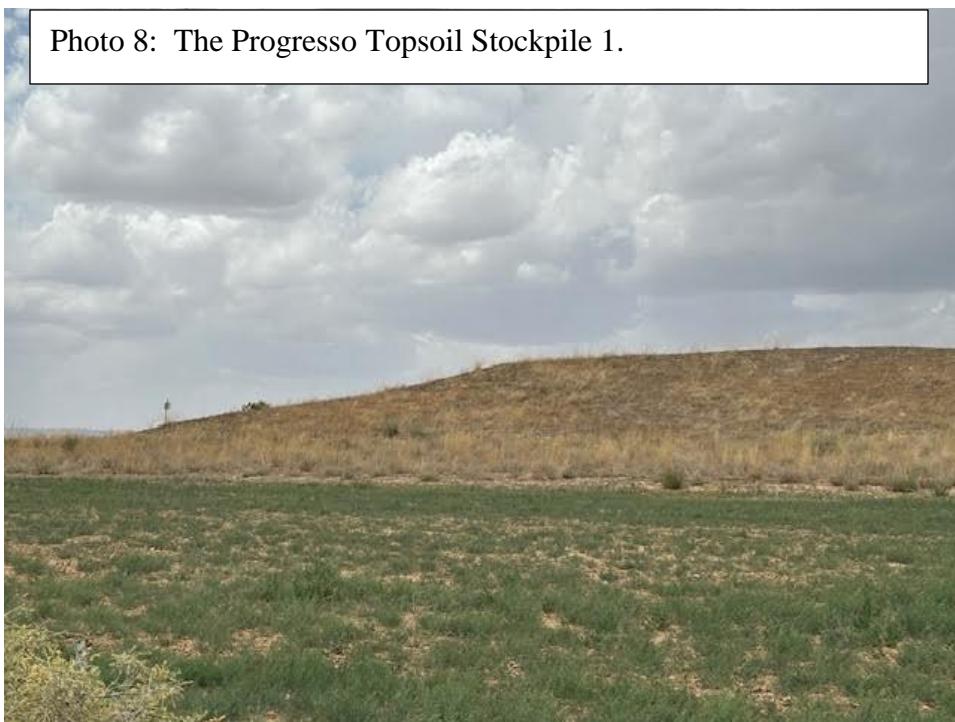
One topsoil pile remains at the New Horizon North Mine named the Progresso Topsoil Stockpile 1 (Photo 8). The topsoil stockpile has been approved to remain as a permanent post mining feature at the request of the landowners. The topsoil stockpile was stable with vegetative cover. There were no erosional feature observed. The perimeter ditch was stable with no obstructions. There was no loss of topsoil resource observed.

Photo 8: The Progresso Topsoil Stockpile 1.
