## Inspection report for Bowie #2 Mine

<b>Permit Number:</b> C-1996-083 <b>Mine Name:</b> Bowie No. 2 Mine <b>Operator:</b> Bowie Resources, LLC <b>Operator Address:</b> Mr. Basil Bear P.O. Box 1488 Paonia, CO 81428	<b>County:</b> Delta <b>Operation Type:</b> Underground <b>Permit Status:</b> Active <b>Ownership:</b> Private
	<b>Operator Representative Present:</b>  Ken Pitt
<b>Operator Representative Signature: (Field Issuance Only)</b>

<b>Inspection Start Date:</b> July 17, 2024 <b>Inspection Start Time:</b> 06:45 <b>Inspection End Date:</b> July 17, 2024 <b>Inspection End Time:</b> 11:15		<b>Inspection Type:</b> Coal Partial Inspection <b>Inspection Reason:</b> Normal I&E Program <b>Weather:</b> Clear	
<b>Joint Inspection Agency:</b>  None		<b>Joint Inspection Contacts:</b>	
<b>Post Inspection Agency:</b>  None		<b>Post Inspection Contacts:</b>	
<b>Inspector(s):</b>  Robert Zuber, P.E.	<b>Inspector's Signature:</b>

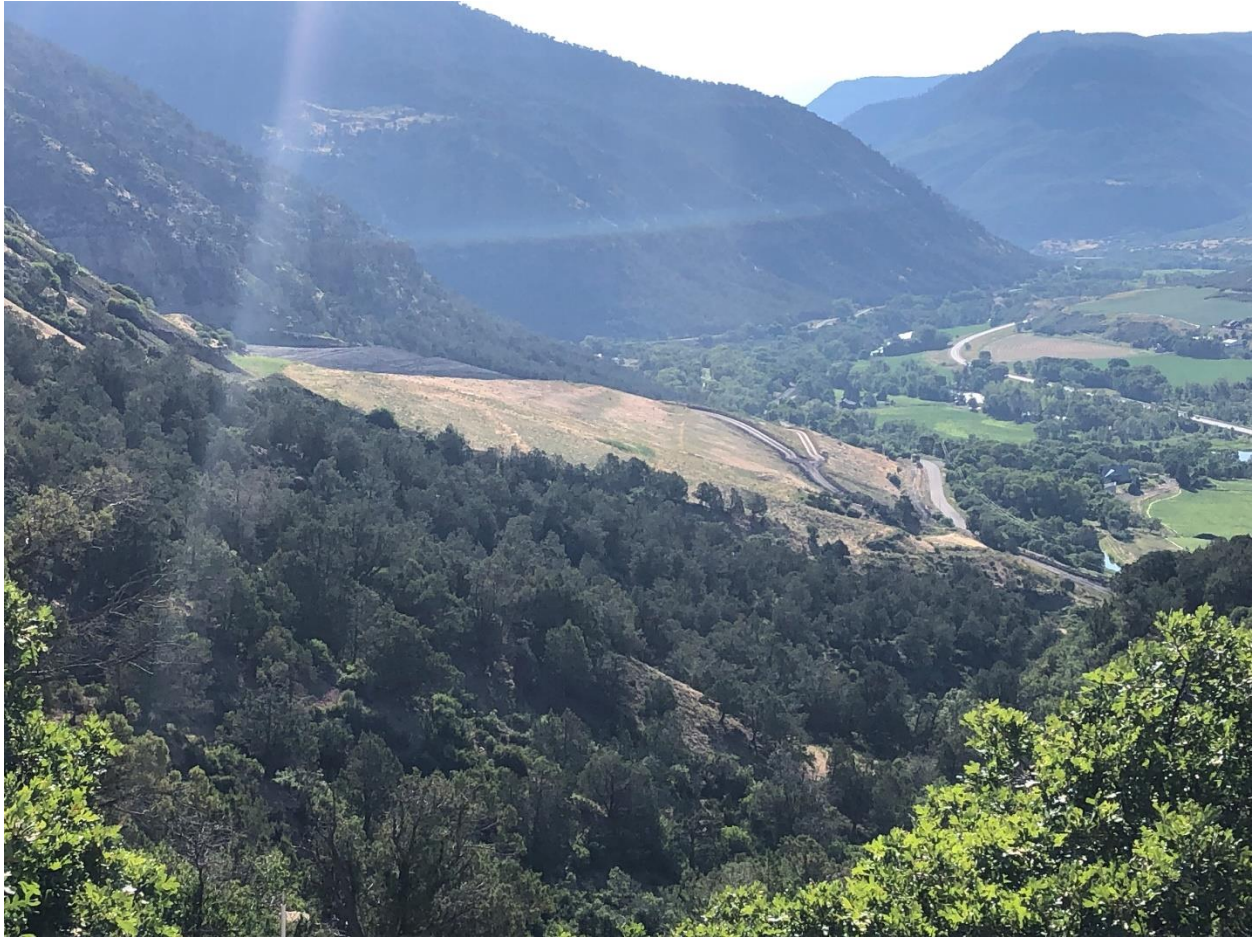
Gob Piles 1, 2, 3, and 4 appeared stable. No problem was identified at the repaired blow out on Gob Pile #4, which occurred in the spring of 2023. Gob Pile #3 is still covered with vegetation; it was clear that BRL has not worked on this pile in recent weeks.

**Gob Piles 1, 2, and 4, from upper Haul Road**

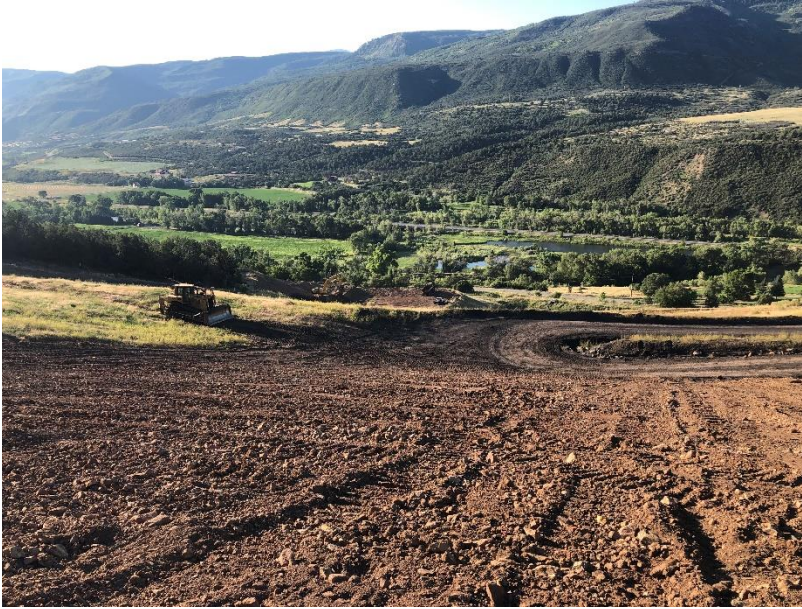
**Gob Pile #2 – source of material is in middle of photo**

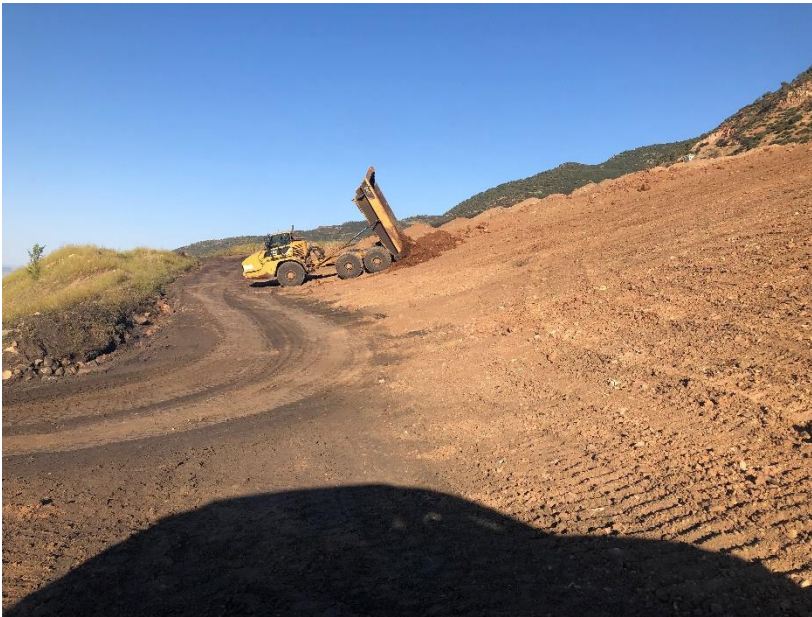
A haul truck was seen dumping coverfill material on the upper slopes of Gob Pile #2. The truck was loaded by an excavator at the soil pile near Pond F. The riprap channel on this slope needs to be reconstructed. No problems were seen with the upper (flat) portion of this pile. It is graded for water to flow to the east side and off the pile. No erosion or low spots were identified.

**Gob Pile #2 – dumping coverfill on upper slope**

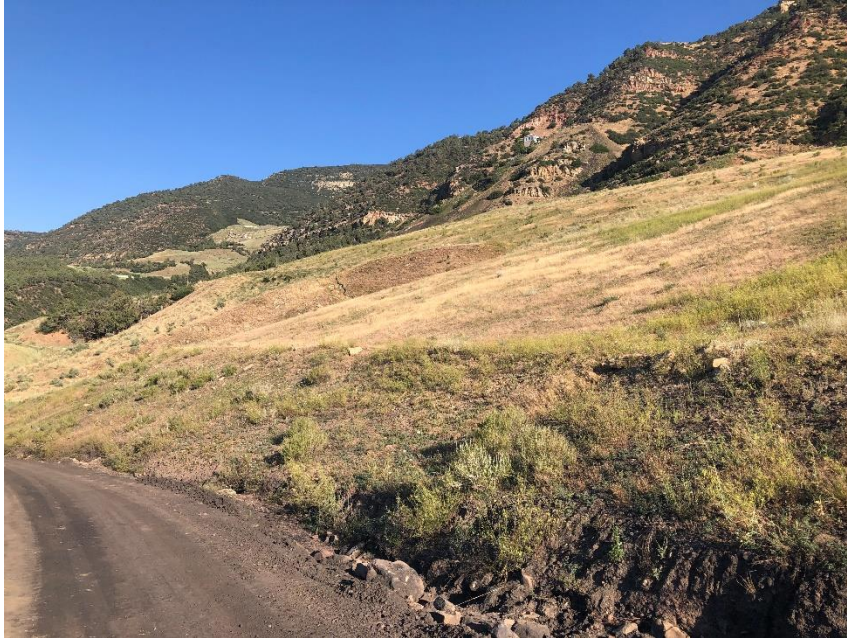
**Gob Piles 1 and 4**

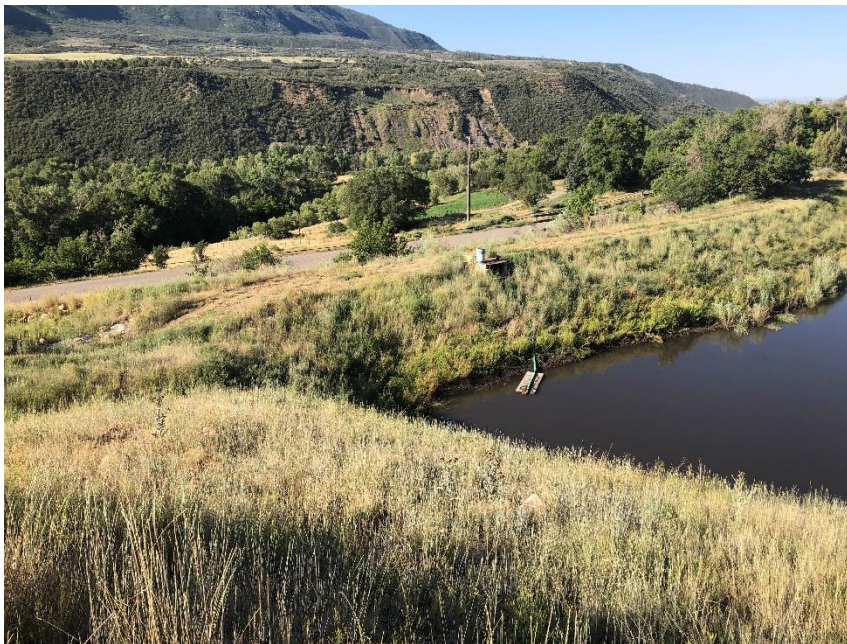
**Pond F**

Six sediment ponds were inspected: B, C, D, F, J, and K. None of the ponds were close to discharging. Three ponds contained visible water: B, D, and F. The bottom of Pond J is obscured by cattails, and no water was seen. The other ponds were obviously dry. No significant problems were identified with embankments, spillways, inlet channels, or other features of the ponds.

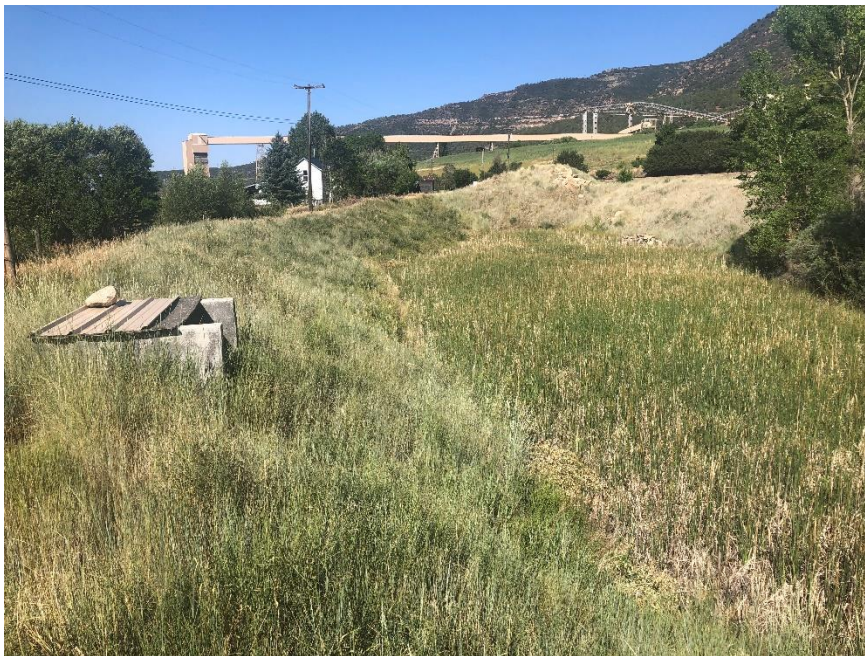
The Division recommended in previous months that willows and small trees be removed or killed on the pond side of Pond J. BRL has removed them.

**Pond J with vegetation removed from inner bank**

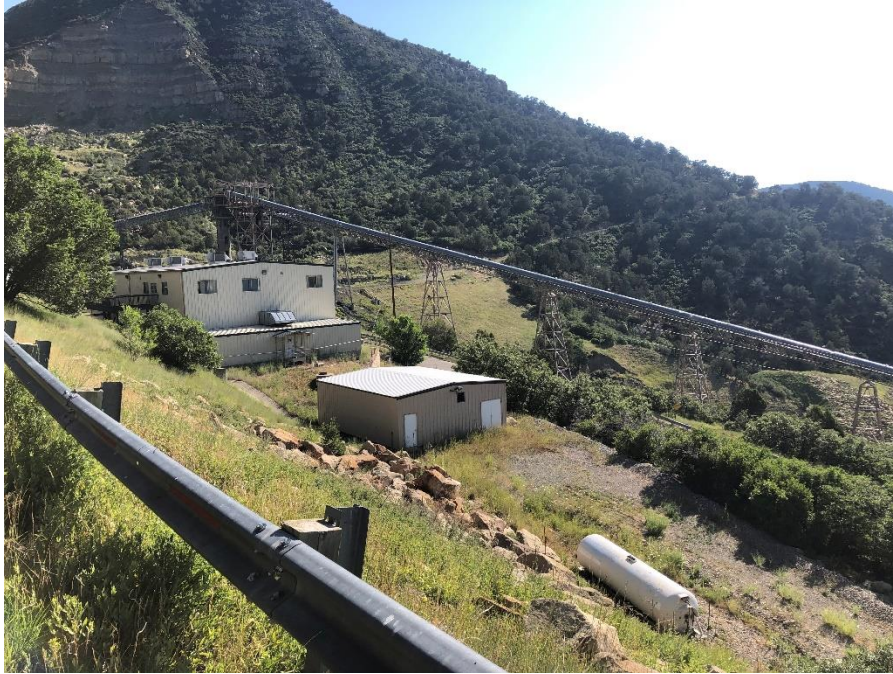
**D Portal Bench – structures at southwest corner**

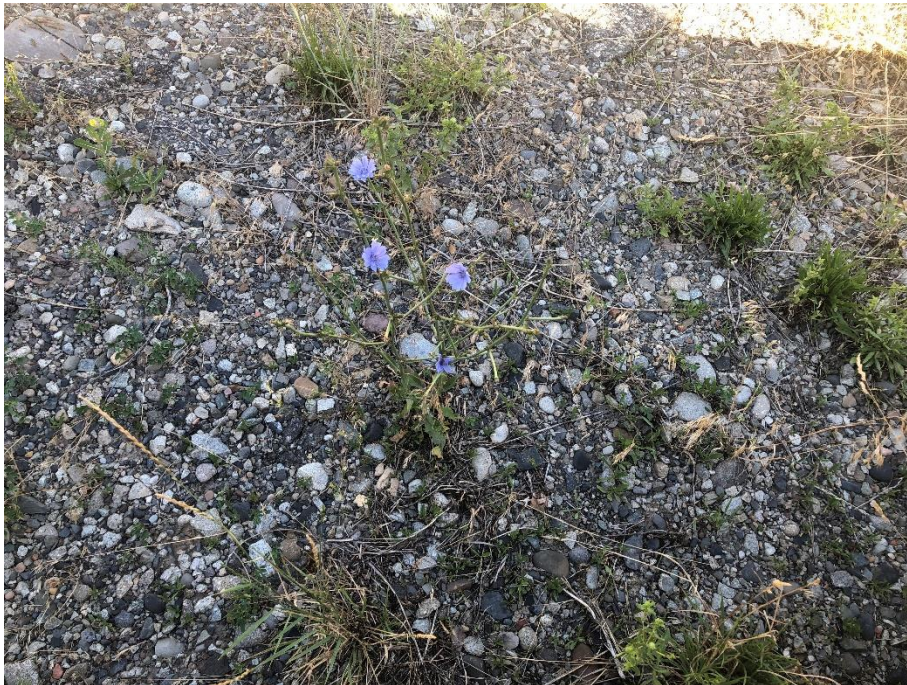
- Knapweed behind the “8” sign, at Curve 8
- Mullein at the Utility Bench
- Chicory in the parking area west of the office on D Portal Bench and also along the road beside Pond B

**Chicory plant in parking lot next to parking by office on D Portal Bench**

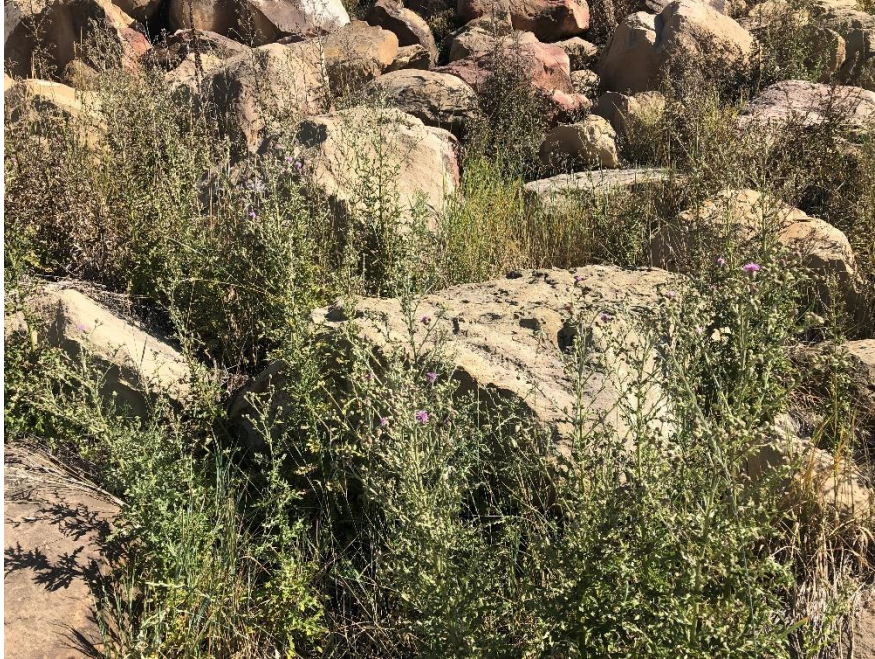
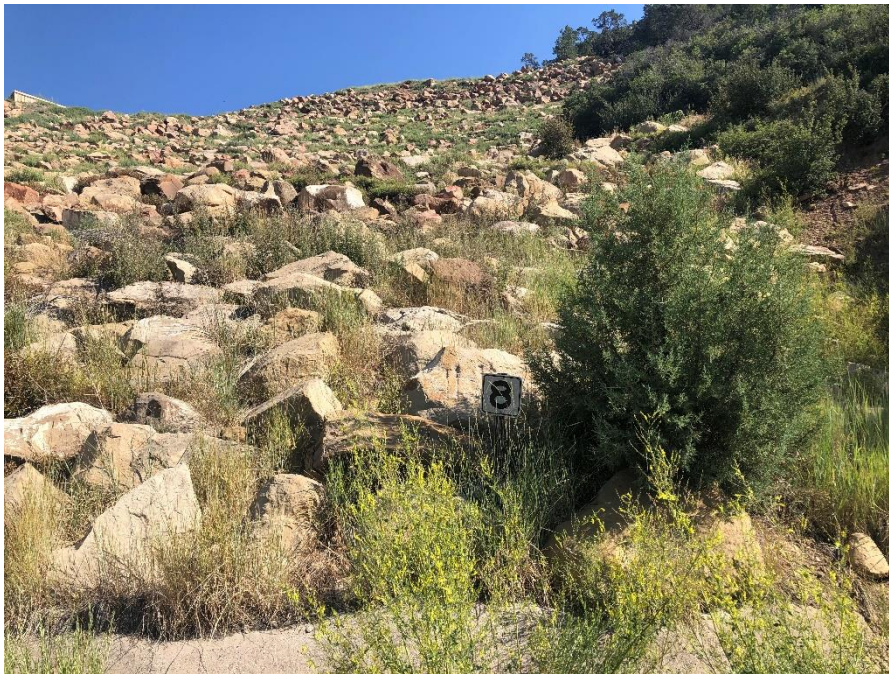
**Knapweed at Curve 8**
