## July inspection report

### PERMIT INFORMATION

<b>Permit Number:</b> C-1982-056 <b>Mine Name:</b> Foidel Creek Mine <b>Operator:</b> Twentymile Coal, LLC <b>Operator Address:</b> Ms. Miranda Kawcak 29515 Routt County Road No. 27 Oak Creek, CO 80467	<b>County:</b> Routt <b>Operation Type:</b> Underground <b>Permit Status:</b> Active <b>Ownership:</b> Private
	<b>Operator Representative Present:</b>  Michael Peterson
<b>Operator Representative Signature: (Field Issuance Only)</b>

### INSPECTION INFORMATION

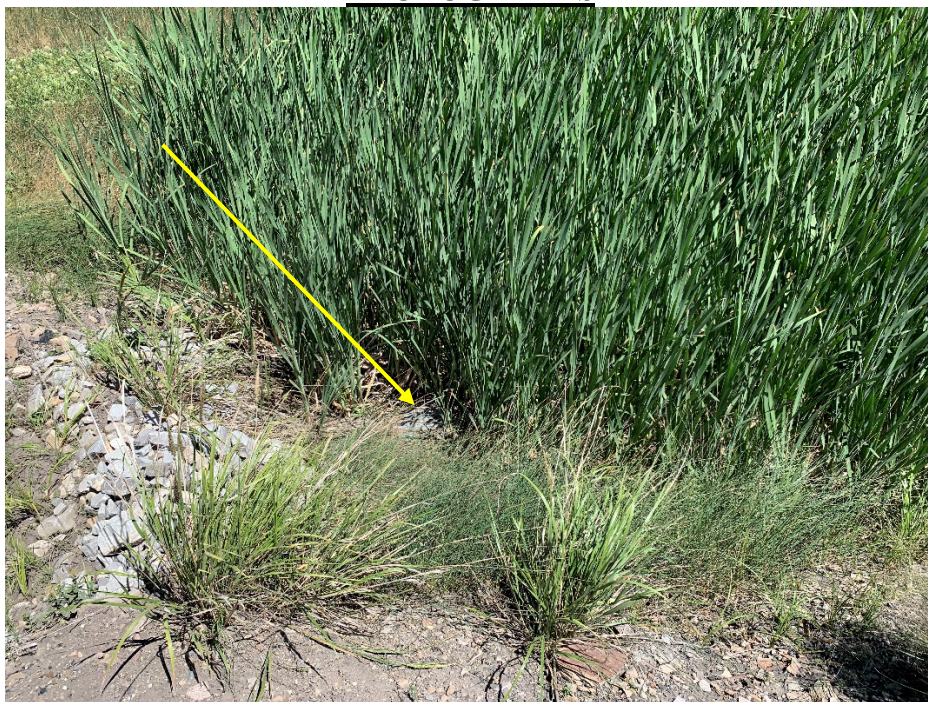
The culvert outlet under the batch weigh loadout road needs to have the cattails cleared (photo 1). The cattails are densely clustered at the end of the culvert, effectively blocking any water flow. This maintenance item was brought up in the June 11, 2024 inspection report and needs to be addressed.

Photo 1 – Cattails are blocking water flow at culvert discharge. Yellow arrow pointing at culvert.

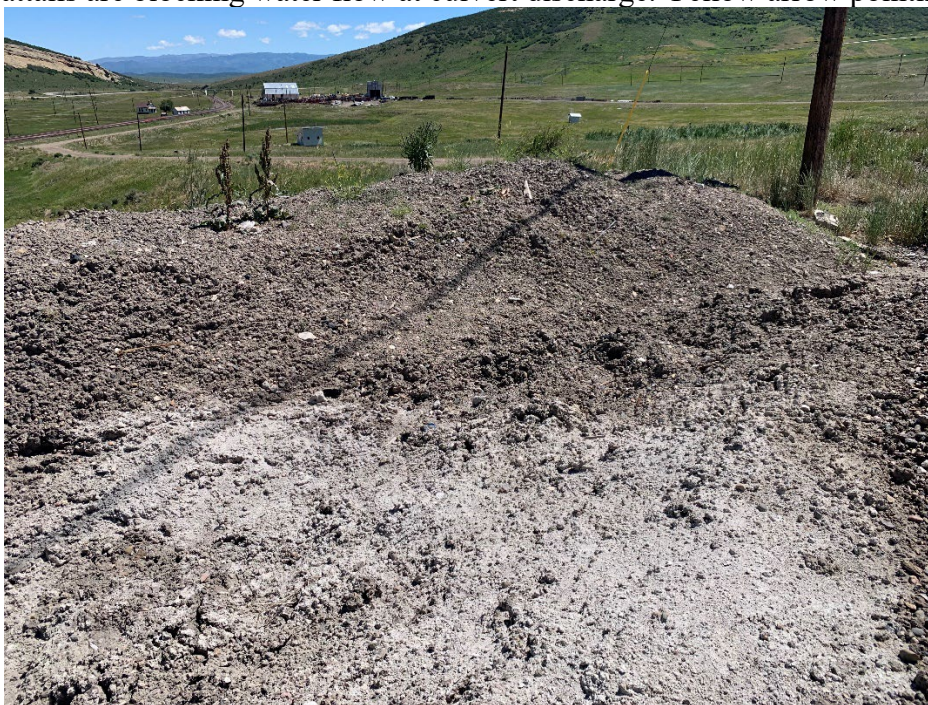
The E-1 ditch behind the maintenance shop was noted in the April 10, 2024 inspection report as being blocked by a pile of ice and debris. The large pile has melted and is no longer blocking the ditch but some debris remains in the ditch that needs to be removed to ensure proper operation (photo 2). Approximately 100 west of that pile there is another pile that is partially obstructing the E-1 ditch (photo 3). This pile also needs to be removed from the ditch to ensure the ditch can operate as designed. Both of these maintenance items were identified in the June 11, 2024 inspection report and need to be addressed.

Photo 2 – Ditch E1 needs to be cleaned to ensure proper operation.

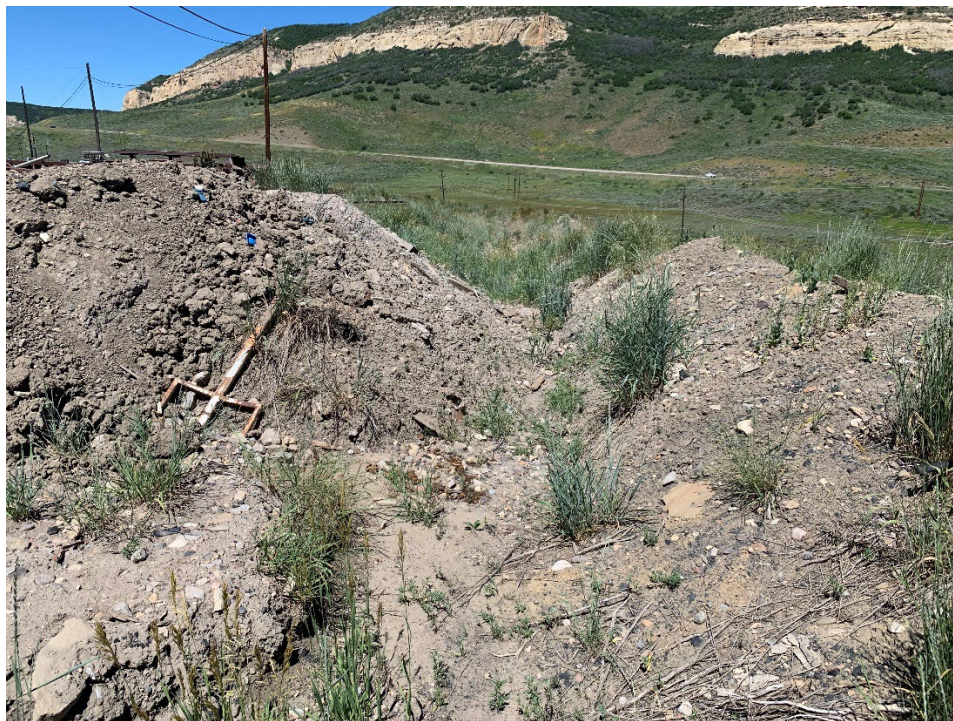
Photo 3 – The 2<sup>nd</sup> location in Ditch E1 that needs to be cleaned.

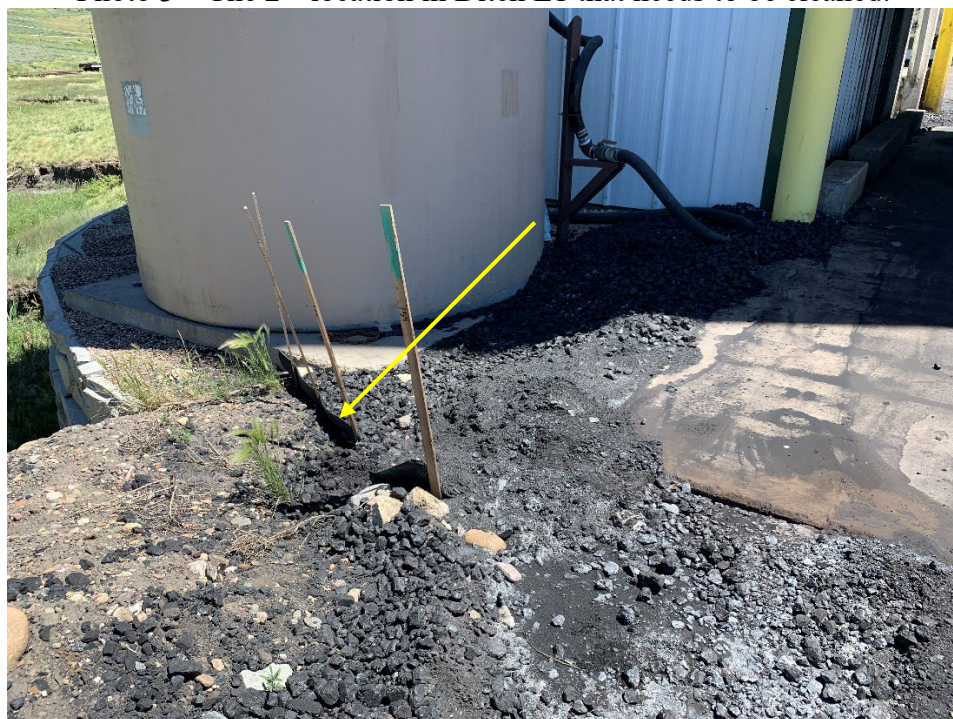
The area to the west of the stocker coal loadout building needs to be addressed because it is not properly controlling runoff. The loadout building is on a piece of ground directly over Foidel Creek and a retaining wall is in place to provide foundational support for the building. A concrete pad located on the opposite side of loadout building is used for the coal haul trucks to park on while being loaded. This concrete pad is approximately 18” higher than the retaining wall. This difference in height directs surface water to flow from the concrete pad towards the retaining wall. During coal loading operations, some coal falls onto the concrete pad which is then

swept off the pad into a pile in the direction of the retaining wall. A silt fence was installed in this area in an attempt to control the sediment, but has failed (photo 4). A section of the fence is buried in coal and water can flow around the end of the fence. Due to space constraints and topography of the area, a different method of sediment control should be utilized for this area, such as an earthen berm. Surface runoff needs to be directed to the sump located about 100 feet west of the stoker coal load out. This item was identified in the June 11, 2024 inspection report and needs to be addressed soon.

Photo 4 – The silt fence is inadequate to control erosion in this area.

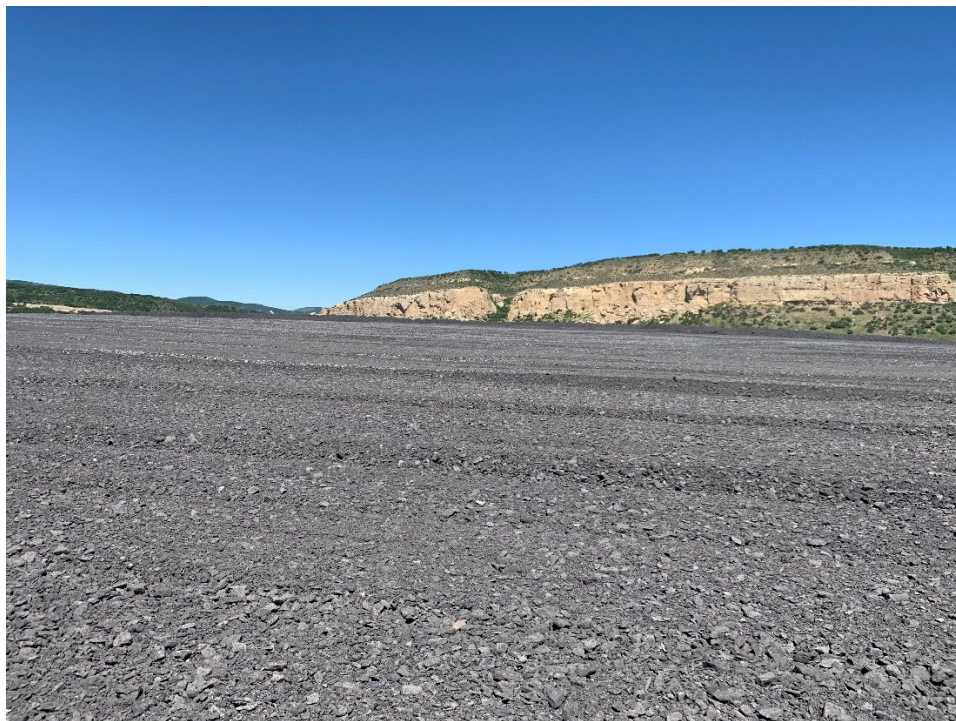
The wash plant was in operation and waste was being hauled to the waste pile and end dumped on the east side of the pile. The top of the waste pile had been graded since the last inspection (photo 5). There were still a few areas that had not been graded but a majority of the piles seen during the last inspection had been graded. The top of the pile was sloping to the east and south to allow for positive drainage. No standing water was seen on the pile.

Photo 5 – Top of coal refuse disposal area facing north.

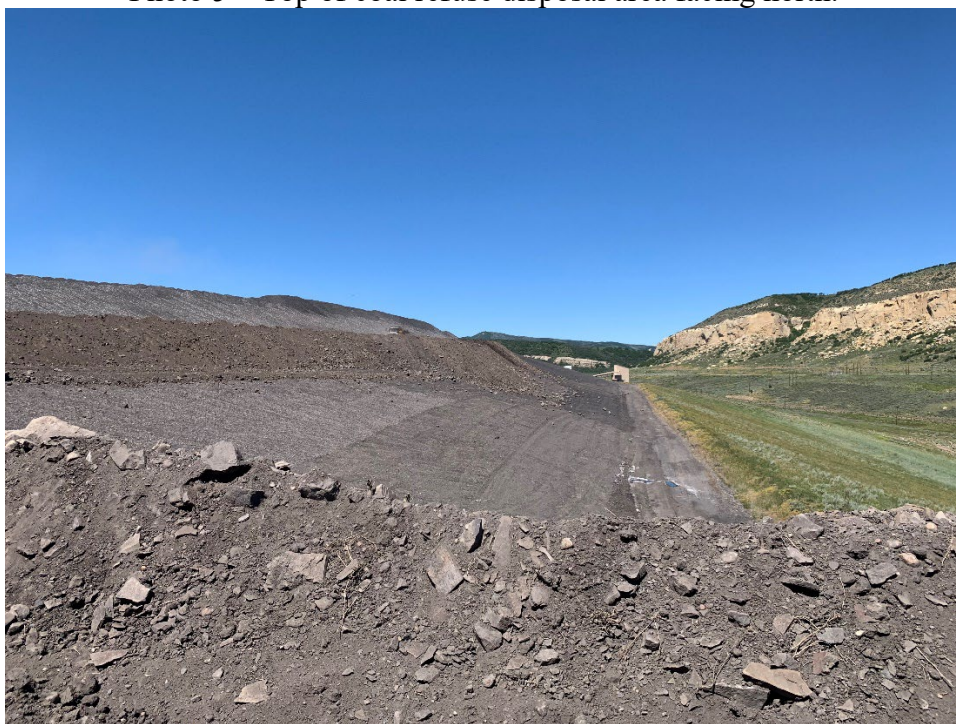
The lift below the active working zone of the coal refuse pile is being prepared for reclamation. The face of the lower lift has been graded to 2.8h:1v as outlined in Exhibit 26A-1 in the permit, although, the slope angle was not verified during this inspection. Subsoil was being end dumped down the face of the lift by a haul truck (photo 6) as part of the required minimum 4.0 feet of suitable cover (2.05-97.5).

Photo 6 – Soil being placed on face of coal refuse disposal pile.

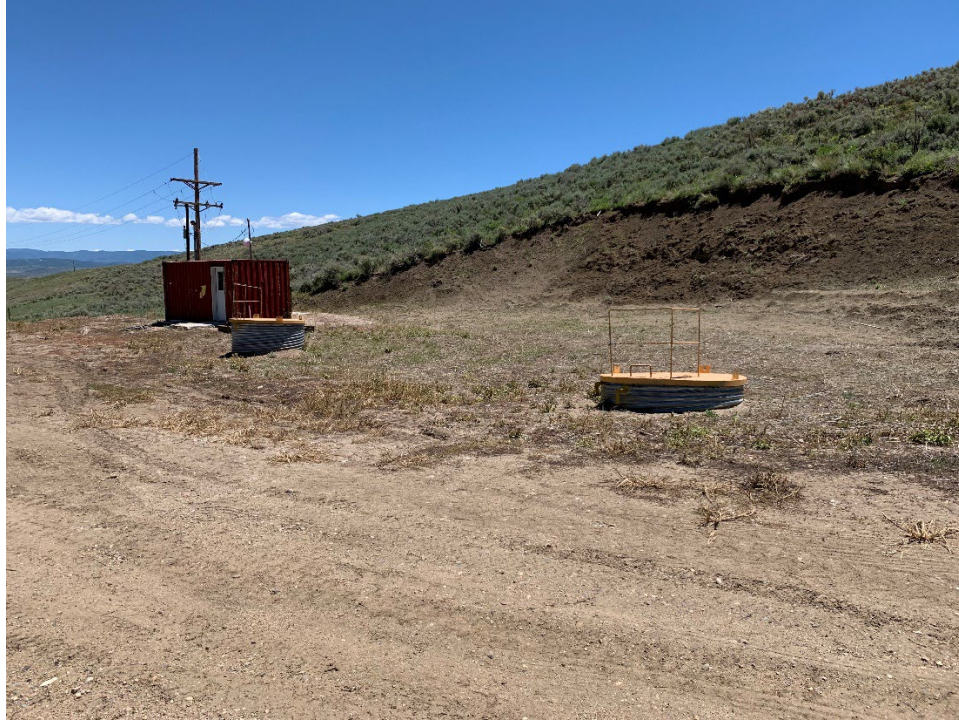
The 18LT Dewatering Borehole pad was inspected. A new borehole is proposed for this location in MR326 (photo 7). The topsoil pile was vegetation and it appeared that the whitetop had been recently treated. The sumps were clear of obstructions.

Photo 7 – 18LT Dewatering Borehole Surface Pad.
