### Report for Bowie #1 inspection

INSP-REPORTC\_C1981038\_RDZ\_07182024.pdf

Permit Number: C-1981-038 Mine Name: Bowie No. 1 Mine Operator: Bowie Resources, LLC Operator Address: Mr. Basil R Bear	County: Delta Operation Type: Underground Permit Status: Active Ownership: Private			
P.O. Box 1488	Operator Representative Present:			
Paonia, CO 81428	None			
Operator Representative Signature: (Field Issuance Only)

Inspection Start Date: July 16, 2024 Inspection Start Time: 14:00 Inspection End Date: July 16, 2024 Inspection End Time: 15:30			Inspection Type: Coal Partial Inspection Inspection Reason: Normal I&E Program Weather: Raining		
Joint Inspection Agency:		Joint	Joint Inspection Contacts:		
None					
Post Inspection Agency:		Post Inspection Contacts:			
None					
Inspector(s):	Inspector's Signature: Signature		Signature Date:		
Robert Zuber, P.E.	Phot D. ZL				
				7/18/2024

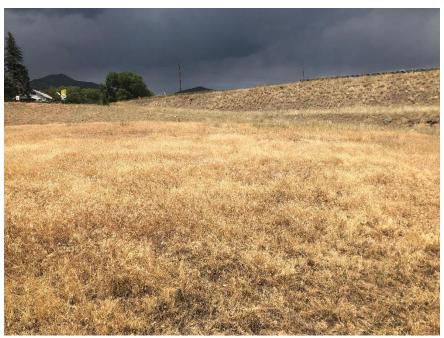
Large quantities of cheat grass were observed at the Coal Storage Area (near Black Bridge Road). This noxious weed should be treated.

Cheat grass at Coal Storage Area near Black Bridge Road

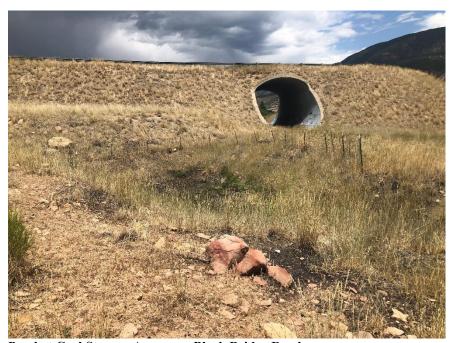
The ponds at the loadout and the Coal Storage Area (near Black Bridge Road) contained no water. No problems were identified with these ponds.

Pond at Coal Storage Area near Black Bridge Road

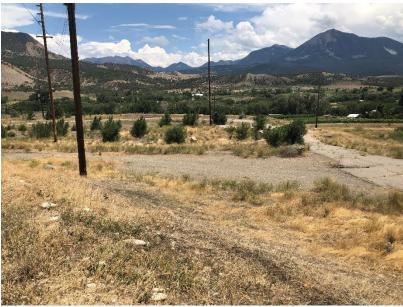
No erosion was seen at the loadout, including the steep slope between the loadout and the orchard below. The trestle across the river appears stable.

West side of loadout

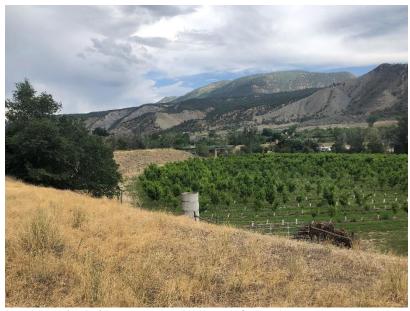
**Loadout with bridge at east end (center of photo)**

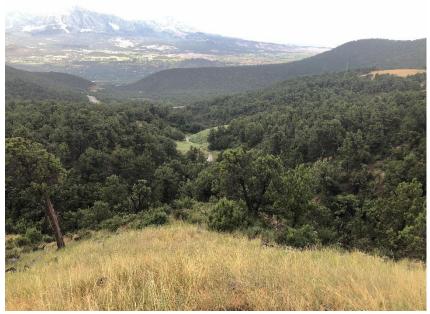
No erosion was seen at the reclaimed ponds at the East Mine (Ponds 1-4). They were viewed from the Old Waste Disposal Area. Rain before and during the inspection resulted in flow in this ephemeral drainage.

**Reclaimed Ponds 3 and 4 at East Mine**

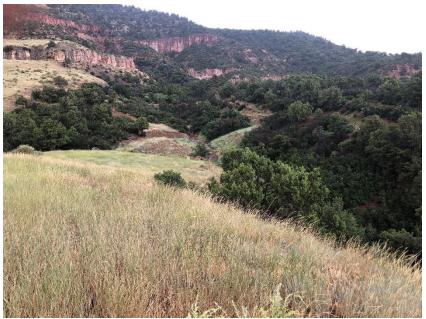
**Reclaimed Ponds 1 and 2 at East Mine**
