MINERALS PROGRAM INSPECTION REPORT
PHONE: (303) 866-3567

MINE NAME: Fountain Colony Pit	MINE/PROSPECTING ID#: M-1987-171	MINERAL: Sand and gravel	COUNTY: El Paso
INSPECTION TYPE: Monitoring	WEATHER: Clear	INSP. DATE: July 17, 2024	INSP. TIME: 10:00
OPERATOR: Kiewit Infrastructure Co.	OPERATOR REPRESENTATIVE: Larry McKinney	TYPE OF OPERATION: 112c - Construction Regular Operation	
REASON FOR INSPECTION: Normal I&E Program	BOND CALCULATION TYPE: None	BOND AMOUNT: \$200,000.00	
DATE OF COMPLAINT: NA	POST INSP. CONTACTS: None	JOINT INSP. AGENCY: None	
INSPECTOR(S): Hunter Ridley	INSPECTOR'S SIGNATURE:

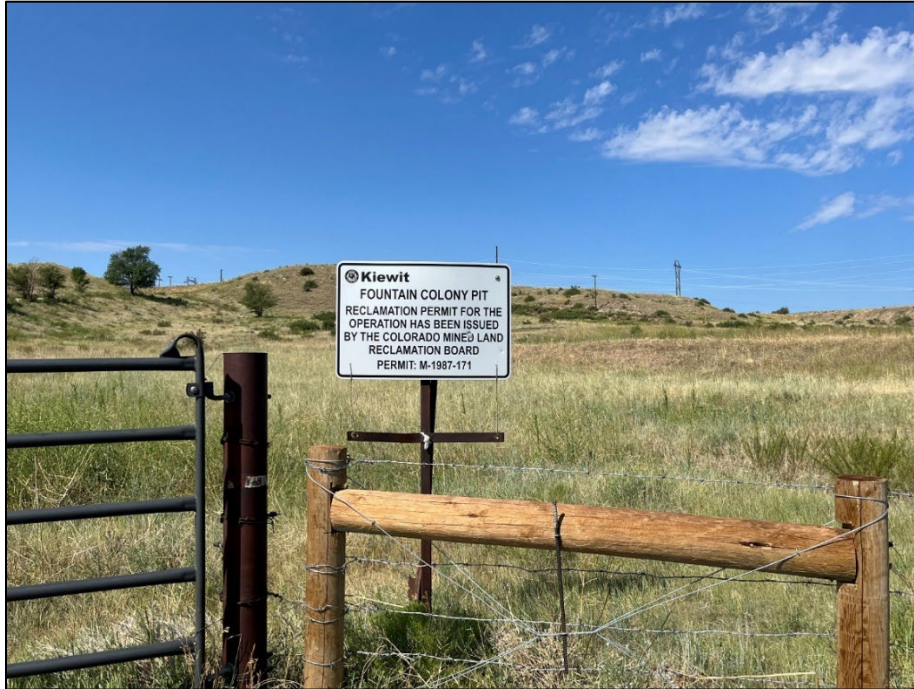
Signs and Markers: The permit sign was properly posted at the access road entrance (Photo 1) and boundary markers were observed to section off the Phase V area.

Photo 1: Mine identification sign located at the entrance to the access road off Charter oak Ranch Road.

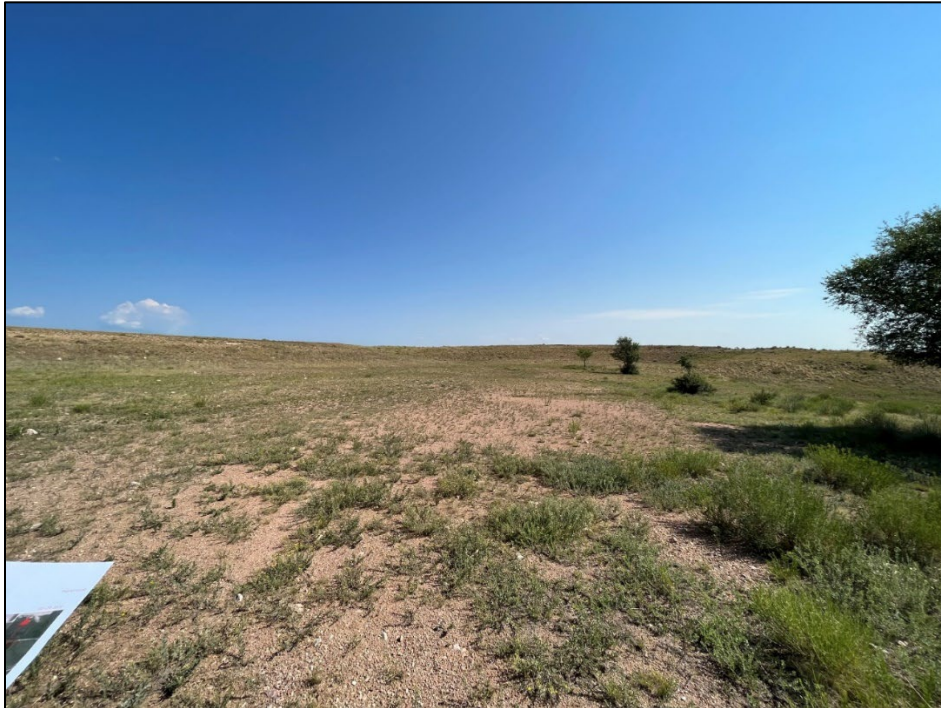
Photo 2: View north of the dsitubred area of Phase V.

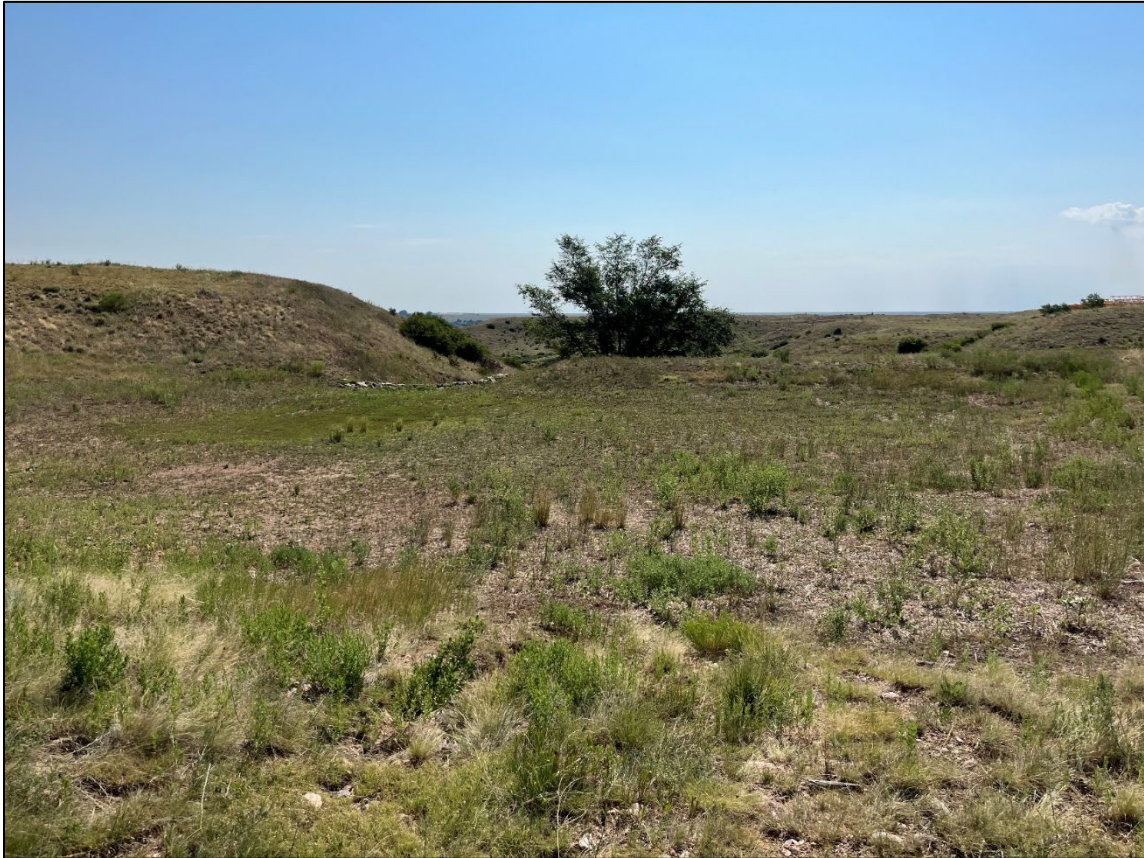
Hydrologic Balance: No standing water was present at the site. Natural drainage has been restored to the east via the small, rip rapped drainage channel (Photos 3 and 4).

Photo 3: View east of the 0.5 acres disturbance and berm which was blown out in a previous year by a storm event.

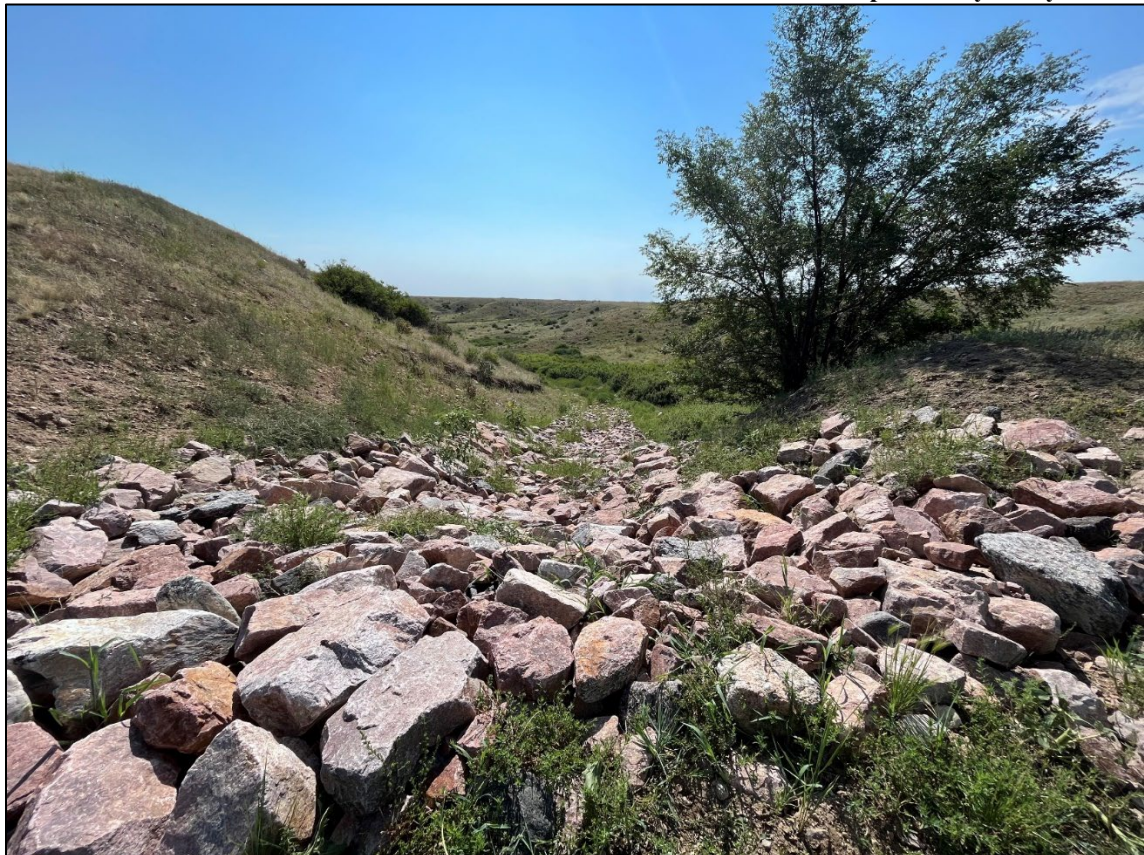
Photo 4: Rip rapped drainage channel on the eastern side of the site.

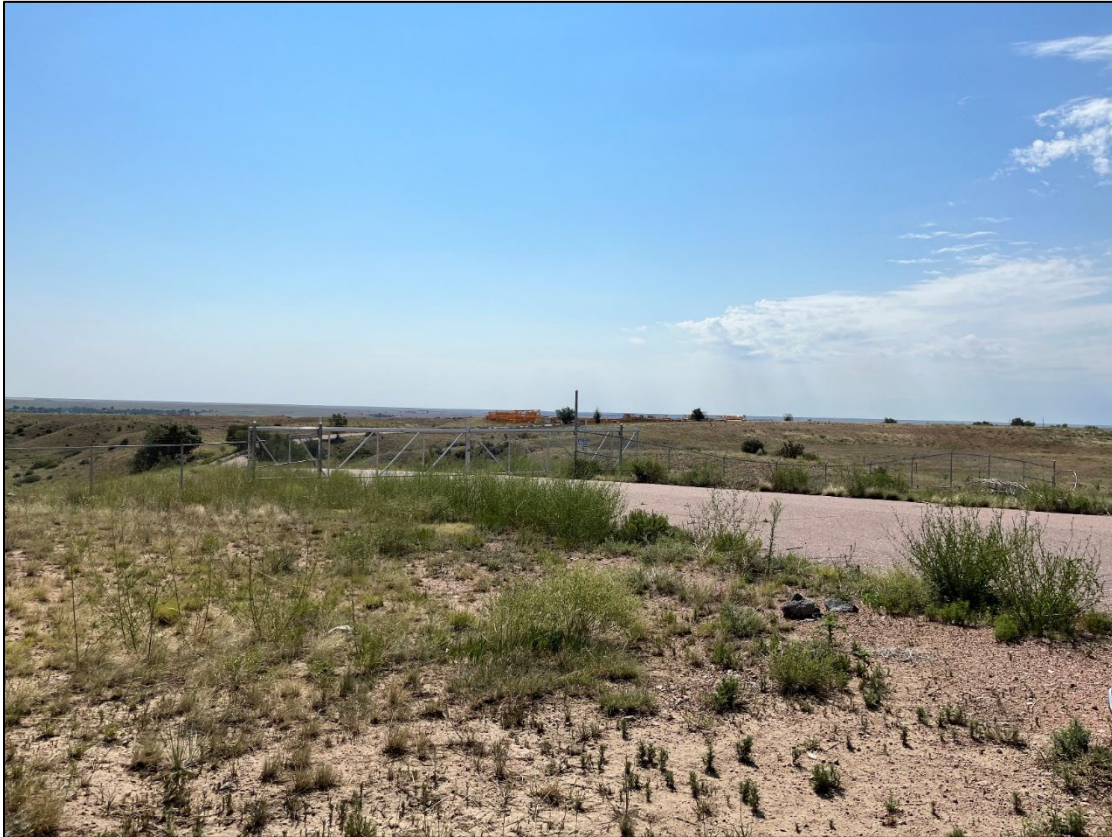
Roads: No changes were observed from the March 2023 inspection. The paved access road will remain in final reclamation (Photo 5).

Photo 5: The paved access road will remain in final reclamation.
