RE: Inspection Report 5/20/2024 Follow Up

The purpose of this correspondence is to provide responses to the two items in your June 20, 2024, inspection report.

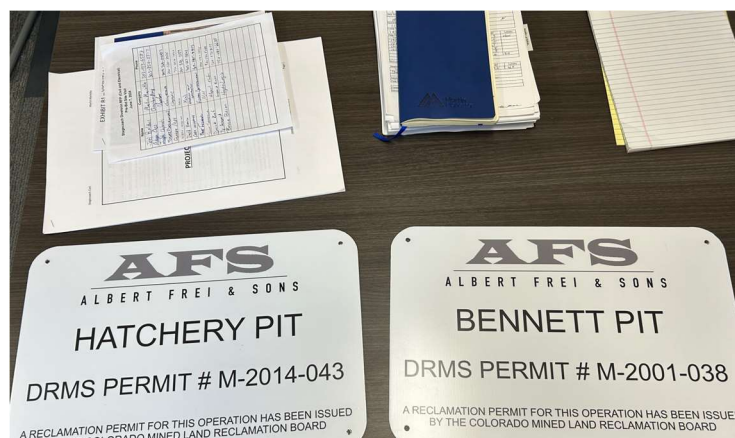
PROBLEM: The mine identification sign was not posted at the entrance of the mine site. This is a problem for failure to post a mine identification sign as required by Section 3.1.12(1) of the rule. The Operator shall, at the entrance of the mine site post a sign, which shall be clearly visible from the access road, with a minimum size equaling one hundred and eighty-seven (187) square inches, such as eleven (11) inches in height and seventeen (17) inches in width, with appropriate font size, with the following: the name of the Operator, a statement that a reclamation permit for the operation has been issued by the Colorado Mined Land Reclamation Board; and the permit number.

The sign has been fabricated, see attached picture and will be installed on Monday July 22 and an additional picture will be sent on Tuesday July 23rd showing the sign installed in the Bennett Pit gate entrance area.
