MINERALS PROGRAM INSPECTION REPORT PHONE: (303) 866-3567

MINE NAME:	MINE/PROSPECTING ID#:	MINERAL:	COUNTY:
Section 20 Gravel Mine	M-2022-001	Sand and gravel	Weld
INSPECTION TYPE:	WEATHER: Clear	INSP. DATE:	INSP. TIME:
Surety Release Inspection		July 19, 2024	10:30
OPERATOR:	OPERATOR REPRESENTATIVE:	TYPE OF OPERATION:	
Red Tierra Equities, L.L.C.	Kyle Regan	112c - Construction Regular Operation	
REASON FOR INSPECTION:	BOND CALCULATION TYPE:	BOND AMOUNT:	
Surety Release Requested		\$5,399,350.00	
DATE OF COMPLAINT:	POST INSP. CONTACTS:	JOINT INSP. AGE	NCY:
NA	None	None	
INSPECTOR(S):	INSPECTOR'S SIGNATURE:	SIGNATURE DAT	E:
Patrick Lennberg	141-12	July 23, 2024	
Chris Girardi	Catmen of

PERMIT #: M-2022-001 INSPECTOR'S INITIALS: JPL INSPECTION DATE: July 19, 2024

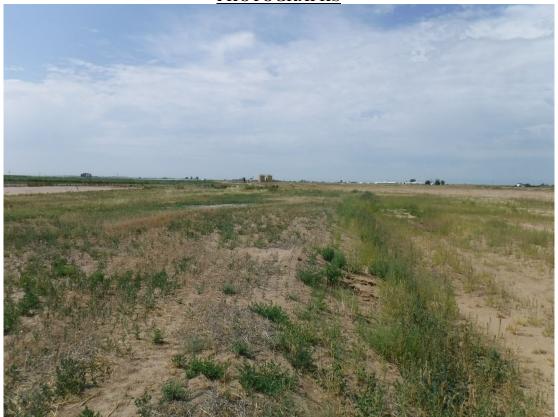
Photo 1: Looking south along the eastern boundary (middle) of the North Infiltration Pond area

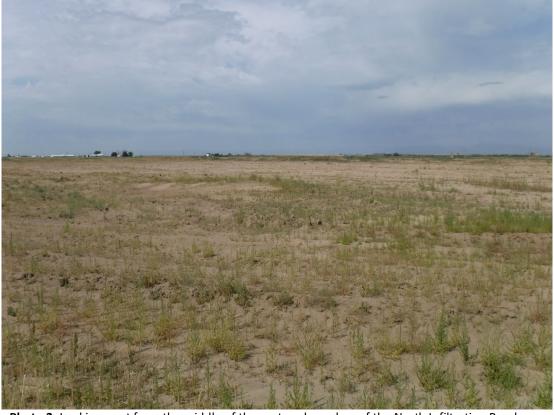
Photo 2: Looking west from the middle of the eastern boundary of the North Infiltration Pond area

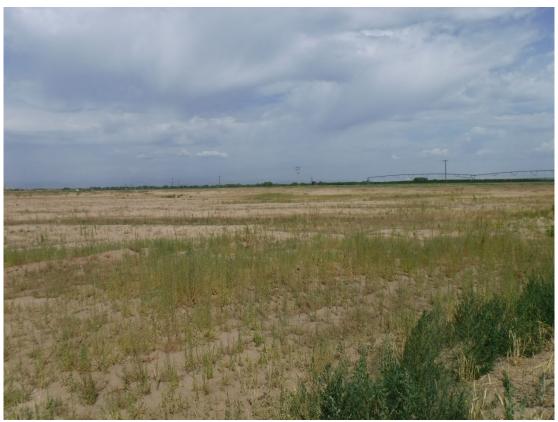
Photo 3: Looking north from the middle of the eastern boundary of the North Infiltration Pond area

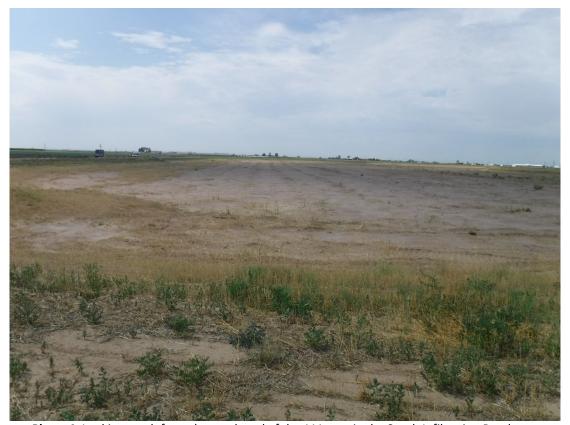
Photo 4: Looking south from the north end of the 111 area in the South Infiltration Pond area

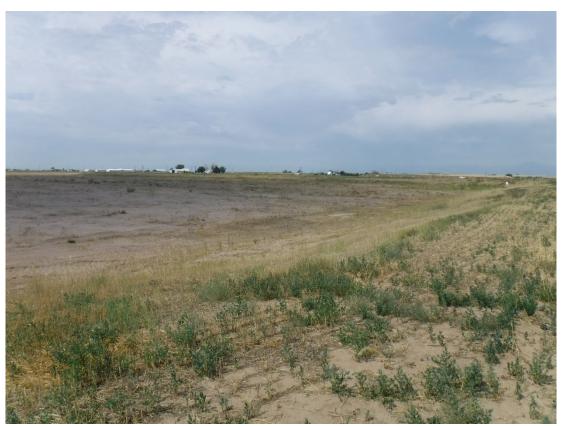
Photo 5: Looking southwest from the north end of the 111 area in the South Infiltration Pond area

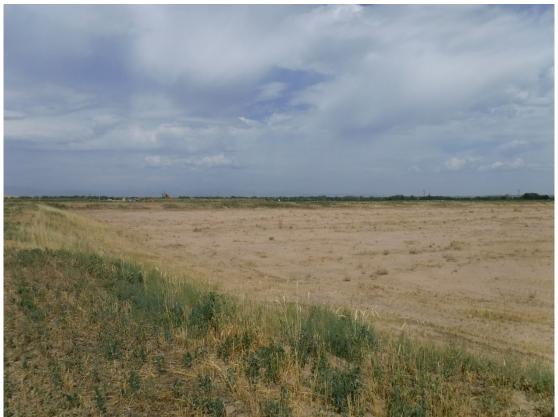
Photo 6: Looking northwest from the south of the North Infiltration Pond area
