**MINERALS PROGRAM INSPECTION REPORT**  
**PHONE: (303) 866-3567**

<b>MINE NAME:</b> Journey Ventures Pit	<b>MINE/PROSPECTING ID#:</b> M-2008-080	<b>MINERAL:</b> Aggregate	<b>COUNTY:</b> Weld
<b>INSPECTION TYPE:</b> Surety Release Inspection	<b>WEATHER:</b> Cloudy	<b>INSP. DATE:</b> July 19, 2024	<b>INSP. TIME:</b> 09:00
<b>OPERATOR:</b> Journey Ventures, LLC	<b>OPERATOR REPRESENTATIVE:</b> Chris Leone	<b>TYPE OF OPERATION:</b> 112c - Construction Regular Operation	
<b>REASON FOR INSPECTION:</b> Surety Release Requested	<b>BOND CALCULATION TYPE:</b> None	<b>BOND AMOUNT:</b> \$487,550.00	
<b>DATE OF COMPLAINT:</b> NA	<b>POST INSP. CONTACTS:</b> None	<b>JOINT INSP. AGENCY:</b> None	
<b>INSPECTOR(S):</b> Patrick Lennberg Chris Girardi	<b>INSPECTOR'S SIGNATURE:</b>

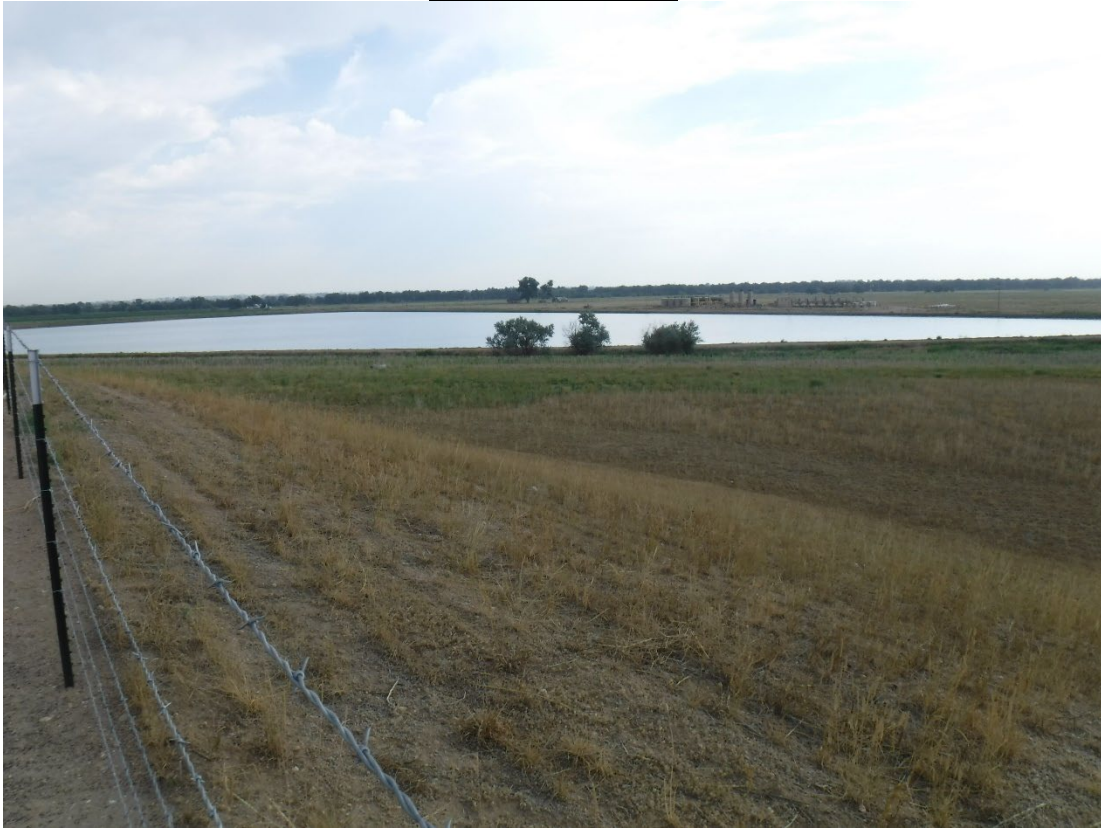
**Photo 1:** Looking north across the site from near the SW permit corner

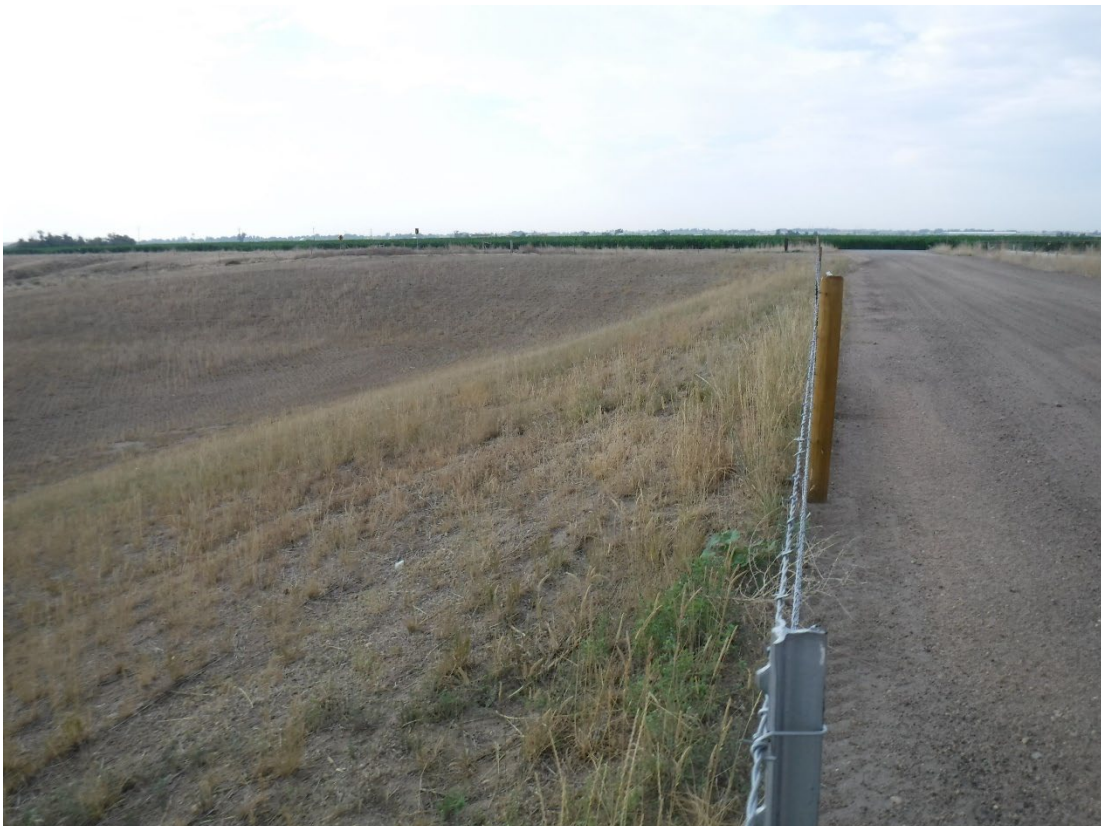
**Photo 2:** Looking at the SW permit corner

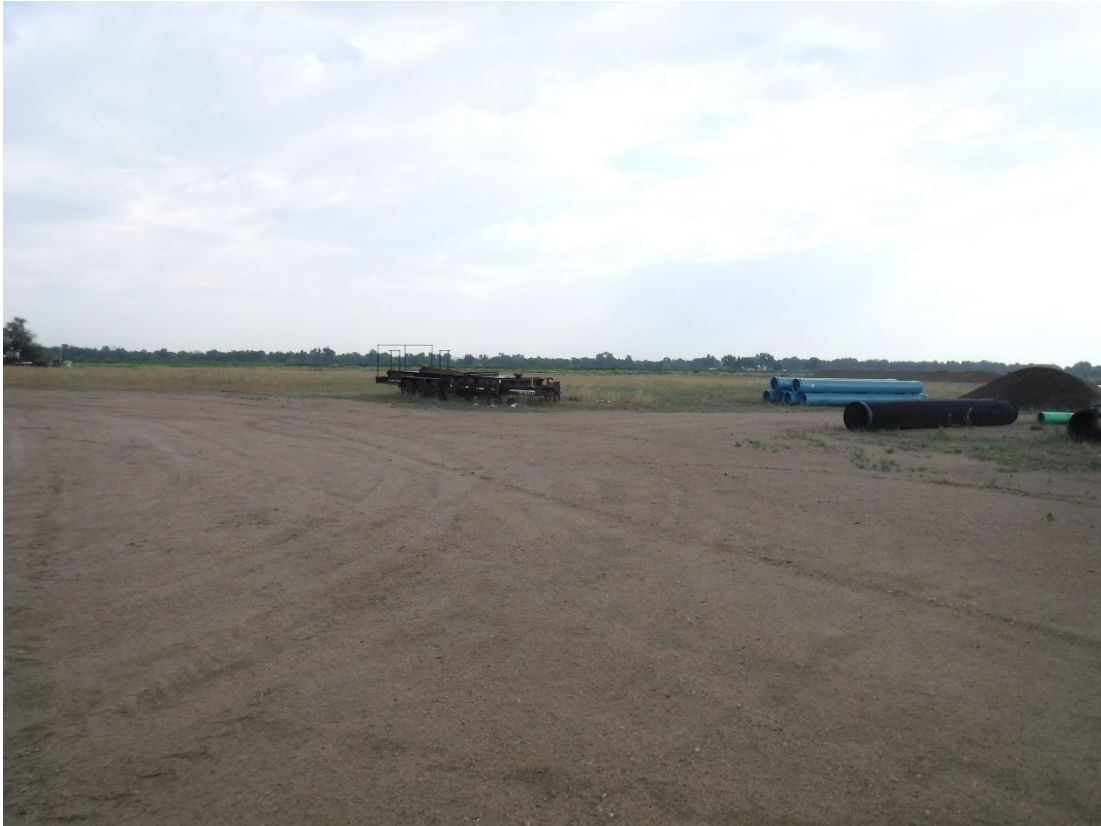
**Photo 3:** Looking north across the laydown area

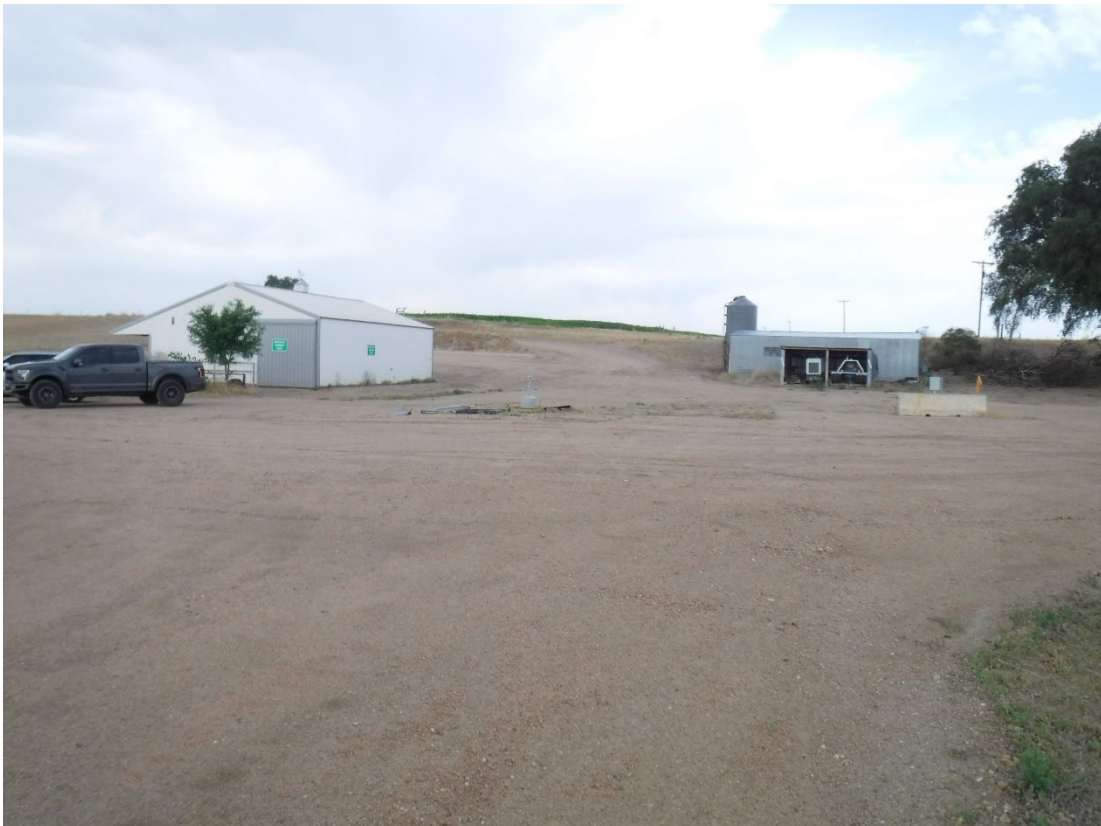
**Photo 4:** Gravel road into permit area and laydown area

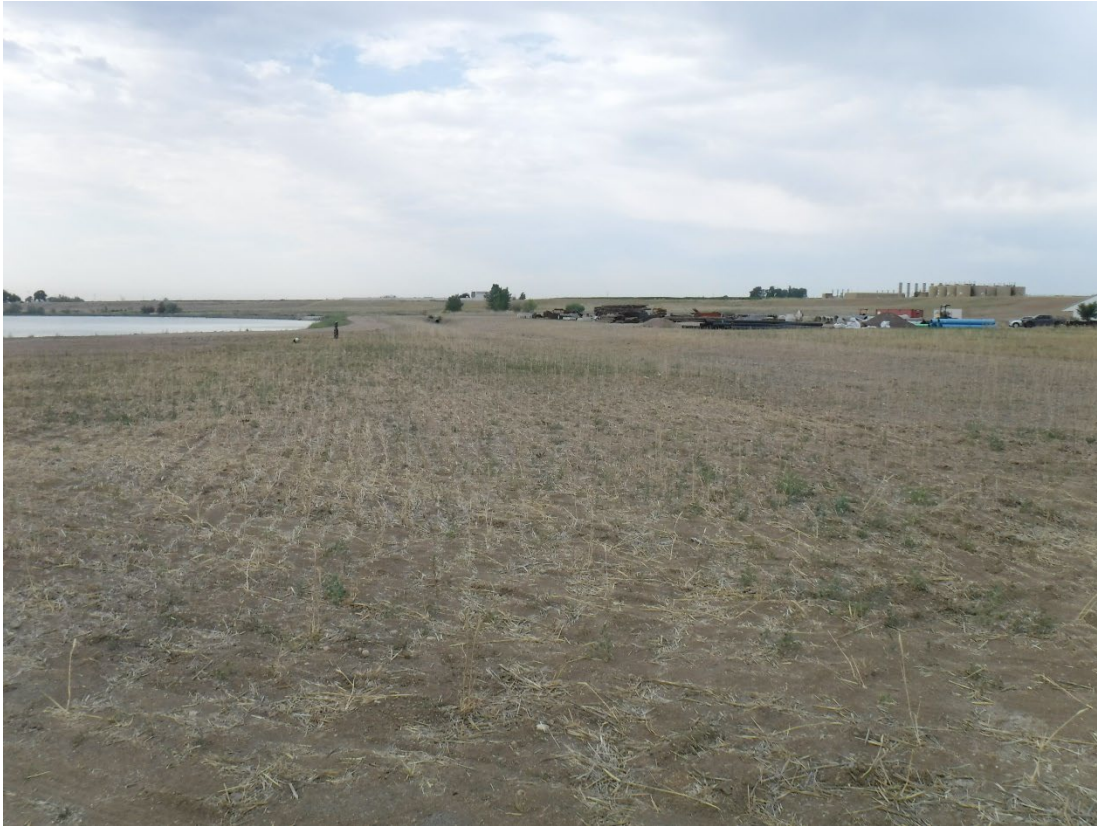
**Photo 5:** Portion of the approved laydown area seeded by landowner (this area was approved for base course covering but the landowner decided to seed it instead)

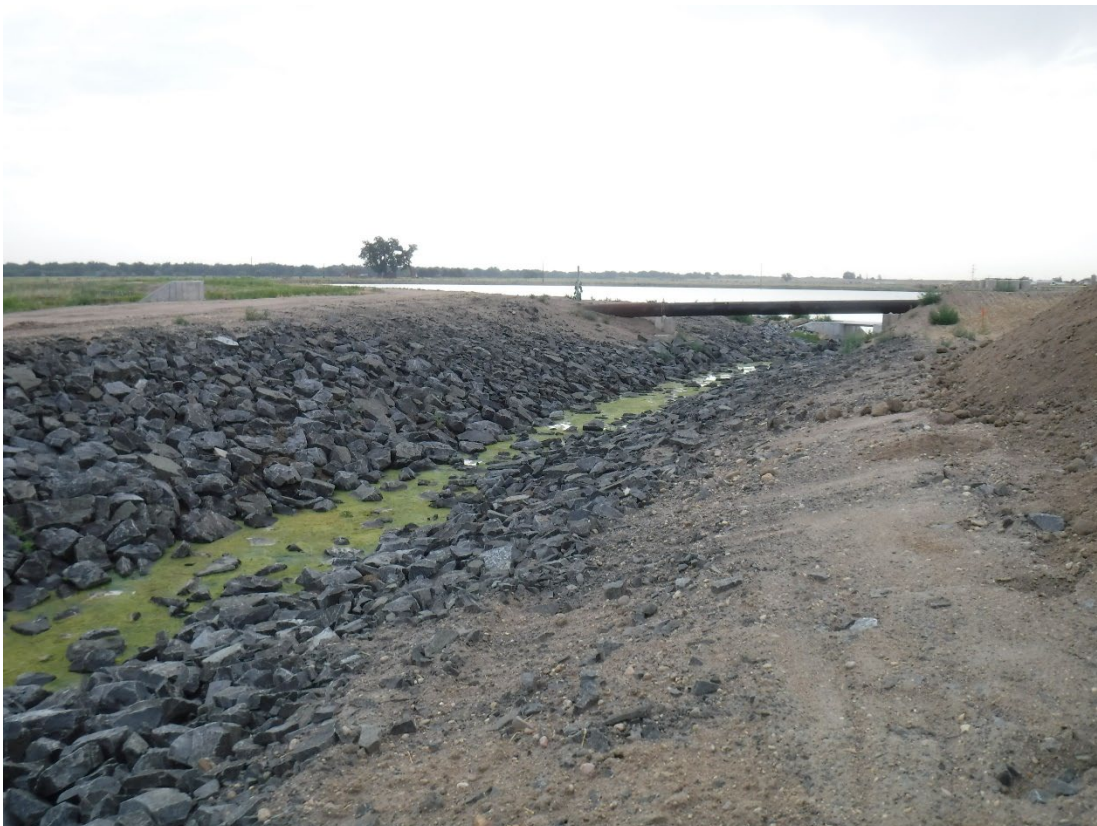
**Photo 6:** Inflow ditch, from Plumb Ditch, to reservoir. Metal pipe across ditch is for discharge.

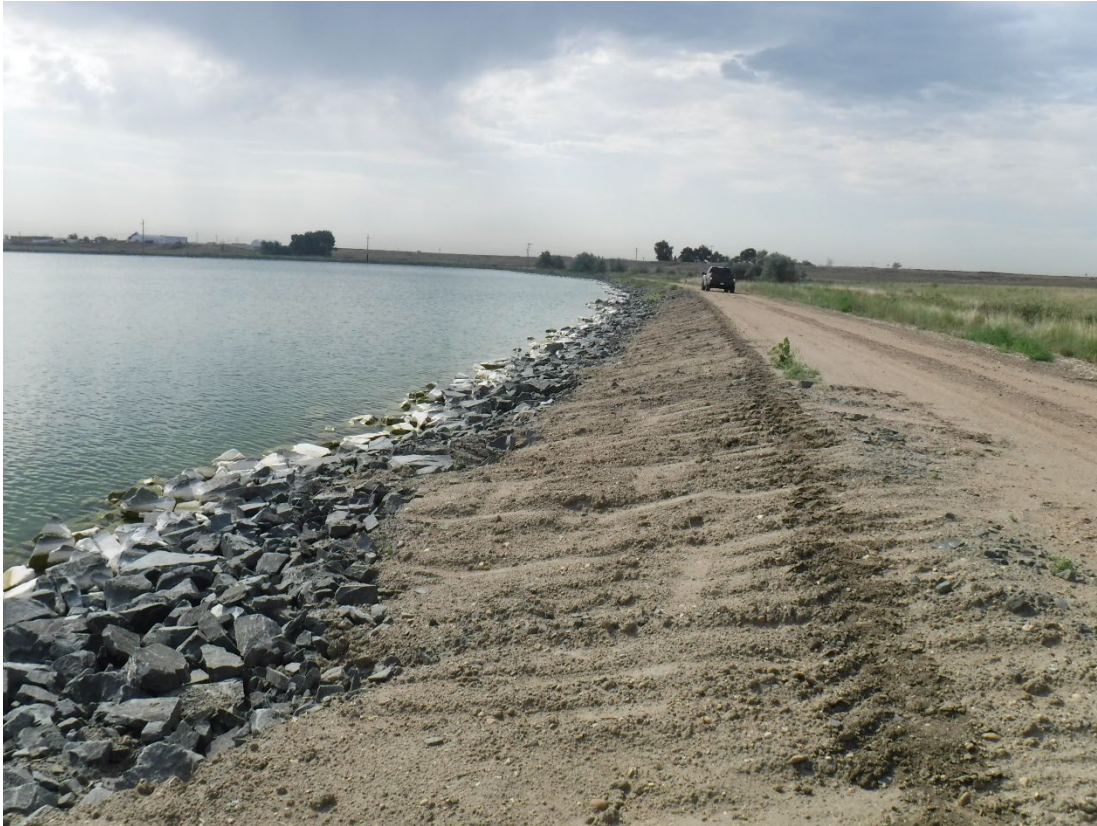
All product stockpiles have been removed from the site. All side slopes around the reservoir have been graded to 3H:1V slope. The land owner, Central Colorado Water Conservancy, has begun the process of placing riprap along the banks of the reservoir. Placing riprap along the shoreline was approved in TR-5 in 2023. Included in that approval was leaving a laydown area (construction yard 3.4 acres), a base course road around the reservoir (3.3 acres) and an area where the spillway and outlet structure is constructed. The plans for the spillway and outlet structure were included in TR-6 that was submitted and approved in July 2024.

**Photo 7:** Recent riprap work completed by landowner

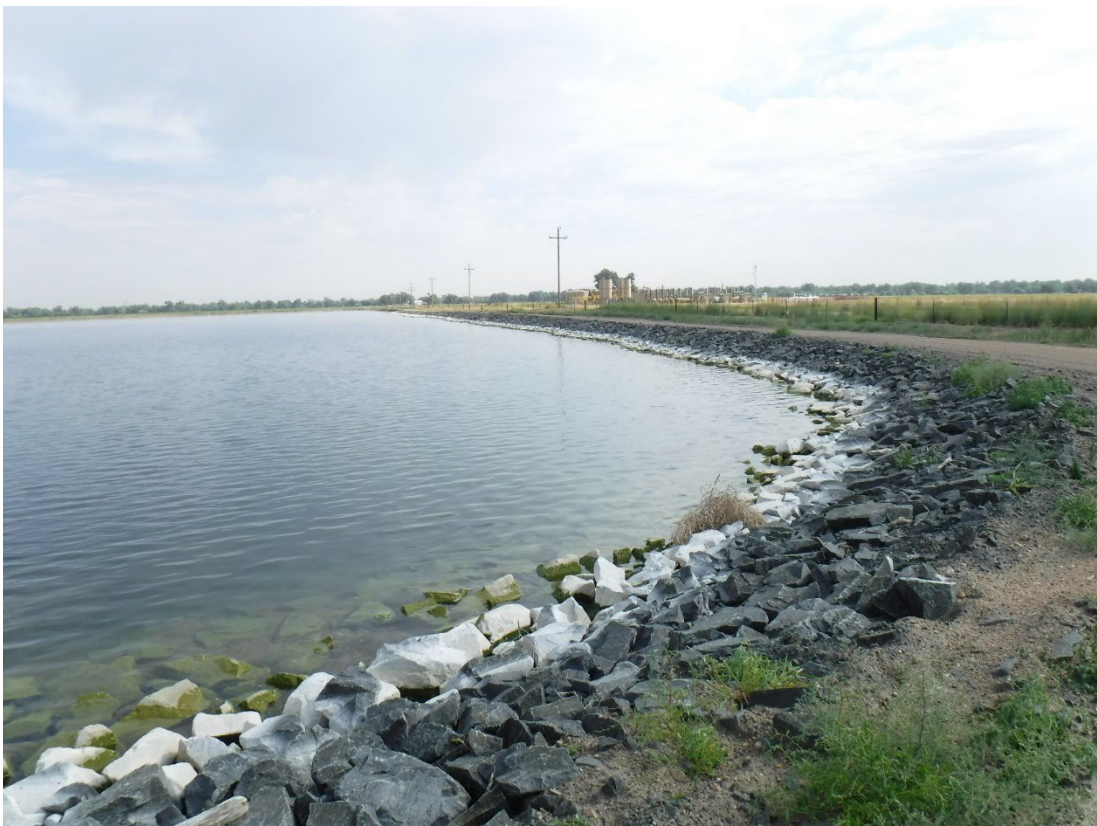
**Photo 8:** Looking north from the SE corner of reservoir

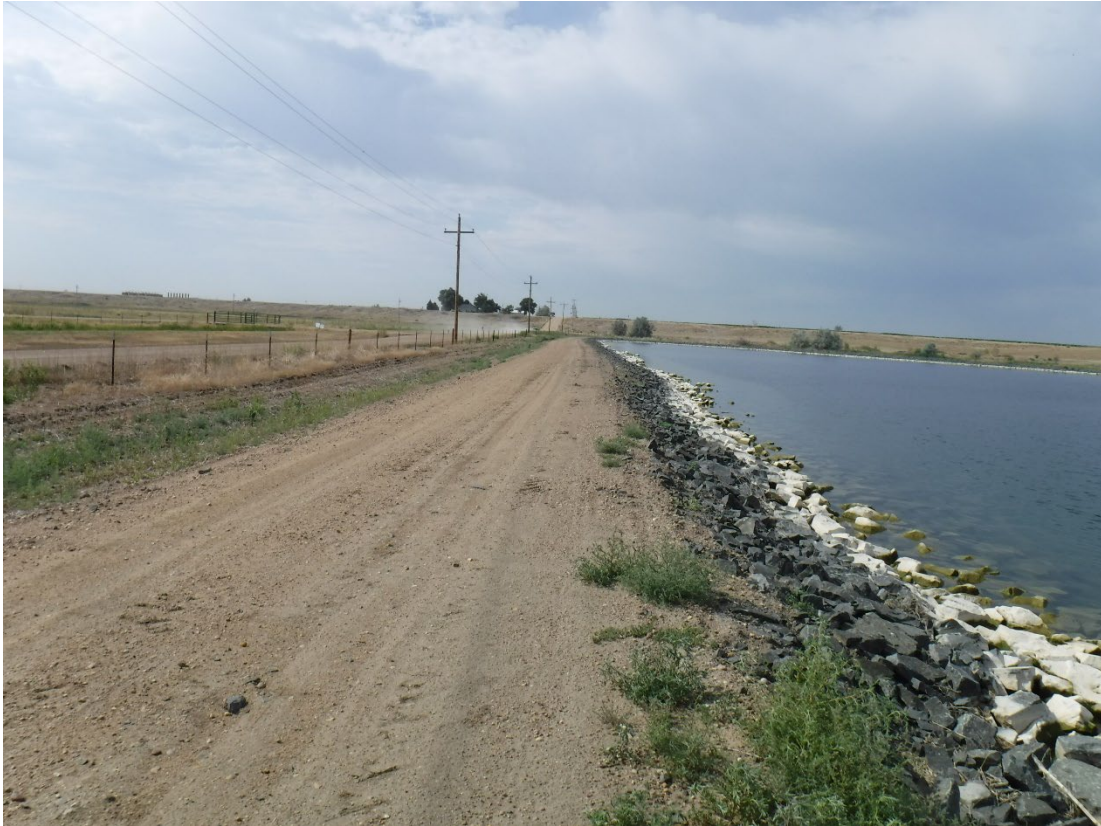
**Photo 9:** Looking south towards the SE corner of reservoir

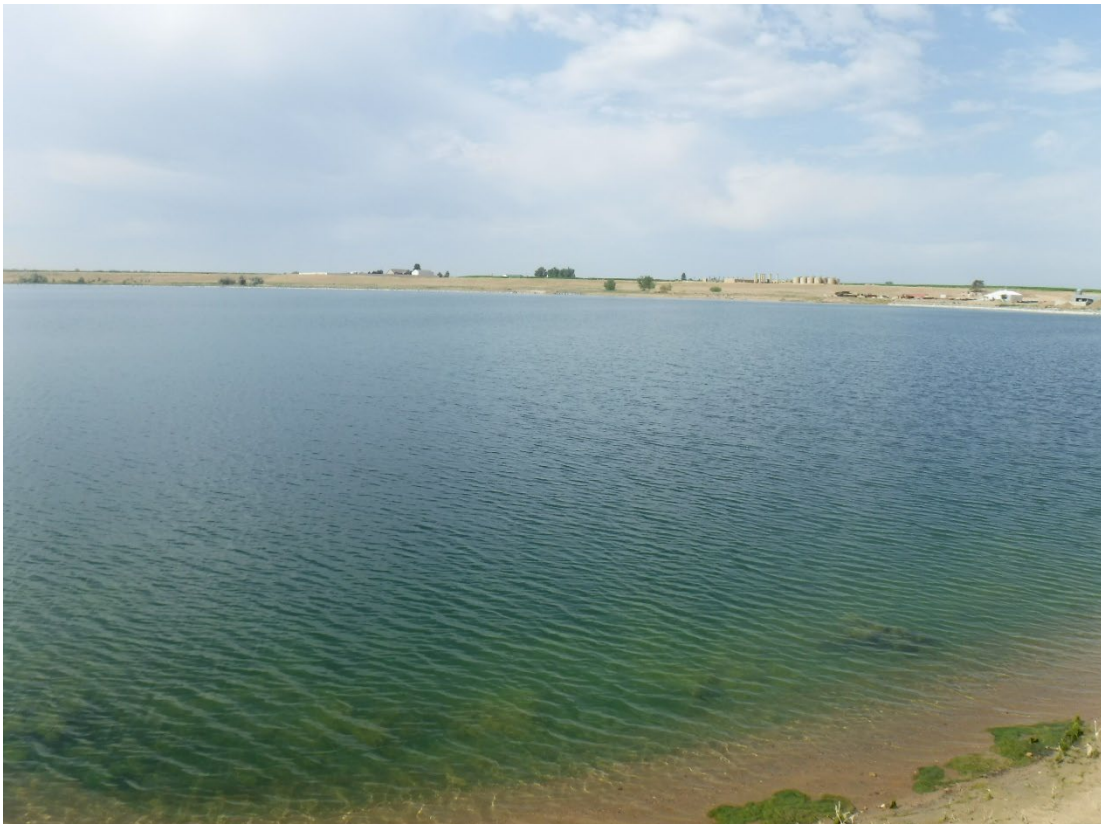
The reservoir is approximately 40 acres in size and was recently filled to capacity during free river flows earlier this year. The slurry wall was approved by the State Engineer's Office in a letter dated November 29, 2021. Vegetation is growing throughout the reseeded areas. There are weeds growing within the permit area however the site is not acting as a source of weeds to the surrounding area. It was noted that the majority of the weeds are located near the surrounding roadways.

**Photo 10:** Looking west across the reservoir

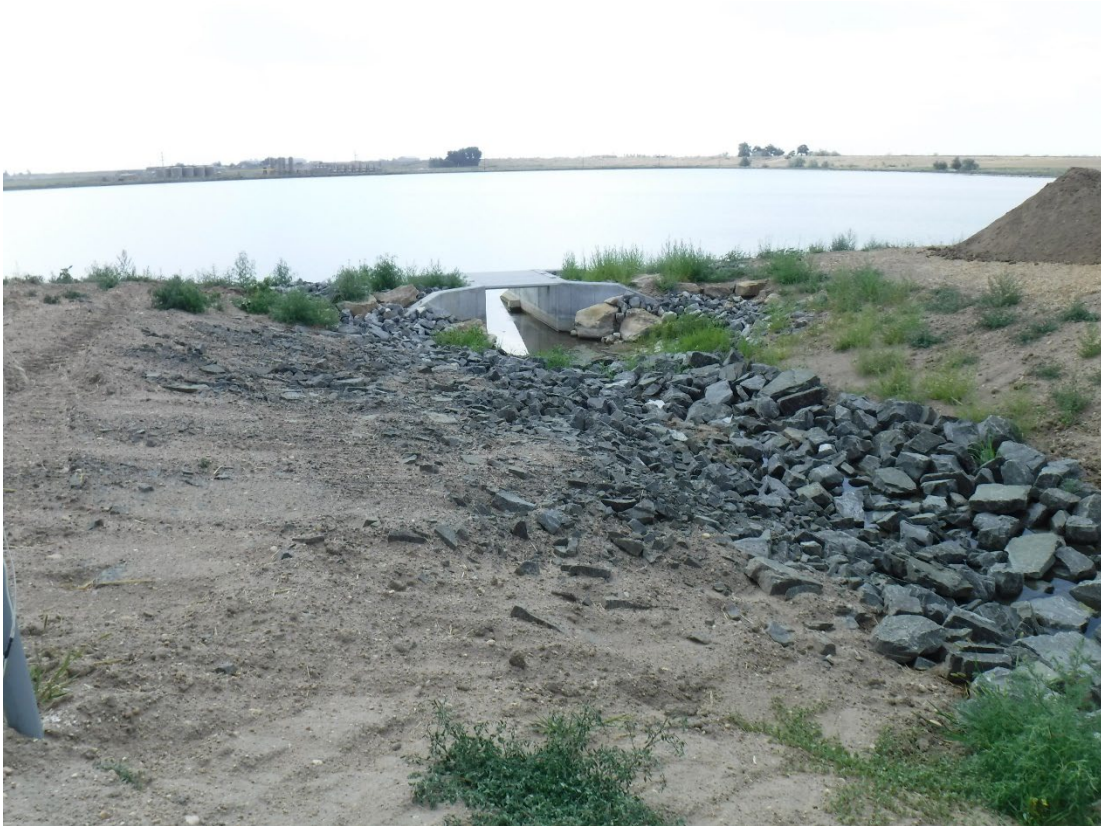
**Photo 11:** Inlet ditch to reservoir

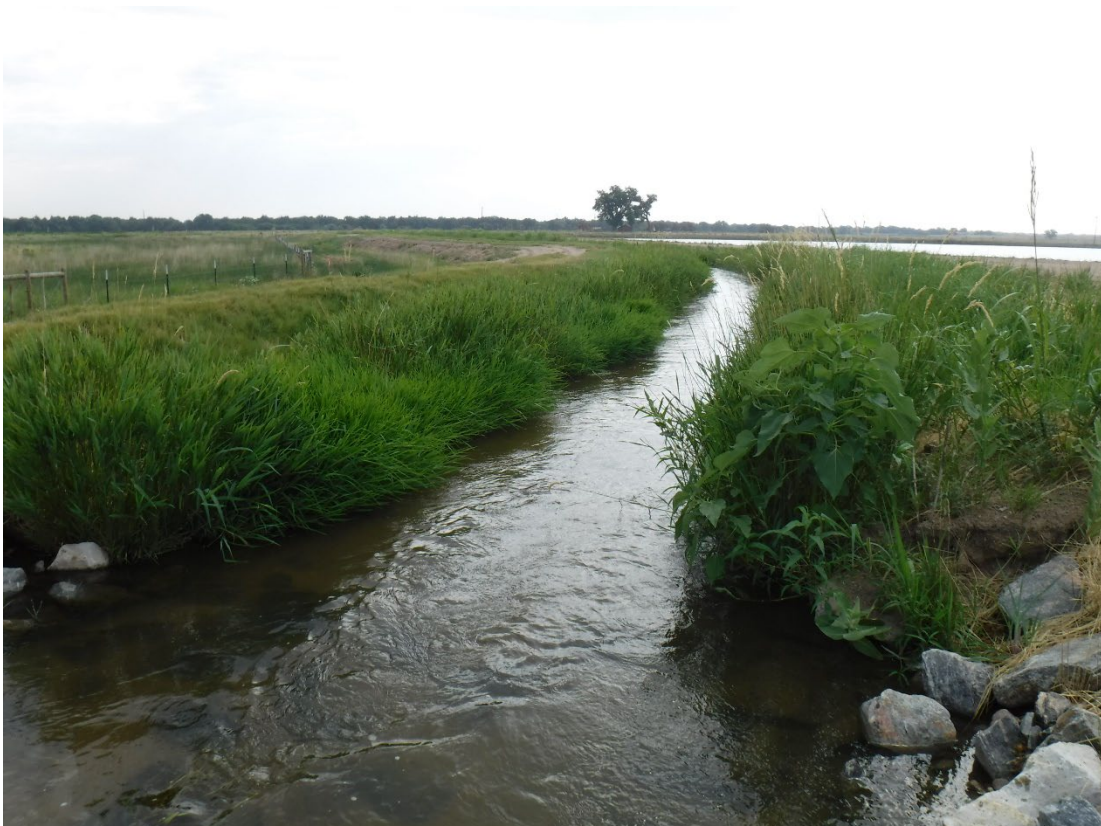
**Photo 12:** Plumb Ditch used to fill the reservoir

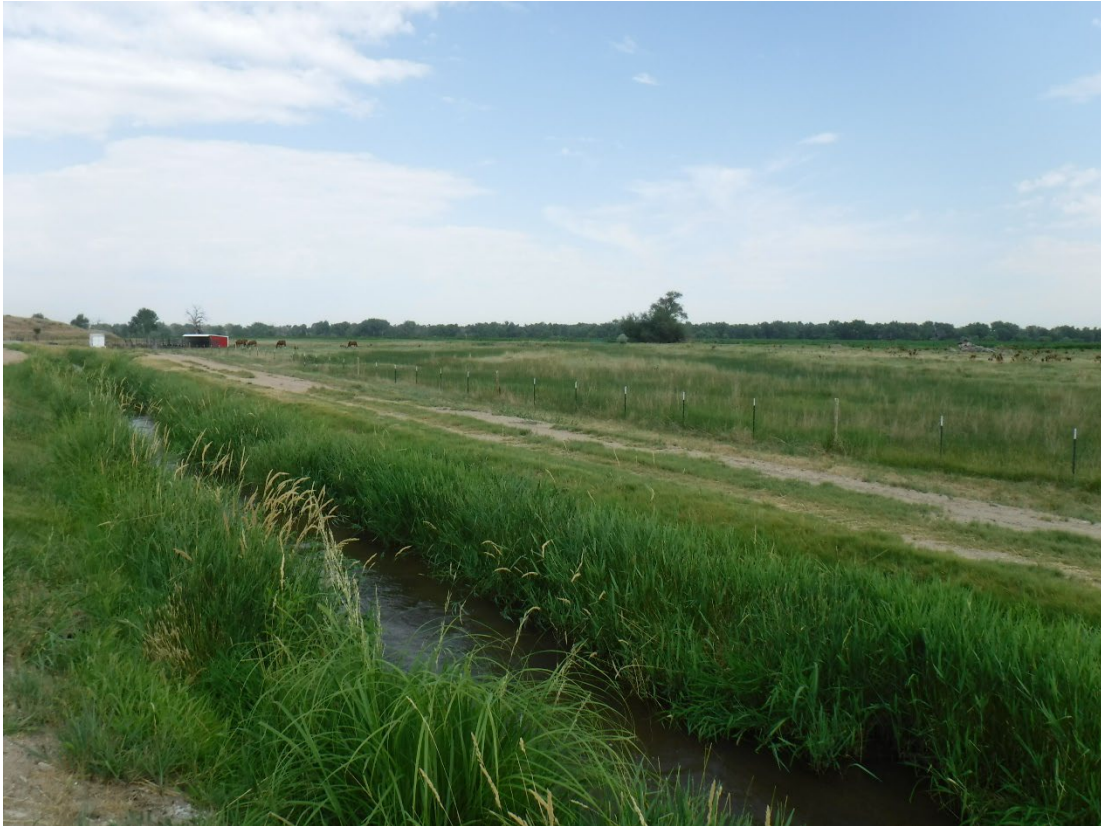
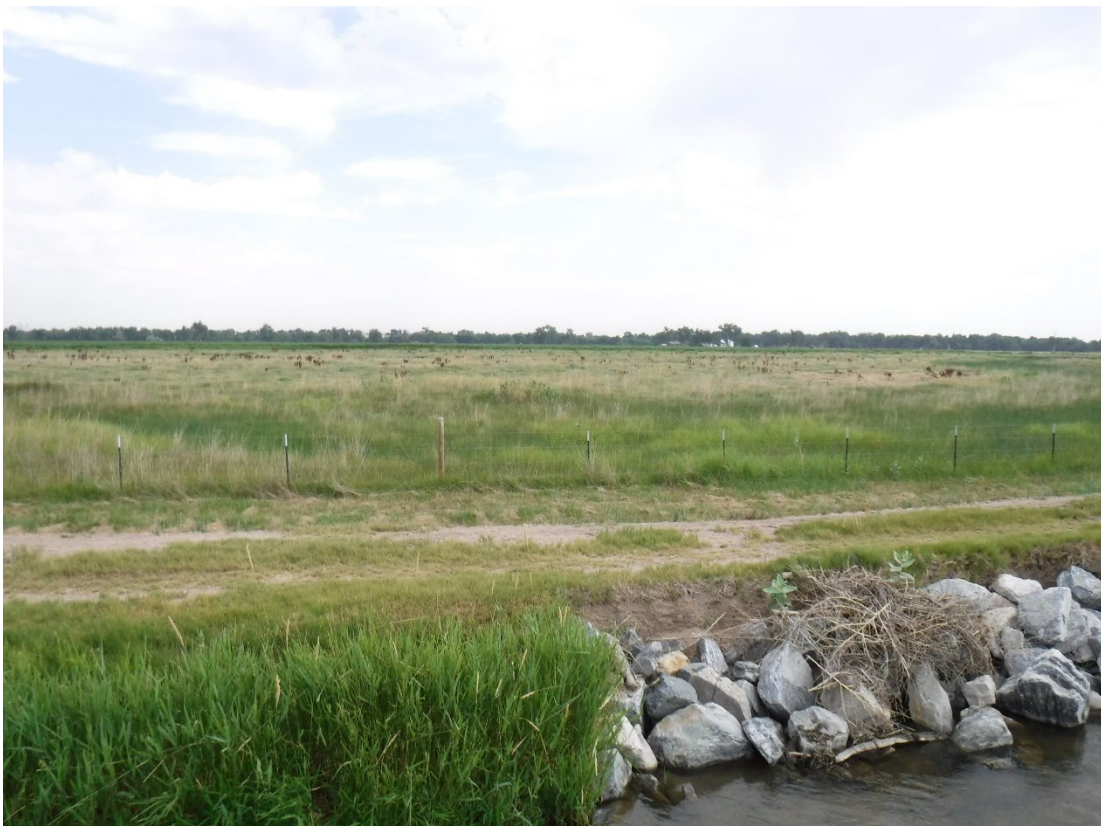
The permit area north of the South Branch of Plumb Ditch was not affected by mining.

**Photo 13:** Unaffected area north of ditch

**Photo 14:** Unaffected area north of ditch
