Huddleston-Berry
Engineering & Testing, LLC

Subject: Summary of Instrumentation Monitoring
2nd Quarter 2024
Bowie Coal Waste Disposal Area No. 2
Paonia, Colorado

SUBJECT: Summary Report, 2nd Quarter 2024, Inclinator and Active Vibrating Wire Piezometer Data April – June 2024, Bowie Mine #2 Coal Waste Disposal Area (CWDA) #2

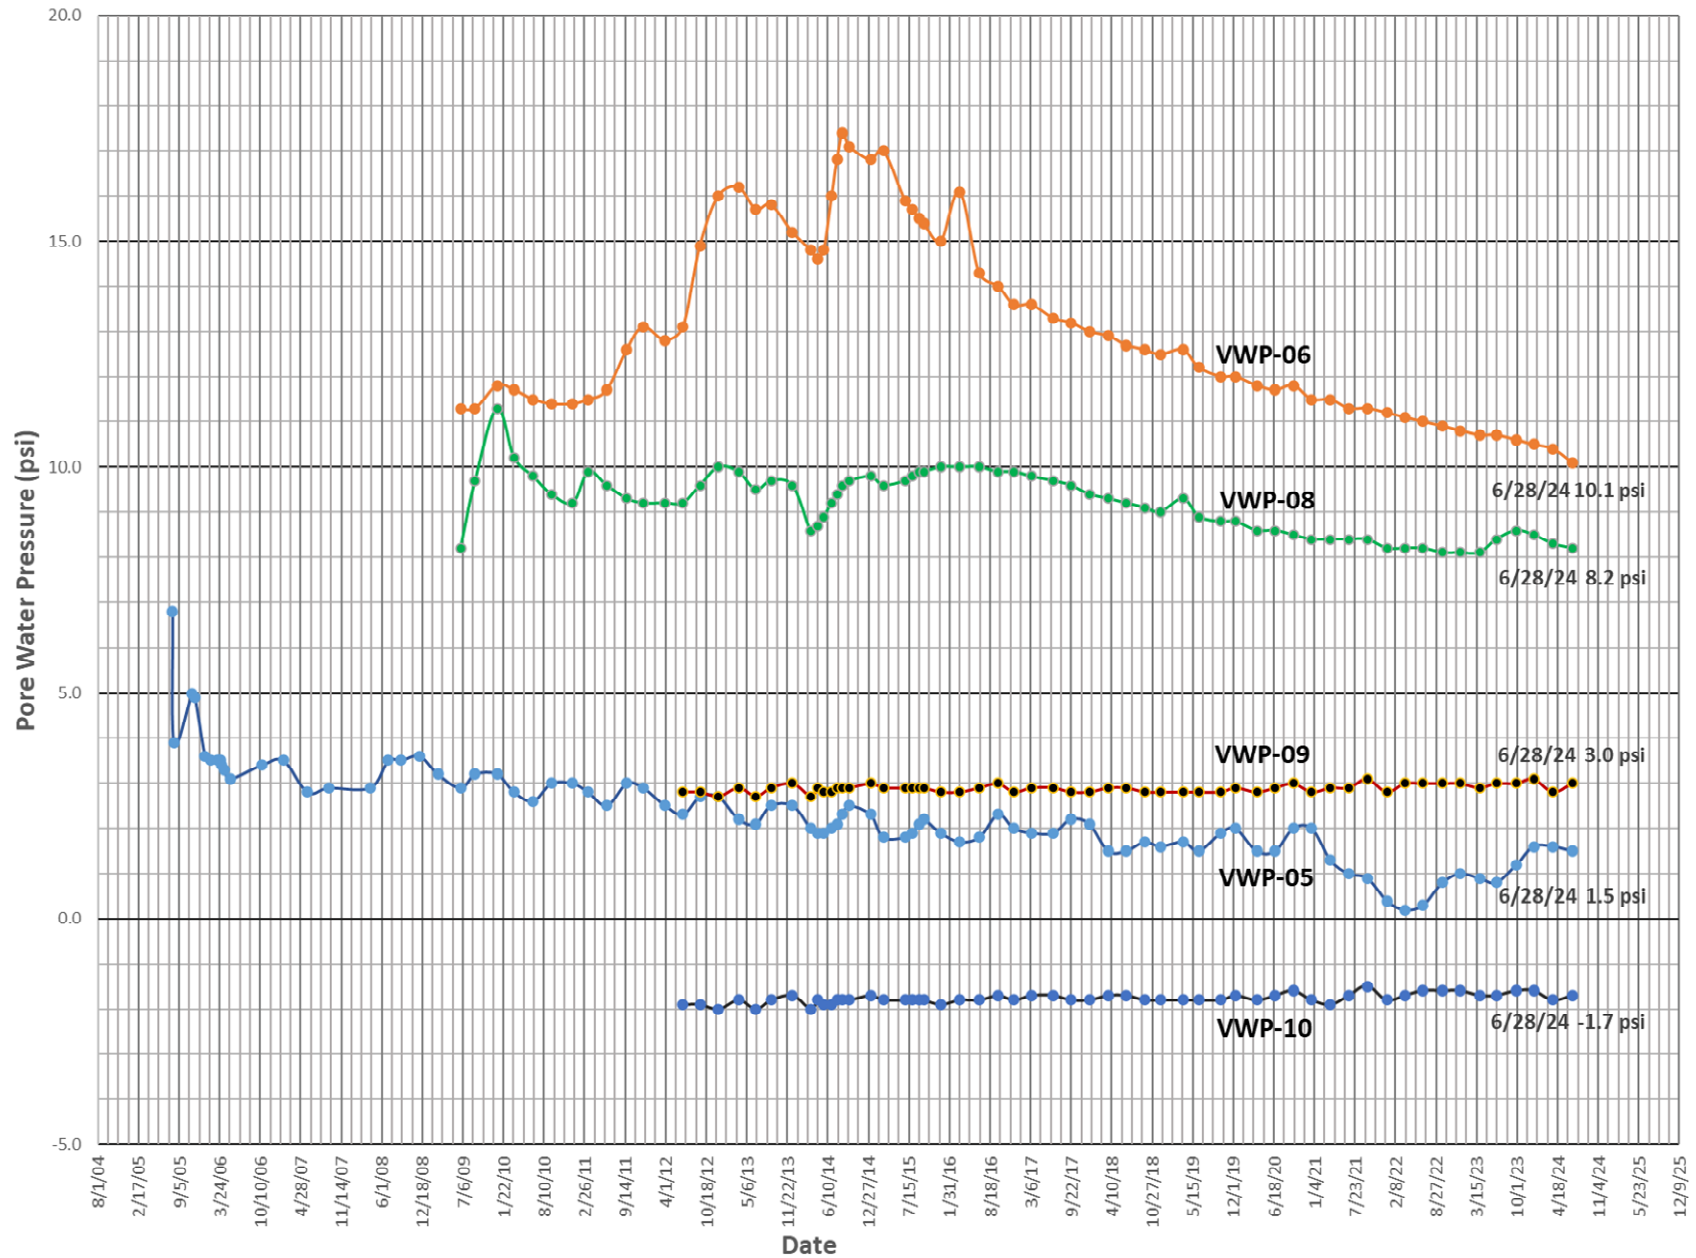
Figure 2 - Bowie Mine #2 - CWDA #2
Active Vibrating Wire Piezometer Data

As seen on Table 1 and Figure 2, the VWP readings and trends are consistent with recent and historic readings. When compared to a year ago (Q2 2023), pore pressure readings in all the

VWP's changed by small amounts (-0.6 to 0.7 psi). When compared with last quarter (Q2 2024), pore pressures also changed by relatively small amounts (-0.3 to 0.2 psi) for all five VWP's. Although four of the five VWP's remain steady or have general declining trends in pore pressure over the life of the VWP's, one of the piezometers (VWP-05) has exhibited pronounced seasonal cyclical behavior for its lifespan, except from mid-2021 to mid-2022 where there was a steady decline in pore pressures. This piezometer generally (but not always) shows low pore pressures for Q1 and Q2 and higher pressures for Q3 and Q4, with a net loss of -5.3 psi over the lifetime of that VWP. The other four VWP's have experienced net changes of -1.2 to 0.2 psi since installation, meaning current readings are very similar to initial readings. For VWP-09 and VWP-10, pressures have been consistent throughout the lifetime of the piezometers; however, for VWP-06 and VWP-08, they experienced wild fluctuations in pore water pressure in the first half of their lifetimes but have settled to pressures similar to the installation pressures in the past several years.

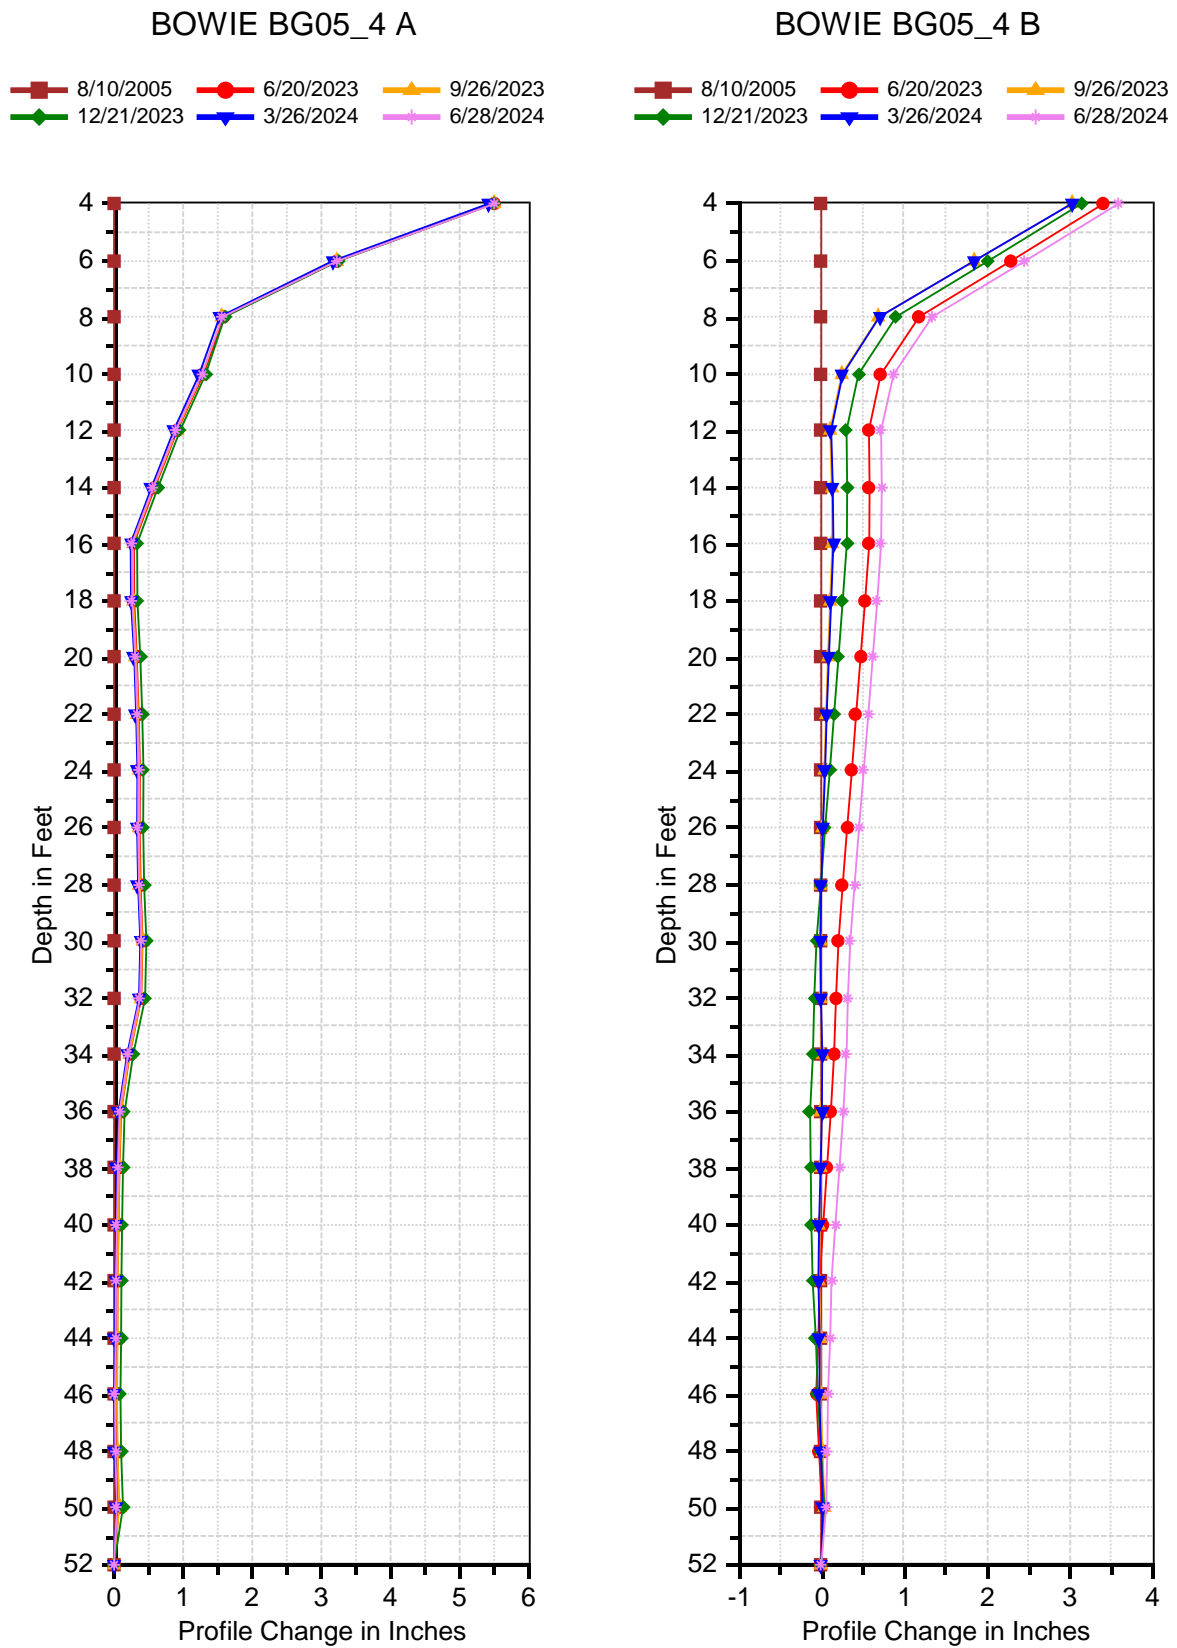
Figure 3 - Inclinometer Displacement Curves

Based on the current inclinometer readings, BG05_7 shows near perfect alignment (essentially identical readings for 19 years) with the initial reading in 2005 for the downslope direction (Axis A). Inclinometers BG05_4 and BG05_5, however, show a bulge of less than 1/2-inch in the inclinometer pipes (below the surface regrading). Based on our records, this bulge developed slowly from 2005 to 2010, but no movement has been recorded since then. This suggests there had been some gob pile settlement early in the lifetime of the inclinometers, but no recent or additional movement has occurred. Some "noise" which is understood to be relatively common in orthogonal direction (Axis B) readings, was observed over the past few years for all three inclinometers. This can be due to various mechanical or installation causes that are unrelated to slope movement. For example, grout voids, poor grout coverage, or soil settlement around the instrument can all contribute to vibrations and pipe movement that impacts inclinometer readings. No software bias adjustments were applied to filter this noise. All readings were

consistent with previous readings and the "displacement" error was within equipment tolerances and not deemed to be due to slope movement.
