## Coal partial Inspection Report, Lorencito Canyon Mine, C-1996-084

**COLORADO**  
Division of Reclamation,  
Mining and Safety  
Department of Natural Resources

<b>Permit Number:</b> C-1996-084 <b>Mine Name:</b> Lorencito Canyon Mine <b>Operator:</b> New Elk Coal Company, LLC <b>Operator Address:</b> Mr. John Terry 12250 Highway 12 Weston, CO 81091	<b>County:</b> Las Animas <b>Operation Type:</b> Surface <b>Permit Status:</b> Permanent Cessation <b>Ownership:</b> Private
	<b>Operator Representative Present:</b>  None
<b>Operator Representative Signature: (Field Issuance Only)</b>

<b>Inspection Start Date:</b> July 17, 2024 <b>Inspection Start Time:</b> 10:20 <b>Inspection End Date:</b> July 17, 2024 <b>Inspection End Time:</b> 12:00	<b>Inspection Type:</b> Coal Partial Inspection <b>Inspection Reason:</b> Normal I&E Program <b>Weather:</b> Cloudy
<b>Joint Inspection Agency:</b>  None	<b>Joint Inspection Contacts:</b>
<b>Post Inspection Agency:</b>  None	<b>Post Inspection Contacts:</b>
<b>Inspector(s):</b>  Amber M. Gibson	<b>Inspector's Signature:</b>

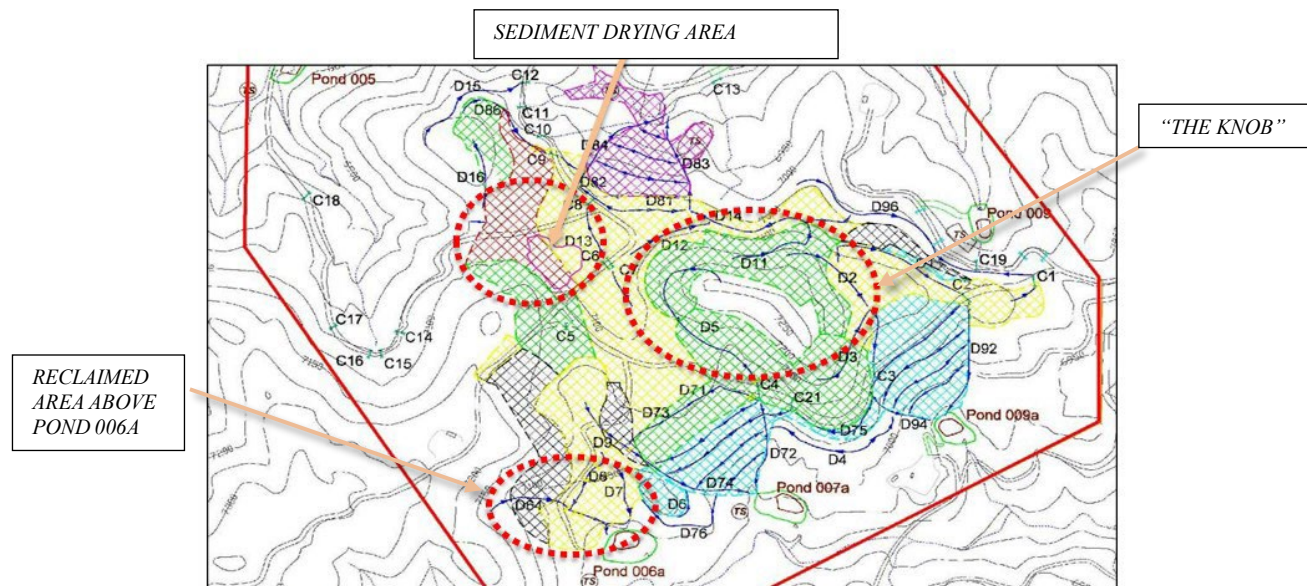
4. The following items pertain to ongoing erosional issues in the areas shown in Figure 1, that pursuant to Rule 4.14.6 need to be addressed. A Technical Revision will be required to expand on the current Rill and Gully plan in the PAP. **The Operator shall submit the technical revision, obtain approval, repair the erosion, and stabilize the slopes pursuant to the approved plan by December 31, 2024.**

FIGURE 1. AREAS WHERE RILLS, GULLIES AND SPARSE VEGETATION HAS BEEN FOUND TO BE A PERSISTENT PROBLEM AT THE SITE ARE WITHIN THE DOTTED CIRCLE AREAS. BACKGROUND IMAGE IS THE 2020 ANNUAL REPORT MAP.

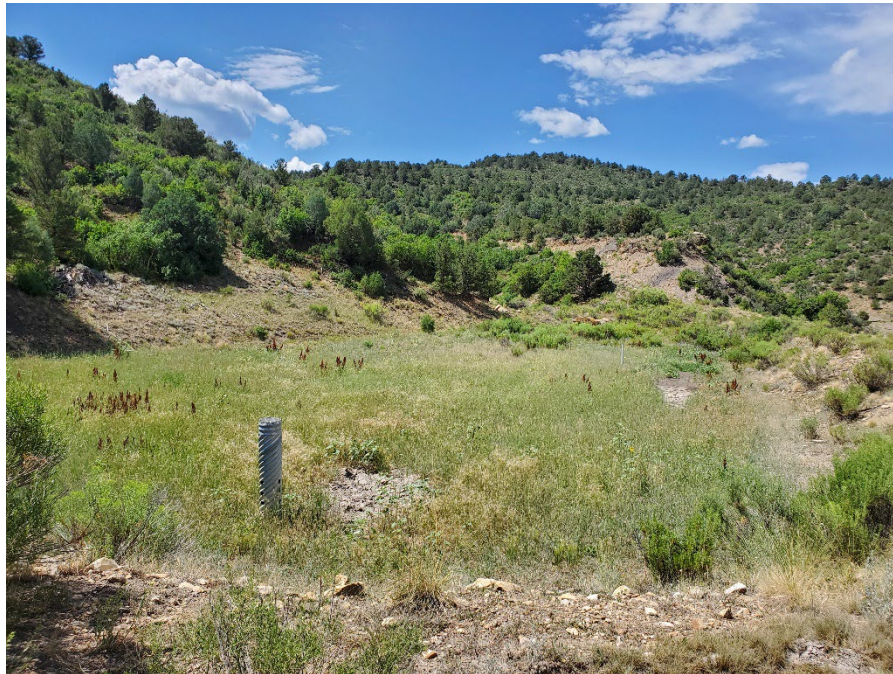
- Pond 005:
  - The pond was dry at the time of the inspection. (Photo 1).
  - The pond embankment was stable and vegetated.
  - The primary and emergency spillways appeared clear and functional.

*Photo 1: Pond 005*

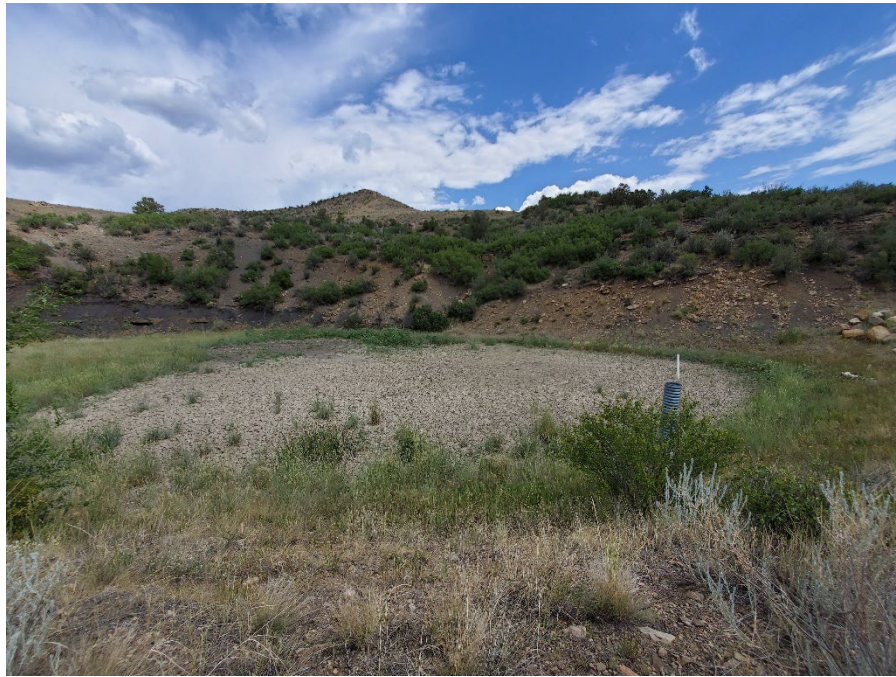
- Pond 007a:
  - The pond was dry at the time of the inspection and. (Photo 2).
  - The pond embankment was stable and vegetated.
  - The primary and emergency spillways appeared clear and functional.
  - The flume was dry and was not discharging (Photo 3).

*Photo 2: Pond 007a*

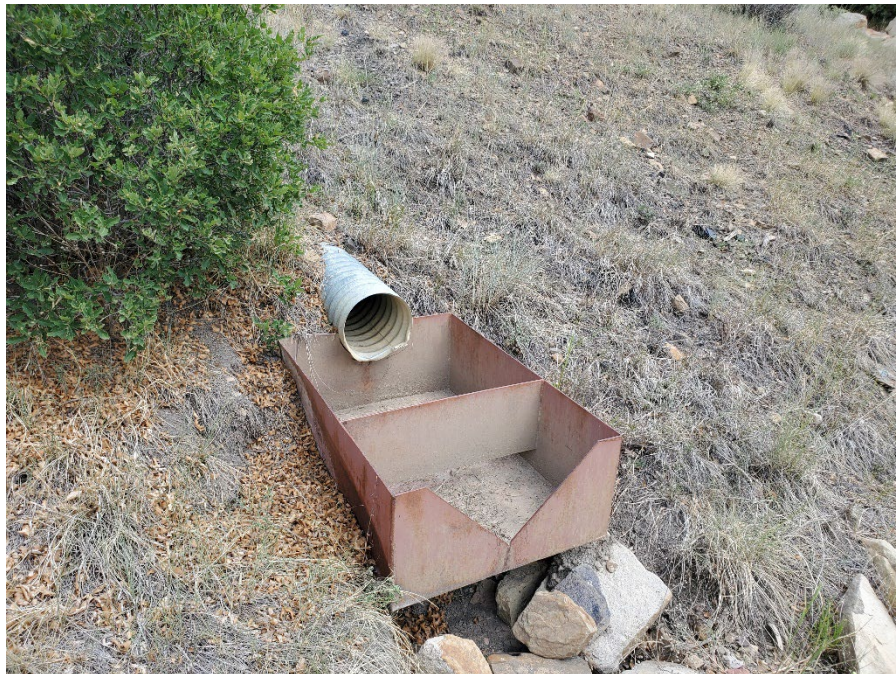
*Photo 3: Flume for Pond 007a*

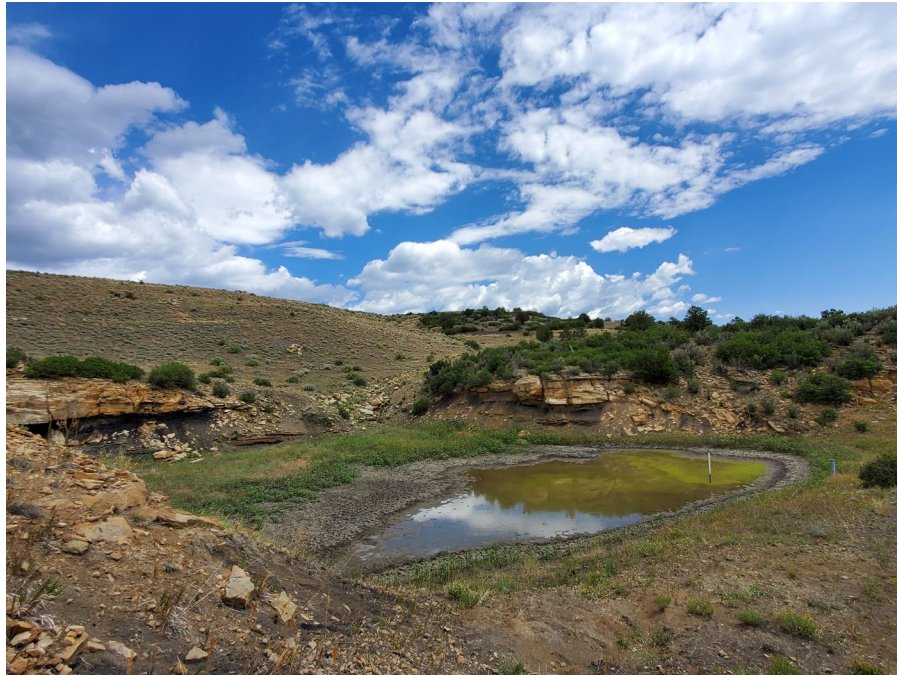
- Pond 009a:
  - The pond held some water at the time of the inspection. (Photo 4).
  - The pond embankment was stable and vegetated.
  - The primary and emergency spillways appeared clear and functional.

*Photo 4: Pond 009a*

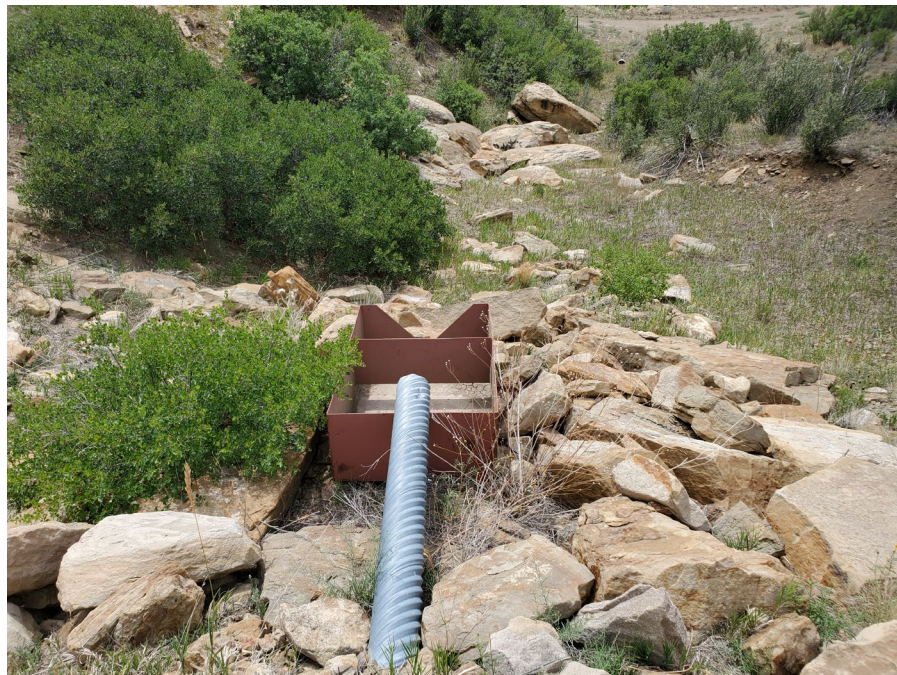
- The flume was dry and was not discharging (Photo 5).

*Photo 5: Flume for Pond 009a*

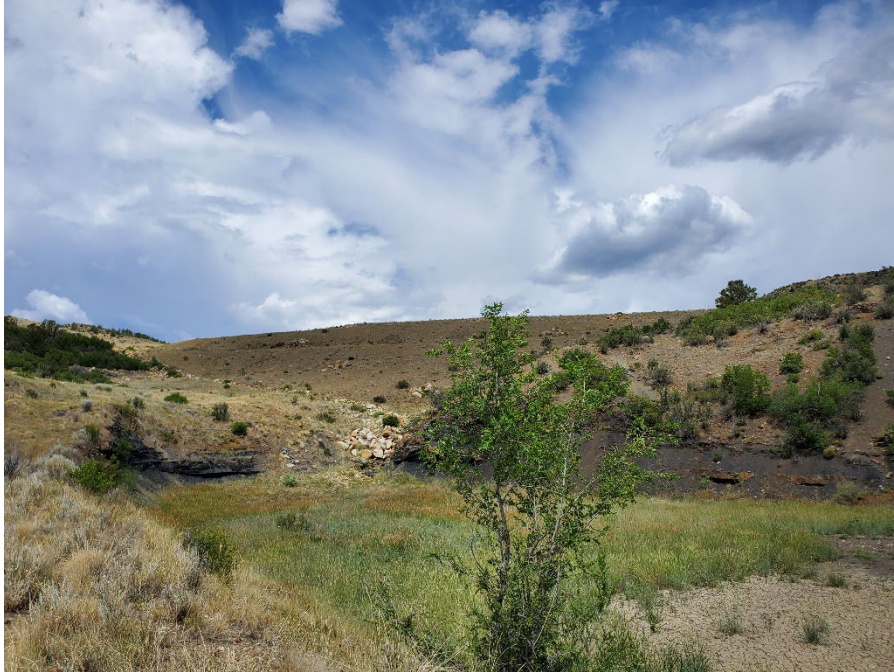
- Fill 007 was observed. Fill 007 was well vegetated and appeared stable (Photo 6).

*Photo 6: Looking north-west at Fill 7. Pond 007a pictured along the bottom of the photo.*

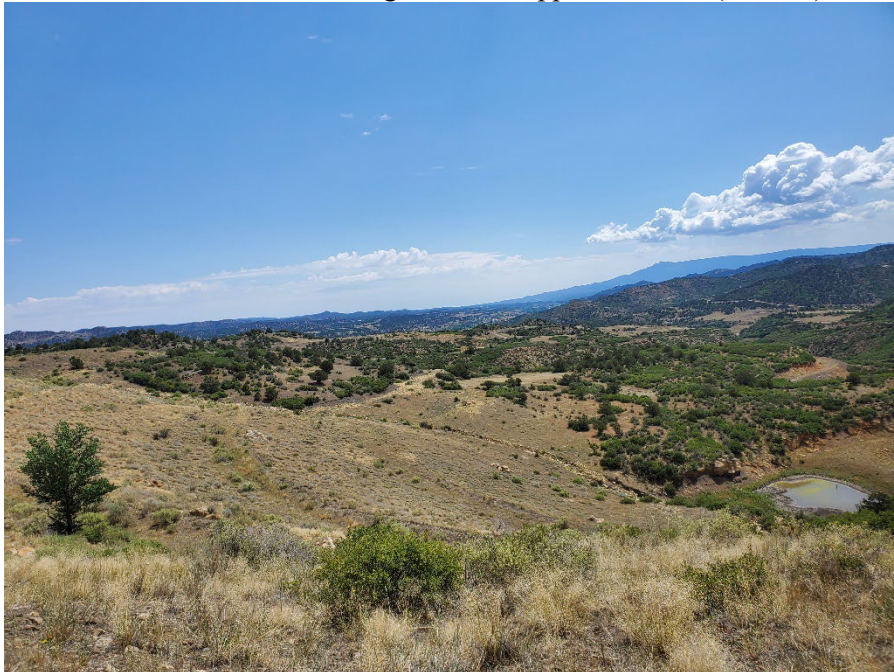
- Fill 009 was observed. Fill 009 was well vegetated and appeared stable (Photo 7).

*Photo 7: Looking south down Fill 009. Pond 009a seen in the bottom right corner of the photo.*

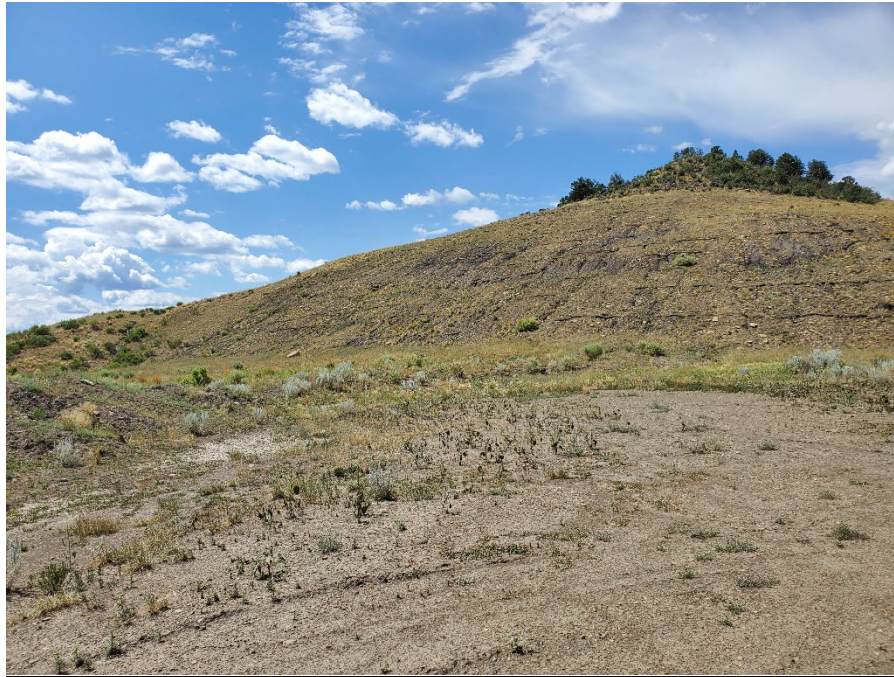
- The area above where NECC stores pond and ditch cleanings consists of a steep slope. This slope was observed (Photo 8). Erosion rills and gullies were observed but the vegetation on this slope appears better established this year than previously observed by DRMS. NECC is encouraged to continue to monitor this area and conduct maintenance as needed.

*Photo 8: Sediment drying area and seeded slope*
