**Inspection Report, Colowyo, C1981019**

**PERMIT INFORMATION**

<b>Permit Number:</b> C-1981-019 <b>Mine Name:</b> Colowyo Coal Mine <b>Operator:</b> Colowyo Coal Company L.P. <b>Operator Address:</b> Mr Tony Tennyson 5731 State Highway 13 Meeker, CO 81641	<b>County:</b> Moffat, Rio Blanco <b>Operation Type:</b> Surface <b>Permit Status:</b> Active <b>Ownership:</b> Private
	<b>Operator Representative Present:</b>  Tony Tennyson / Tom Fry
<b>Operator Representative Signature: (Field Issuance Only)</b>

**INSPECTION INFORMATION**

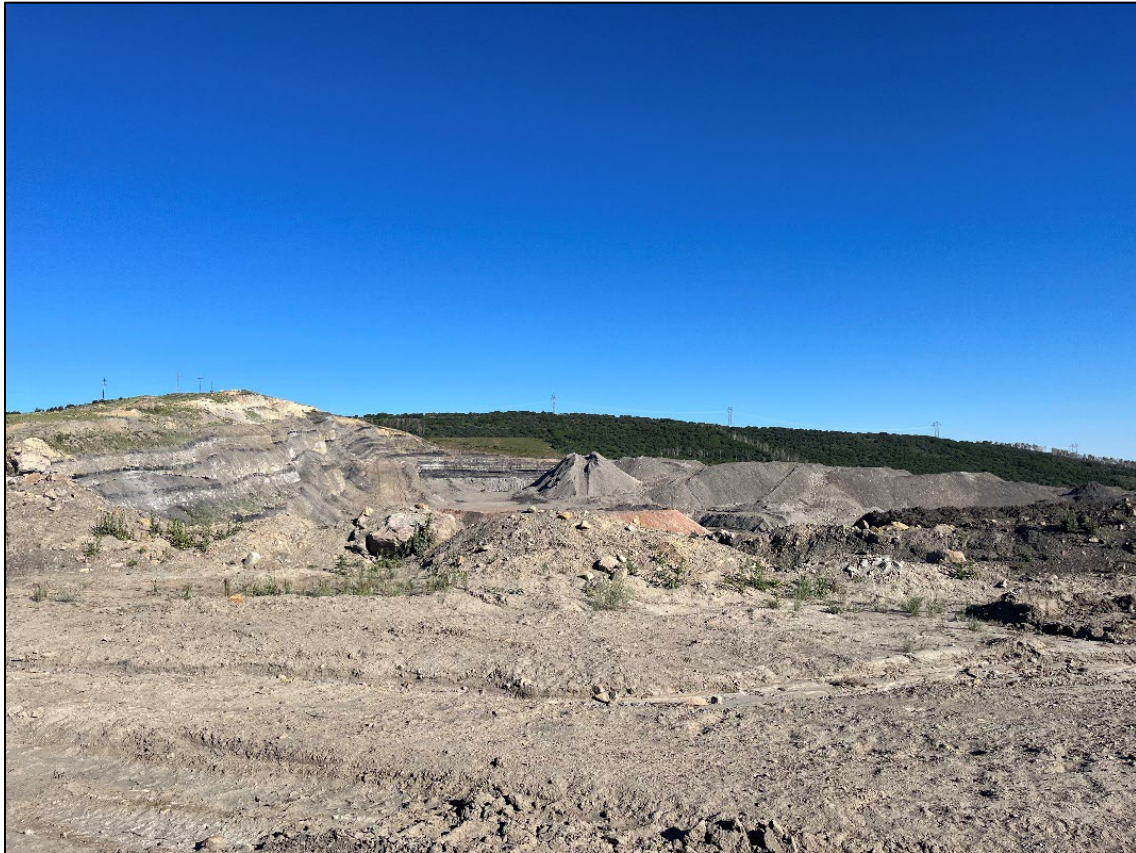
Active backfill operations were not observed in the South Taylor Pit during the inspection but had progressed since the Division's last inspection. Spoil is excavated from a temporary spoil located just north of the pit. An ~400 ft highwall remains to the west for possible future use (Photo 1). A crusher is present in this area.

*Photo 1: View north of the South Taylor Pit, backfill work ongoing.*

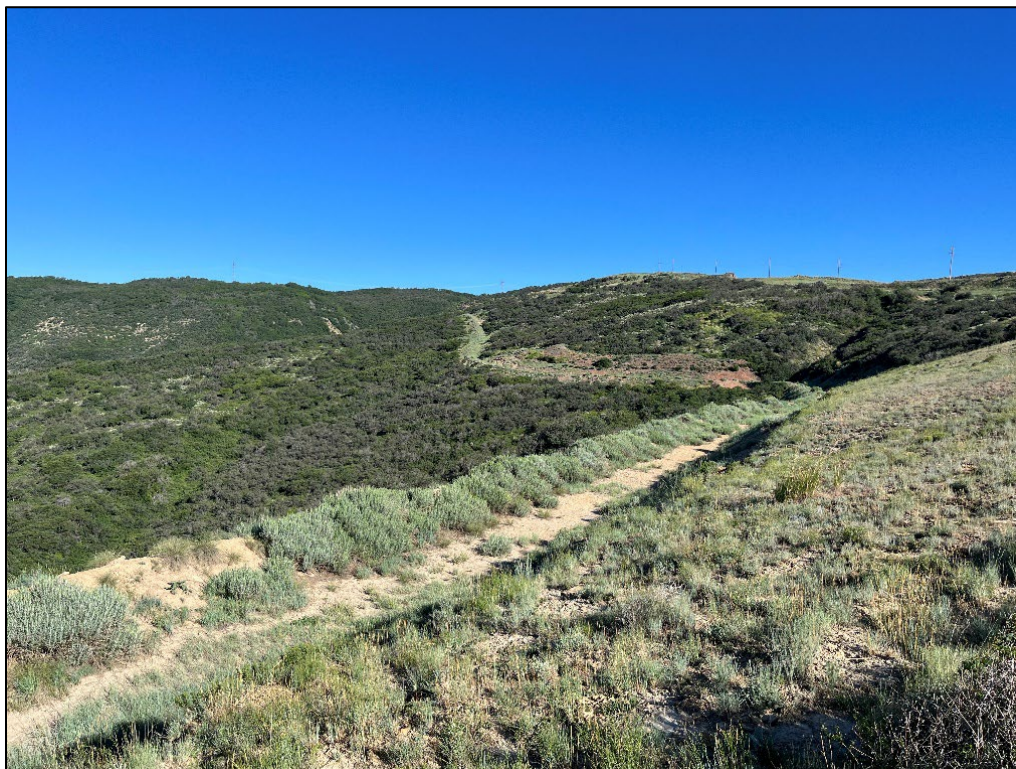
*Photo 2: View northwest of Section 29 Ditch which eventually connects with Section 28 Ditch.*

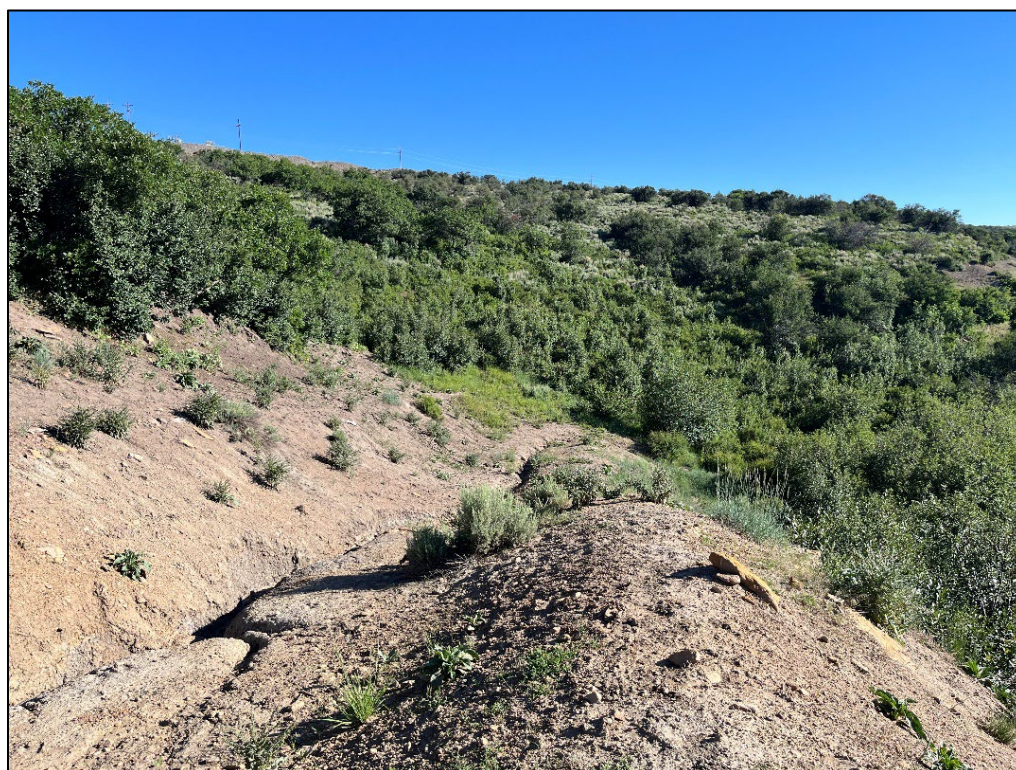
*Photo 3: Section 28 Ditch, view northeast.*

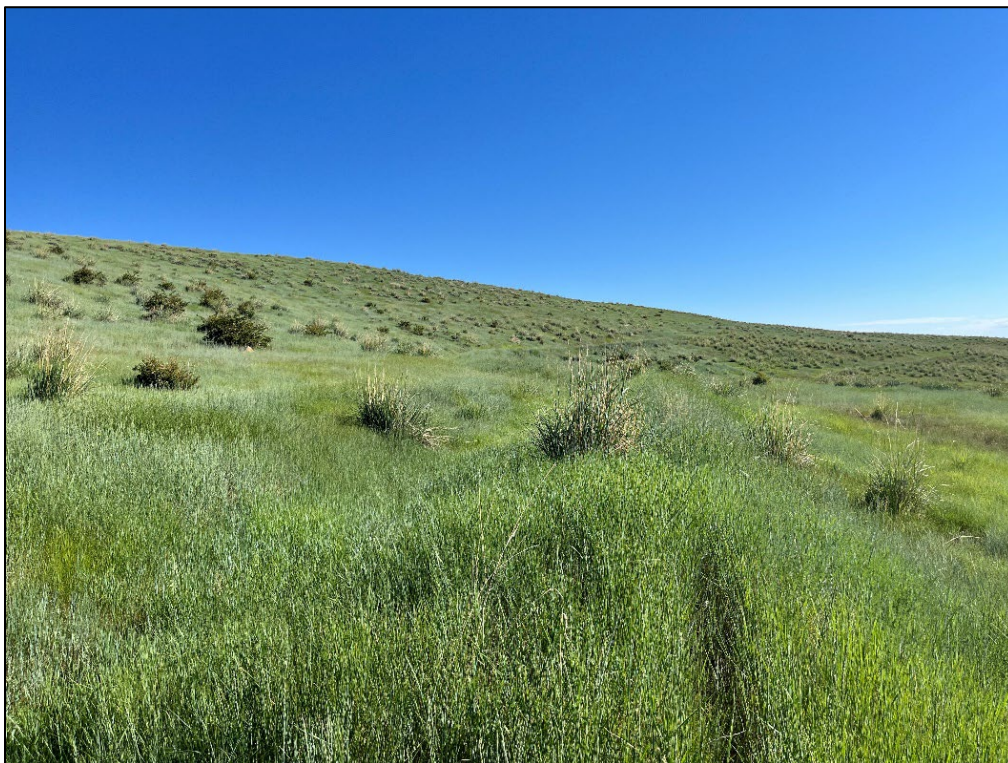
The West Taylor Pond was inspected in the South Taylor Area. The West Taylor Pond was inspected from below the Taylor valley fill area. The pond was holding water at the time of inspection and appeared stable. Several ditches along the perimeter of the disturbance areas near South Taylor were inspected this month via walking along the path of the ditch. This includes Section 28 and 29 ditches (Photos 2 and 3), West Section 16 Ditch (Photos 4 and 5), and the southern end of the South Collection Ditch (Photo 6). All ditches were mostly dry. Section 16 ditch is heavily vegetated over. Many game trails were noted in these ditch areas.

*Photo 4: Section 16 Ditch, view north.*

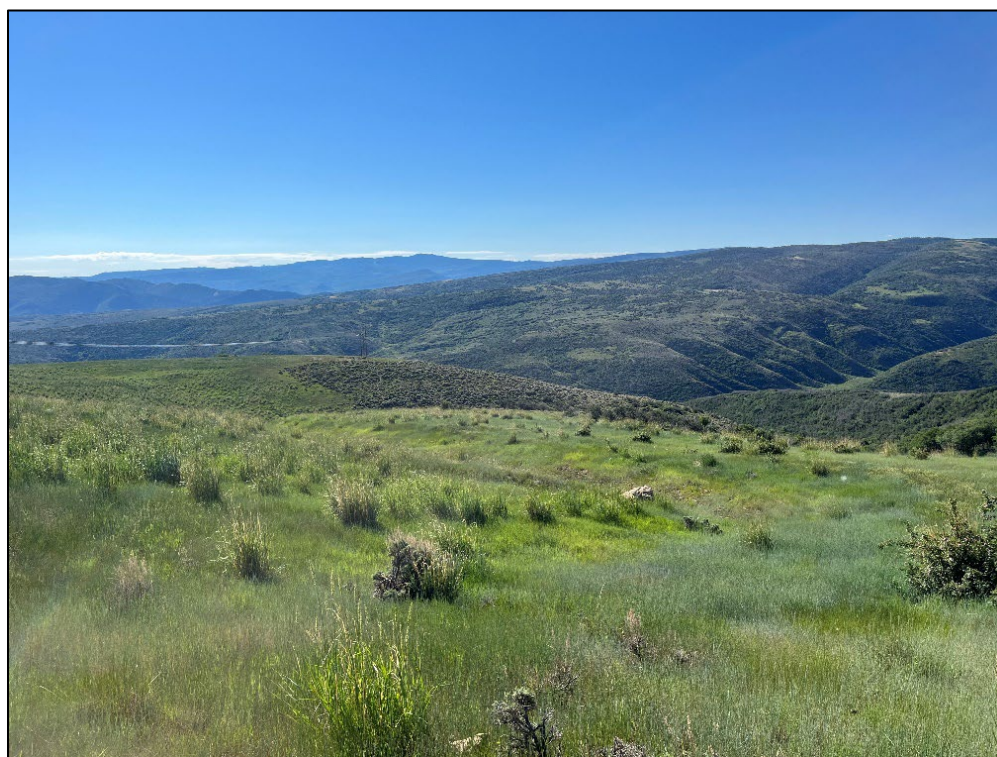
*Photo 5: Section 16 Ditch, view East.*

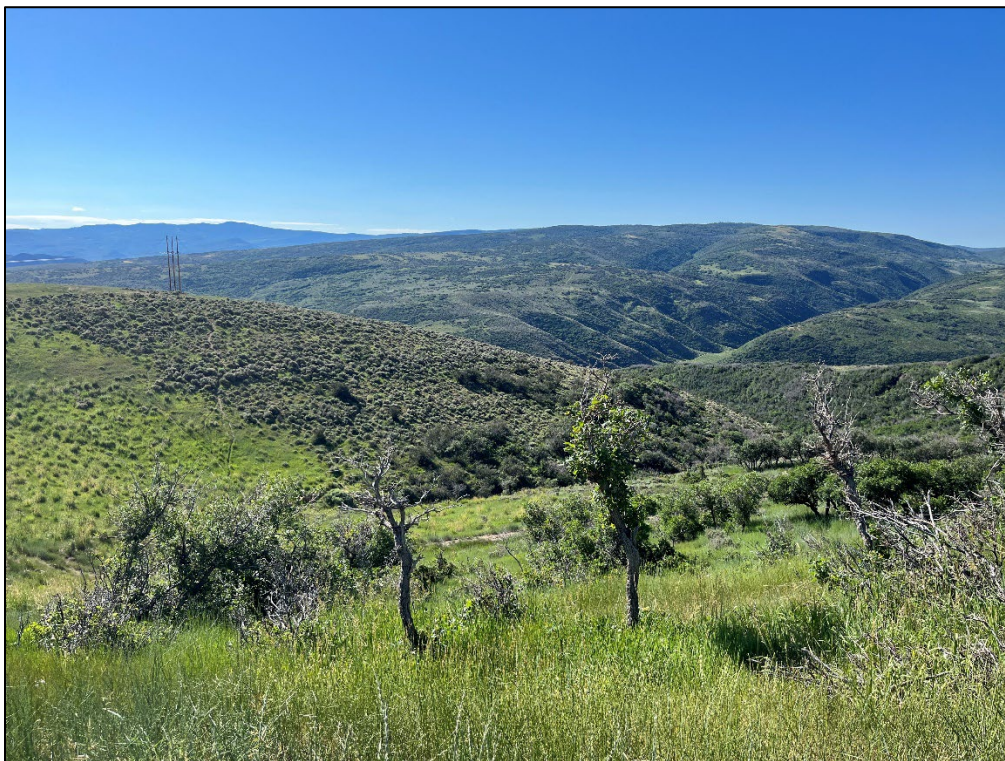
*Photo 6: View east from Section 16 ditch into the South Collection ditch.*

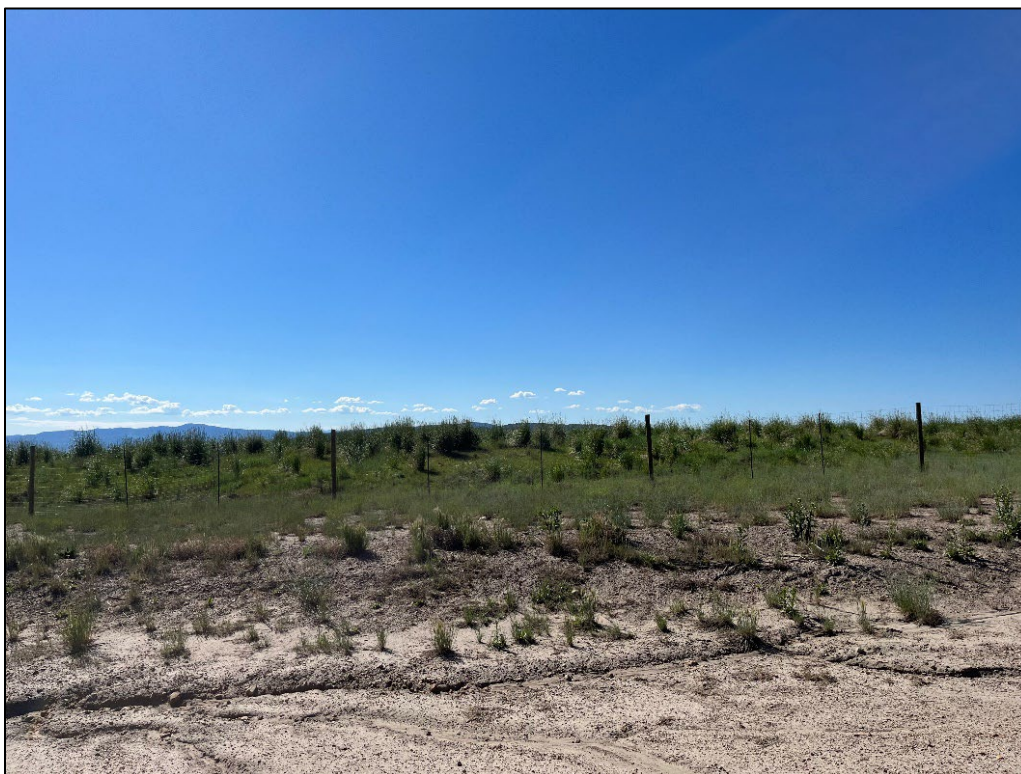
Reclamation parcels along the South Taylor Pit were inspected. One reclamation parcel is pictured in Photo 7. This parcel contains a test plot for various shrubs which was planted several years ago. Vegetation has been established, but the entire parcel is not yet fully vegetated. There were no signs of erosion across these reclamation areas.

*Photo 7: View south of the reclamation parcel adjacent to the South Taylor pit.*

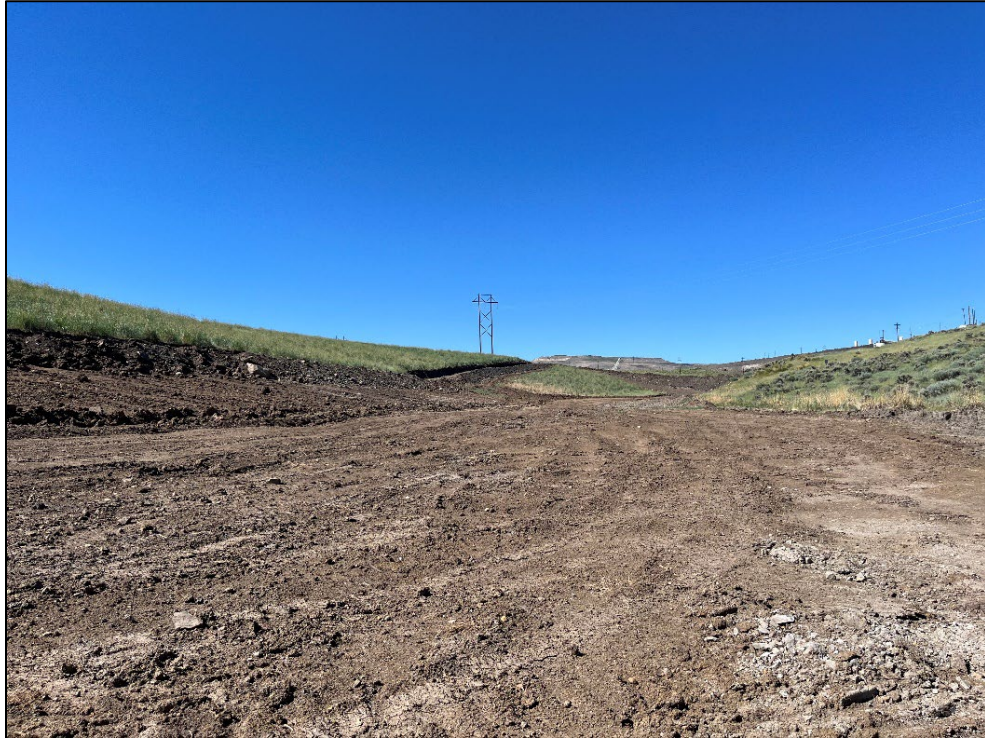
Section 16 Pond was observed during this inspection and no issues were noted. Observations in the East Pit focused on the continued development of the Upper and Lower Section 3 Ponds, located just below the primary crushing facility at the site. These will be non-discharging structures located in Streeter Ditch. An access road will also be constructed to aid in construction and future cleanout of the ponds. Topsoil has been stripped from this area and the footprint of the two pond is now visible (Photos 8 and 9).

*Photo 8: View west of the continued work on the Upper and Lower Section 3 sediment ponds.*

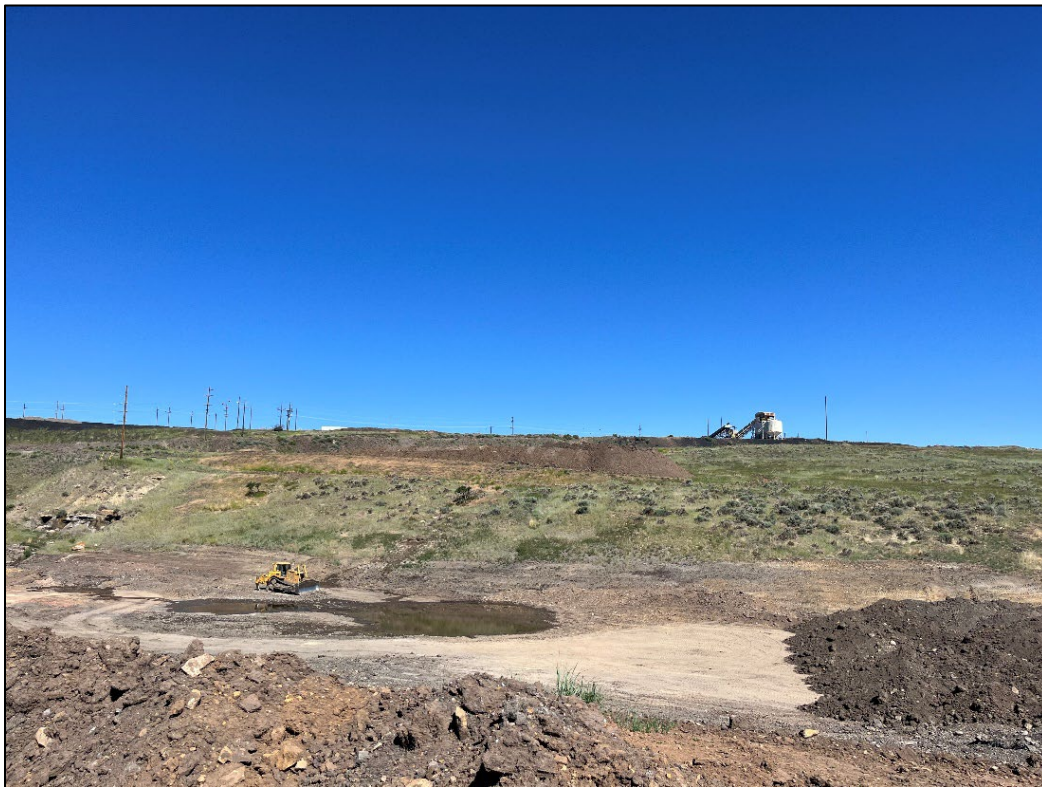
*Photo 9: View north of continued work on Upper and Lower Section 3 ponds.*

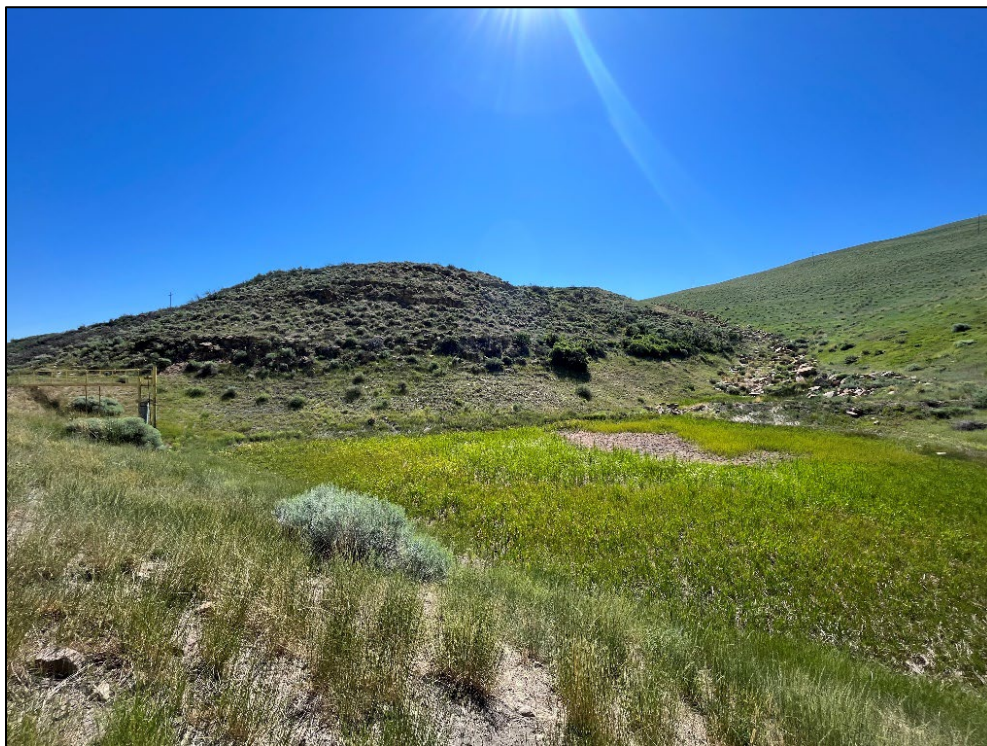
*Photo 10: West Pit Pond, view east.*

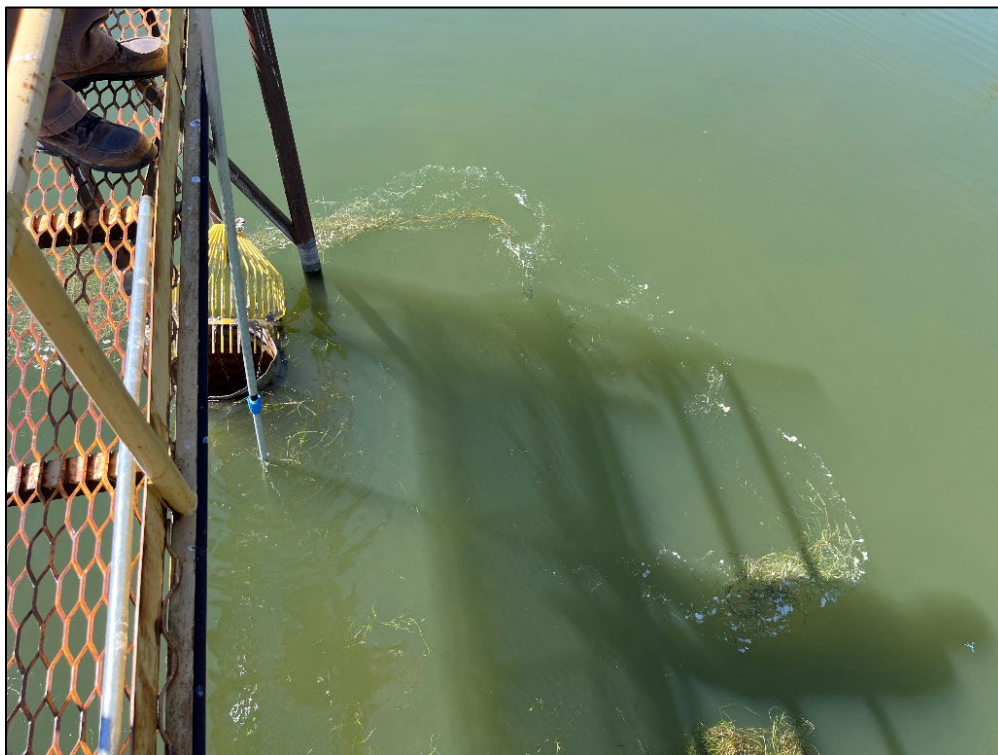
*Photo 11: Congested inlet being partially cleaned at the East Taylor Pond.*

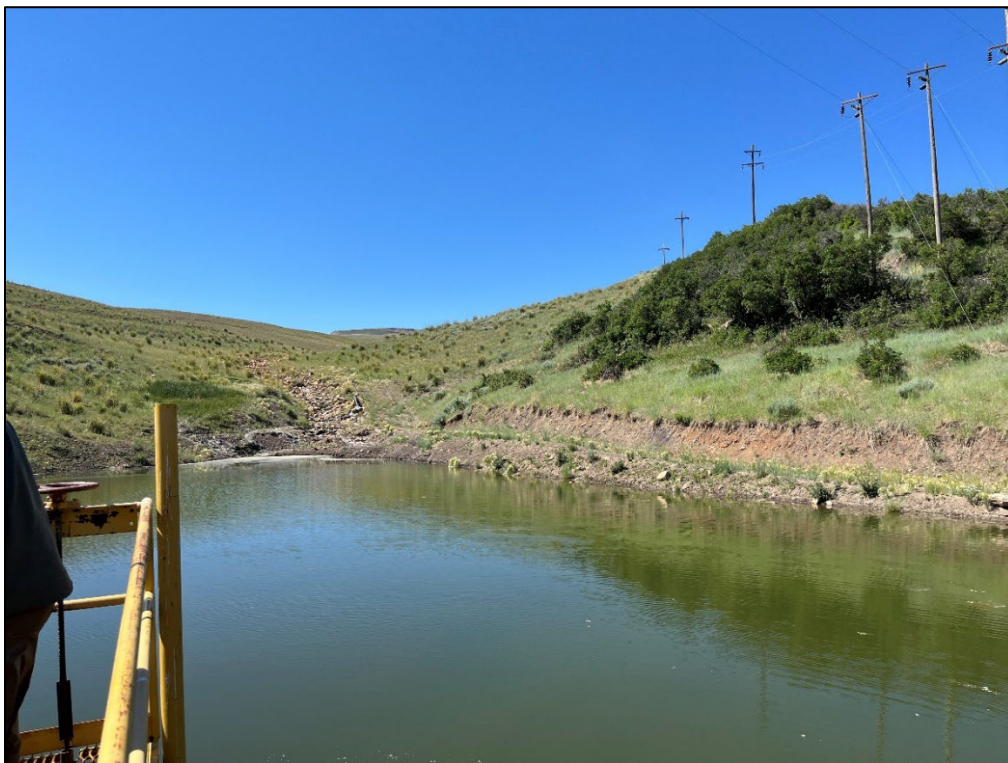
The East Taylor Pond (Photo 12) in the West Pit area was inspected this month. The East Taylor Pond was able to be accessed via a small offroad trail along Taylor Creek. At the time of inspection, aquatic growth was partially obstructing an outlet structure for the pond. Some of this growth was removed immediately (Photo 11). A full cleaning by site personnel was scheduled by Tom Fry for that same day. The West Pit Pond was also accessed via this road during the inspection. This pond was dry at the time of inspection (Photo 10). Several sumps along Taylor Creek were observed to be in the process of being pumped and cleaned out at the time of inspection.

*Photo 12: View south of East Taylor Pond.*

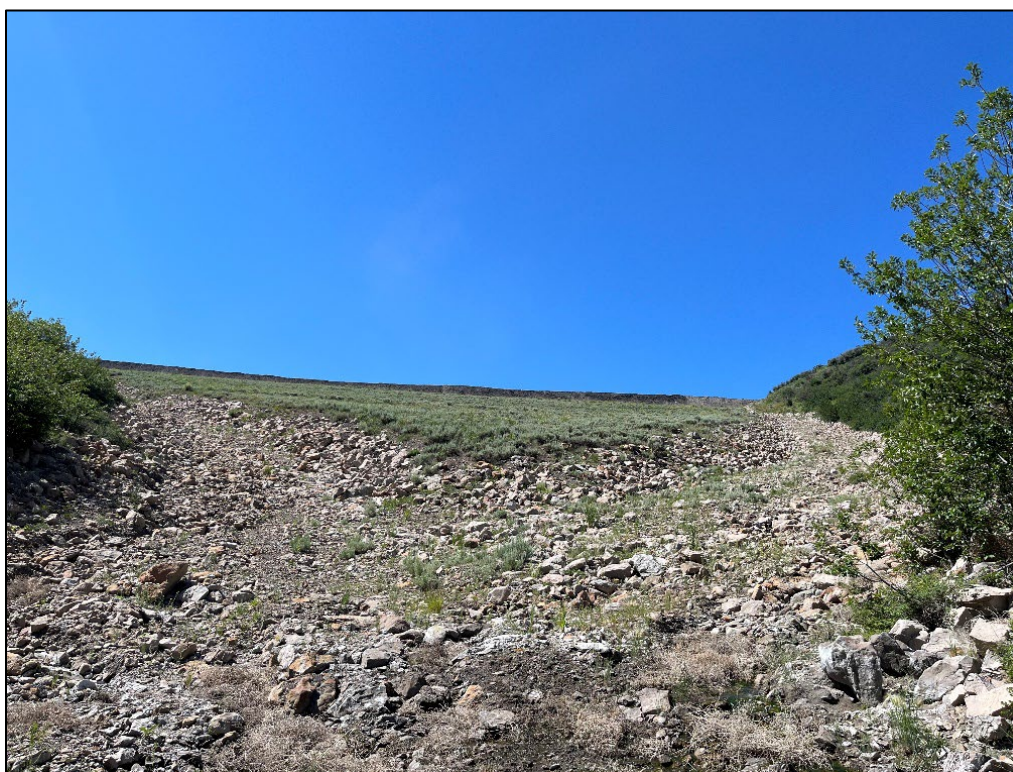
The Taylor Valley Fill area was inspected from below (Photo 13) at the West Taylor Pond. The slope face was noted to be stable at the time of inspection; no major signs of erosion or concerns were observed. The side ditches which divert water around the fill were observed to be stable and working to transport water into the West Taylor Pond.

*Photo 13: View looking south and up at the Taylor Valley Fill area and side ditches.*

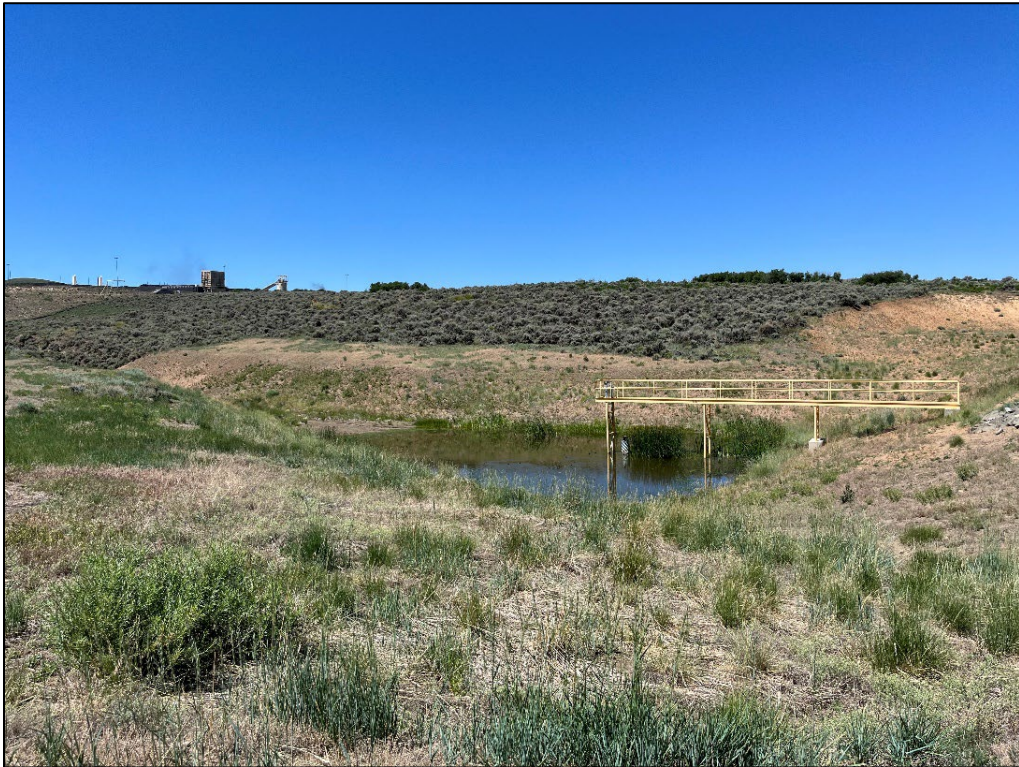
*Photo 14: Section 26? Pond in the Collom Pit area.*

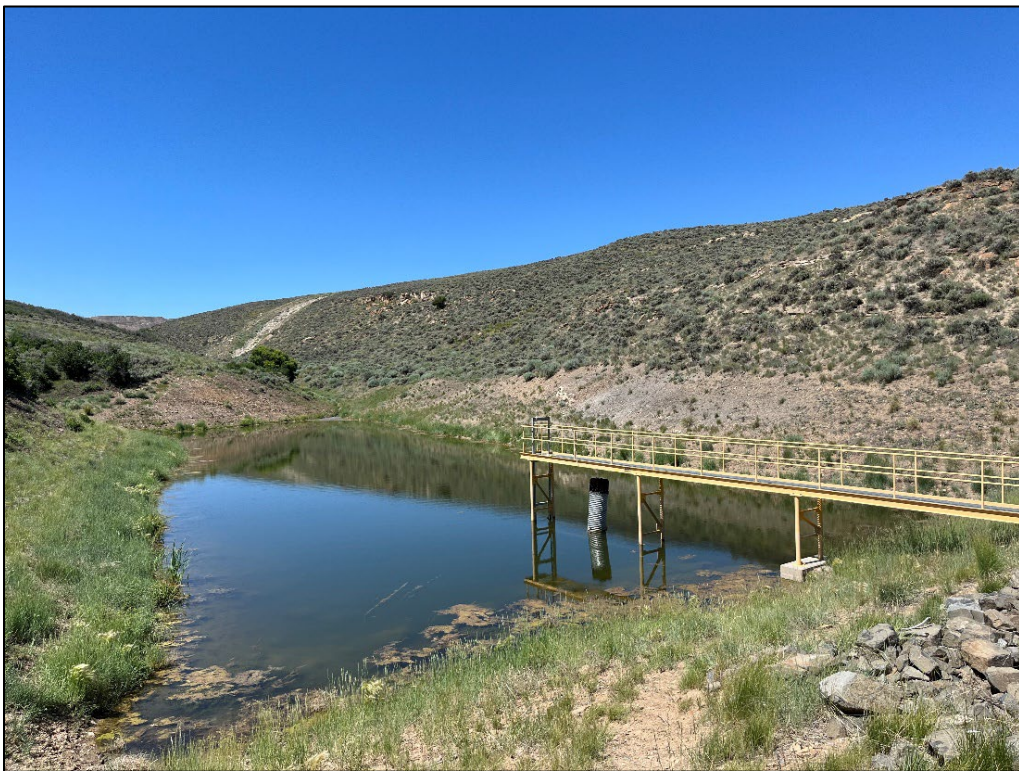
*Photo 15: Section 25 Pond in the Collom Pit, D-3 Ditch is visible in the background.*

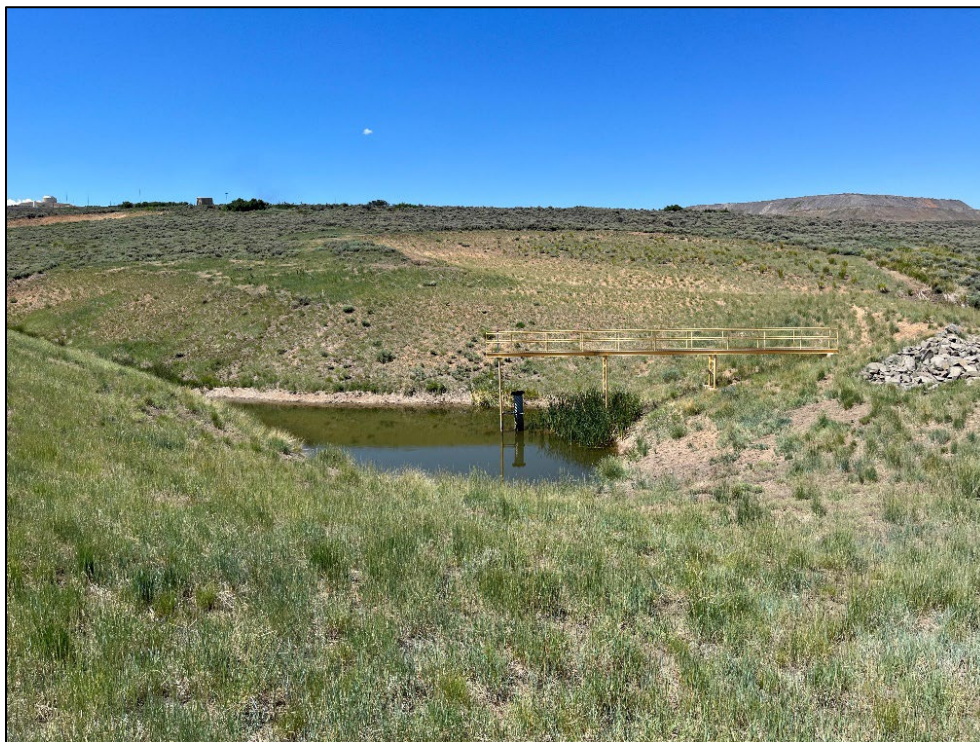
*Photo 16: Middle Pond in the Collom Pit area.*

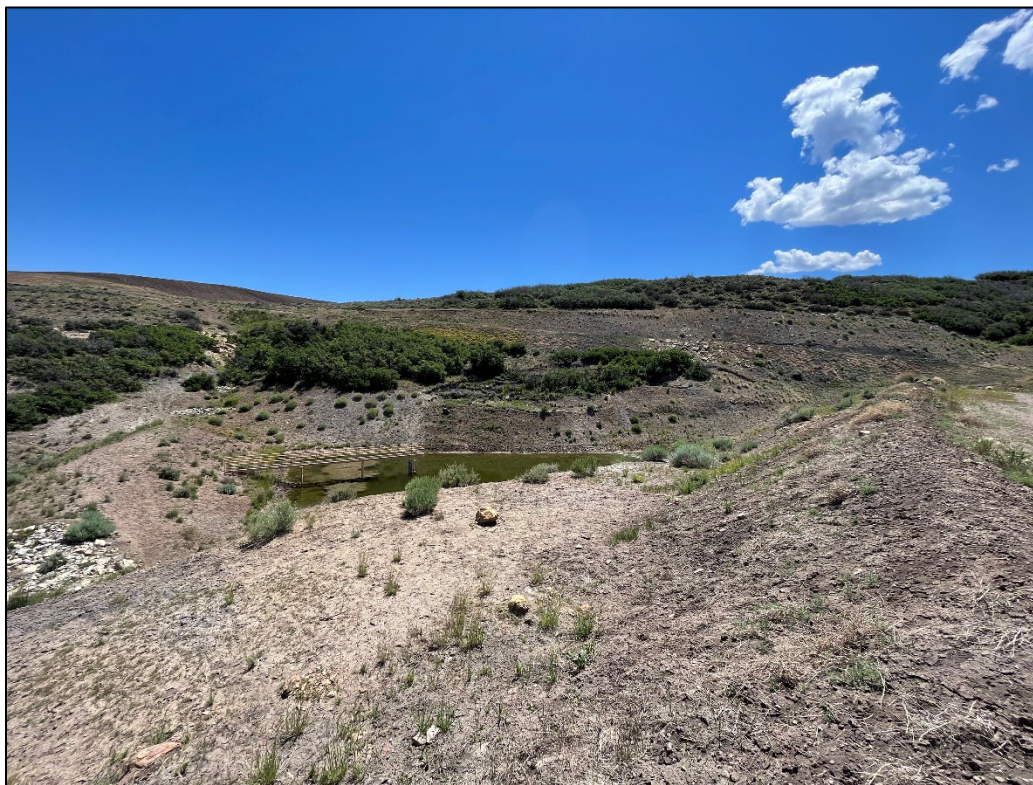
The following Ponds in the Collom Pit area were inspected this month: Section 36 Pond, Sidehill Pond, Middle Pond (Photo 16), Section 25 Pond (Photo 15), and Section 26 Pond (Photo 17). No outstanding problems were noted at any of the ponds. The slump area at Section 26 Pond continues to be monitored closely for any signs of degradation. No observations of movement had occurred since the last inspection. All ponds were observed to be holding water, though Middle Pond volume was low. Waterfowl were seen to be using many of these ponds for habitat.

*Photo 17: Section 26 Pond, slump area has not recently progressed.*

- Monitor the slump area at Section 26 Pond

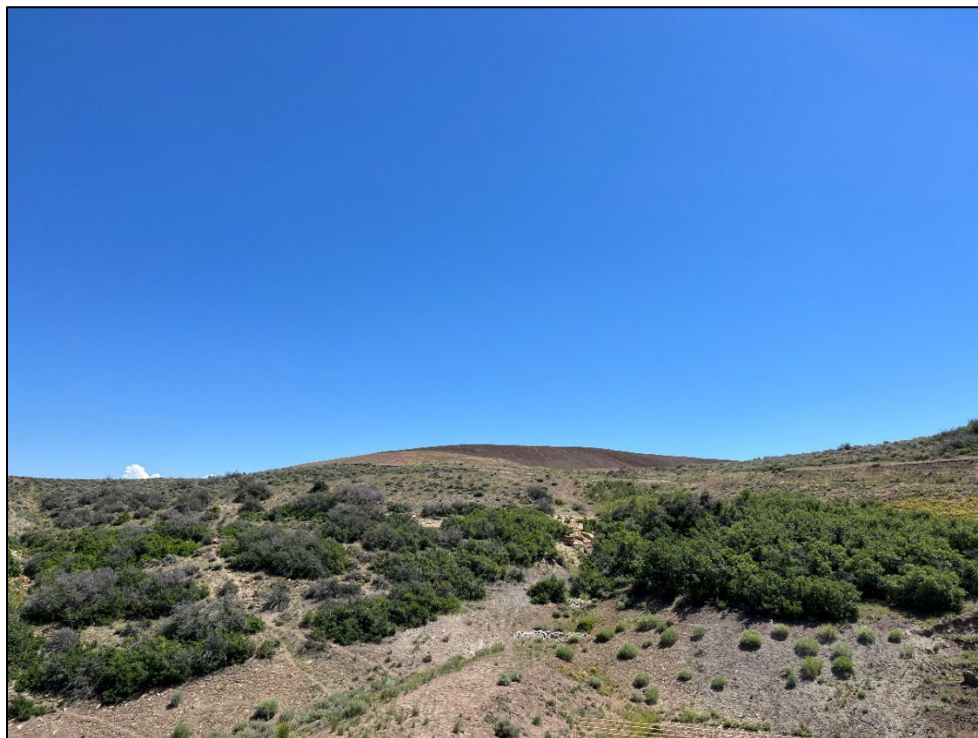
Topsoil piles across the site contained appropriate markers. The topsoil pile behind Section 26 Pond has been shaped and graded (Photo 18). Site representative Tom Fry stated the site's intention to seed the pile for stabilization as required by Rule 4.06 in the Fall of 2024.

*Photo 18: The large topsoil pile in the northern portion of Collom Pit has been graded for planned reseeded.*

- Seed the topsoil pile in the northern section of Collom Pit when conditions allow
- Monitor the small erosional feature in D4, repairs will be necessary if conditions worsen

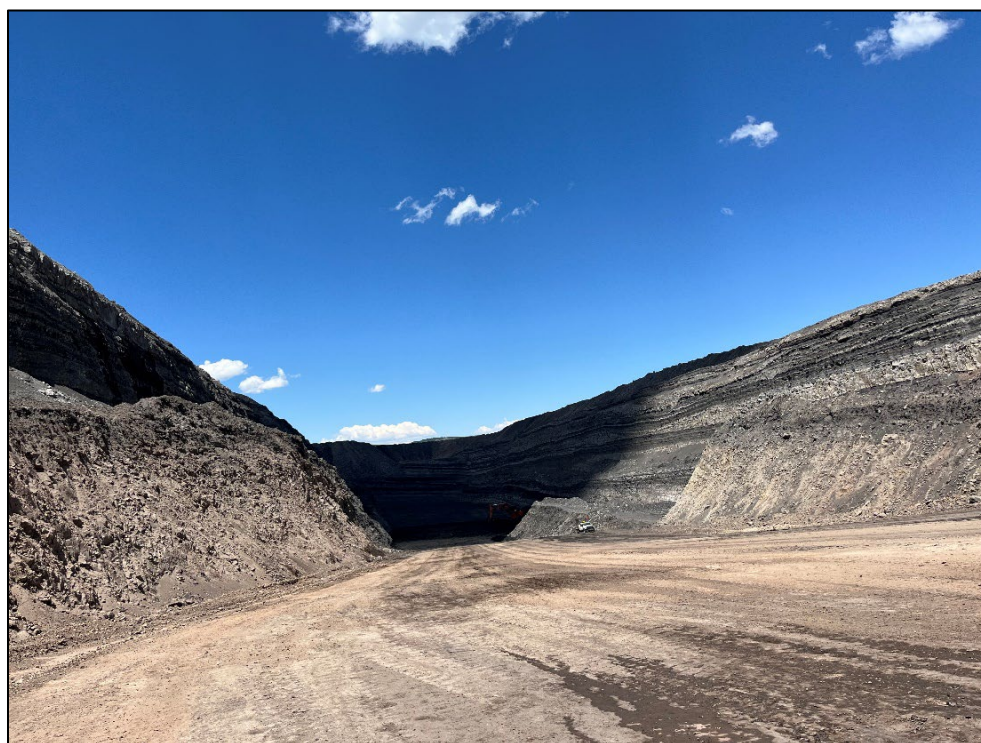
All blasting on site is currently concentrated in the active cut, truck & load area of Collom Pit (Photo 19). No blasts were observed during the inspection.

*Photo 19: View west into the active cut and hauling area in Collom Pit.*

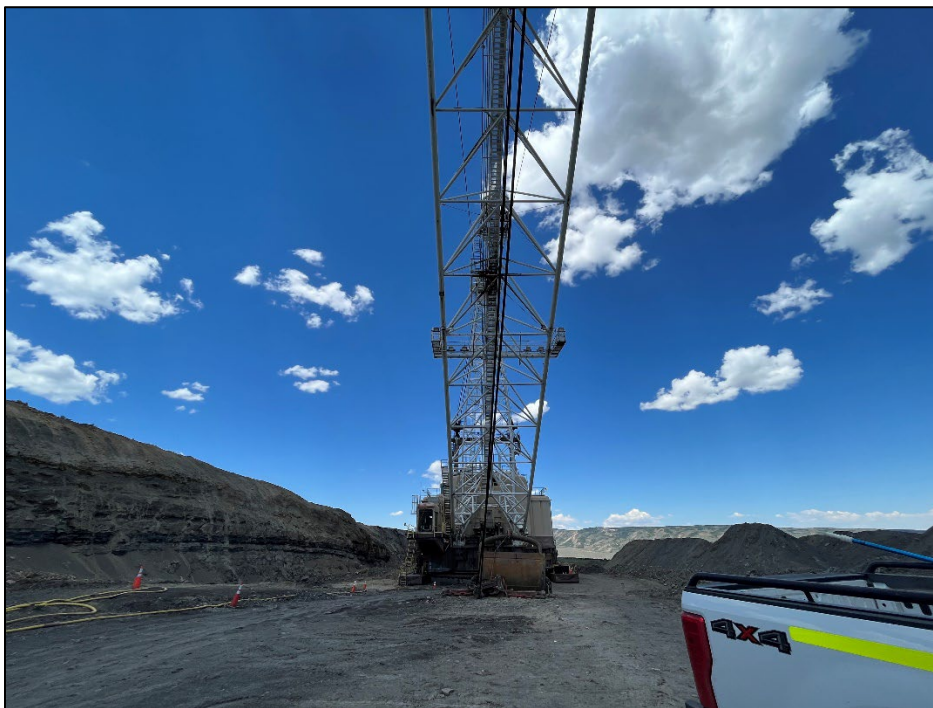
Truck teams were noted to be actively excavating and hauling previously blasted material from the western side of the Collom Pit. Highwall mining operations were not able to be observed during the inspection due to ongoing work to lay cables in the area, which blocked access to this area's entrance. Both draglines located in the Collom Pit were inactive at the time of inspection (Photo 20).

*Photo 20: One of two draglines located in Collom Pit, this dragline was inactive at the time of inspection.*
