MINERALS PROGRAM INSPECTION REPORT

MINE NAME: WM – Colorado Springs Landfill	MINE/PROSPECTING ID#: M-2024-039	MINERAL: Borrow material	COUNTY: El Paso
INSPECTION TYPE: Illegal(Unpermitted Operation)	WEATHER: Clear	INSP. DATE: July 18, 2024	INSP. TIME: 12:00
OPERATOR: WM Colorado Springs Landfill	OPERATOR REPRESENTATIVE: Cheyenne Jurick & Jeremy Jaramillo	TYPE OF OPERATION: ILL - Illegal	
REASON FOR INSPECTION: Citizen Complaint	BOND CALCULATION TYPE: None	BOND AMOUNT: None	
DATE OF COMPLAINT: July 16, 2024	POST INSP. CONTACTS: None	JOINT INSP. AGENCY: None	
INSPECTOR(S): Hunter Ridley Zach Trujillo	INSPECTOR'S SIGNATURE:

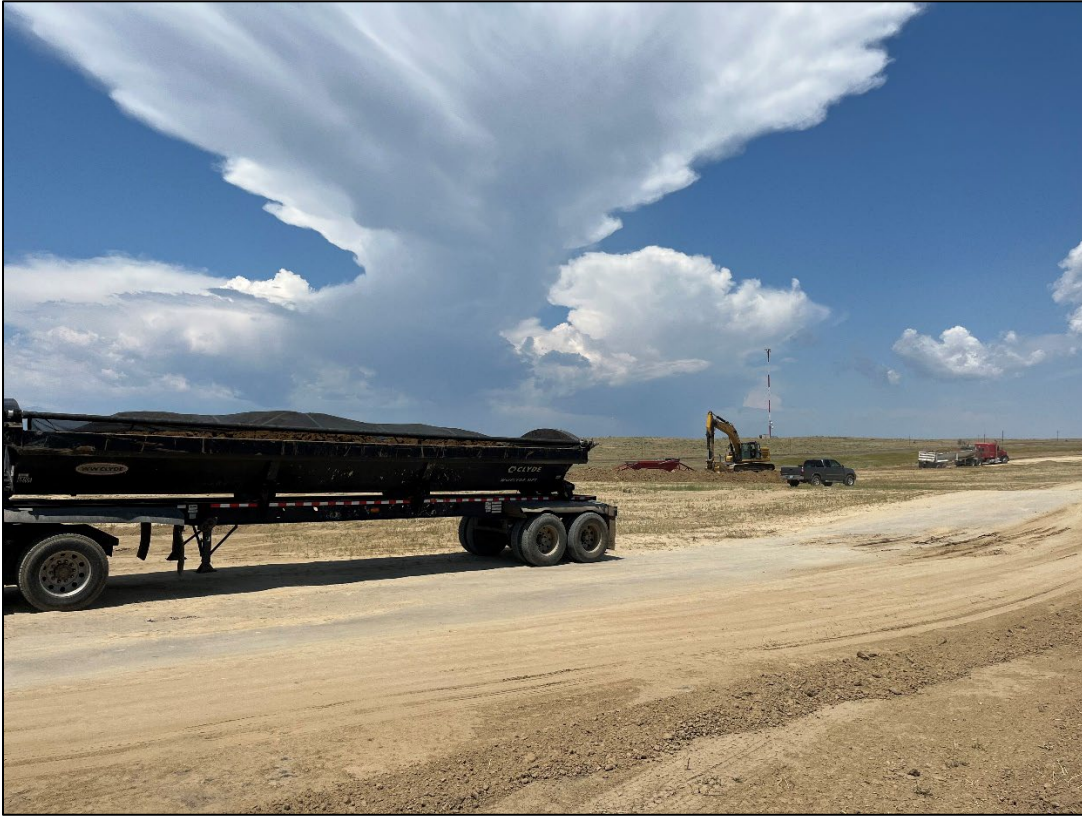
Photo 1: View northwest of the active excavation area.

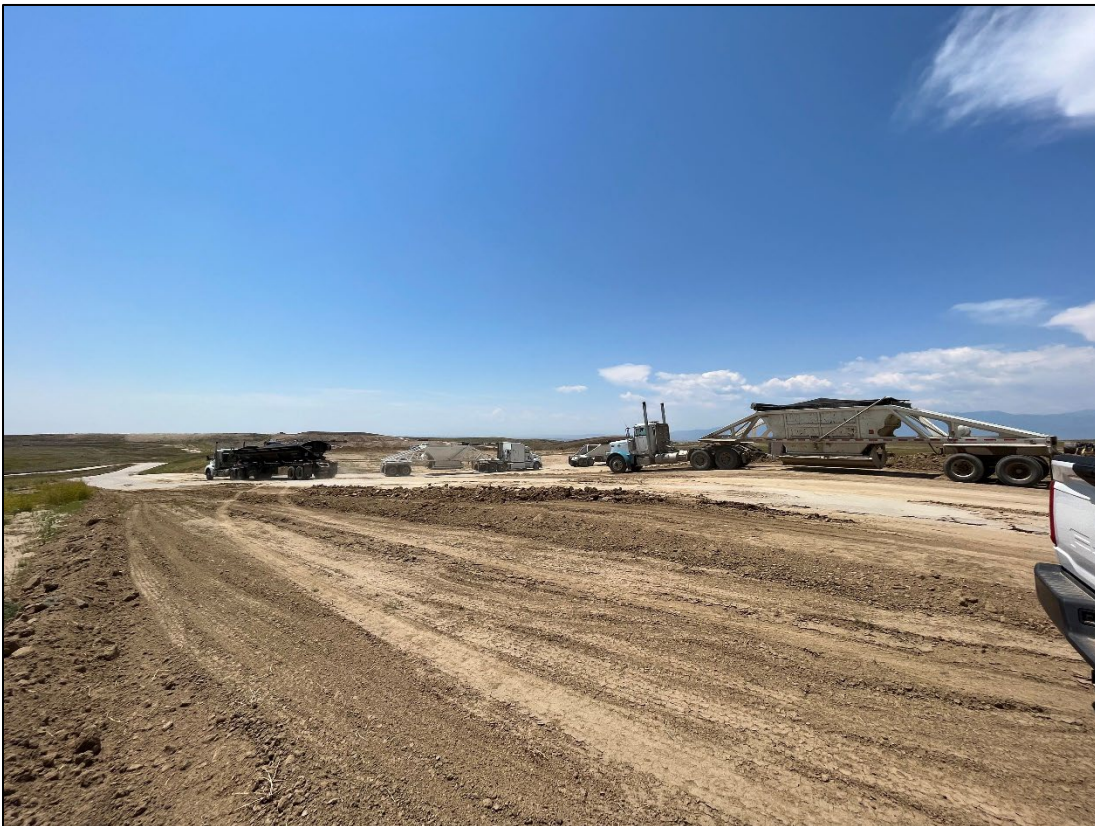
Photo 2: View southwest of trucks lined up to receive material.

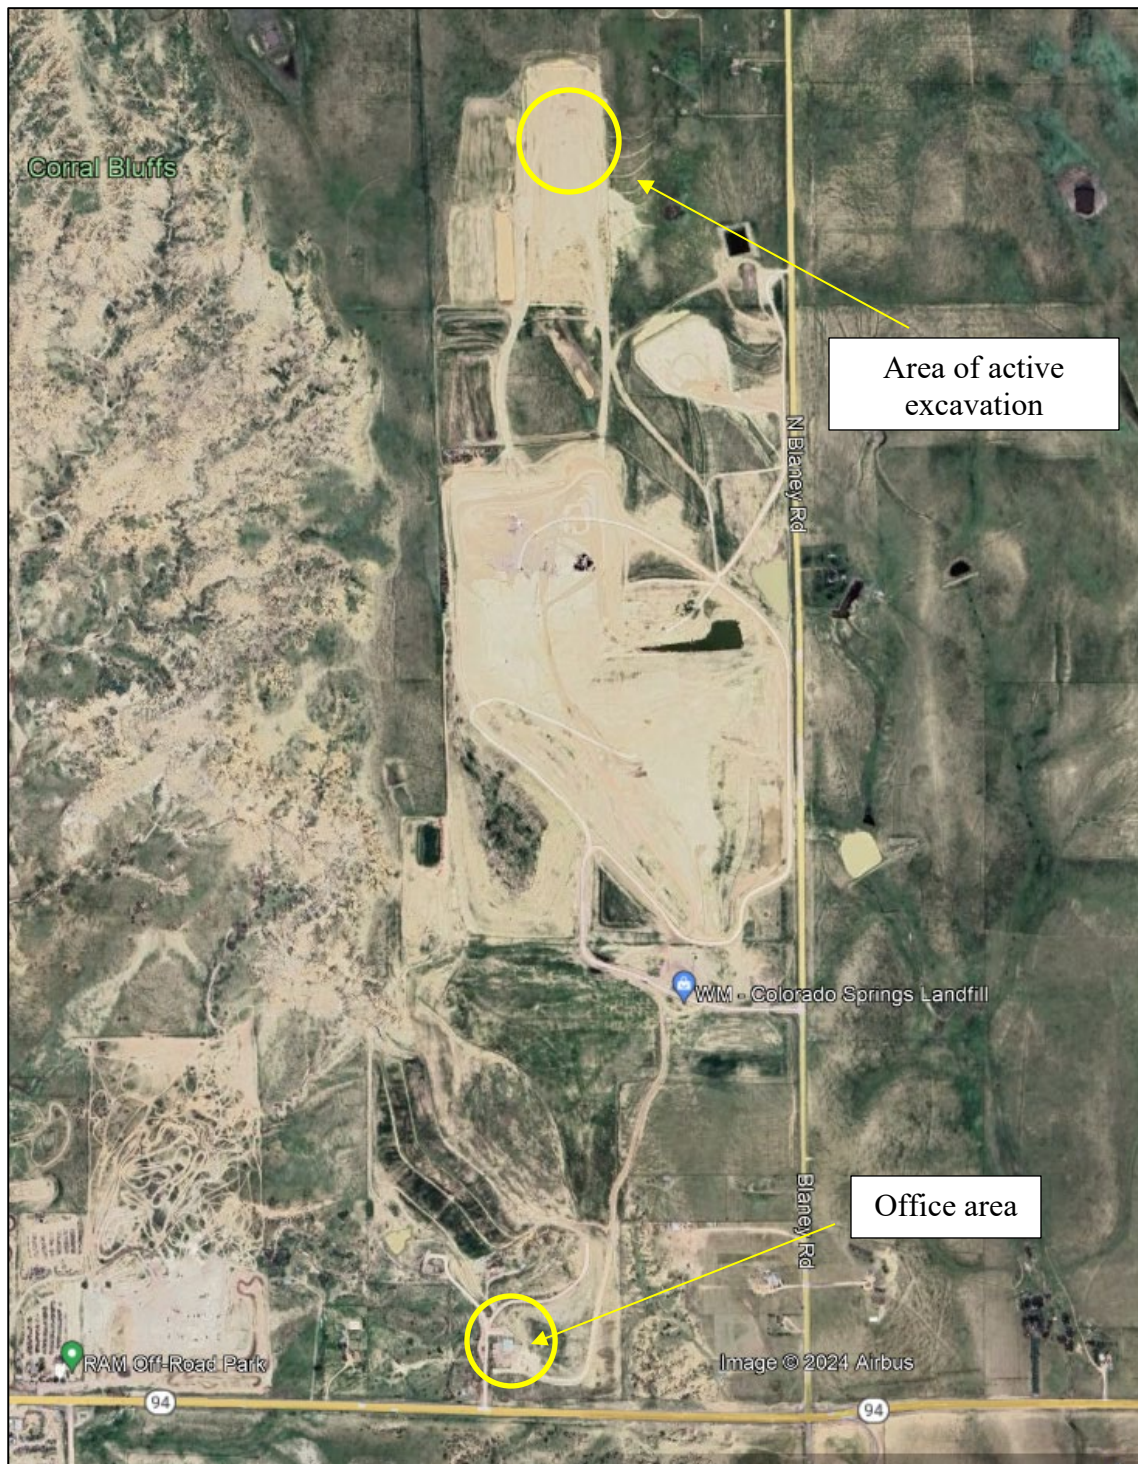
Site representatives stated that the most recent excavation of material was coming from the northern portion of the site and was being sold offsite to support a project for Airport and Power in Colorado Springs. This area of excavation is highlighted on the site map below (Figure 1). While this area has been excavated multiple times over the years to support onsite activities and other off-site contracts, representatives stated that this particular project's excavation began on Monday July 15, 2024. Mr. Jaramillo stated that approximately 50 trucks per day, which hold 15 – 18 CY each, were transporting this material offsite for the Airport and Power Contract. The contract is volume based, meaning that the entire project would take upwards of several months to complete. Mrs. Jurick stated that a liability bond is held with CDPHE for a reseedling plan for the excavation area.

Figure 1: Site map, produced with 2023 Google Earth imagery.
