## Inspection Report, June 26, 2024 Cresson Project M-1980-244

**MINERALS PROGRAM INSPECTION REPORT**  
**PHONE: (303) 866-3567**

<b>MINE NAME:</b> Cresson Project	<b>MINE/PROSPECTING ID#:</b> M-1980-244	<b>MINERAL:</b> Gold and silver	<b>COUNTY:</b> Teller
<b>INSPECTION TYPE:</b> Multi Person Inspection	<b>WEATHER:</b> Clear	<b>INSP. DATE:</b> June 26, 2024	<b>INSP. TIME:</b> 12:10
<b>OPERATOR:</b> Cripple Creek & Victor Gold Mining Company	<b>OPERATOR REPRESENTATIVE:</b> Joshua Adams, Brian Doering	<b>TYPE OF OPERATION:</b> 112d-3 - Designated Mining Operation	
<b>REASON FOR INSPECTION:</b> Normal I&E Program	<b>BOND CALCULATION TYPE:</b>	<b>BOND AMOUNT:</b> \$268,665,580.00	
<b>DATE OF COMPLAINT:</b> NA	<b>POST INSP. CONTACTS:</b> None	<b>JOINT INSP. AGENCY:</b> None	
<b>INSPECTOR(S):</b> Lucas West Elliott Russell	<b>INSPECTOR'S SIGNATURE:</b>

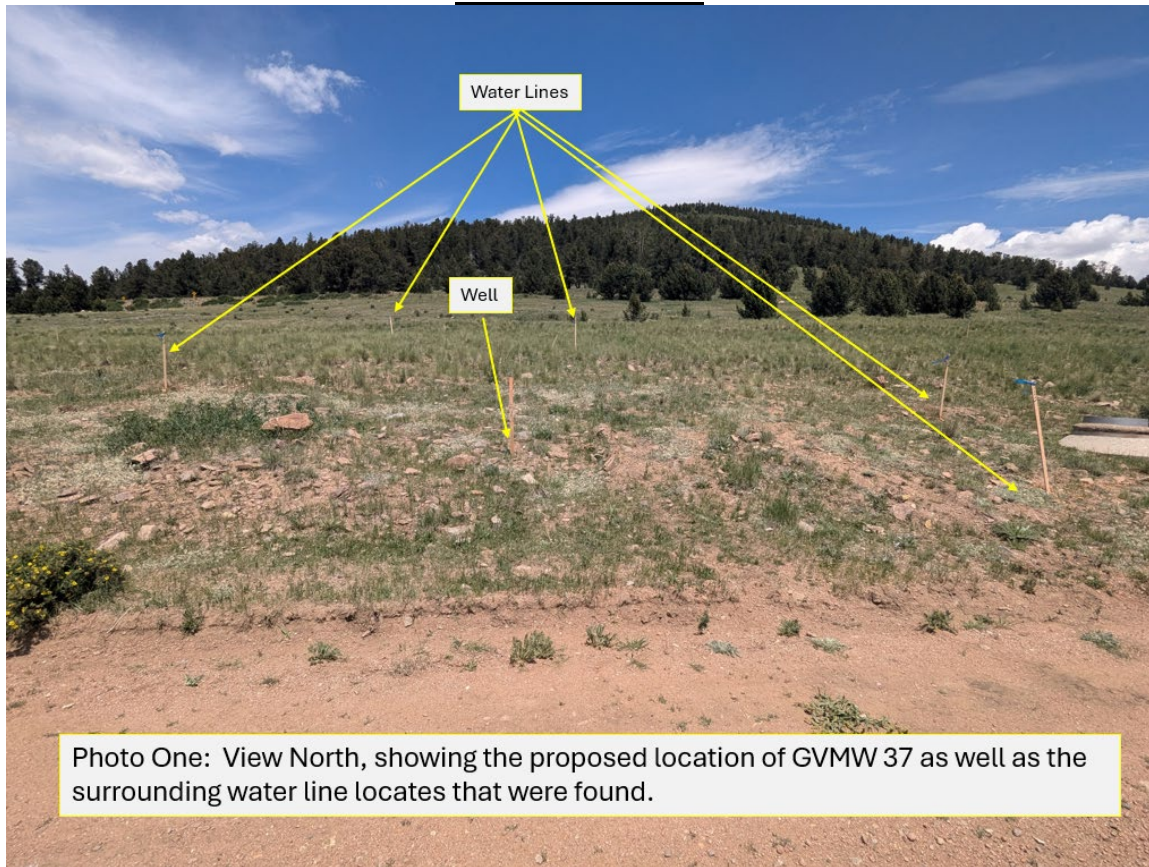
During this inspection the proposed location of GVMW 37 was observed. The proposed location, shown in Photo One, lies on the North side of the access road, and upon completing survey locates in the area it was found to be nestled between several historic and current water lines. On site discussions centered around moving the proposed location, to the South side of the access road, to avoid potential issues intercepting the utilities. The alternate location for the paired wells is approximately 250 feet to the Southeast and appears to be a suitable alternative. The alternate location can be seen in Photo Two.

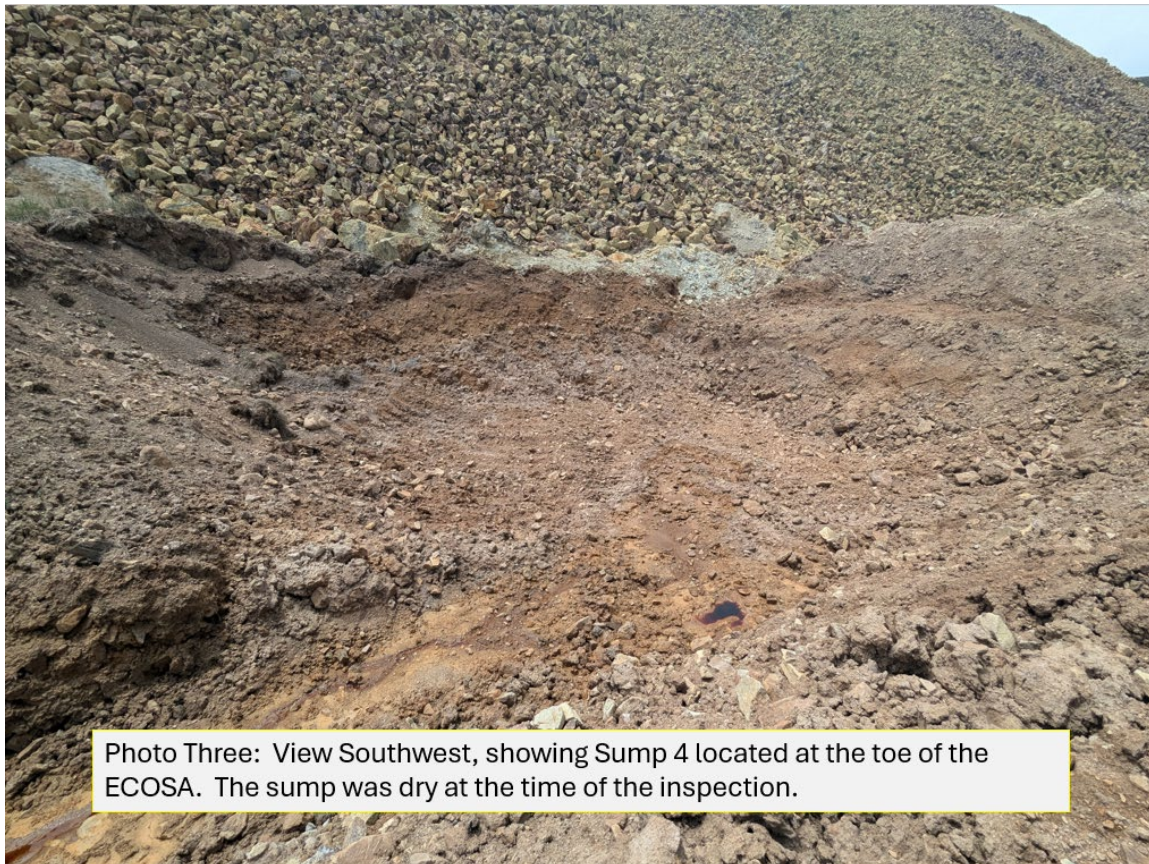
Photo Three: View Southwest, showing Sump 4 located at the toe of the ECOSA. The sump was dry at the time of the inspection.

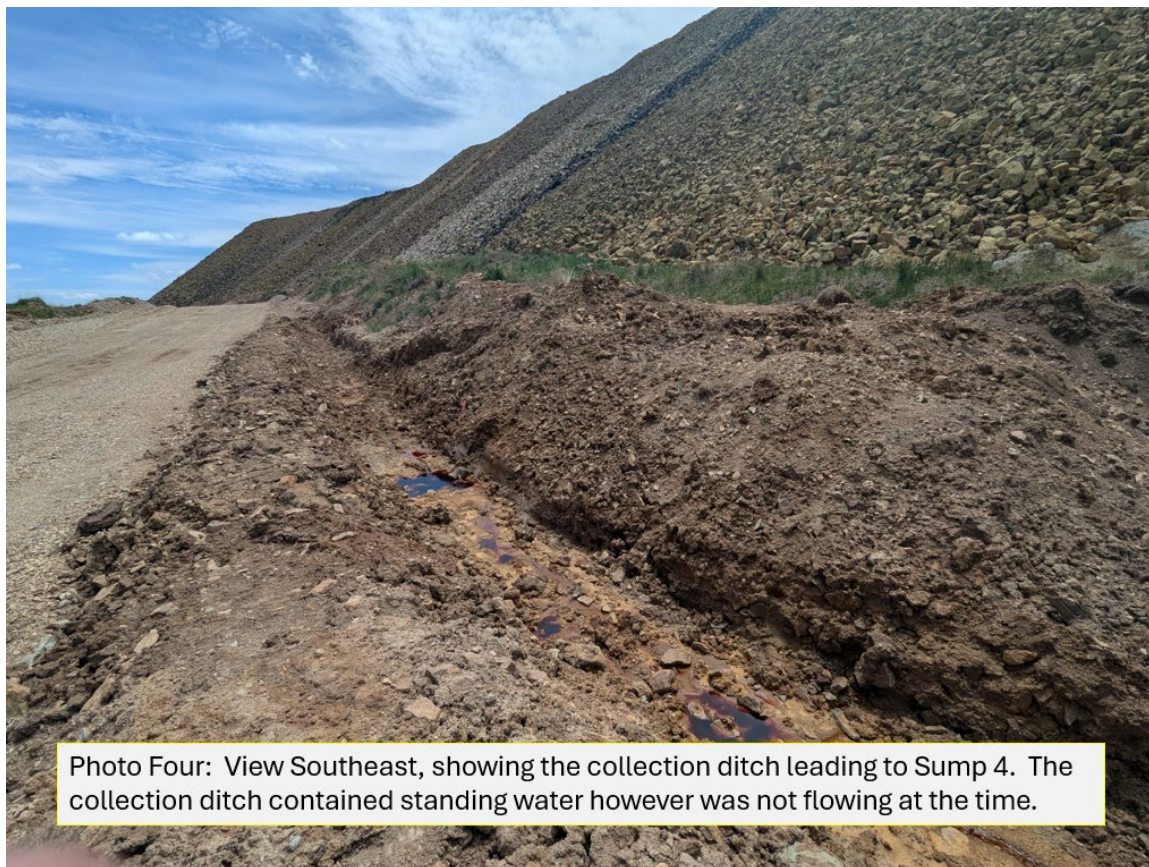
Photo Four: View Southeast, showing the collection ditch leading to Sump 4. The collection ditch contained standing water however was not flowing at the time.

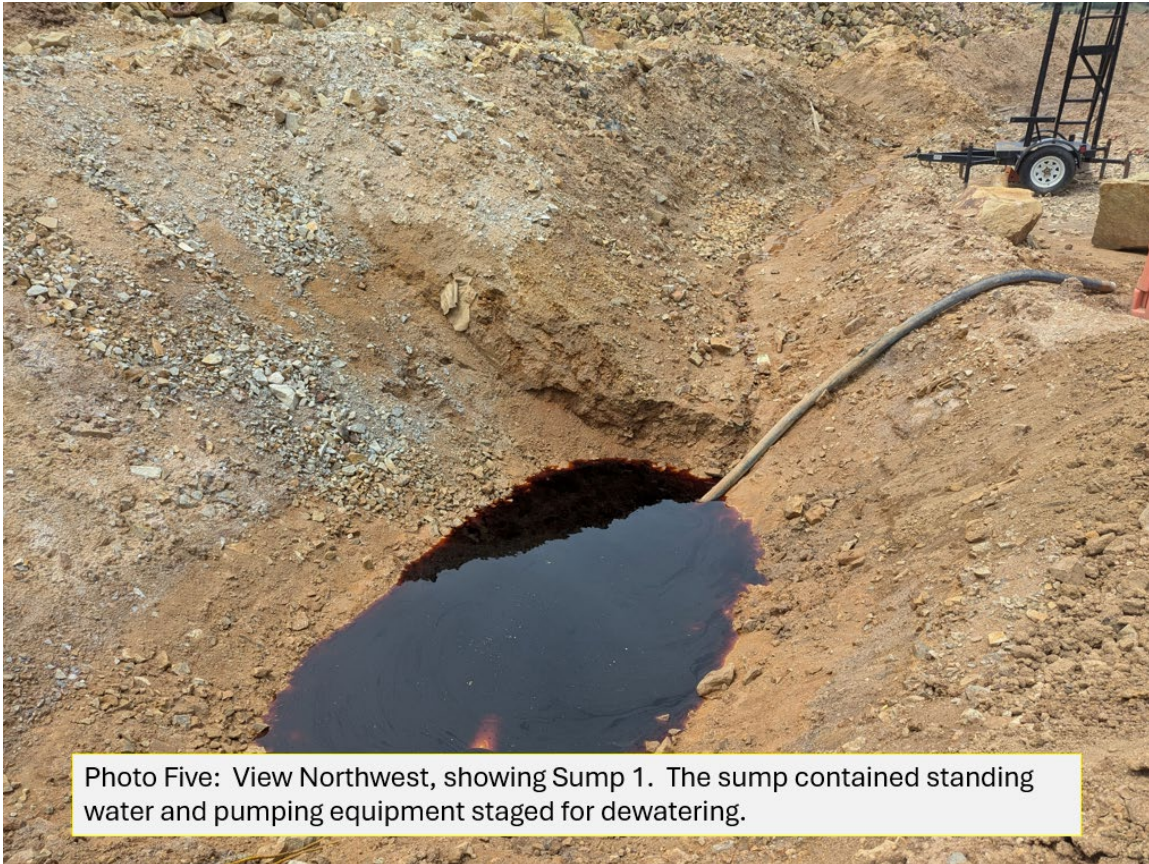
Photo Five: View Northwest, showing Sump 1. The sump contained standing water and pumping equipment staged for dewatering.

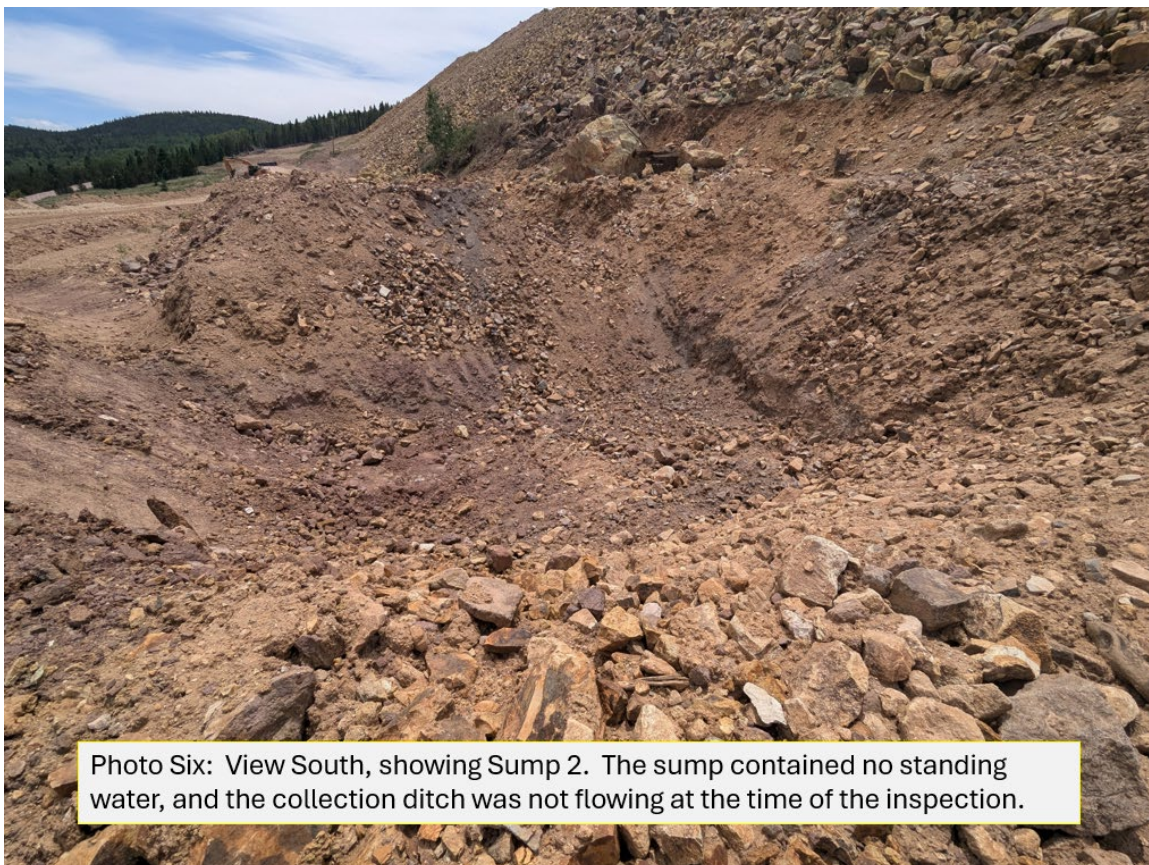
Photo Six: View South, showing Sump 2. The sump contained no standing water, and the collection ditch was not flowing at the time of the inspection.

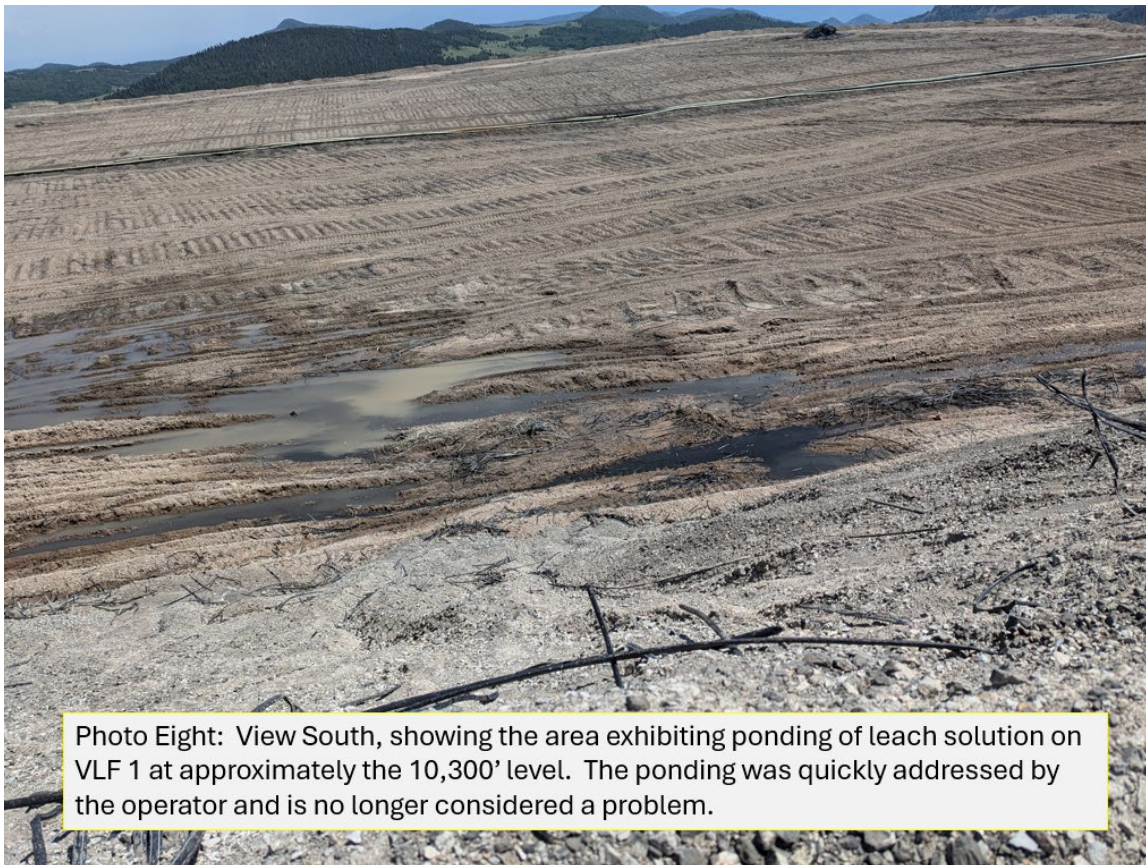
The secondary purpose of the inspection was a general site tour. This portion covered the various leach piles in both VLF 1 and 2 as well as the main facilities such as the ADR. During the inspection, ore stacking efforts were being conducted at the 10,300' level of VLF 2. On VLF 1, at around the 10,300' level significant ponding of leach solution was noted. The area of ponding can be seen in Photo Eight. The problem was discussed with the Operator representatives as it is in conflict with commitments made in the Permit. The day after the inspection, June 27, 2024, the Operator provided photo documentation that the problem had been corrected. The area was ripped and graded, allowing the ponded solution to infiltrate and no longer be impounded on the surface. This is not cited as a problem at this time due to the Operators swift response and mitigation efforts.

Photo Eight: View South, showing the area exhibiting ponding of leach solution on VLF 1 at approximately the 10,300' level. The ponding was quickly addressed by the operator and is no longer considered a problem.

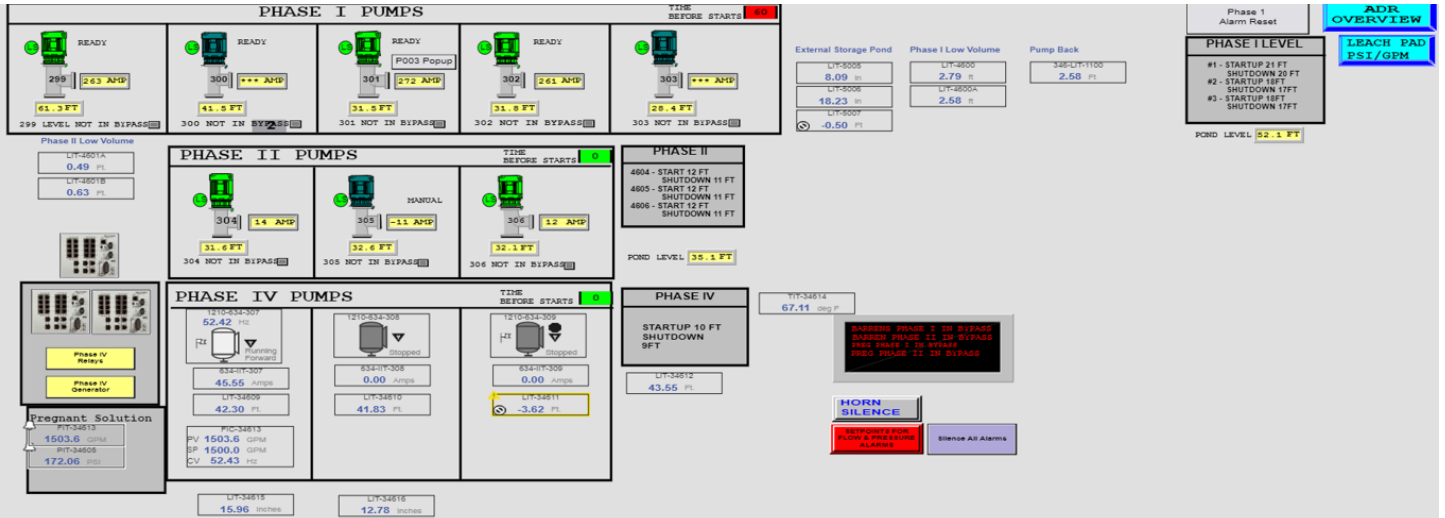
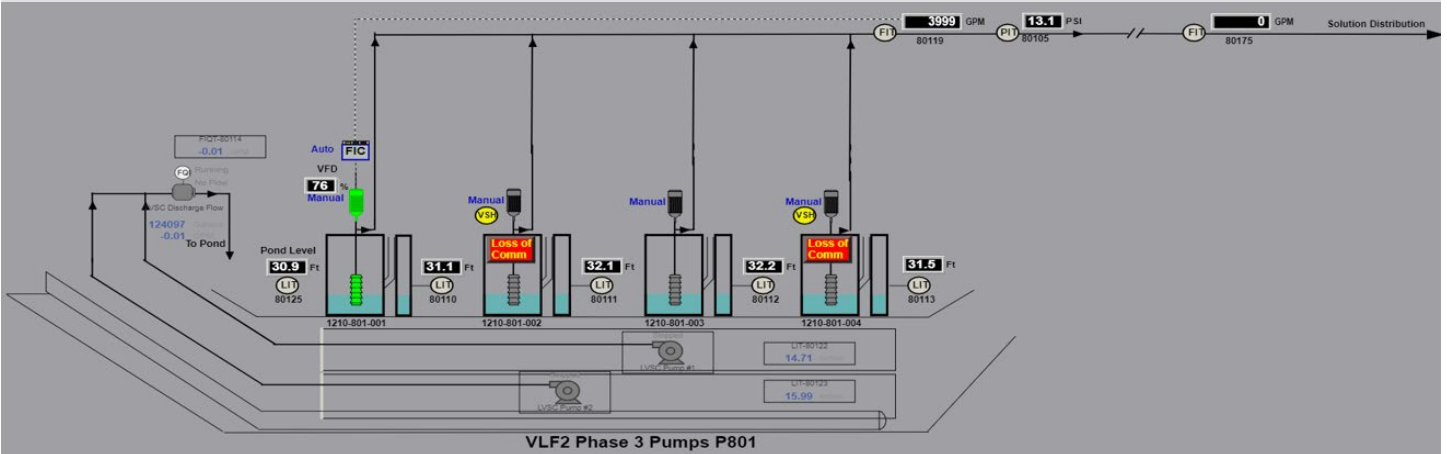
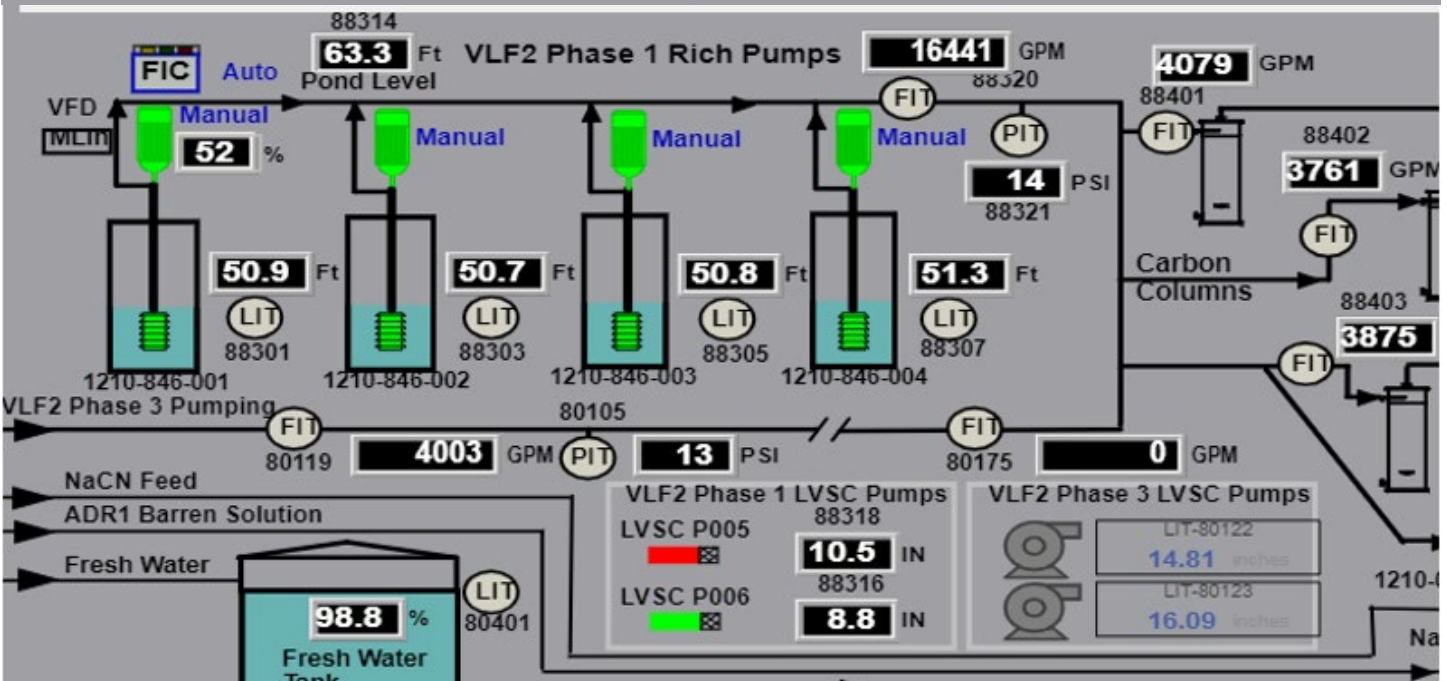
Additionally, the ADR was inspected and the remote monitoring system that monitors solution levels in VLF 2 was observed. In addition to the mitigation documentation, the Operator provided screen shots of the monitoring system taken at the time of the inspection. All pump levels and flow rates appeared to be within operational norms for the site and no problems were identified. The screen shots are included with this report.
