### MINERALS PROGRAM INSPECTION REPORT

| <b>MINE NAME:</b><br>Ragsdale Reservoirs | <b>MINE/PROSPECTING ID#:</b><br>M-2020-007 | <b>MINERAL:</b><br>Gravel, sand and borrow material | <b>COUNTY:</b><br>Weld |
| <b>INSPECTION TYPE:</b><br>Surety Release Inspection | <b>WEATHER:</b> Clear | <b>INSP. DATE:</b><br>July 16, 2024 | <b>INSP. TIME:</b><br>10:00 |

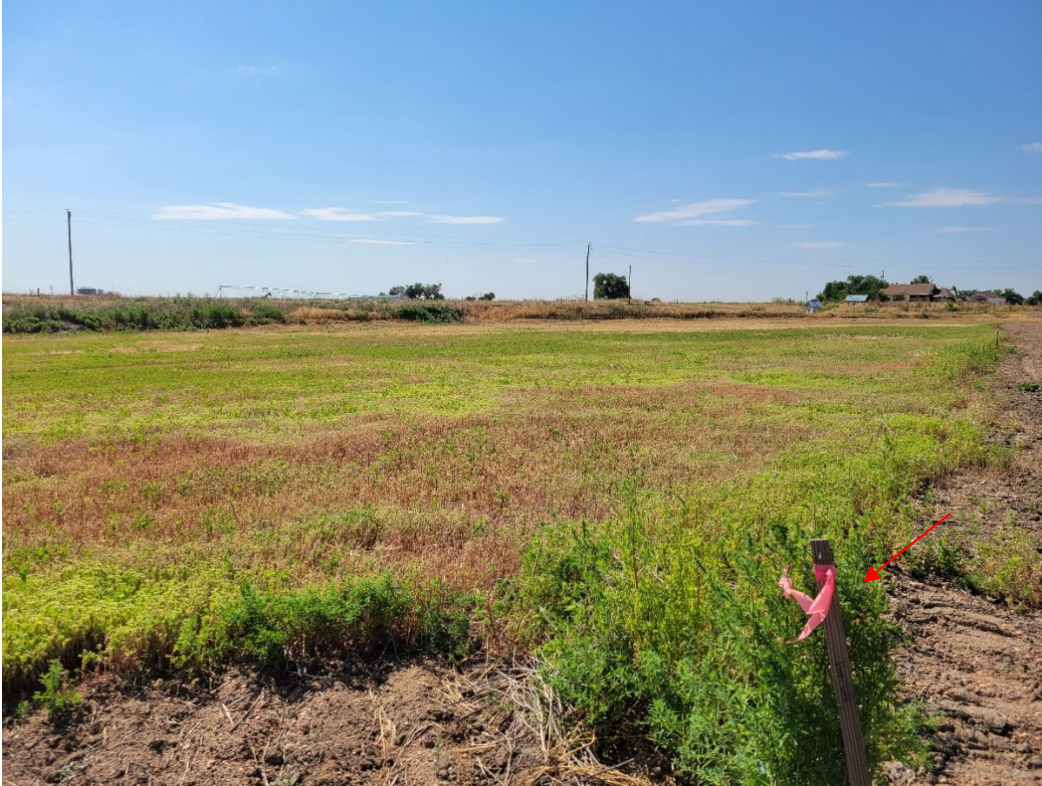
Photo 1: Looking south across the proposed 1.95-acre release area. New boundary marker in the foreground (red arrow).

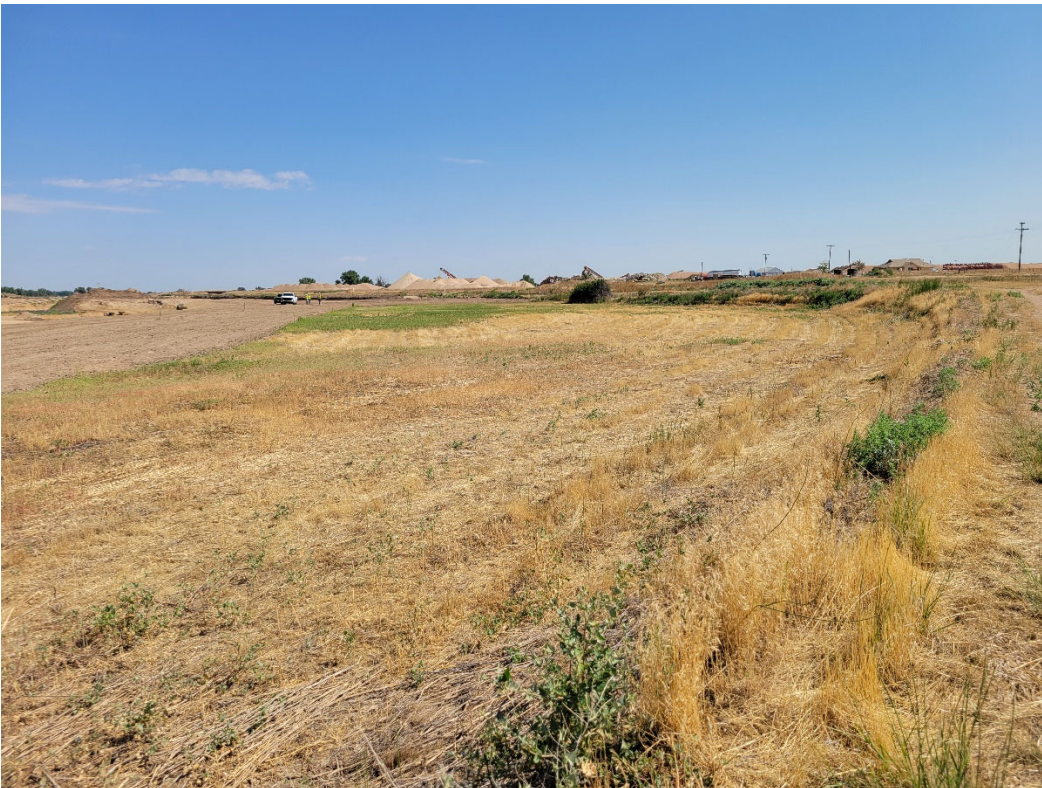
Photo 2: Looking north across the proposed 1.95-acre release area.

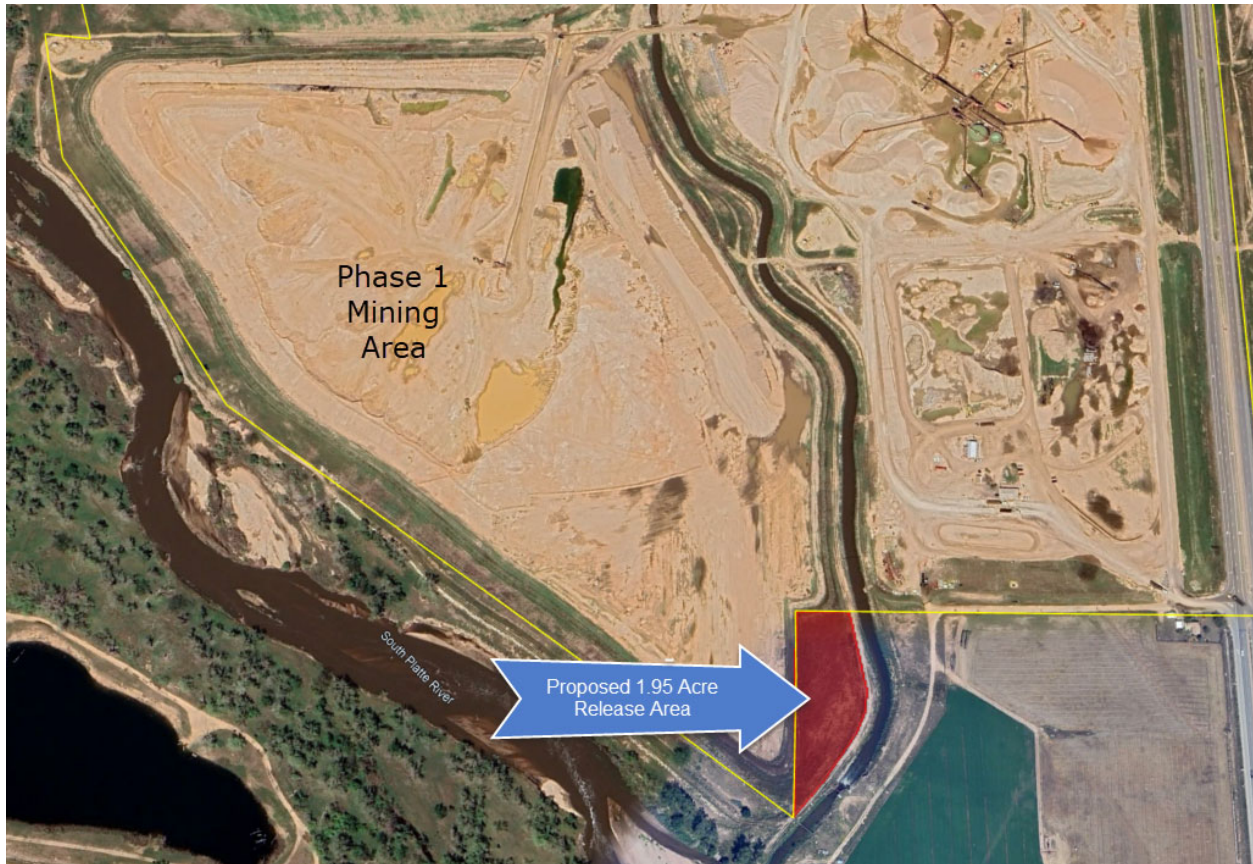
Image 1: Google imagery showing the Phase 1 mining area. Release area shown in red. Image dated 9/04/2023.

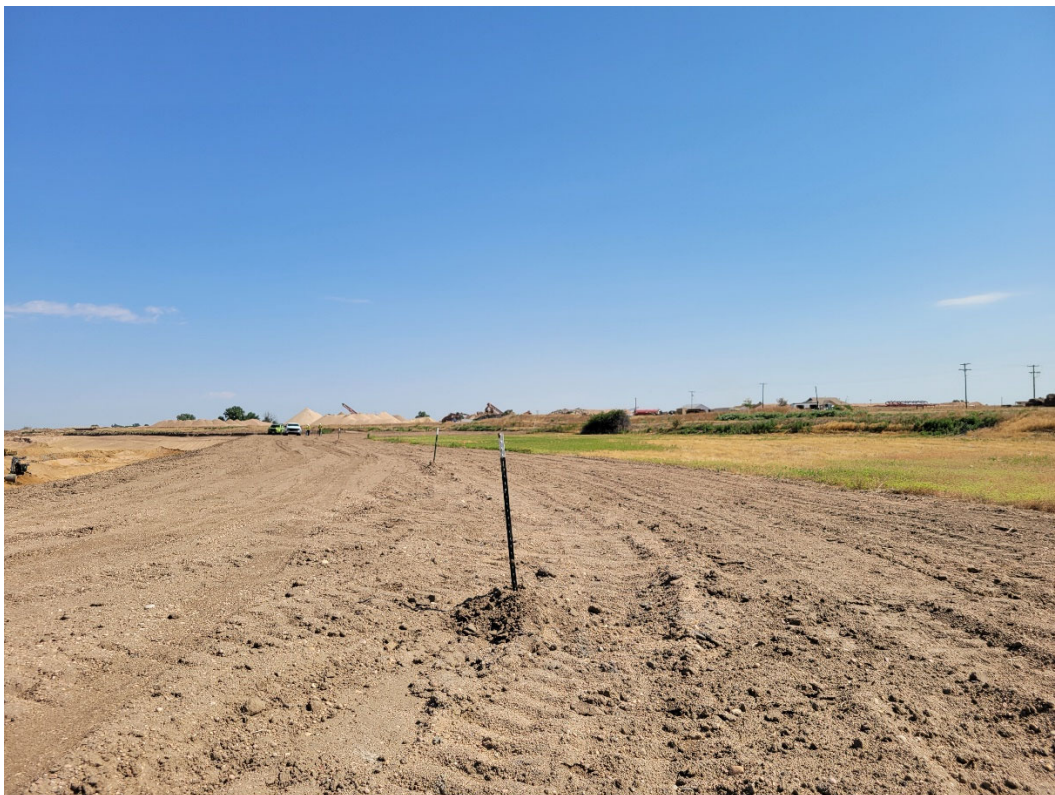
Photo 3: Looking north from the southern end of the Phase 1 mining area. Metal posts with white tops mark the installed slurry wall around the reservoir.

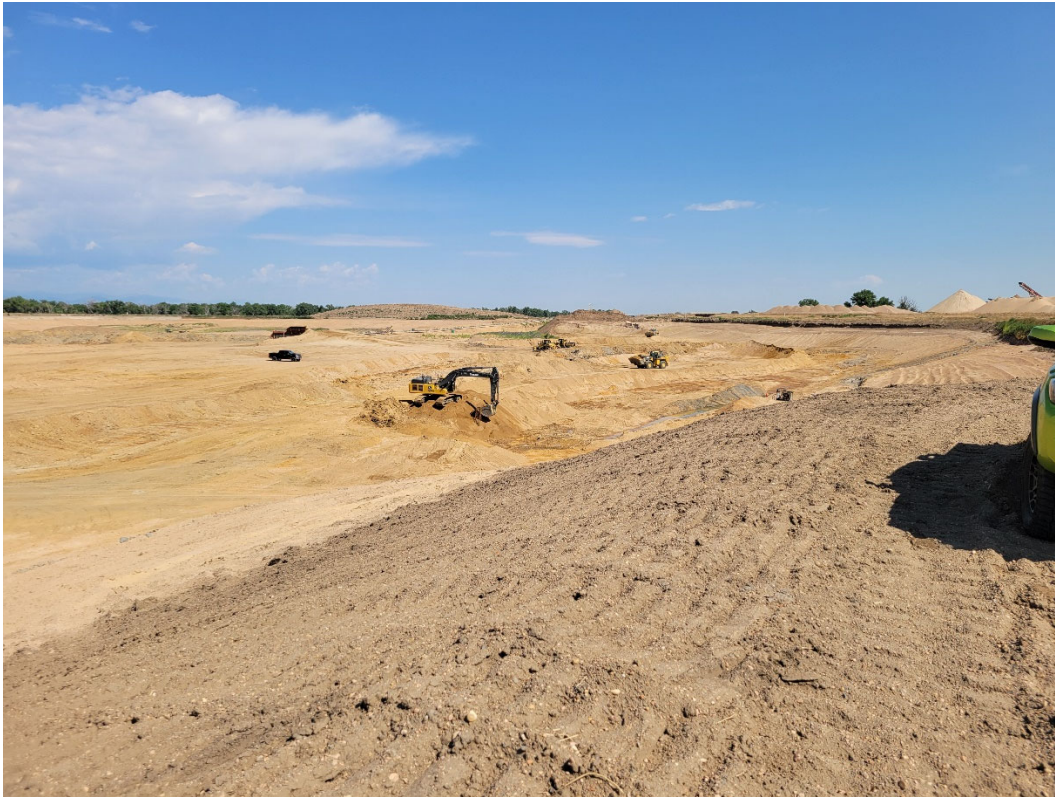
The Division observed the Phase 1 and Phase 2 mining areas on the west side of the permit area. Mining is nearing completion in Phase 1 and LGE has started on reclamation of the slopes around the reservoir. During this inspection, the Division observed mining equipment operating in the bottom of the reservoir. A slurry wall is installed around the perimeter. The Operator is in the process of conducting a leak test to certify the liner. The side slopes of the reservoir are graded to 3H:1V slope and topsoiled in preparation for seeding. Approved concrete rip rap, approximately 12-24" in size, mixed with finer material, was observed placed along the western side slopes of the reservoir. Per the approved reclamation plan, a section of the rip rap on the south end of the reservoir was covered with topsoil. The Operator discussed removing this requirement to topsoil the concrete rip rap from the reclamation plan. LGE plans to submit an amendment to the Division for a future conveyor belt running from the Phase 3/Plant Site on the west side of the permit area to the east side of Highway 285. The Operator could either submit a Technical Revision to propose a new reclamation plan for the western slopes of the Phase 1 reservoir or include this change in the upcoming amendment application.

Photo 4: Looking north at mining operations in the Phase 1 area. Reservoir slopes have been graded to 3H:1V and topsoil has been placed on top.

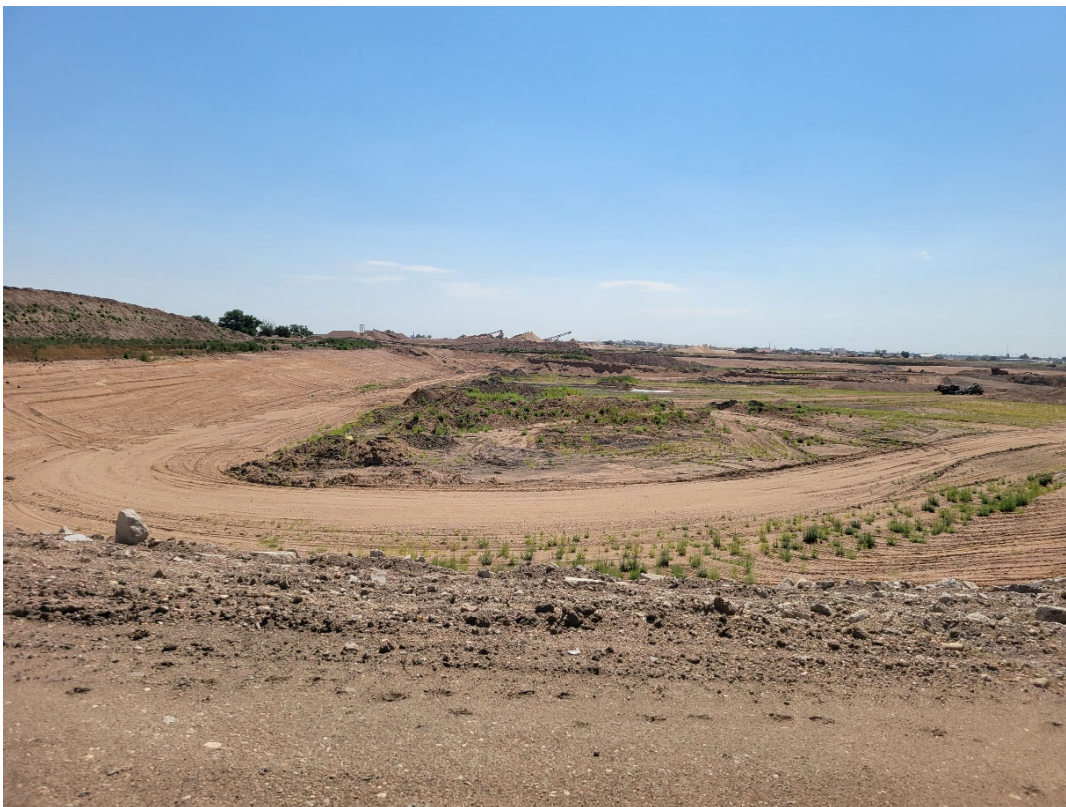
Photo 5: Looking south from the north end of the Phase 1 mining area. Slopes are 3H:1V and concrete rip rap is placed along the western side.

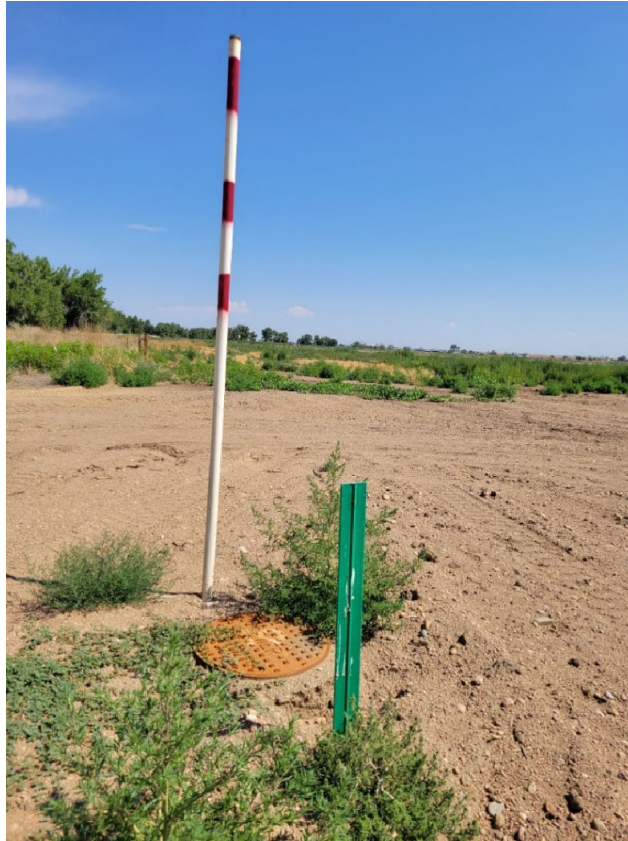
During this inspection, LGE showed the Division a groundwater drain that runs between the Phase 1 and Phase 2 mining areas. The drain was recently installed to move groundwater from the east around the slurry walled reservoirs to the South Platte River. LGE informed the Division that they installed the permanent drain for the landowner, Cannon Land Company. Following the inspection, the Division reviewed the permit file and approved mining and reclamation plan maps and determined the underground drain was not included in the original plans for the site. In response to an email request from the Division, LGE provided the schematics and plans for of the installed groundwater drain. Based on the observations during this inspection and the schematics and plans provided, LGE will need to submit a Technical Revision and obtain approval for the groundwater drain.

Photo 6: Looking at groundwater drain marker and manhole/cleanout near the western boundary, between the Phase 1 and Phase 2 areas.

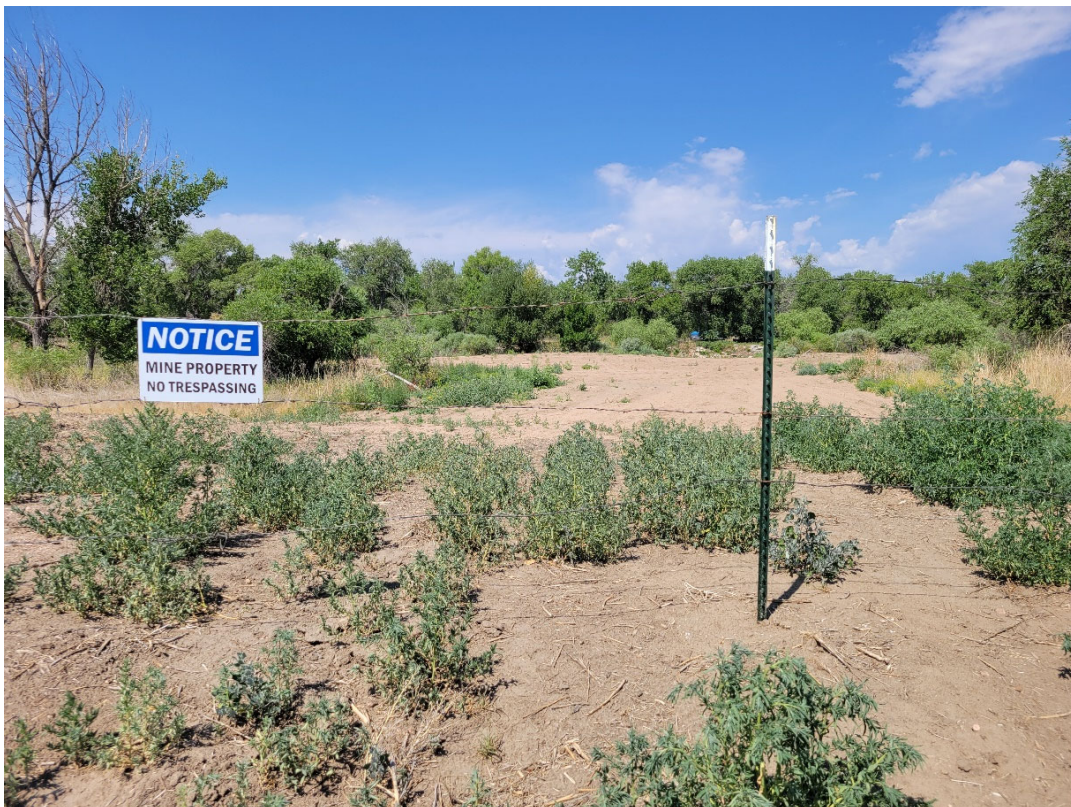
Based on the description in the 2020 application, the western permit boundary is 100 feet east and parallel to the east toe of a historic levee/berm that was built by the landowner along the South Platte River. During this inspection, the Division observed a barbed wire fence on top of the historic levee/berm. The operator stated the fence is the western permit boundary marker, which is inconsistent with the description in the application. **Problem 1 cited above states that LGE shall survey the western permit boundary and ensure it is marked as described in the approved application. The operator shall demonstrate compliance by submitting photographic evidence of the installation of the markers in place along point location data by the corrective action date.** Additionally, when the operator submits the next revision or amendment, the mining and reclamation maps should be updated to clearly show a 100' buffer between the toe of the historic levee and the permit boundary.

Photo 7: Looking west from the boundary fence on top of the levee that runs along the western side of the permit area. The newly installed groundwater drain runs beneath this area.

**CORRECTIVE ACTIONS:** The operator shall survey and install boundary markers along the western side of the permit area, 100 feet east and parallel to the toe of the historic levee/berm. The boundaries of the affected area must be marked by monuments or other markers that are clearly visible and adequate to delineate such boundaries. The operator shall demonstrate compliance by submitting photographic evidence of the installation of the markers in place, along with point location data, to the Division by the corrective action date.

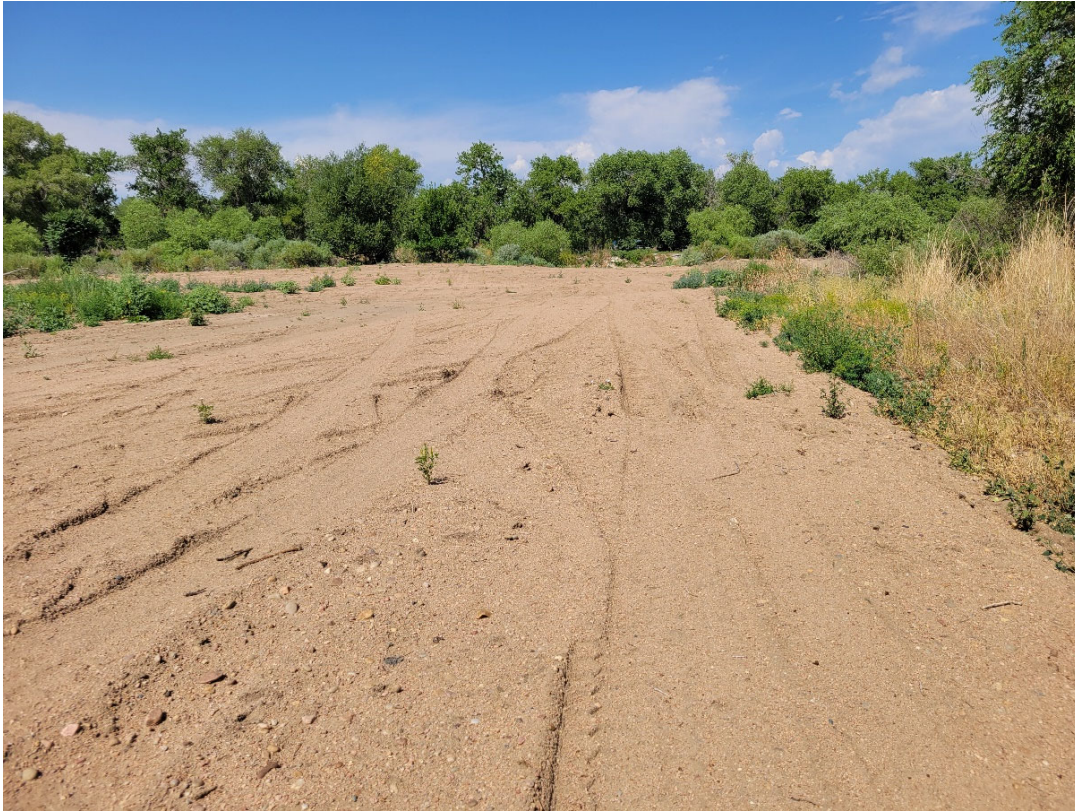
**POSSIBLE VIOLATION:** Possible Violation: The Division observed an underground drain installed along the northern end of the Phase I mining area. The drain was installed to move groundwater around the slurry walled reservoirs and extends beyond the western permit boundary where it discharges to the South Platte River. Land was affected outside of the approved permit boundary for the installation of the drain. This is a possible violation at this time pursuant to C.R.S. 34-32.5-116(4)(i) for failure to protect areas outside of the affected land from slides or damages occurring during the mining operation.

Additionally, the Division observed the groundwater drain outlet in the South Platte River, which flows parallel to the western permit boundary. According to the description in the 2020 application, the western permit boundary is 100 feet east and parallel to the east toe of a historic levee/berm that was built by the landowner along the South Platte River. Based on this description and observations in the field, the Division determined the buried groundwater drain extends 400-feet from the western permit boundary to the South Platte River. The Division observed a 20-foot-wide x 400-foot-long disturbance patch between the western permit boundary and the outlet point. Therefore, this section of the groundwater drain is outside the permitted acres. Concrete was placed at the culvert outlet to prevent erosion around the drain. **Based on the observations during this inspection, approximately 8000 ft<sup>2</sup> (0.18 acre) was affected outside of the approved permit boundary for the installation of the groundwater drain. Pursuant to C.R.S. 34-32.5-116(4)(i) this is a possible violation for failure to protect areas outside of the affected land from slides or damages occurring during the mining. As cited above, this Possible Violation will require a hearing before the Mined Land Reclamation Board. The schedule and other details for the MLRB hearing will be provided under a separate document to be sent via certified mail to the operator.**

Photo 8: Looking west towards the South Platte River at the area of disturbance outside the permit boundary. The groundwater drain is installed beneath the ground here.

**CORRECTIVE ACTIONS:** This possible violation will require a hearing before the Mined Land Reclamation Board. The schedule and other details for the MLRB hearing will be provided under a separate document to be sent via certified mail to the operator.

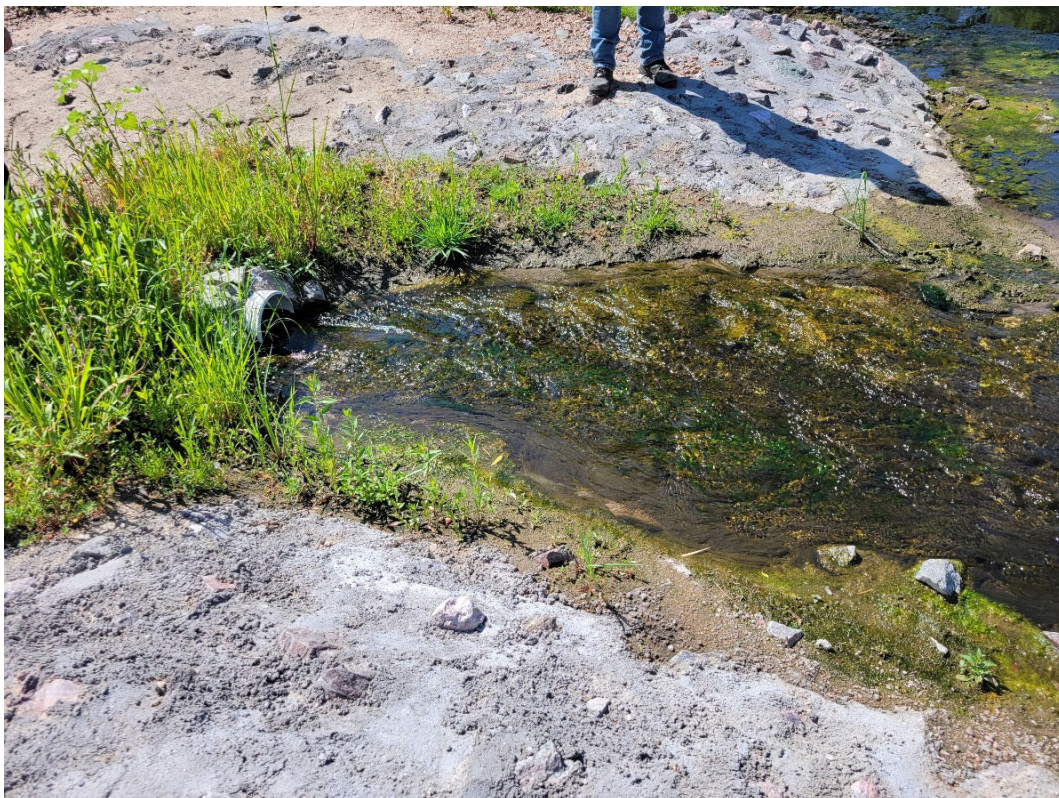
Photo 9: Looking at the outlet for the groundwater drain in the South Platte River.

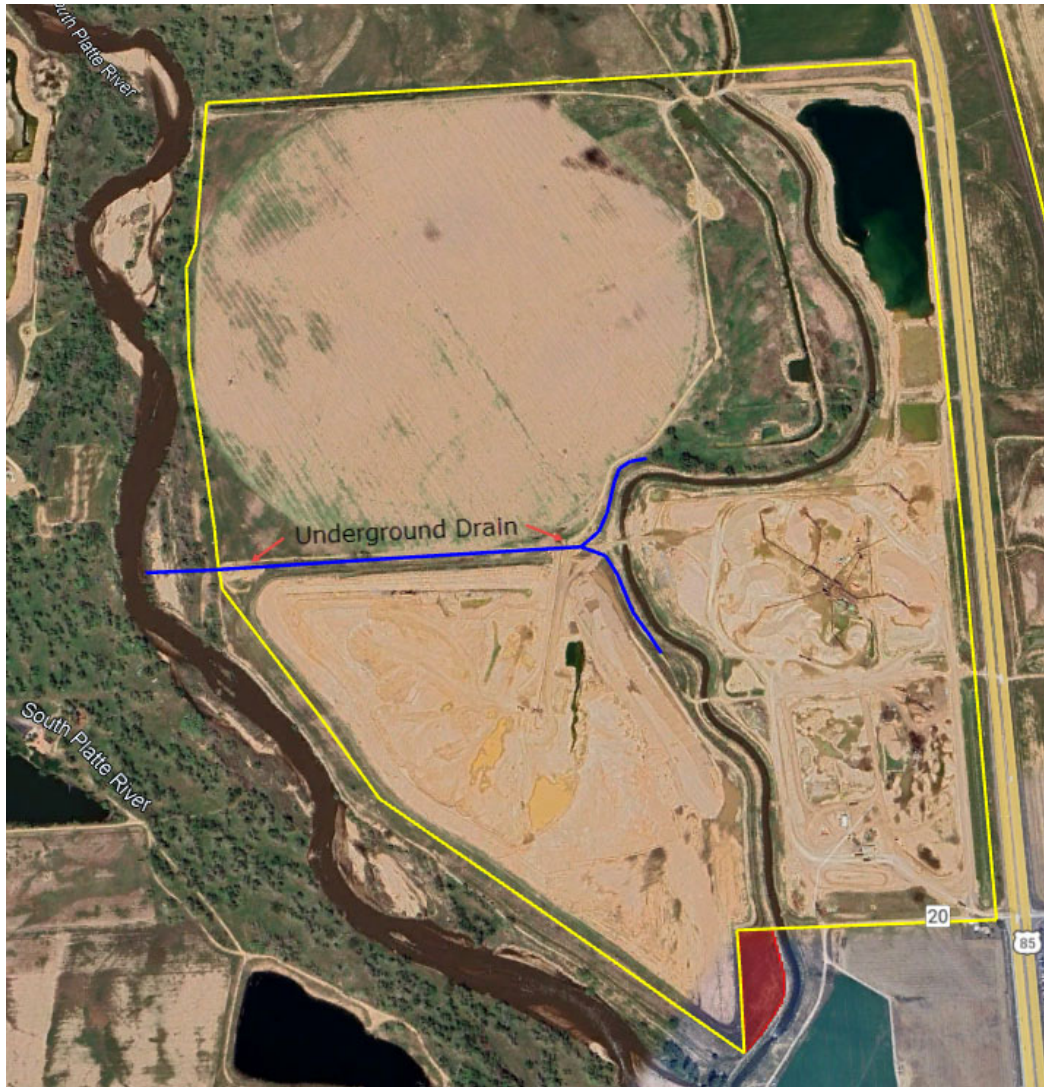
Image 2: Google Imagery showing the approximate permit boundary on the west side of the permit area and the location of the installed groundwater drain (blue line) between the Phase 1 and Phase 2 mining areas. Image dated 9/4/2023.

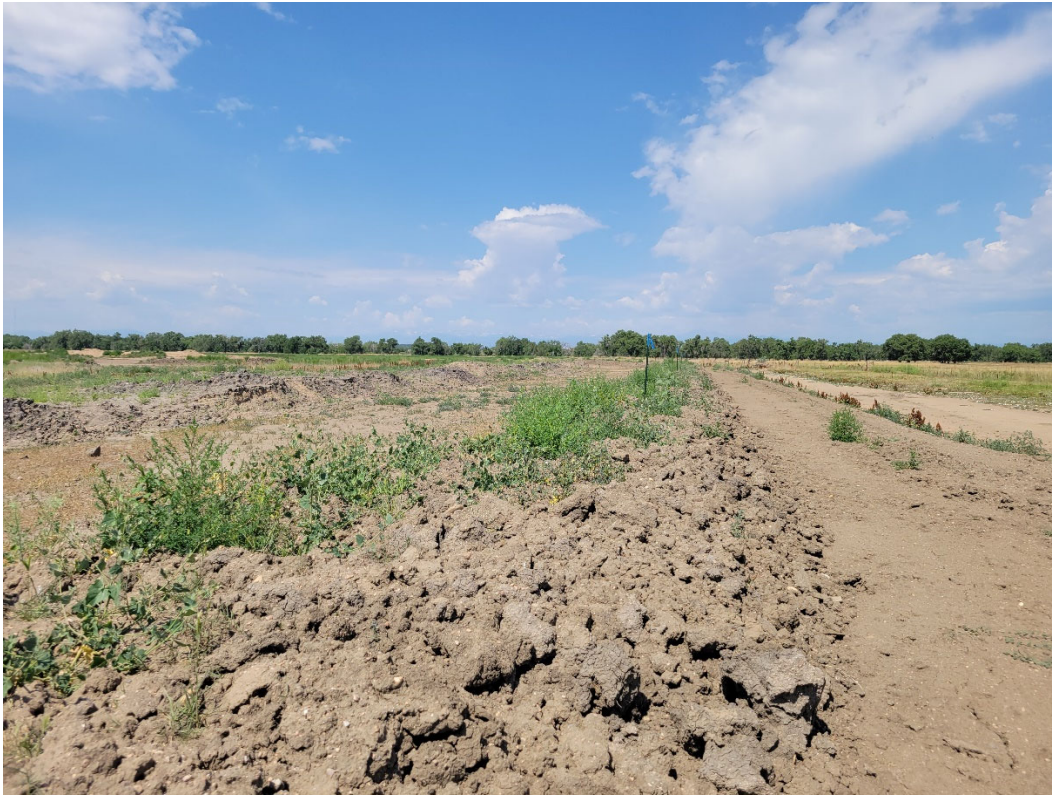
The Division viewed the slurry wall recently installed around the perimeter of the Phase 2 area. Additionally, the Operator pointed out that the oil and gas wells depicted on the mining and reclamation maps in the Phase 1 and Phase 2 areas have been removed, along with the associated gas lines. The Operator should depict this change on the mining and reclamation maps in the next technical revision.

Photo 10: Looking west at the recently installed slurry wall that runs along the northern border of the Phase 2 area.

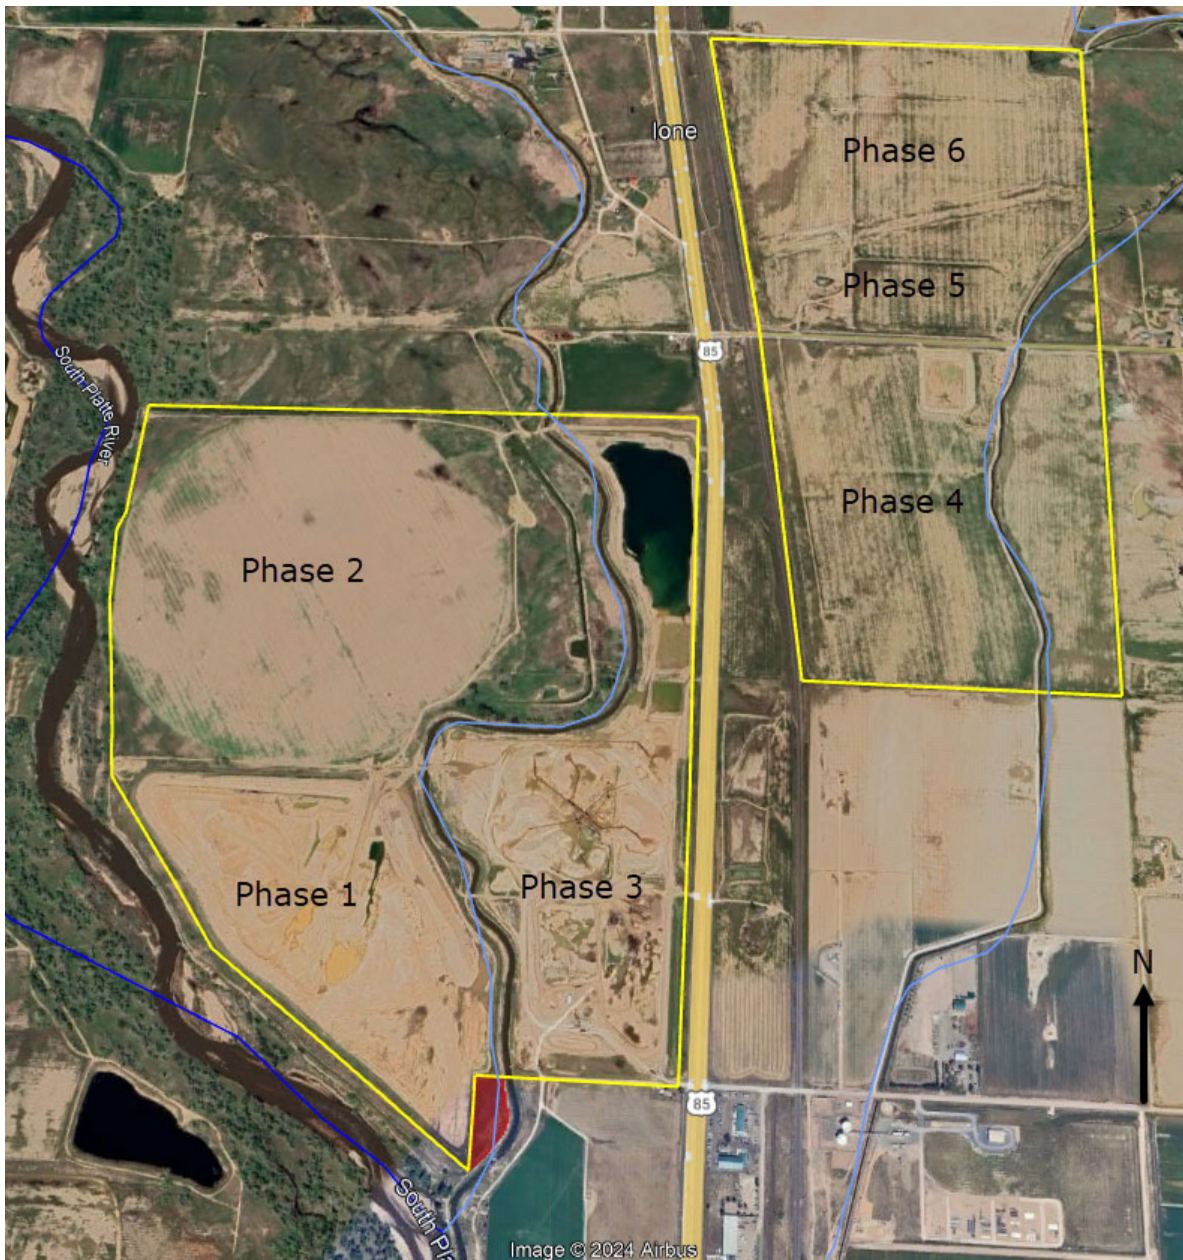
Image 3: Google Imagery depicting permitted area and mining phases. Image dated 9/4/2023.
