Division of Reclamation,
Mining and Safety

PERMIT INFORMATION

Permit Number: C-1981-012 Mine Name: New Elk Mine Operator: New Elk Coal Company, LLC Operator Address: Mr. Jim Begano 12250 Highway 12 Weston, CO 81091	County: Las Animas Operation Type: Underground Permit Status: Active Ownership: Private
	Operator Representative Present: Jim Begano
Operator Representative Signature: (Field Issuance Only)

Inspection Start Date: July 16, 2024 Inspection Start Time: 12:30 Inspection End Date: July 16, 2024 Inspection End Time: 14:20	Inspection Type: Coal Partial Inspection Inspection Reason: Normal I&E Program Weather: Clear
Joint Inspection Agency: None	Joint Inspection Contacts:
Post Inspection Agency: None	Post Inspection Contacts:
Inspector(s): Amber M. Gibson	Inspector's Signature:

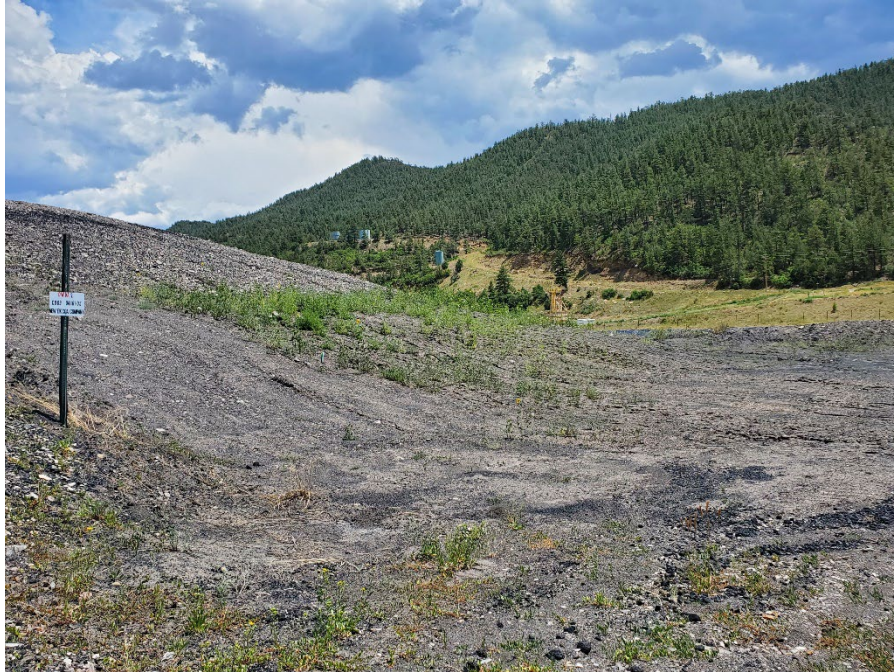
- Material from pond and ditch cleanings has not been placed in the east side of DWDA #2 since the cessation of pond pumping for the 2023 season. The Operator has been pumping the ponds this season, but no pond cleanings have occurred at this time. The previous cleanings have some volunteer vegetation growing on them (Photo 1).

Photo 1: Volunteer vegetation growing on the previous pond cleanings on the east side of DWDA #2.

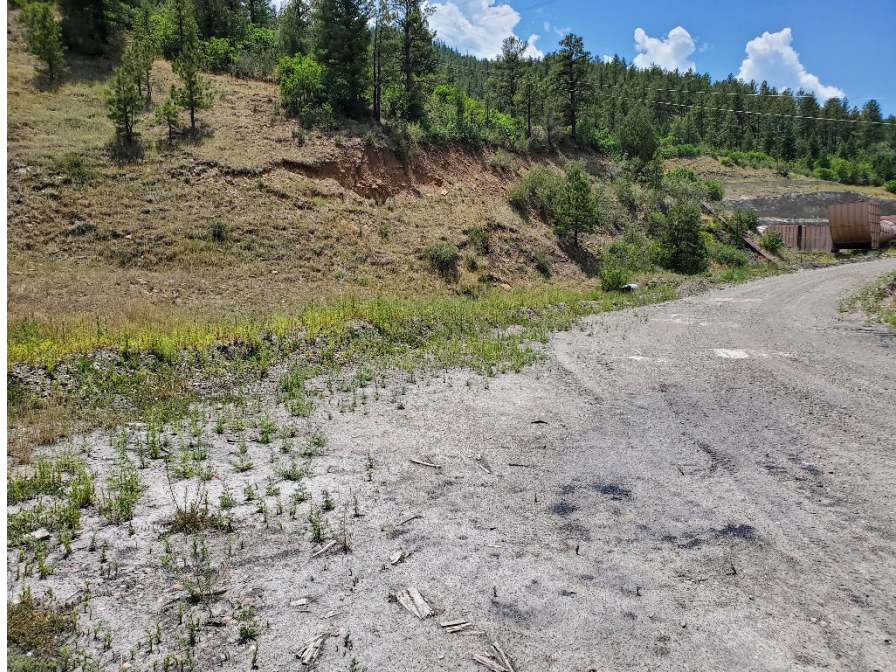
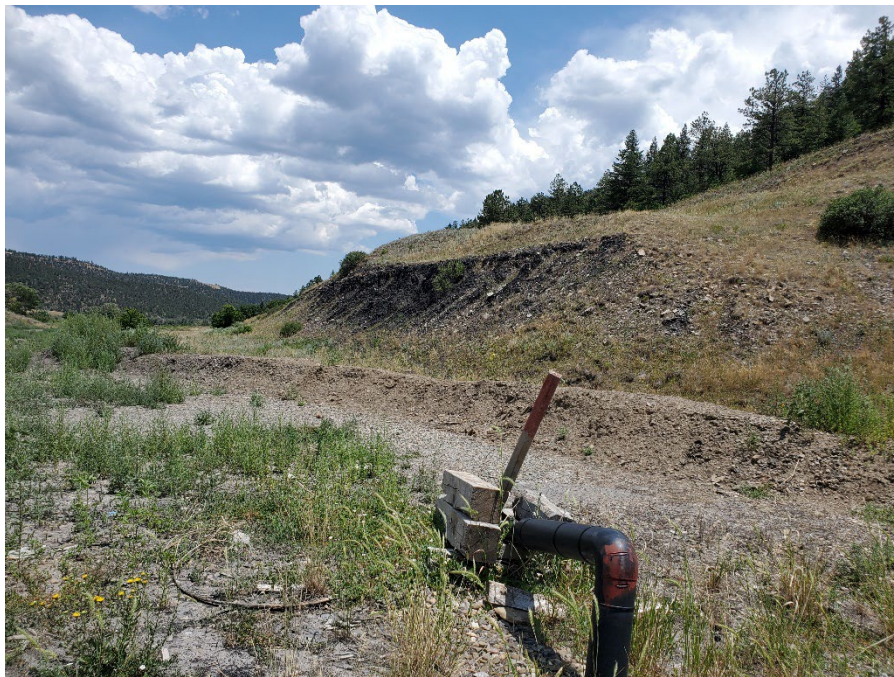
- The berm along the south-side of the haul road between the Silos and Pond 007A is in good condition and appears to be effectively controlling run-off (Photos 2 and 3).

Photo 2: Looking south-west at the berm along the south side of the haul road leading to the silos.

Photo 3: Looking south-east at the berm along the south side of the haul road leading to the silos.

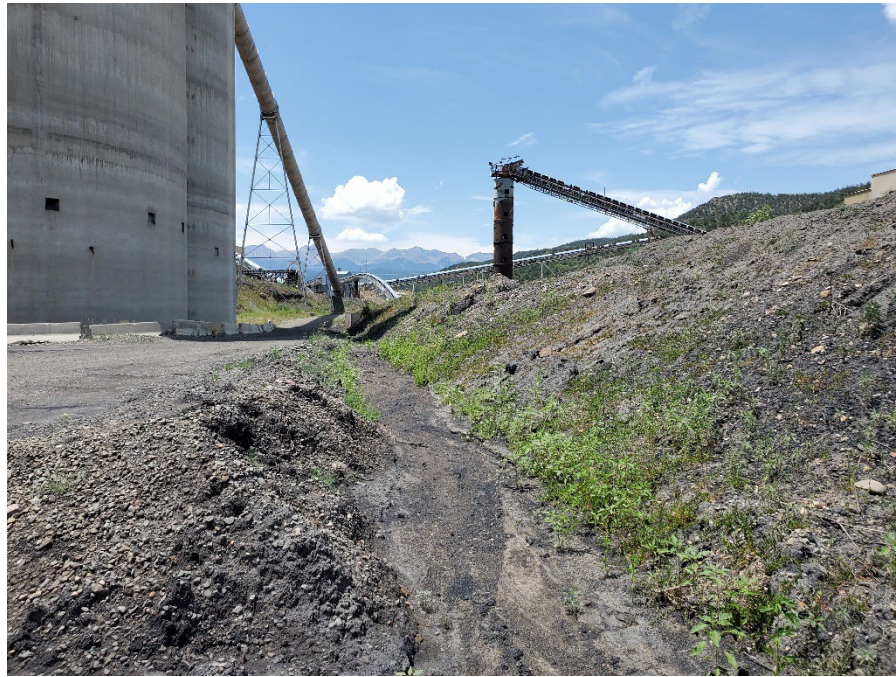
- Ditch D24B was clear of obstructions and appeared to be functioning adequately (Photo 4).

Photo 4: Looking west down ditch D24B.

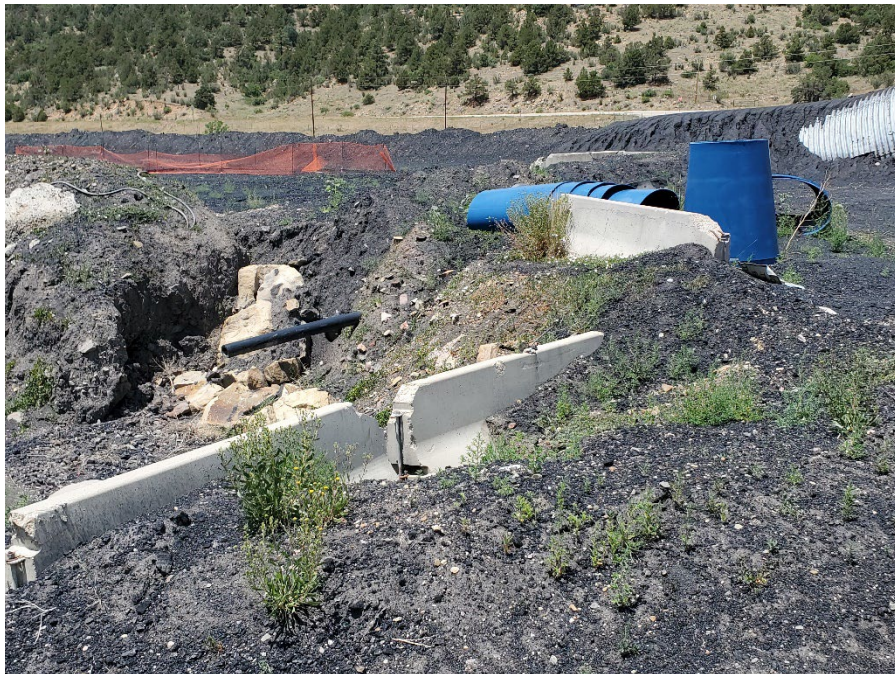
- Run-off from the raw coal storage area on the southwest side of the portion of the haul road entering the storage area appears to be draining to ditch D22, as designed (Photo 5).

Photo 5: Run-off from the raw coal storage area draining into D22.

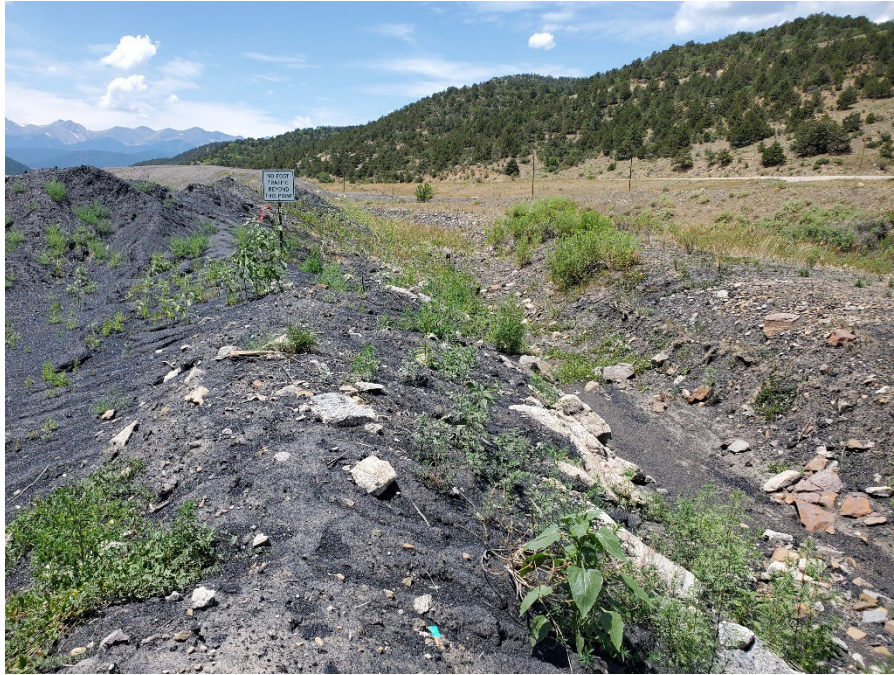
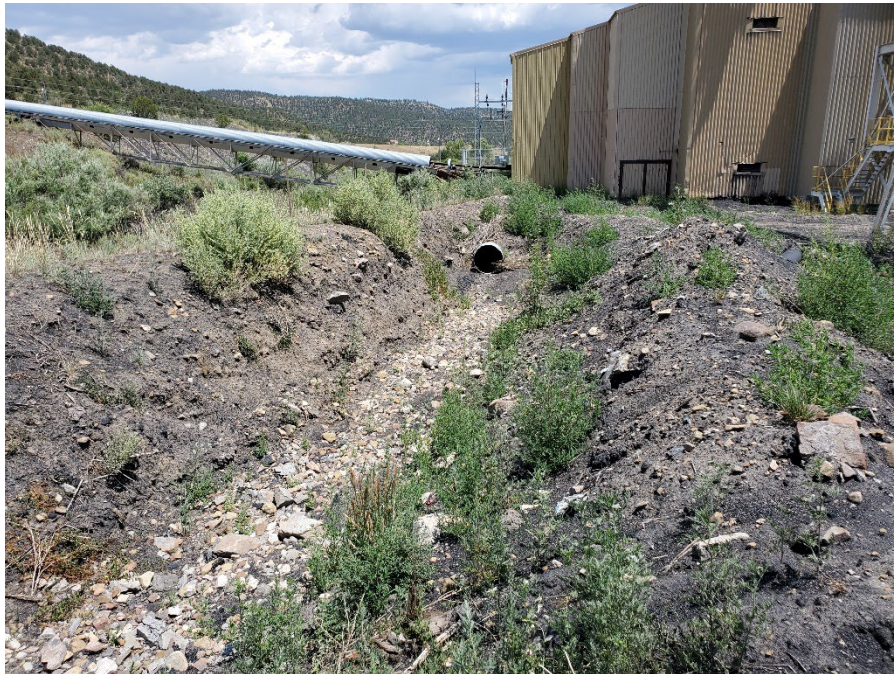
- Run-off on the north side of the raw coal storage area appears to be entering ditch D32 and flowing into culvert C64 as designed. D32 and C64 were clear of obstructions at the time of the inspection (Photos 6-7).

Photo 6: Looking west into D32, standing on the northern berm in the raw coal storage area.

Photo 7: Looking east into D32, leading to C64, standing on the northern berm in the raw coal storage area.

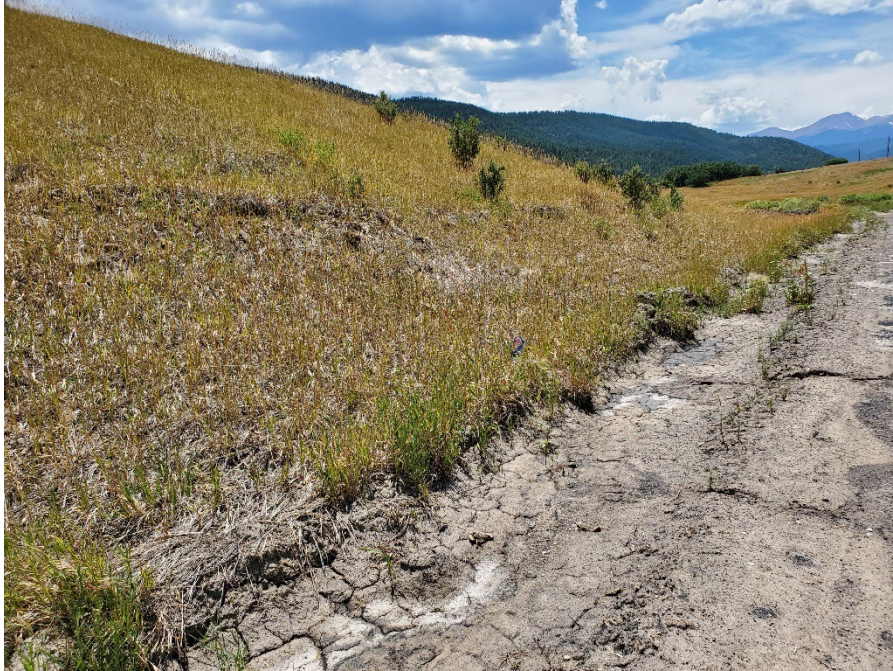
- Ditch D2 on the north side of DWDA #1 was dry at the time of the inspection (Photo 8).

Photo 8: Looking west down D2.

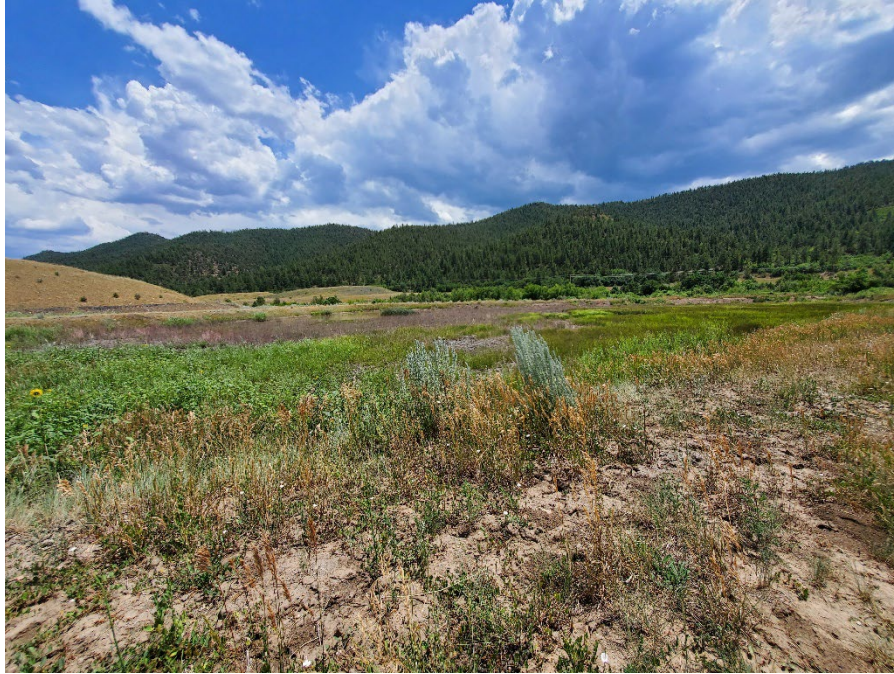
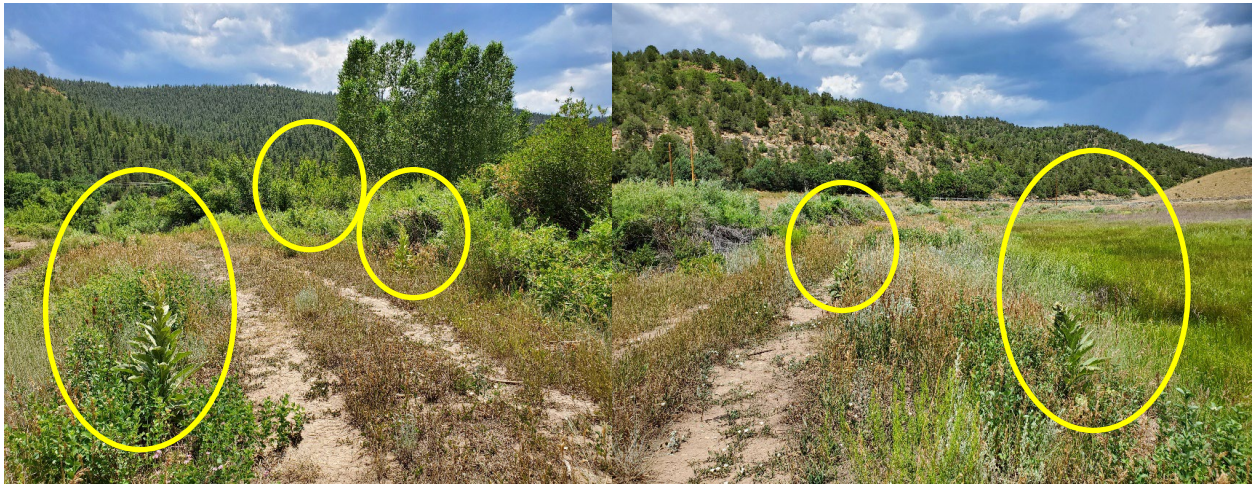
- Pond 004A was mostly dry, with some water restricted to the southeast corner of the pond (Photo 9). Pond 004A was not discharging. The banks were vegetated and appeared to be stable. The principal and emergency spill ways were clear.
 - The state listed noxious weed, Mullein, was observed along the light use road leading to the southwest corner of Pond 004 (Photo 10). **The Operator shall treat and or remove the Mullein from the area around Pond 004.**

Photo 9: Looking south-east across Pond 004A.

Photo 10: Some Mullein circled in yellow. (Left) Looking south down the light use road leading to Pond 004A. (Right) Looking north up the light use road leading to Pond 004A.

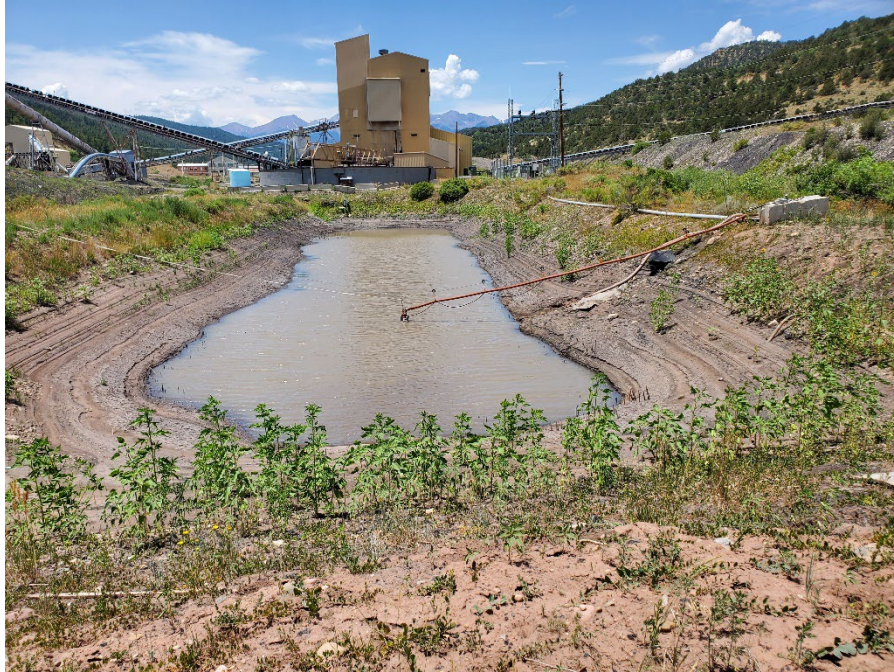
- Pond 006A contained some water and appears to have had plenty of capacity remaining at the time of the inspection (Photo 11). The pond was not discharging. The banks were vegetated and appeared to be stable.

Photo 11: Pond 006A.

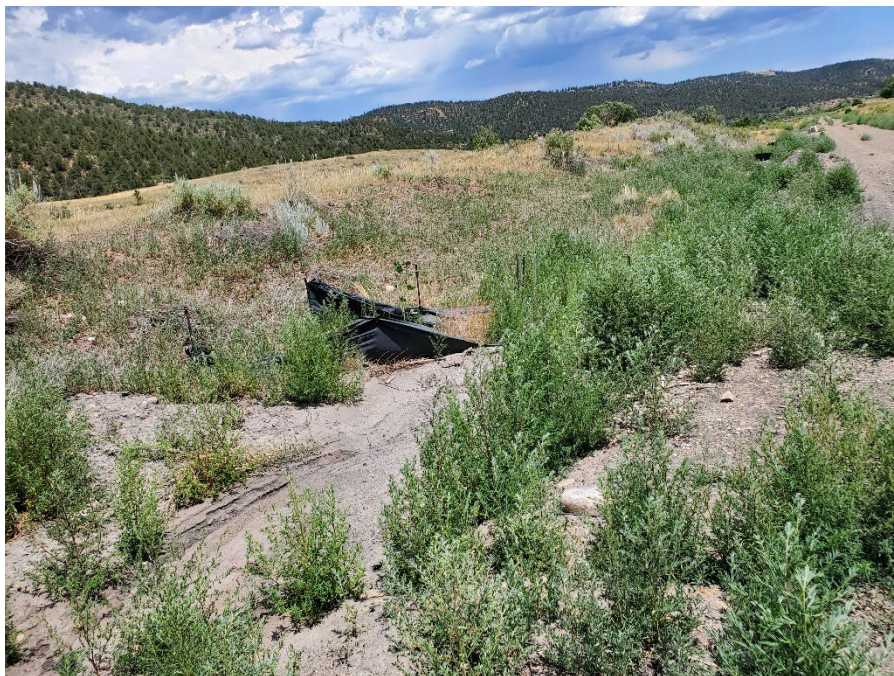
- Pond 007A was mostly dry at the time of the inspection, and was not discharging. The emergency spillway was free of obstructions and the embankment appeared to be stable. The east side of Pond 007A has vegetation growing within it, but the pond itself has plenty of capacity at this time. As noted in the June 2024 inspection report, the Division observed what seems to be new erosion on the north-west side of the northern bank. **The Operator shall repair the erosion on the bank.**
- **The silt fences along the SAE near Pond 007A that were damaged as of snowfalls, mentioned in the January - May 2024 reports, still need to be repaired.** The western-most silt fence on the north side of the access road and the south side of Pond 007A (Photo 12) is in the most disrepair. The following silt fences in the sequence are in decent condition and appear to be functioning properly.

Photo 12: Silt fence on southeast side of Pond 007A.

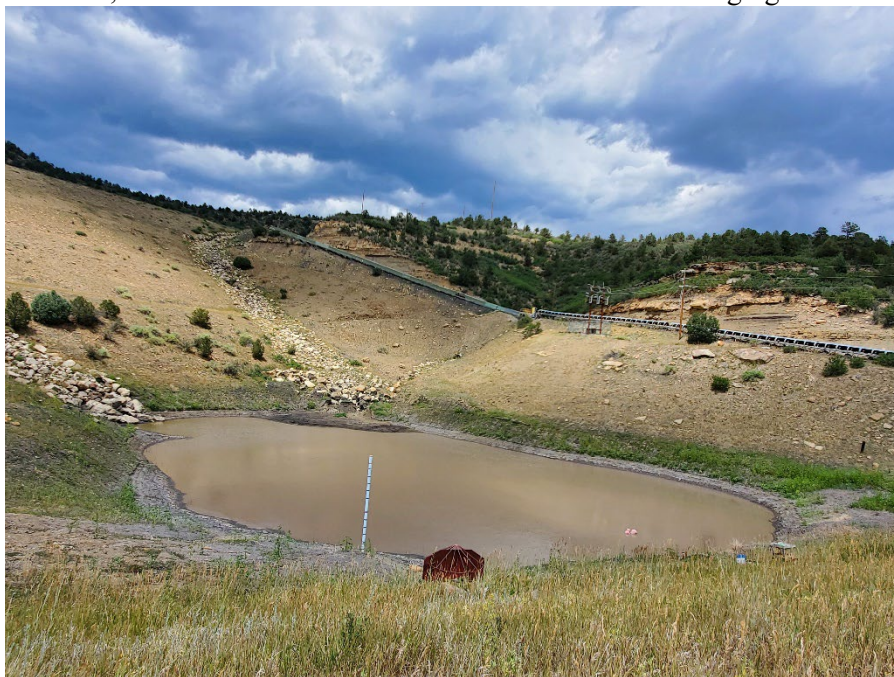
- Pond 08 contained some water, and was well below its capacity (Photo 13). The spillways appeared clear, and the banks were stable. Pond 08 was not discharging.

Photo 13: Pond 08.

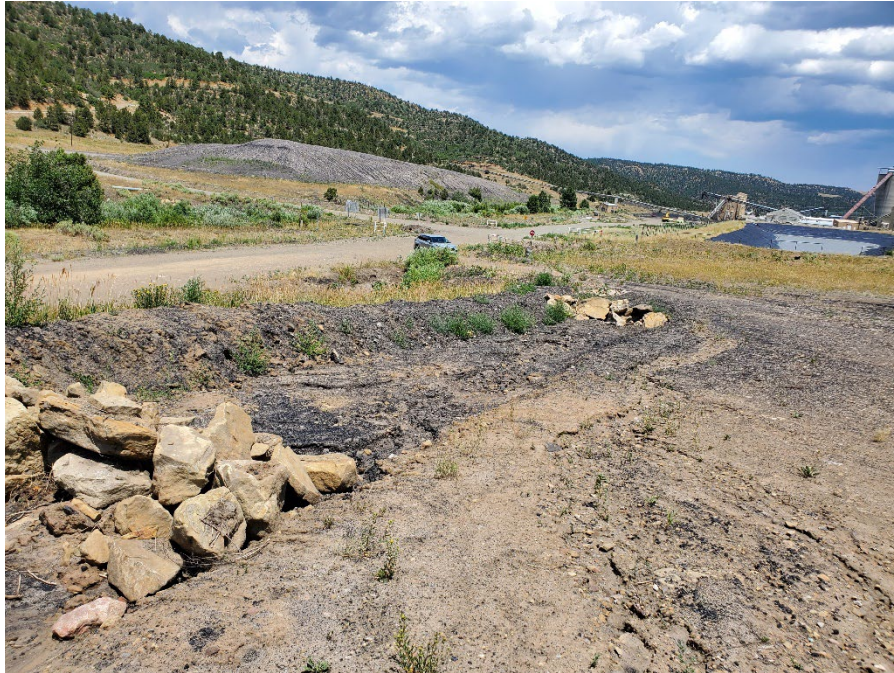
- The water bar installed along the north entrance to the soil storage area and Topsoil Pile #1, and the check dams along the northwest and northeast sides of the area appear stable and allow run-off to flow into culverts C9A and C9, as designed.
 - Some minor side cutting was observed along the south side of one of the check dams along the northwest side of the soil storage area, but the check dam still appeared to be functional. The Division advises the Operator to monitor this area and repair the banks of the check dams if the side-cutting begins to impair their function.

Photo 14: Looking northeast at the check dams bordering the northwest side of the soil storage area.

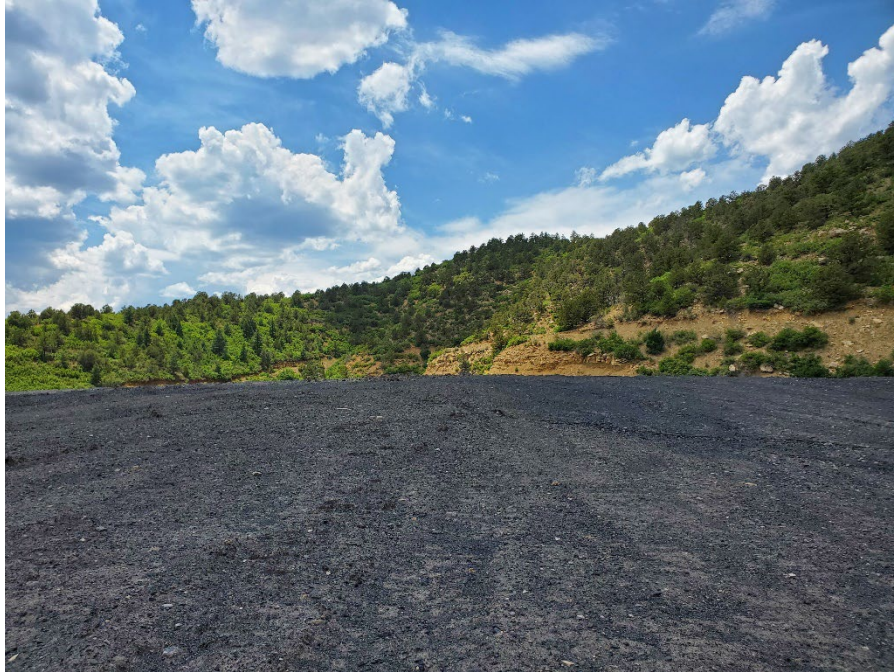
- The mine was idle at the time of the inspection. Therefore, the wash plant was not processing coal at the time of the inspection. The RDA appears to exhibit positive drainage at this time (Photo 15). The underdrains in the northeast and northwest corners appear to be clear of obstructions, and appear to be functioning as intended.

Photo 15: Positive drainage on RDA.

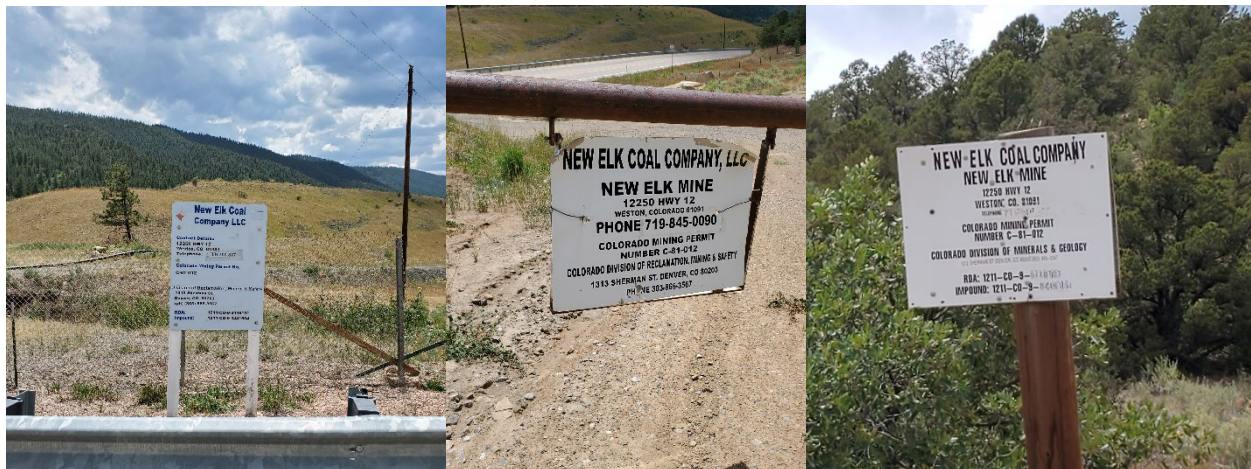
- A mine sign was observed at the main entrance to the New Elk mine site, at the entrance to the RDA, and at the entrance leading to Containment #5, in compliance with Rule 4.02 (Photo 16).

Photo 16: (Left to Right) Sign at entrance to: Main Site, RDA, and Containment #5.
