Inspection Report July 2024 Seneca IIW

PERMIT INFORMATION

Permit Number: C-1982-057 Mine Name: Seneca IIW Mine Operator: Seneca Property LLC Operator Address: Ms. Miranda Kawcak 29515 Routt County Road 27 Oak Creek, CO 80467	County: Routt Operation Type: Surface Permit Status: Permanent Cessation Ownership: Private
	Operator Representative Present: Miranda Kawcak
Operator Representative Signature: (Field Issuance Only) This report was issued electronically from the Divisions' Denver Office.

Inspection Start Date: 24 July 2024 Inspection Start Time: 9:00 a.m. Inspection End Date: 24 July 2024 Inspection End Time: 3:30 p.m.		Inspection Type: Coal Complete Inspection Inspection Reason: Normal I&E Program Weather: Partly Cloudy	
Joint Inspection Agency: None		Joint Inspection Contacts:	
Post Inspection Agency: None		Post Inspection Contacts:	
Inspector(s): Robin Reilley, M.S. GISP	Inspector's Signature:

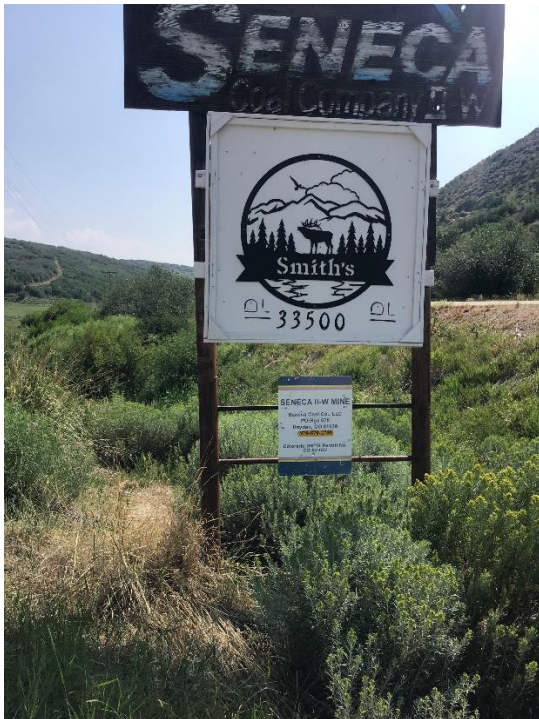
- The mine identification signs were in place at the site entrance from the County Road and the road up to Pond 15. The signs were intact, displaying all required information: mine name, operator name, address, phone number, DRMS permit number and contact information.

Photo 1: Mine Identification sign at site entrance.

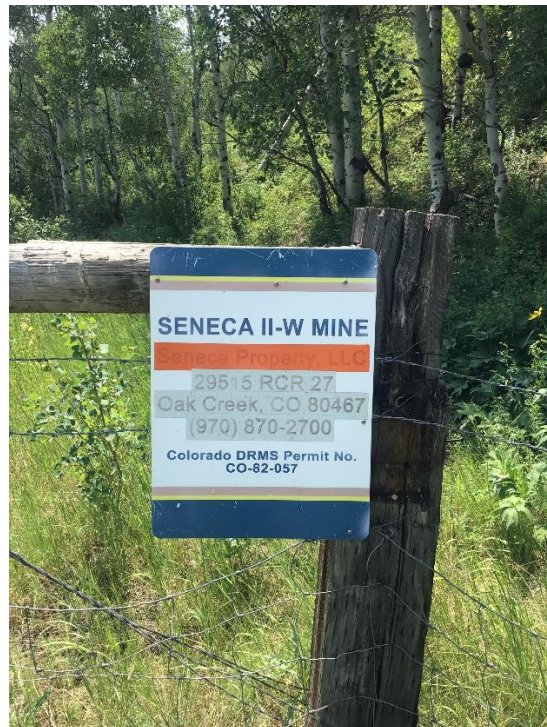
Photo 2: Mine Identification sign road to Pond 15.

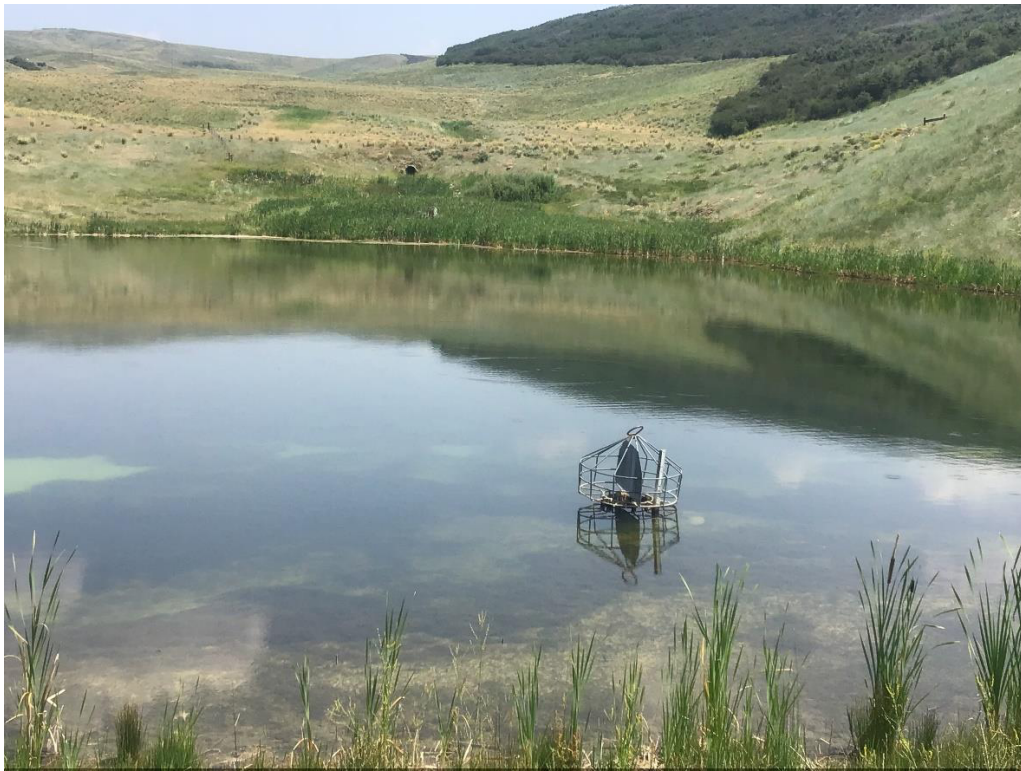
The two slumps and associated crack between them at Pond 6 appeared stable at the time of inspection. No new movement was noted at the time of inspection. Yellow sweet clover had established itself in the slump that occurred in the spring of 2022

Photo 3: Pond 6, exhibiting very clear water and discharging.

- Pond 6: Vegetation, willows and grasses should be cleared from flume entrance and exit.
- Pond 16: Grasses around flume need to be removed.
- Pond 17: Cattails at flume entrance require removal.

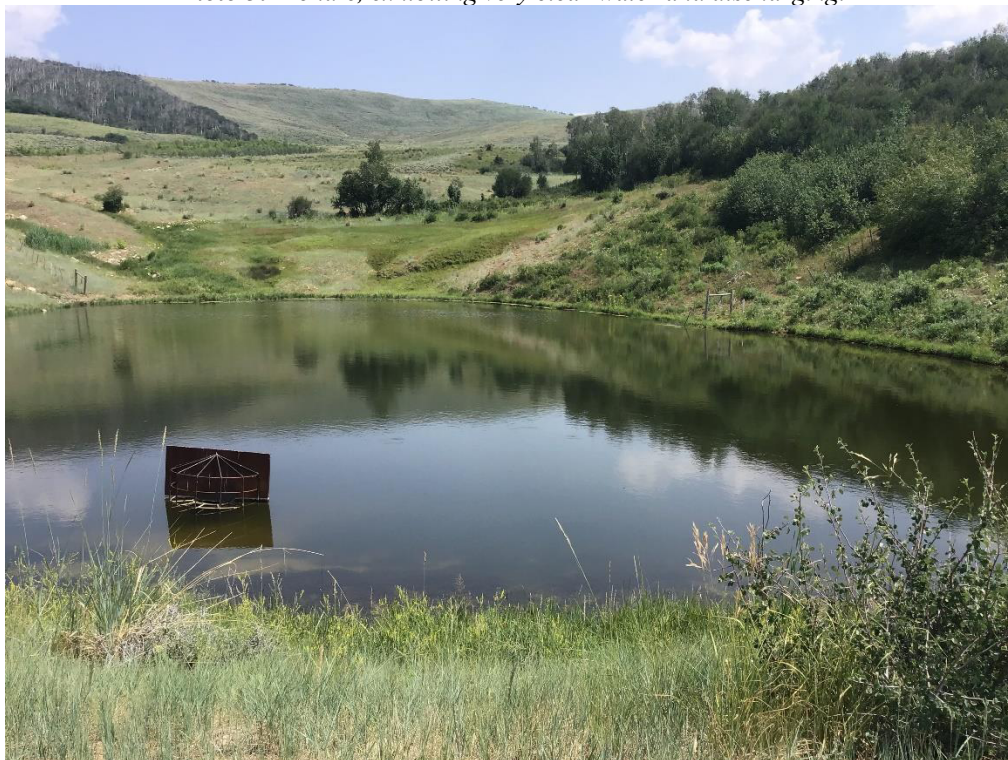
Photo 4: Pond 16, looking up valley, discharging clear water.

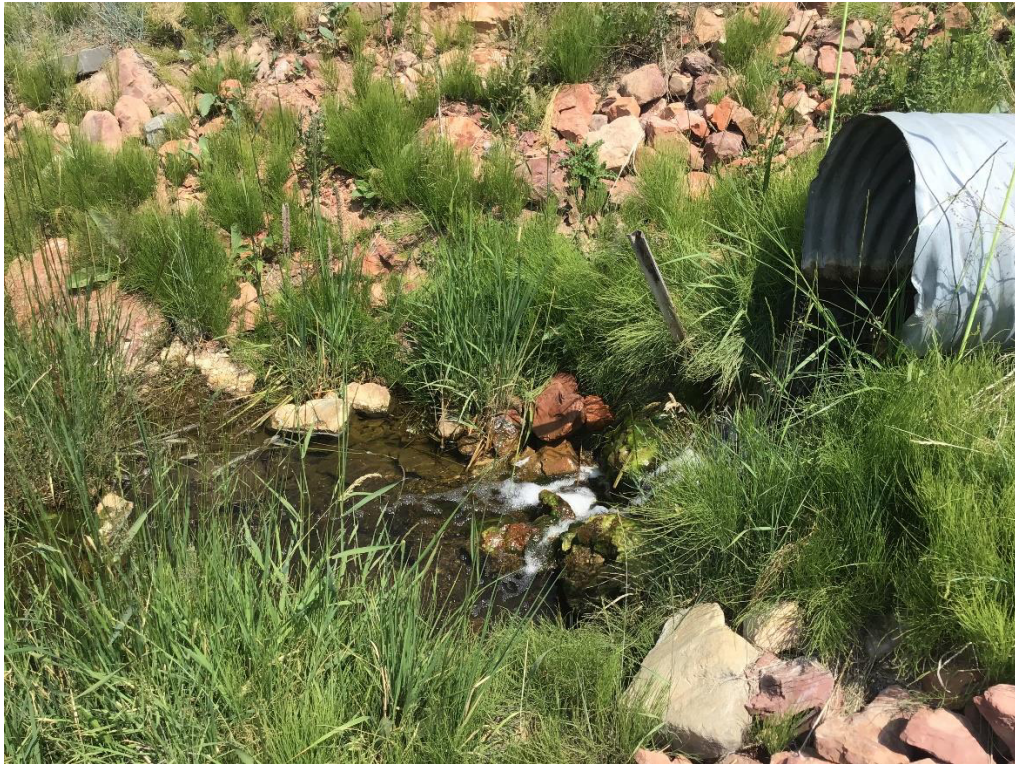
Photo 5: Pond 16 discharge culvert, discharging clear water.

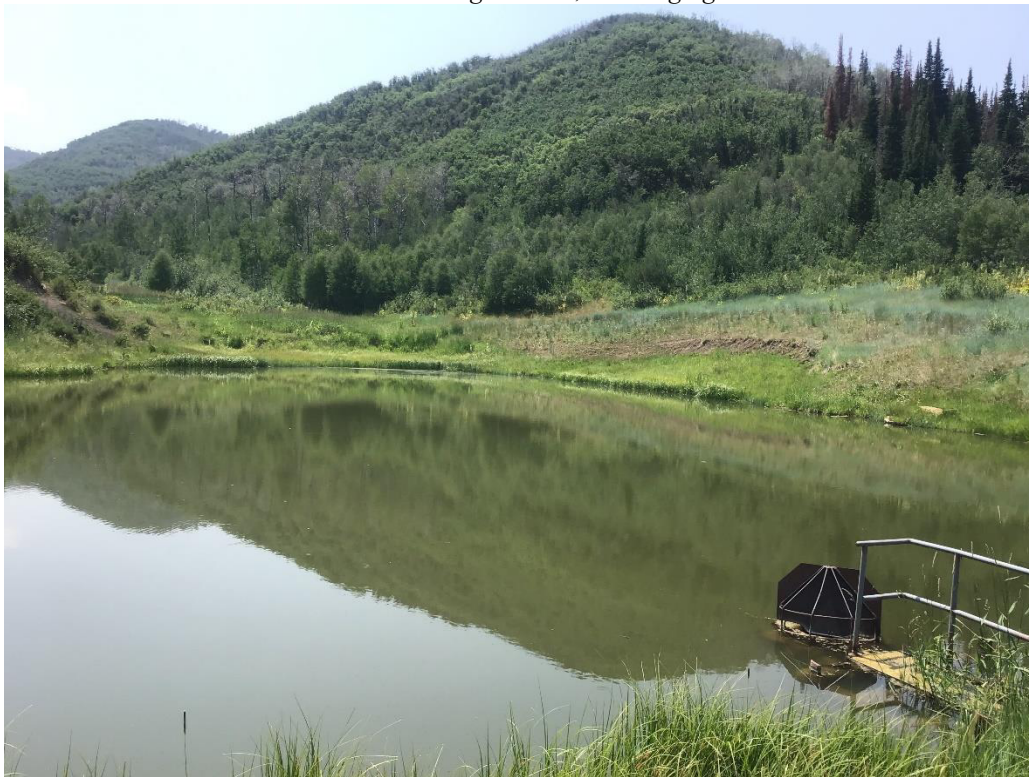
Photo 6: Pond 15 looking up valley, discharging at the time of inspection.
