Inspections 2024 July: Williams Fork and Yoast

PERMIT INFORMATION

Permit Number: C-1994-082 Mine Name: Yeast Mine Operator Address: Seneca Property LLC Ms. Miranda Kawcak 29515 Routt County Road No. 27 Oak Creek, CO 80467	County: Routt Operation Type: Surface Permit Status: Permanent Cessation Ownership: Private Operator Representative Present: Miranda Kawcak
Operator Representative Signature: (Field Issuance Only) This report was issued electronically from the Divisions' Denver Office.

Inspection Start Date: 24 July 2024 Inspection Start Time: 9:30 a.m. Inspection End Date: 24 July 2024 Inspection End Time: 1:30 p.m.	Inspection Type: Coal Complete Inspection Inspection Reason: Normal I&E Program Weather: Partly Cloudy
Joint Inspection Agency: None	Joint Inspection Contacts:
Post Inspection Agency: None	Post Inspection Contacts:
Inspector(s): Robin Reilley, M.S. GISP	Inspector's Signature:

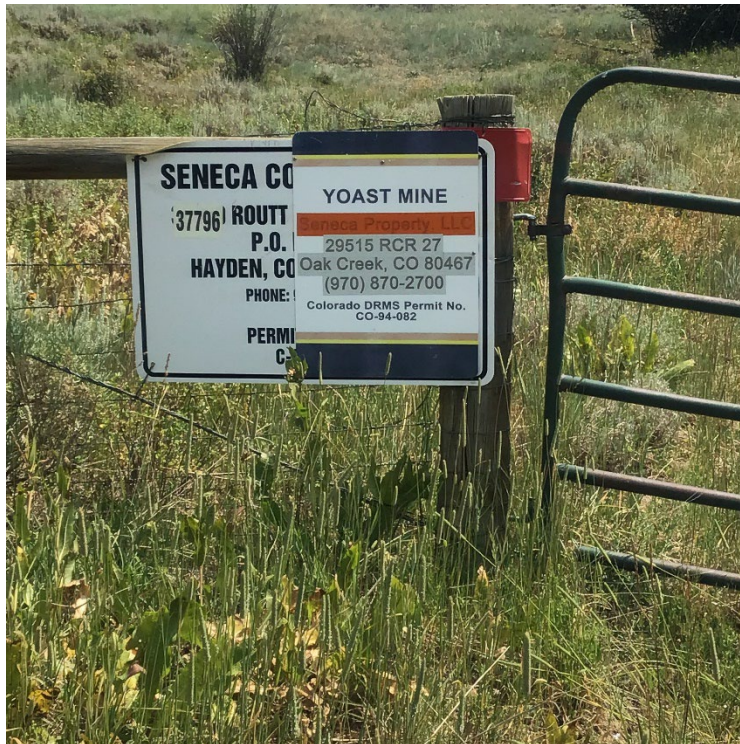
- The mine identification signs were in place at the site entrance and along County Road 37 where the ponds are accessed. The signs were intact, displaying all required information: mine name, operator name, address, phone number, DRMS permit number and contact information.

Photo 1: Yoast permit identification sign on County Road 37.

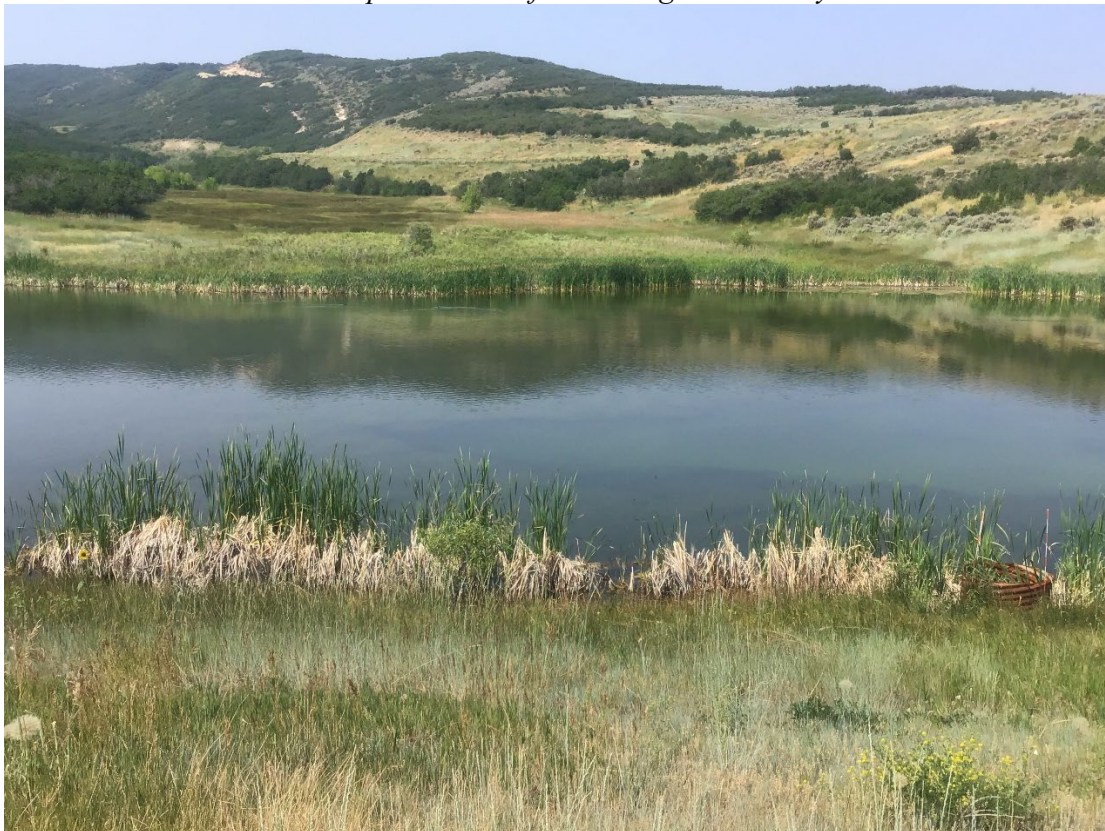
Photo 2: Pond 10 looking up valley to the associated wetlands.

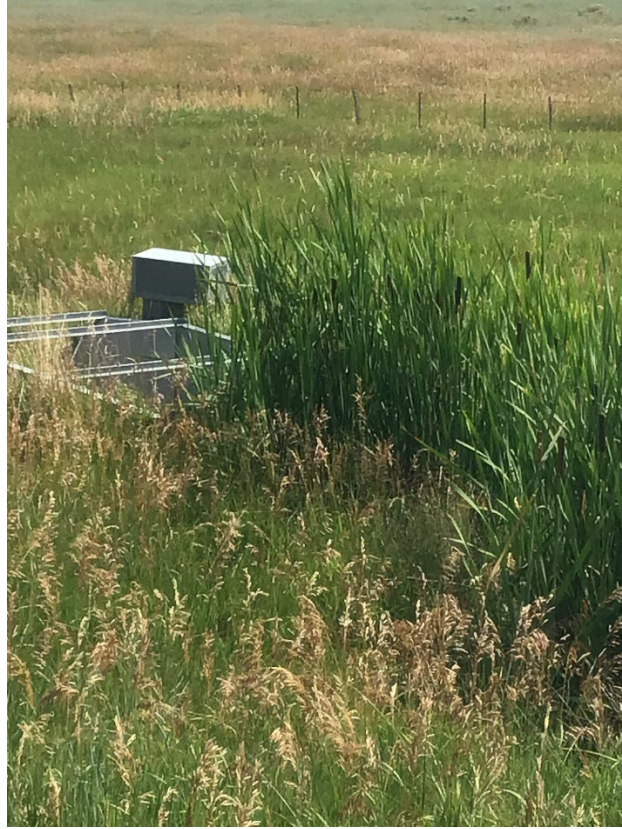
- Pond 10 discharging through the decant well
- Decant structure is rusted at well and along culvert to flume., and there is a stand of cattails at the entrance to the flume.
- Pond 12 was discharging clear water at the time of inspection.
- Flume is difficult to reach due to verdant summer vegetation.
- Pond 13 appeared slightly turbid and was not discharging at the time of inspection.
- Pond 13 had been scheduled for a dye treatment in early June to prevent summer algal growth. As there were small algal mats present, it appears the dye was not administered.
- Springs above Ponds 12 and 13 were dry at the time of inspection.
- Pond 14 held water at the time of inspection.

Photo 3: Pond 10 flume and stand of cattails at flume entrance.

1. Decant structure at pond 10 requires repairs.
2. Cattails at Pond 12 flume entrance and along upstream portion of flow path should be removed.

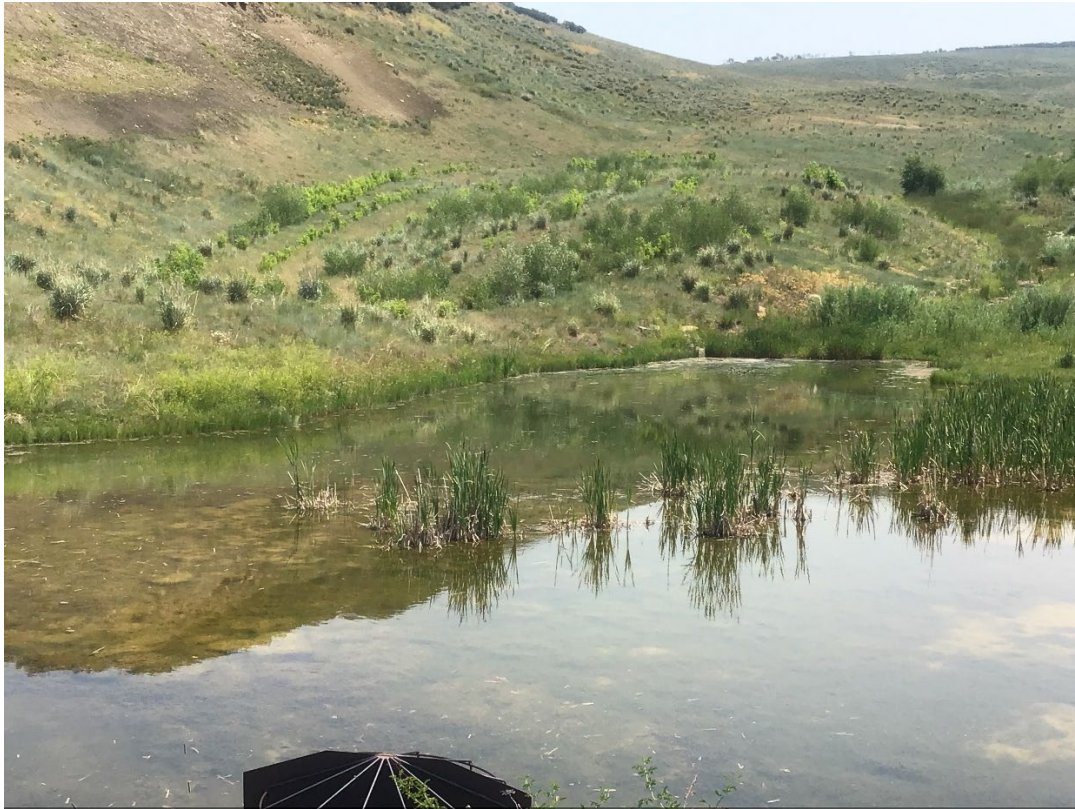
- Revegetated areas of reclamation appear stable with good cover and an adequate species diversity consisting of shrubs, grasses, and native perennials.
- Vegetation had matured for the summer, and some species were beginning to dry up and become dormant.
- Tree plantings at Pond 12 appeared vigorous and healthy.

Photo 4: Pond 12 and healthy tree stands in the background.
