Inspections 2024 July: Williams Fork and Yoast

22 July 2024

Permit Number: C-1981-044
Mine Name: Williams Fork Mines
Operator: Moffat County Mining, LLC
Operator Address:
Ms. Miranda Kawcak
29515 Routt County Road #27
Oak Creek, CO 80467
Operator Was issued electronically from the Divisions' Denver Office.

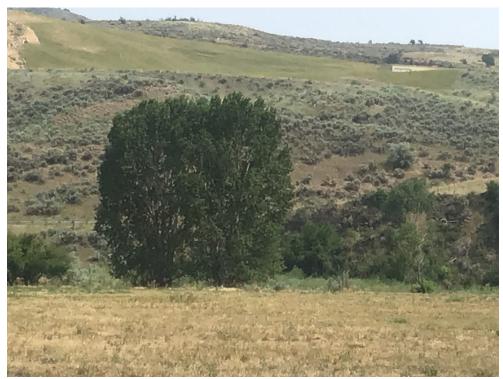
- o Reclamation of the 5A Portal area is complete.
- o Backfilling, grading, topsoil and seeding occurred in 2023 at the 5A Portal.

Photo 1: Backfilled and graded 5A Portal slopes and service building, viewed from bottomland below.

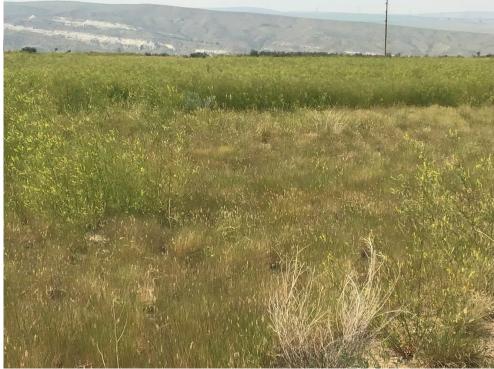
- O Slope to Pond 5A-P1 were well vegetated with yellow sweet clover, for the most part obscuring any gullies and rills.
- o Stream buffer zone along the Williams Fork River was marked.
- O Ditches throughout the site, along haul roads and in the cropland area appeared to be functioning adequately.

Photo 2. Slope toward the 5AP1 Pond below the shop are, vegetation comprises some grasses and a plethora of yellow sweet clover.

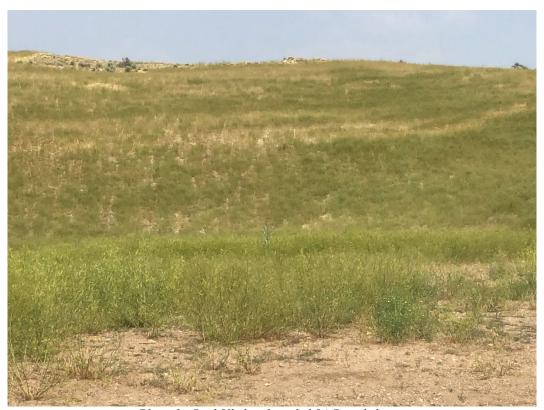
Photo 3: Backfilled and graded 5A Portal slopes.

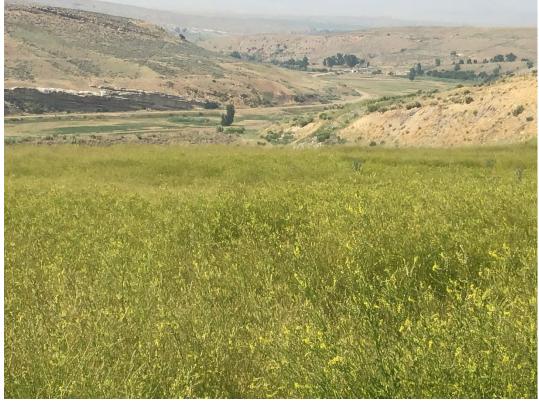
- o Revegetated areas of reclamation appear stable at the time of inspection.
- 5A Portal area exhibits grasses, and a dense stand of yellow sweet clover obscuring the small sage shrubs.
- o Croplands exhibited dry with stubble having been harvested in early July.
- o 2600 bales of hay were cropped.

Photo 4: Overview of cropland area adjacent to the Williams Fork River, looking north west from the 5A Portal above.
