# Re: M2020007 Ragsdale Reservoirs Acreage Release AR1 Inspection Report

# MINERALS PROGRAM INSPECTION REPORT PHONE: (303) 866-3567

MINE NAME:	MINE/PROSPECTING ID#:	MINERAL:	COUNTY:
Ragsdale Reservoirs	M-2020-007	Gravel, sand and	Weld
		borrow material	
INSPECTION TYPE:	WEATHER: Clear	INSP. DATE:	INSP. TIME:
Surety Release Inspection		July 16, 2024	10:00
OPERATOR:	<b>OPERATOR REPRESENTATIVE:</b>	TYPE OF OPERAT	FION:
L. G. Everist, Incorporated	Lynn Mayer Schults	112c - Construction	Regular Operation

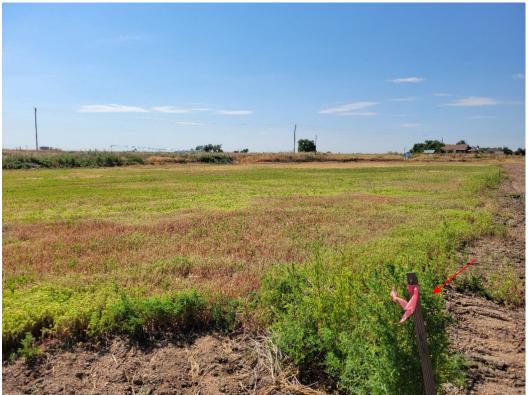
Photo 1: Looking south across the proposed 1.95-acre release area. New boundary marker in the foreground (red arrow).

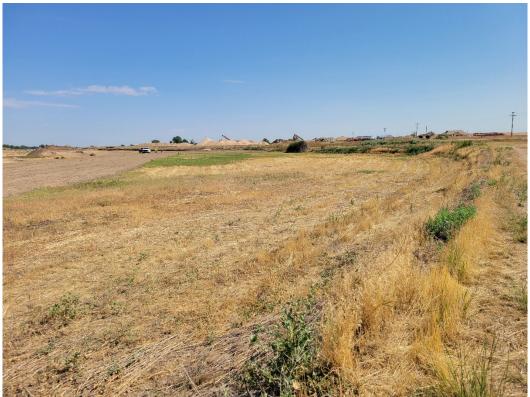
Photo 2: Looking north across the proposed 1.95-acre release area.

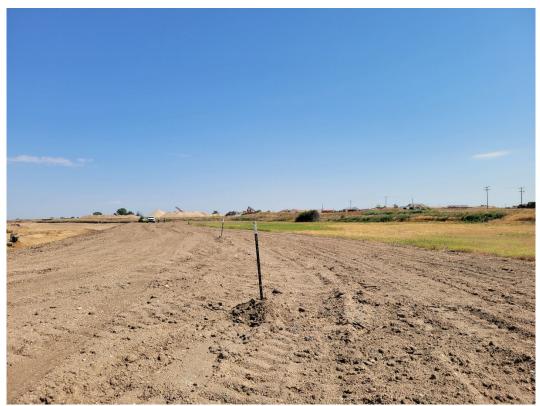
Photo 3: Looking north from the southern end of the Phase 1 mining area. Metal posts with white tops mark the installed slurry wall around the reservoir.

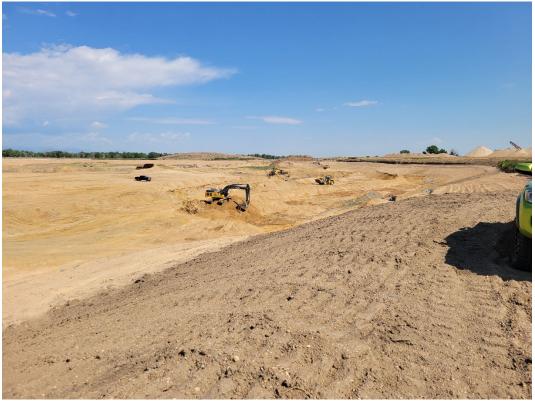
Photo 4: Looking north at mining operations in the Phase 1 area. Reservoir slopes have been graded to 3H:1V and topsoil has been placed on top.

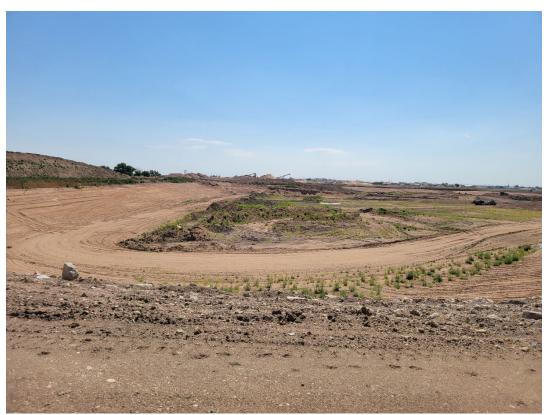
Photo 5: Looking south from the north end of the Phase 1 mining area. Slopes are 3H:1V and concrete rip rap is placed along the western side.

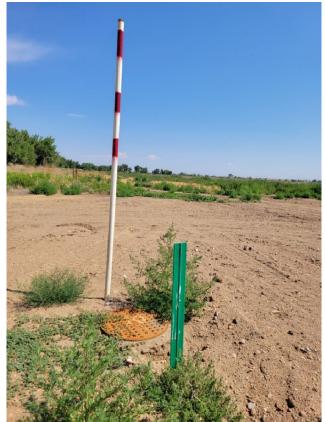
During this inspection, representatives of LGE showed the Division an underdrain that runs between the Phase 1 and Phase 2 mining areas. The drain was recently installed to move groundwater from the east around the slurry walled reservoirs to the South Platte River. Ms. Shults informed the Division that they installed the permanent underdrain for the landowner, Cannon Land Company. Following the inspection, the Division reviewed the permit file and approved mining and reclamation plan maps and determined the underdrain was not included in the original plans for the site. In response to an email request from the Division, LGE provided the schematics and plans for of the installed underdrain.

Photo 6: Looking at the underdrain marker and manhole/cleanout near the western boundary, between the Phase 1 and Phase 2 areas.

Based on the observations during this inspection and the schematics and plans provided, LGE will need to submit an Amendment Application and obtain approval for the underdrain and extend the permit boundary to encompass the area affected by the installation and operation of the drain.

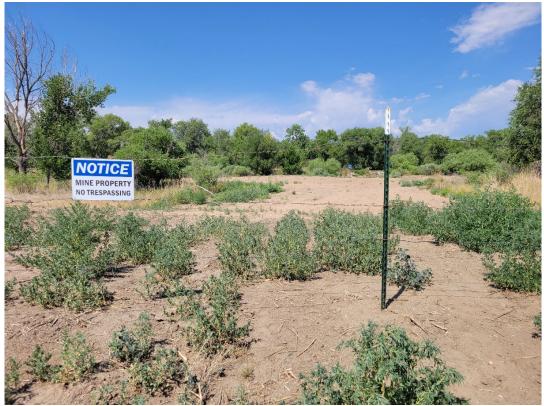
Based on the description in the 2020 application, the western permit boundary is 100 feet east and parallel to the east toe of a historic levee/berm that was built by the landowner along the South Platte River. During this inspection, the Division observed a barbed wire fence on top of the historic levee/berm. The operator stated the fence is the western permit boundary marker, which is inconsistent with the description in the application. **Problem 1 cited above states that LGE shall survey the western permit boundary and ensure it is marked as described in the approved application. The operator shall demonstrate compliance by submitting photographic evidence of the installation of the markers in place along point location data by the corrective action date. Additionally, when the operator submits the next revision or amendment, the mining and reclamation maps should be updated to clearly show a 100' buffer between the toe of the historic levee and the permit boundary.**

Photo 7: Looking west from the boundary fence on top of the levee that runs along the western side of the permit area. The newly installed underdrain runs beneath this area.

**CORRECTIVE ACTIONS:** The operator shall survey and install boundary markers along the western side of the permit area, 100 feet east and parallel to the toe of the historic levee/berm. The boundaries of the affected area must be marked by monuments or other markers that are clearly visible and adequate to delineate such boundaries. The operator shall demonstrate compliance by submitting photographic evidence of the installation of the markers in place, along with point location data, to the Division by the corrective action date. **CORRECTIVE ACTION DUE DATE:** 8/28/24

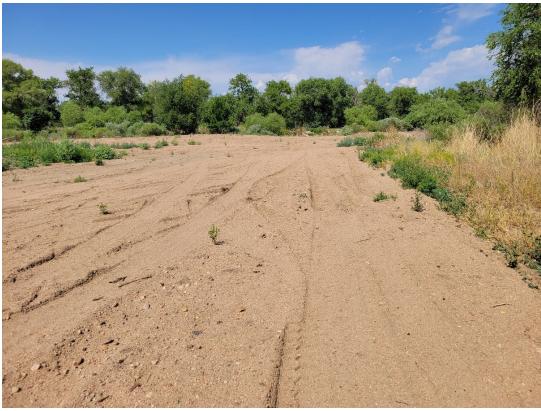
**POSSIBLE VIOLATION:** Possible Violation: The Division observed an underdrain that runs between the Phase 1 and Phase 2 mining areas. The drain was installed to move groundwater from the east around the slurry walled reservoirs and extends beyond the western permit boundary where it discharges to the South Platte River. Land was affected outside of the approved permit boundary for the installation of the drain. This is a possible violation at this time pursuant to C.R.S. 34-32.5-116(4)(i) for failure to protect areas outside of the affected land from slides or damages occurring during the mining operation.

Photo 8: Looking west towards the South Platte River at the area of disturbance outside the permit boundary. The underdrain is installed beneath the ground here.

**CORRECTIVE ACTIONS:** This possible violation will require a hearing before the Mined Land Reclamation Board. The schedule and other details for the MLRB hearing will be provided under a separate document to be sent via certified mail to the operator.

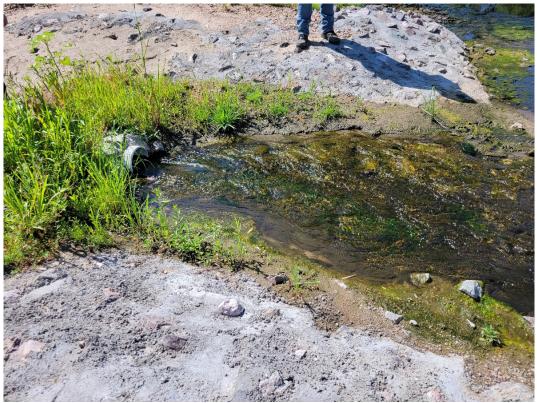
Additionally, the Division observed the underdrain outlet in the South Platte River, which flows parallel to the western permit boundary. According to the description in the 2020 application, the western permit boundary is 100 feet east and parallel to the east toe of a historic levee/berm that was built by the landowner along the South Platte River. Based on this description and observations in the field, the Division determined the underdrain extends 400-feet beyond the western permit boundary to the South Platte River. The Division observed a 20-foot-wide x 400-foot-long disturbance patch between the western permit boundary and the discharge point. Concrete was placed at the culvert outlet to prevent erosion around the drain. Therefore, this section of the underdrain is outside the permitted area. Based on the observations during this inspection, approximately 8000 ft<sup>2</sup> (0.18 acre) was affected outside of the approved permit boundary for the installation of the underdrain. Pursuant to C.R.S. 34-32.5-116(4)(i) this is a possible violation for failure to protect areas outside of the affected land from slides or damages occurring during the mining. As cited above, this Possible Violation will require a hearing before the Mined Land Reclamation Board. The schedule and other details for the MLRB hearing will be provided under a separate document to be sent via certified mail to the operator.

Photo 9: Looking at the discharge location for the underdrain in the South Platte River.

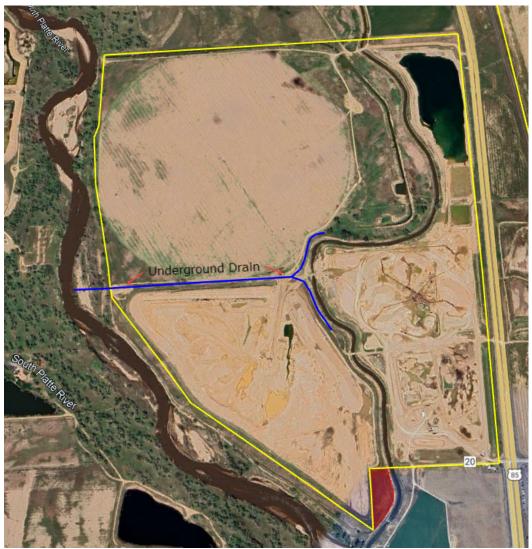
Image 2: Google Imagery showing the approximate permit boundary on the west side of the permit area and the location of the installed underdrain (blue line) between the Phase 1 and Phase 2 mining areas. Image dated 9/4/2023.

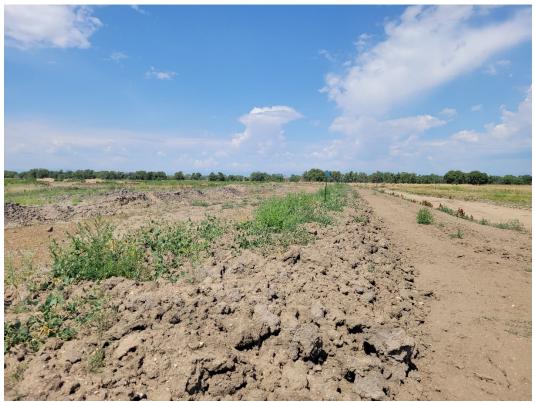
The Division viewed the slurry wall recently installed around the perimeter of the Phase 2 area. Additionally, the Operator pointed out that the oil and gas wells depicted on the mining and reclamation maps in the Phase 1 and Phase 2 areas have been removed, along with the associated gas lines. The Operator should depict this change on the mining and reclamation maps in the next permit revision.

Photo 10: Looking west at the recently installed slurry wall that runs along the northern border of the Phase 2 area.
